# Inspection Report

**UNCOVER**  
BUILDING AND PEST INSPECTIONS

**1 Sample St , Sample, Nsw, 2281**

### Handover Inspection

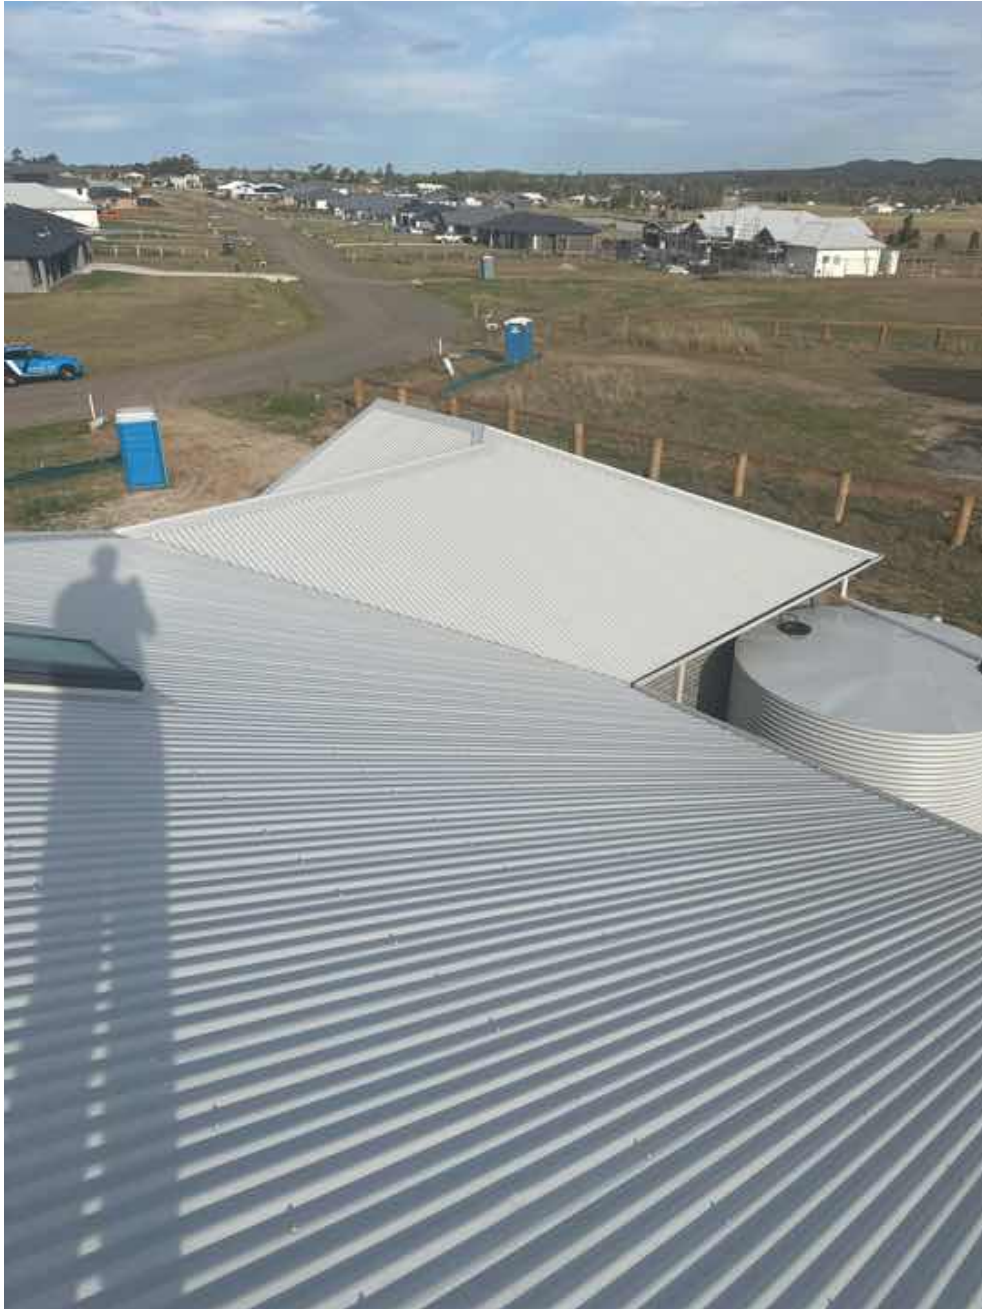
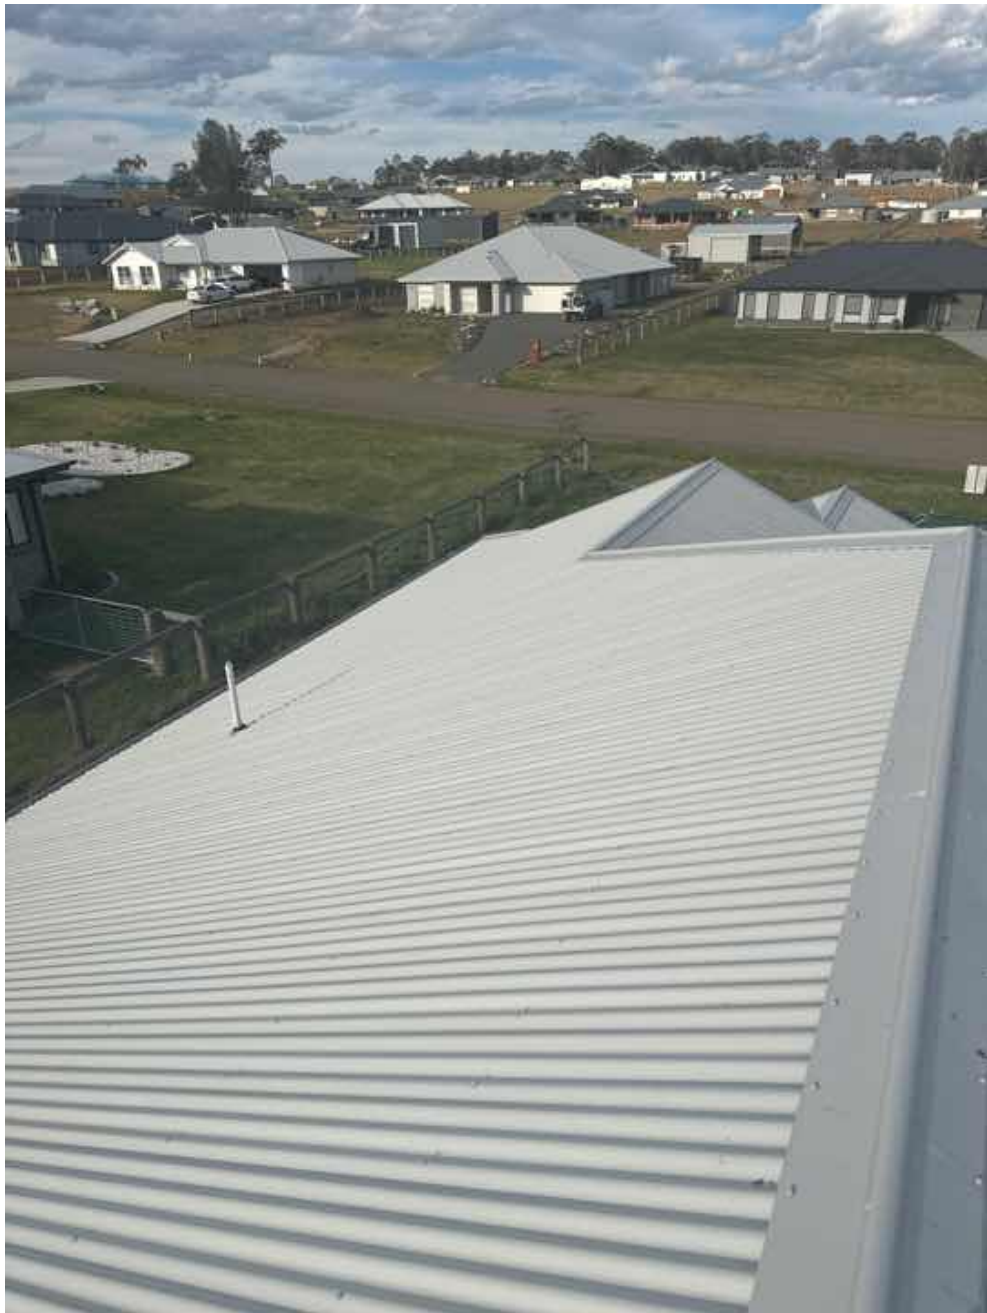
Of the visible areas inspected the roof appears to be acceptable.

NOTE: This is not a guarantee that the roof will not leak, recommend monitoring after each rainfall event for the first year of service.

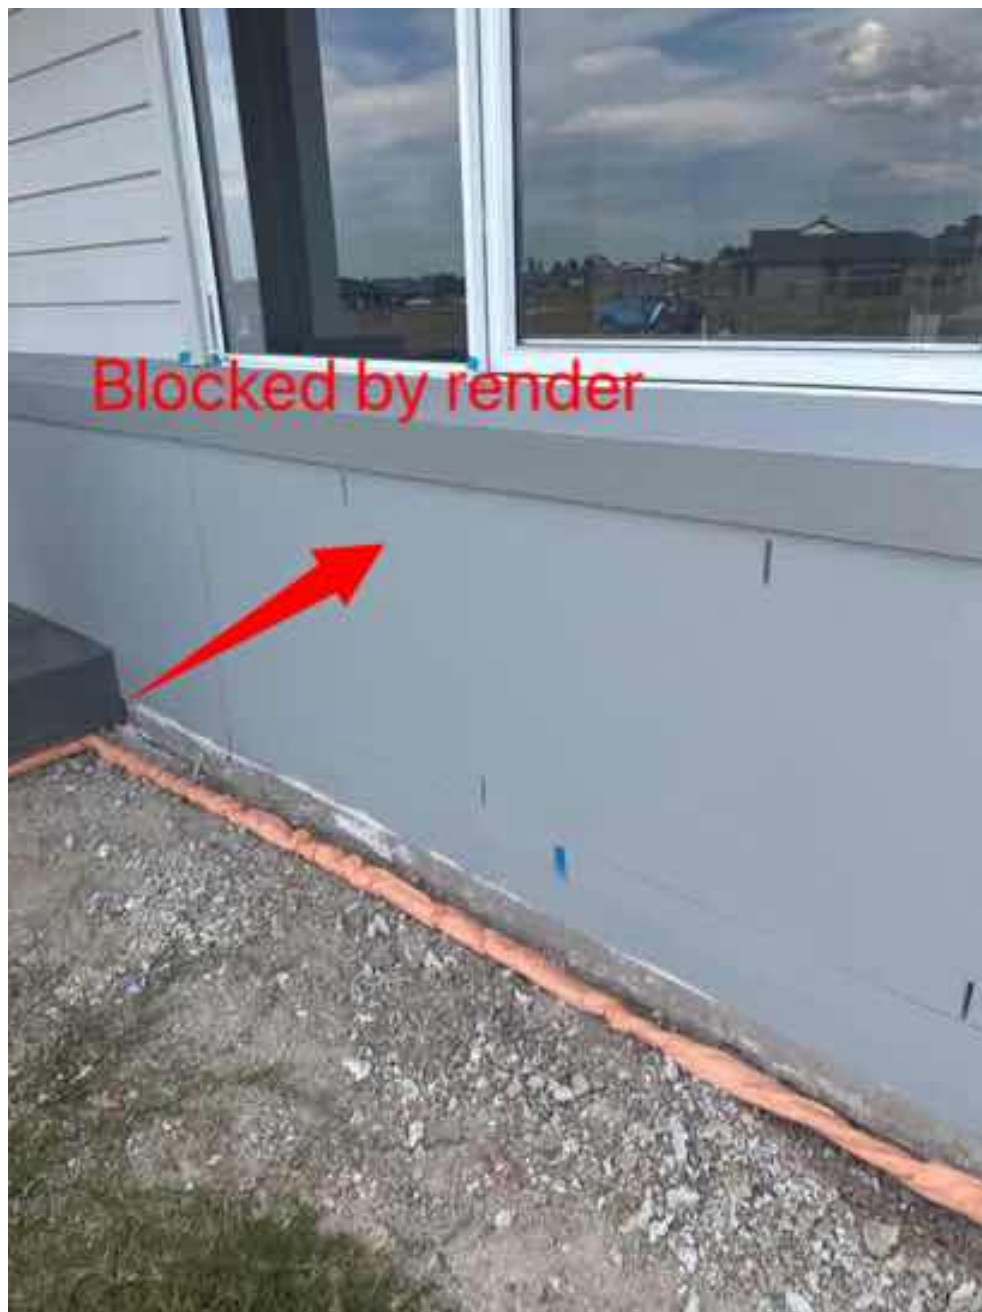
Weep holes are blocked or partially blocked by render in areas. Requires cleaning out.

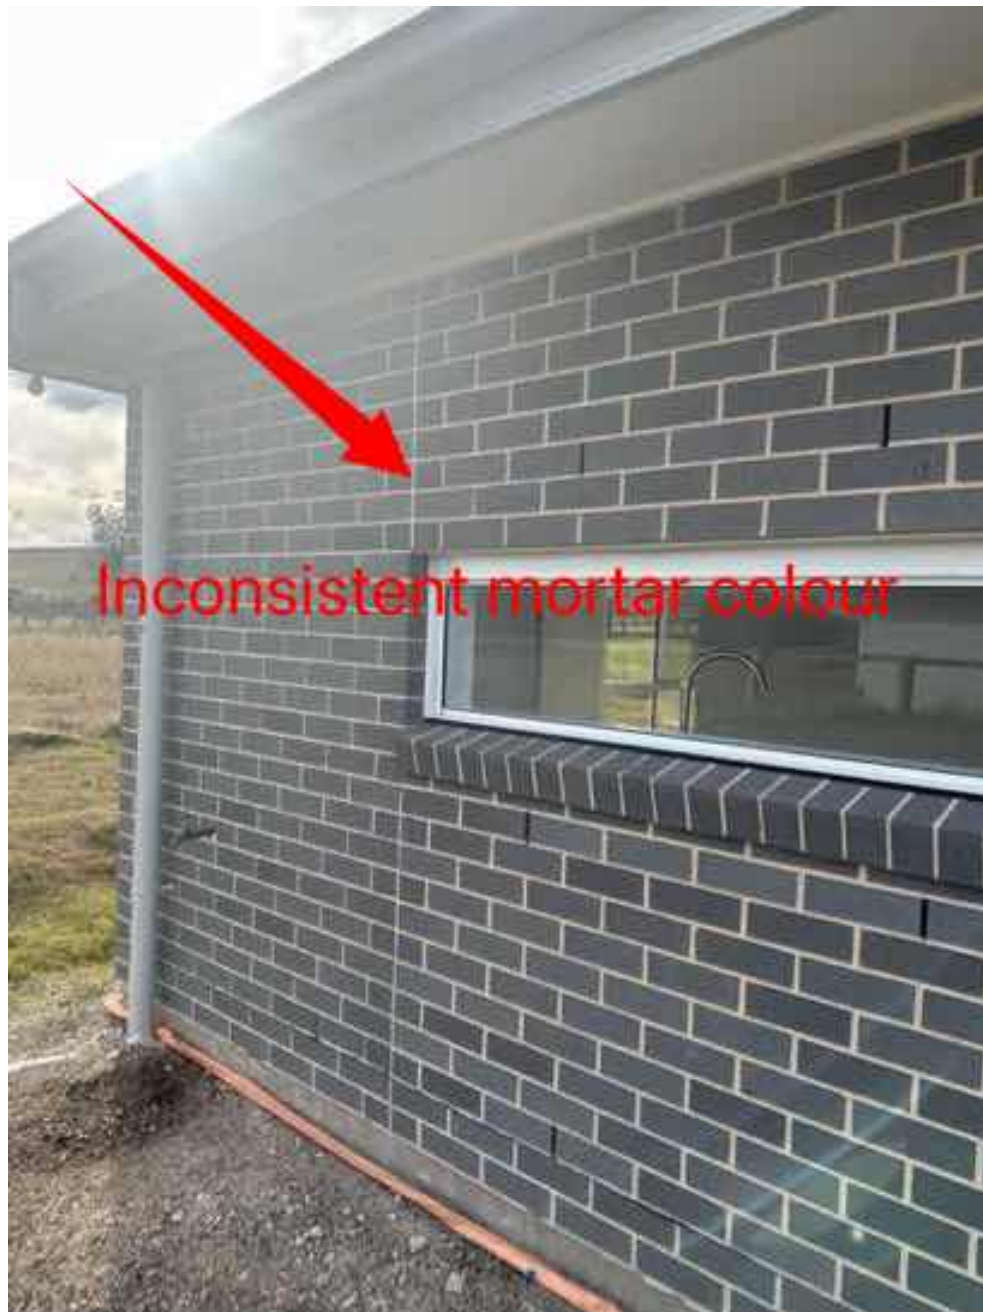
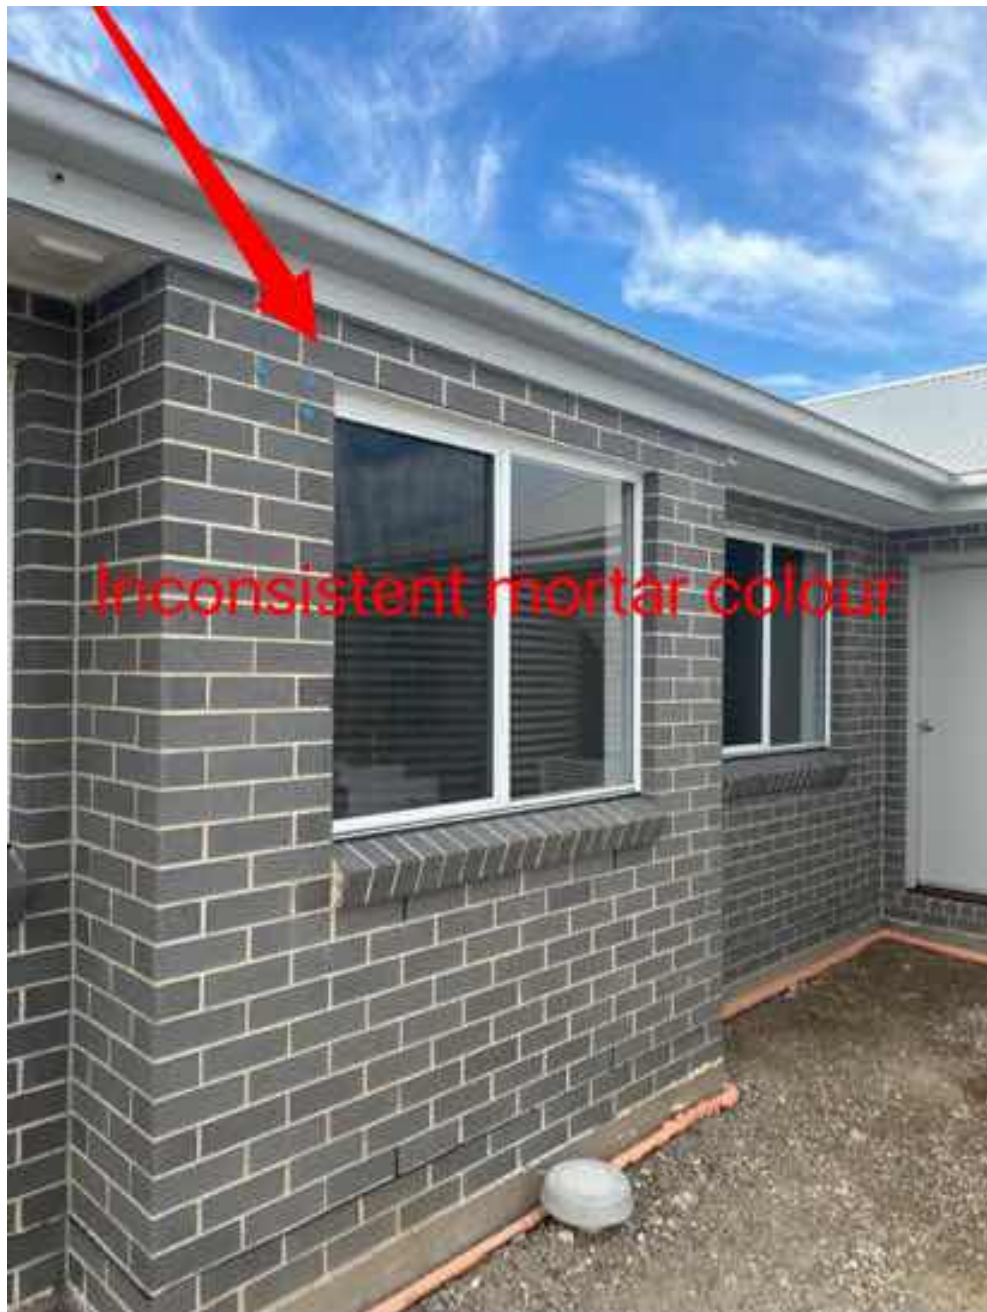
Brickwork cleaning required. Stains, mortar smears are visible from a normal viewing position which is 1.5m. The NSW Guide To Standards and Tolerances 2017 - section 3.11 "stains, mortar smears and damage caused by cleaning is defective if they are visible from a normal viewing position"

Missing vertical articulation joints. The National Construction Code clause 3.3.5.15 states that vertical articulation joints must be put in masonry veneer walls in accordance with

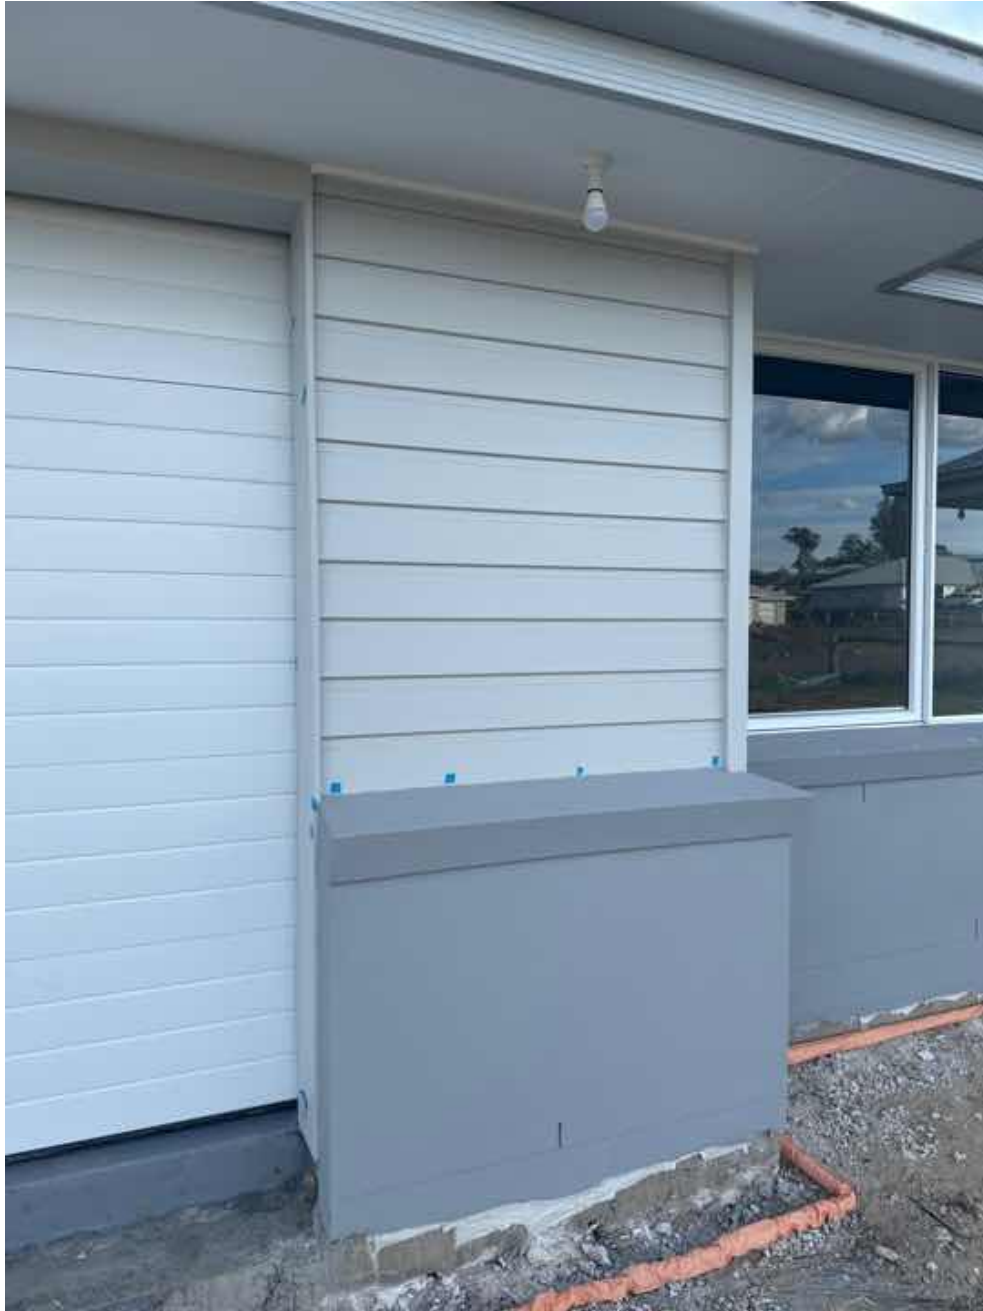
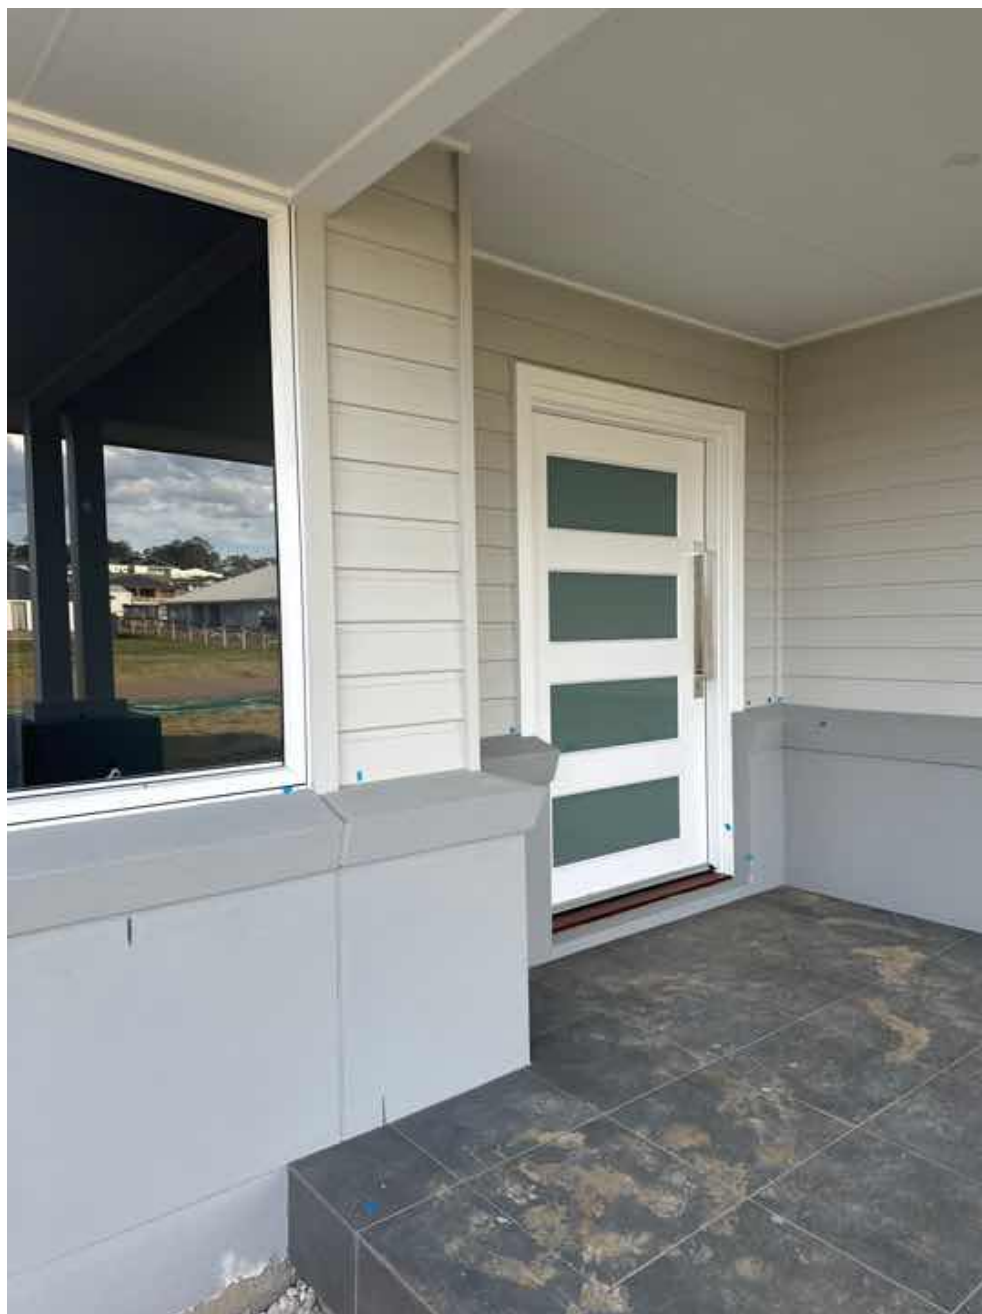
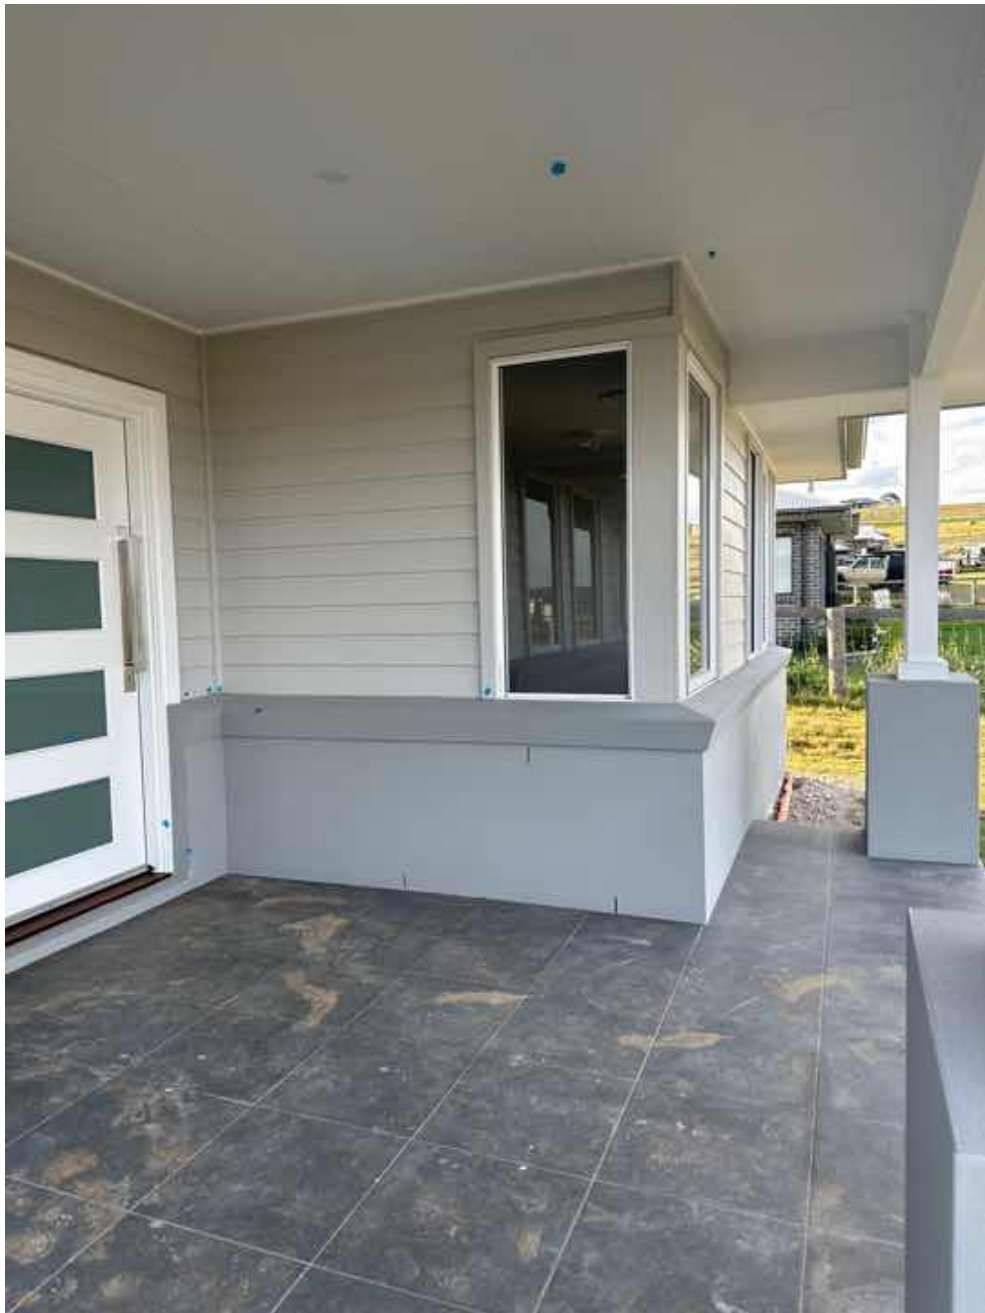
Paint touch-ups required.

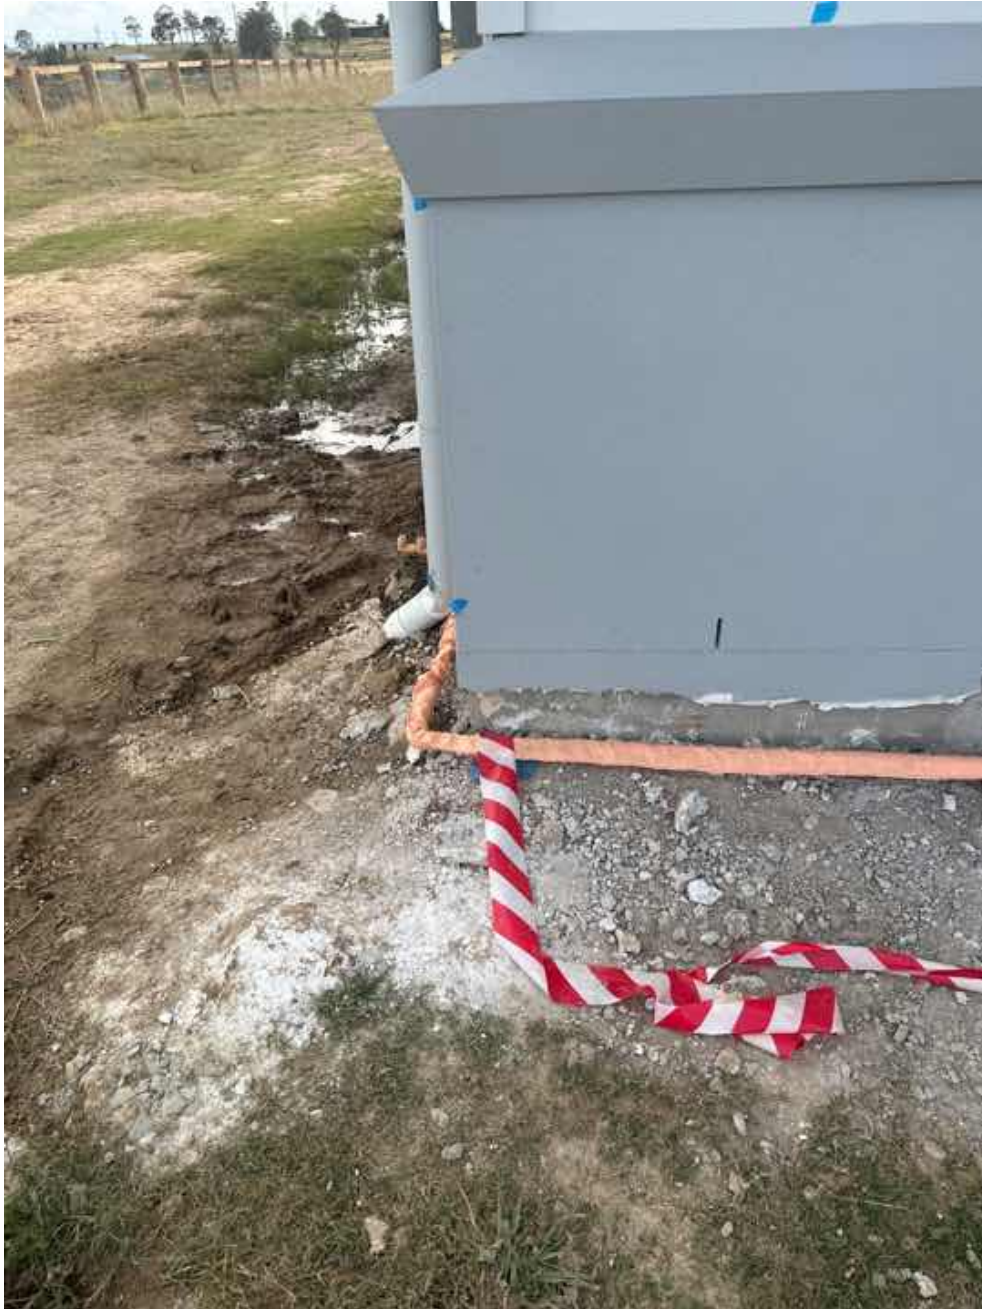
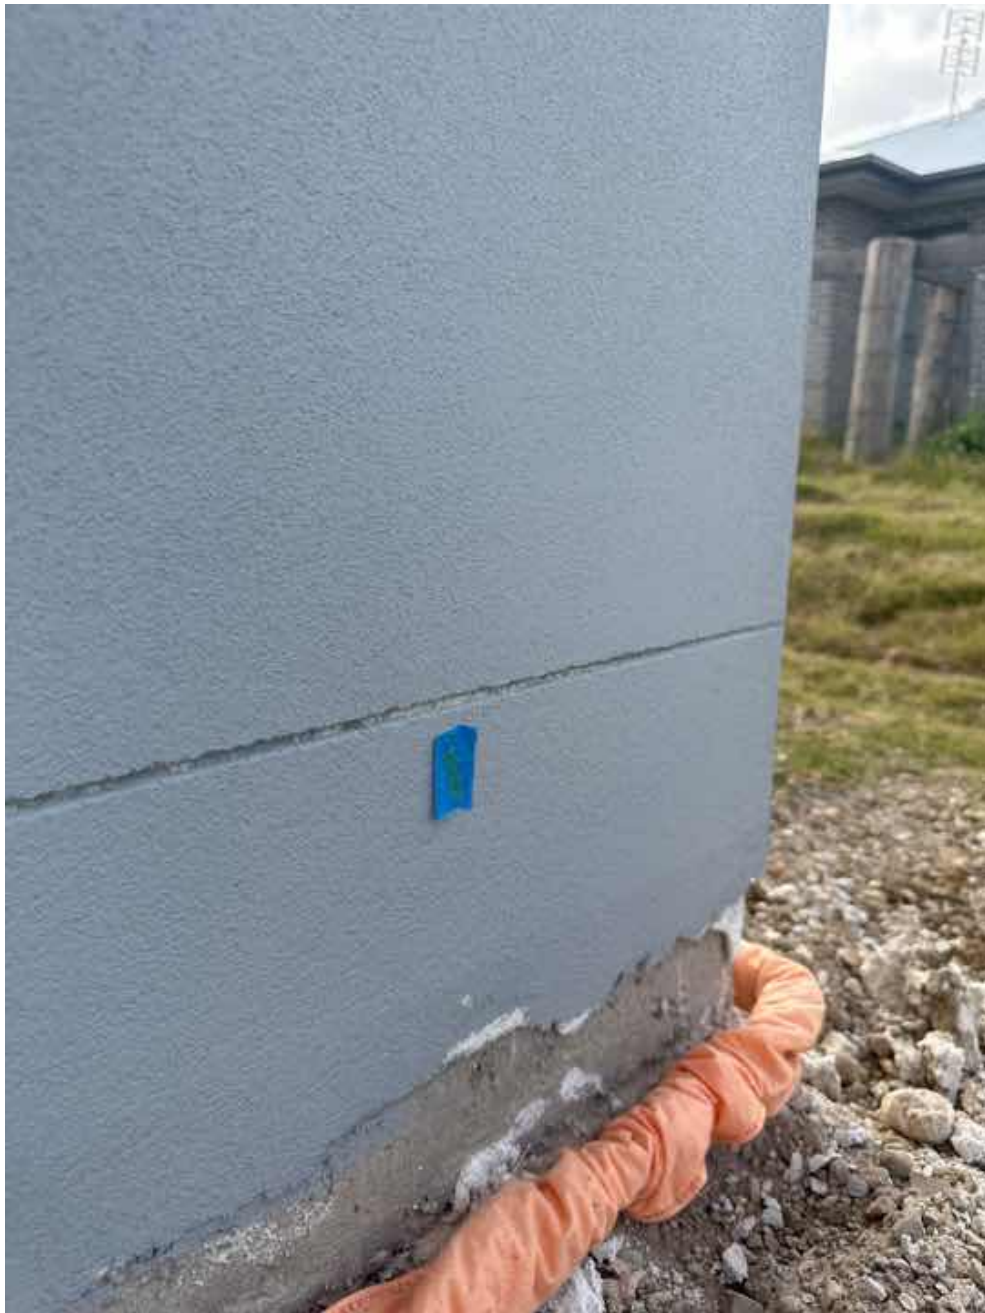
Paint touch-ups required to rendered surfaces.

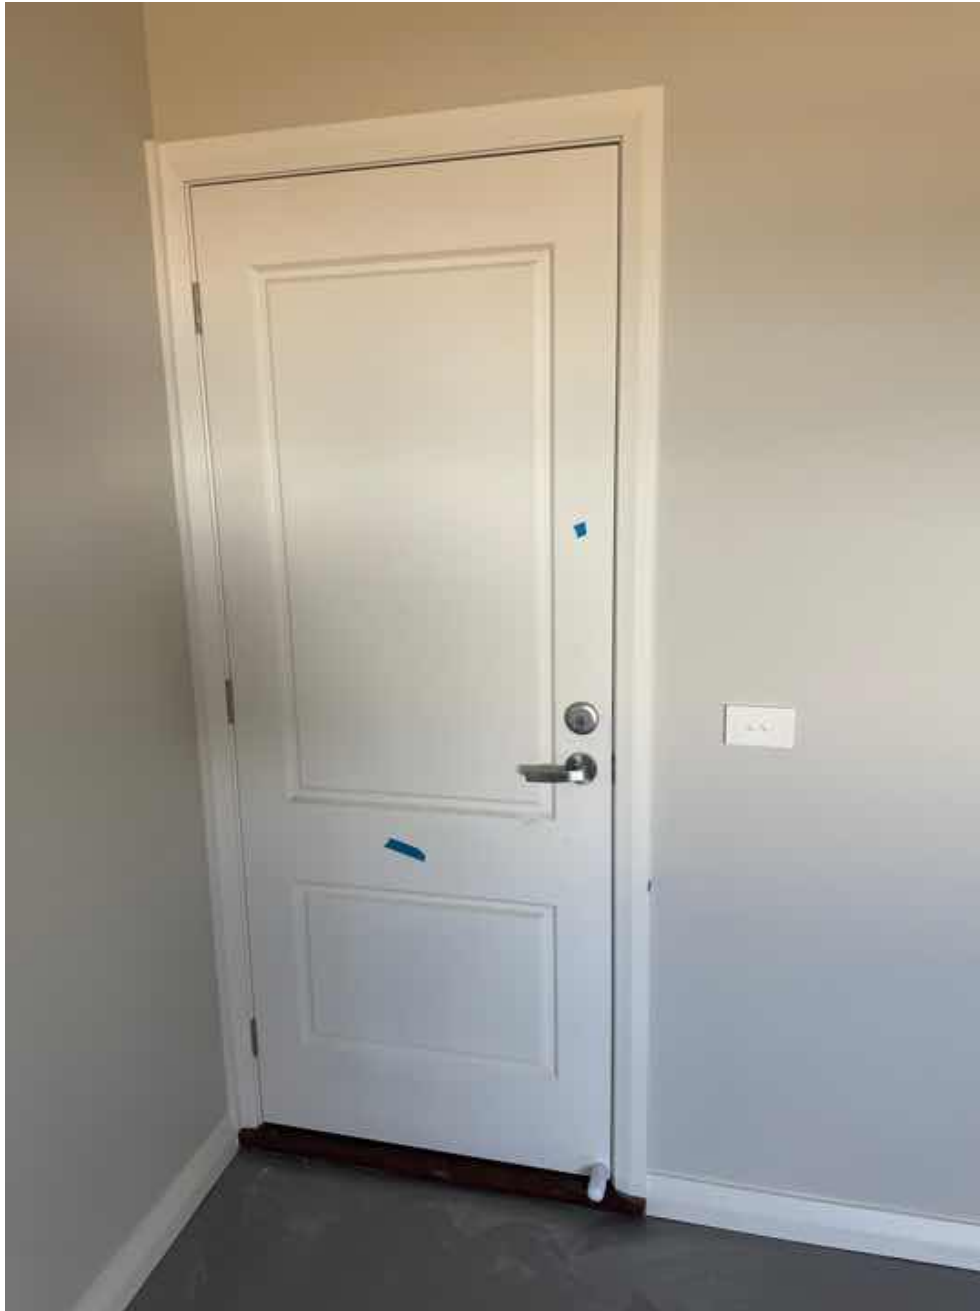
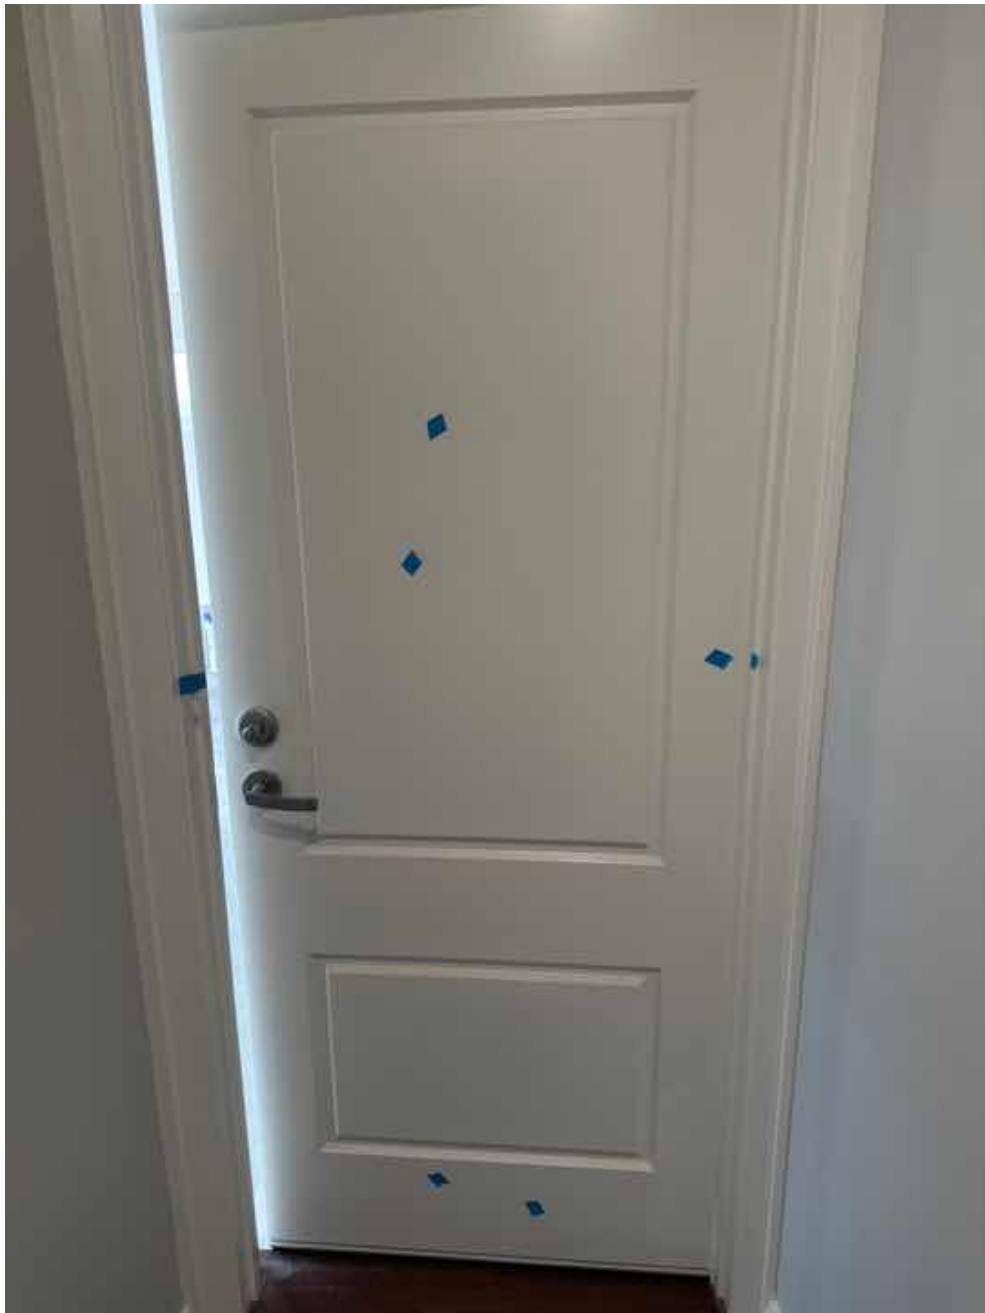
Paint touch ups required.

Weather seals not installed. In Accordance with the National Construction Code 2019 Amendment 1 Energy Efficiency clause 3.12.3.3, seals must be fitted to all external doors and internal doors between the house and the garage, where the internal garagedoor opens into a conditioned area. A draft protection device is to be fitted to the bottom of doors and seals to the remaining edges.

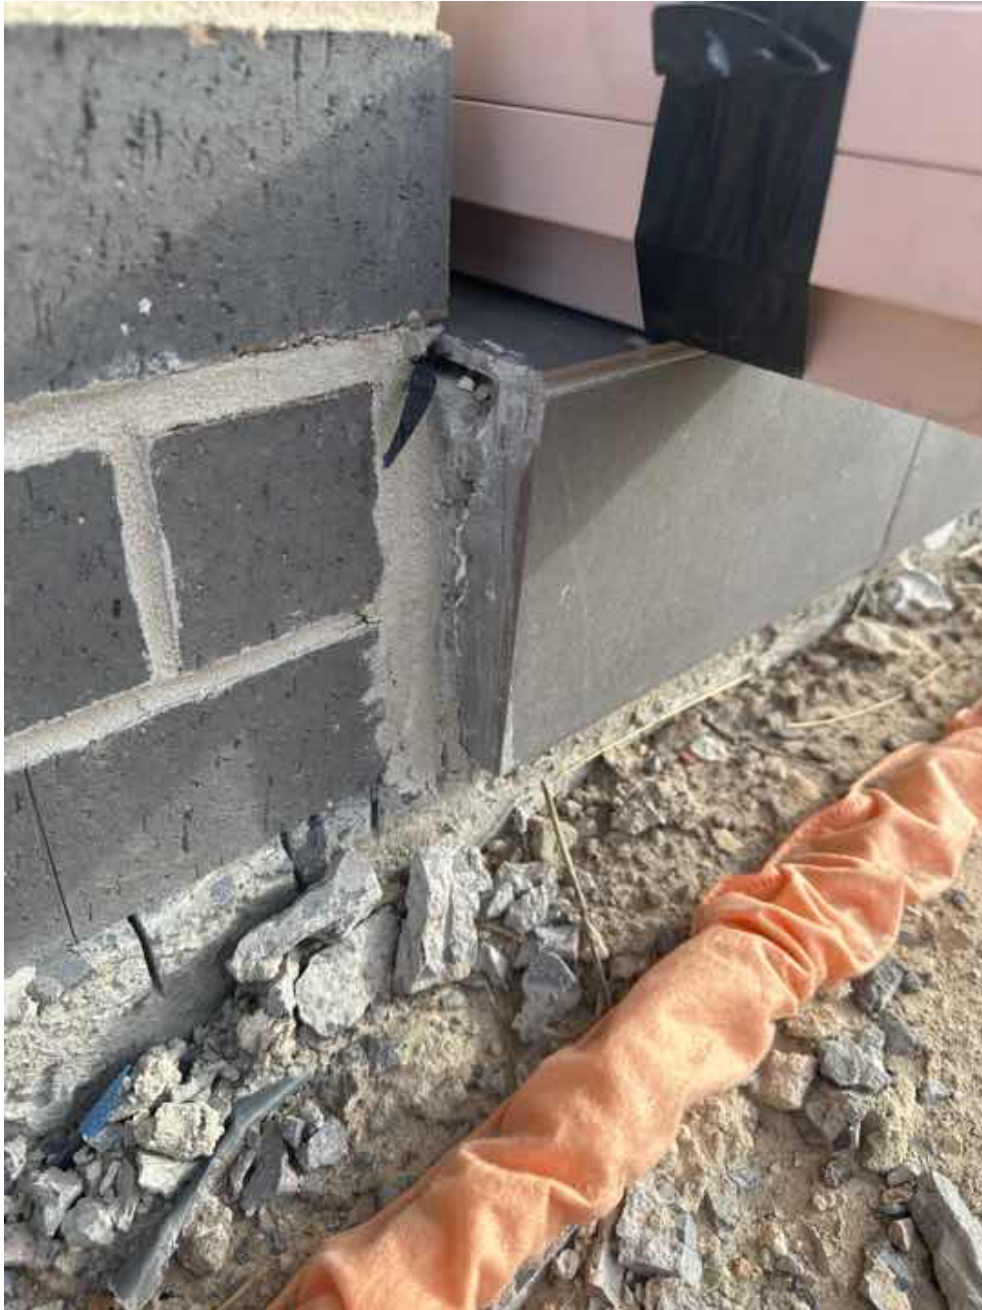
Tile missing to small return on alfresco area. Amendment required

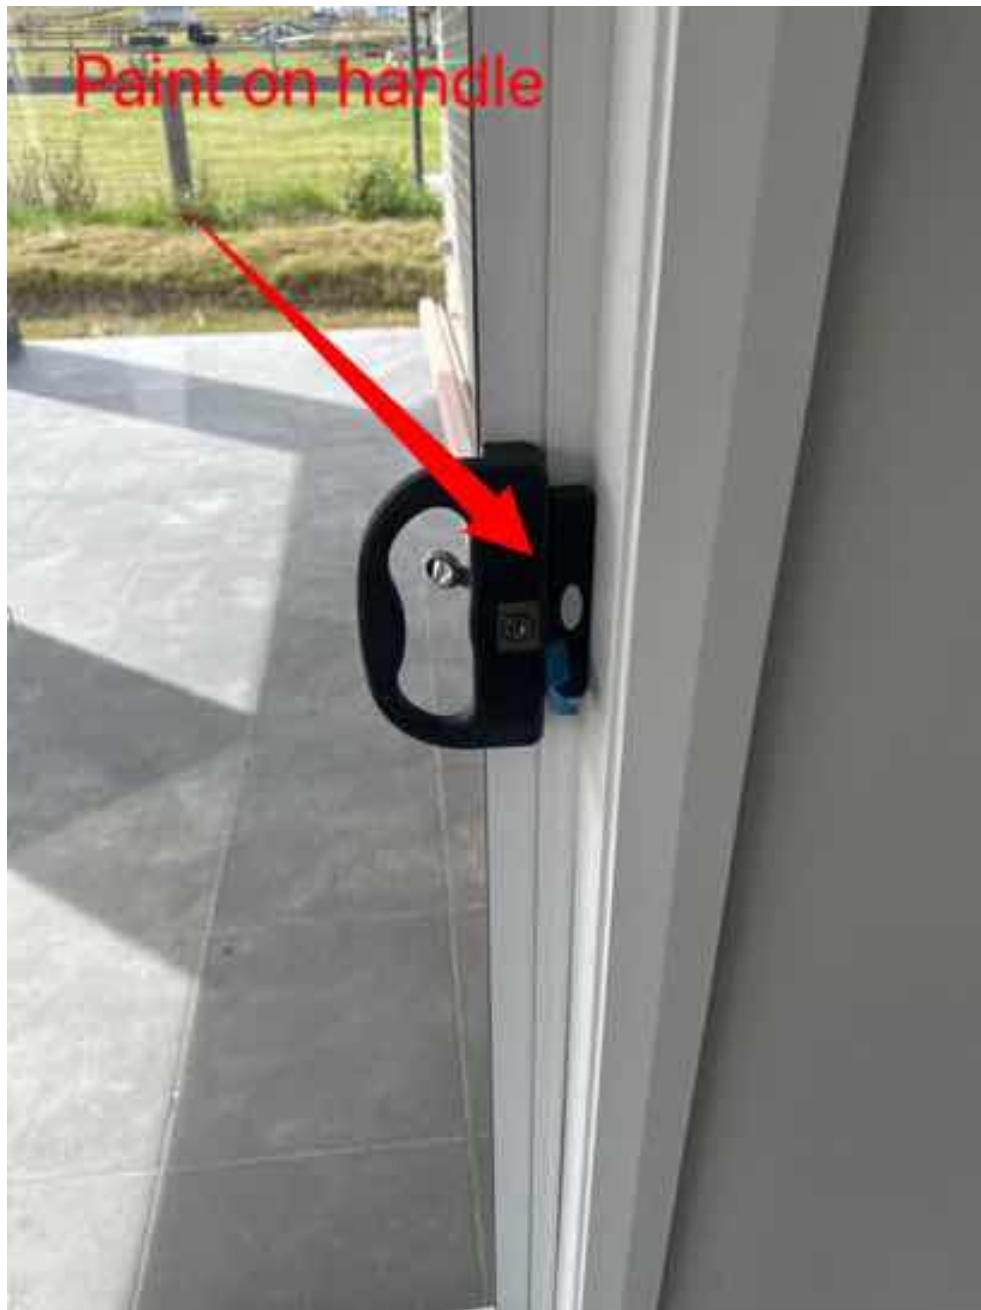
Paint touch ups required.

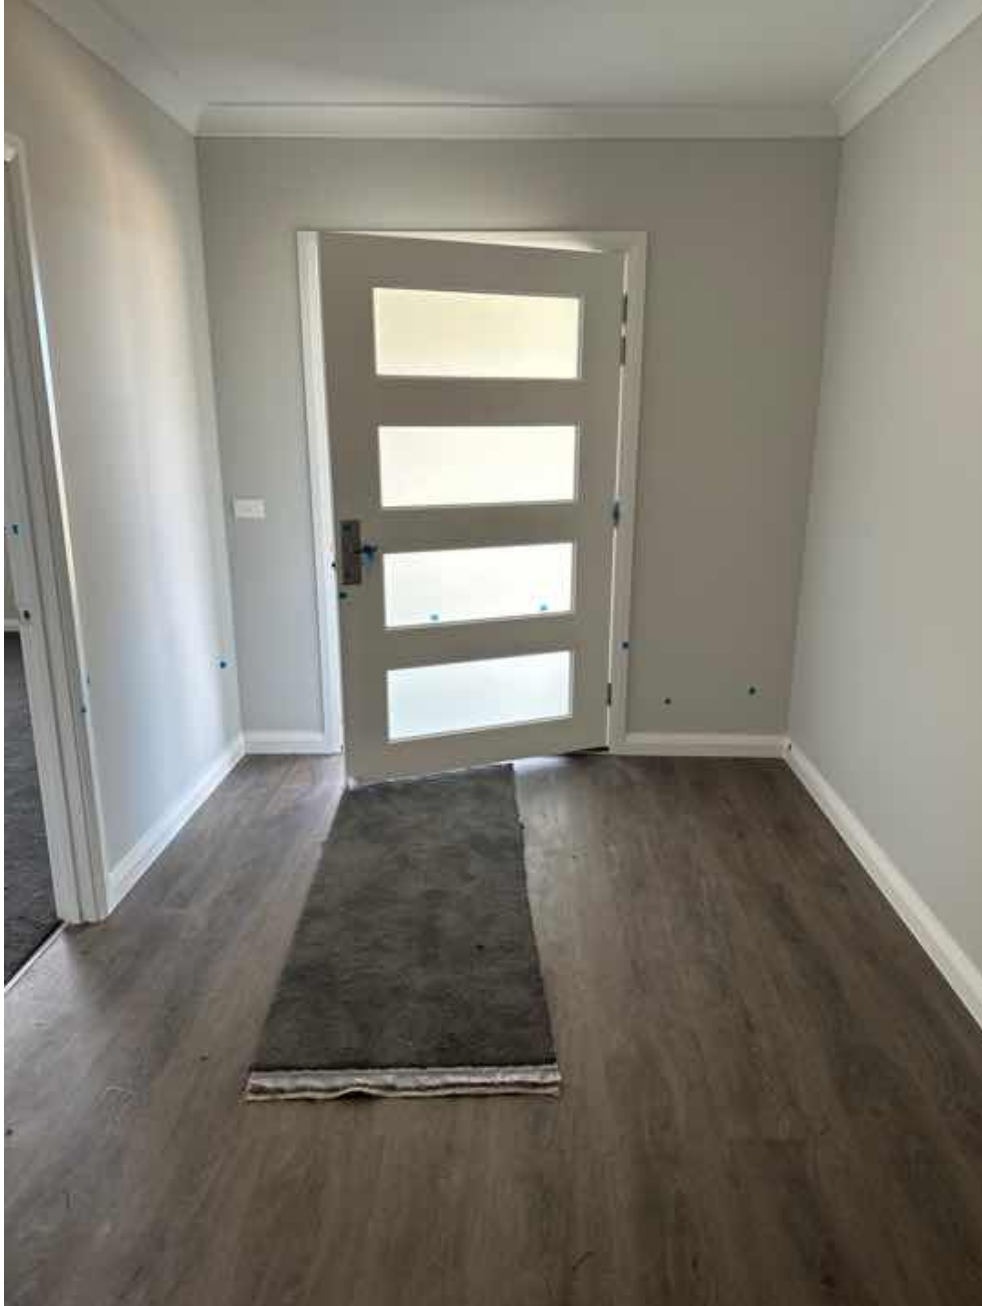
Rectification work required

A builders clean is required.
