# Inspection Report

**UNCOVER**  
BUILDING AND PEST INSPECTIONS

**1 Sample St , Sample, Nsw, 2281**

### Handover Inspection

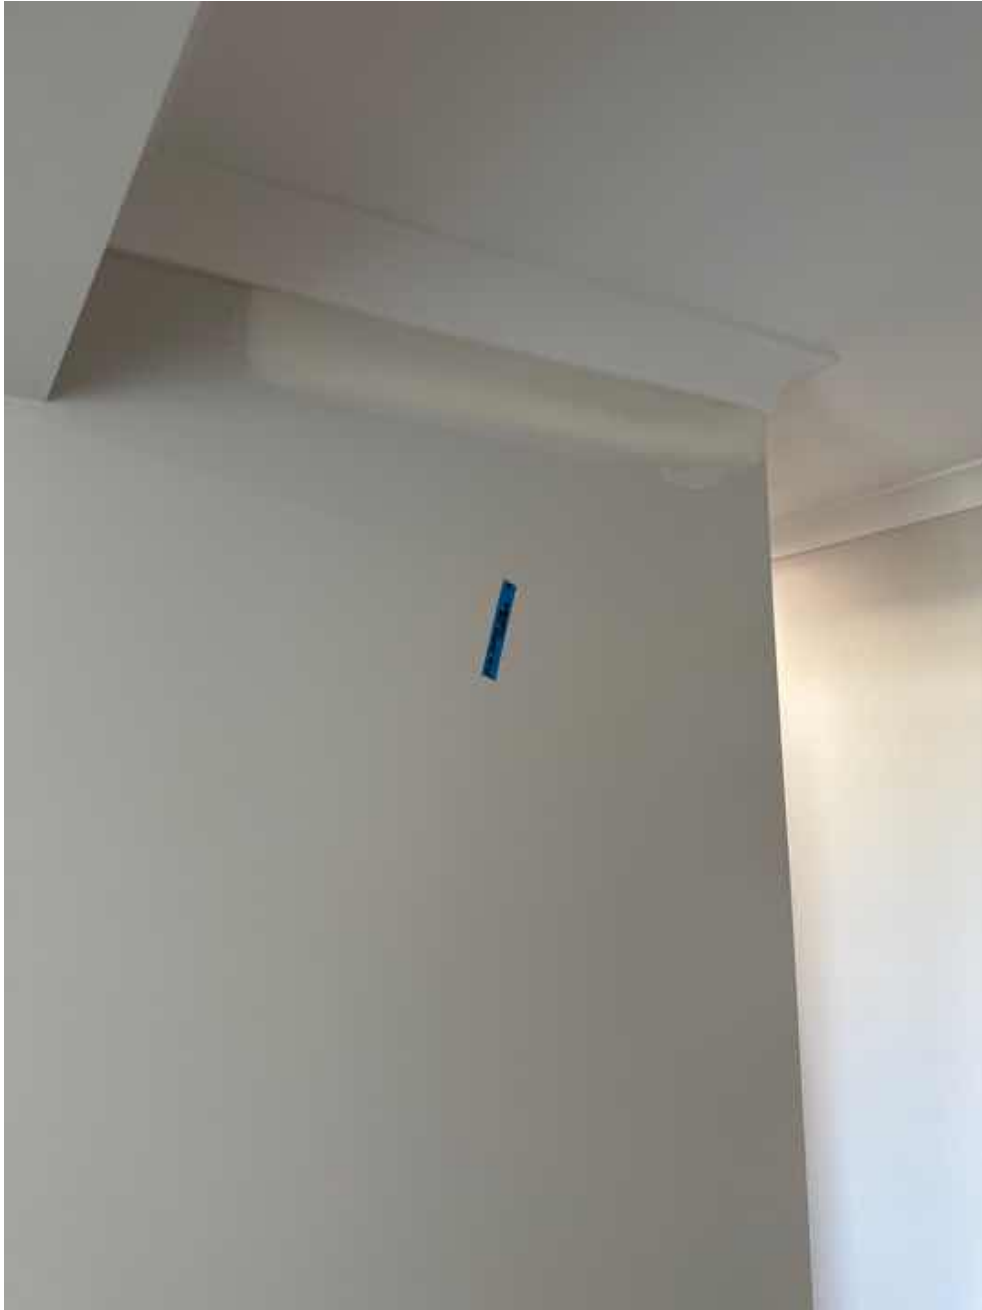
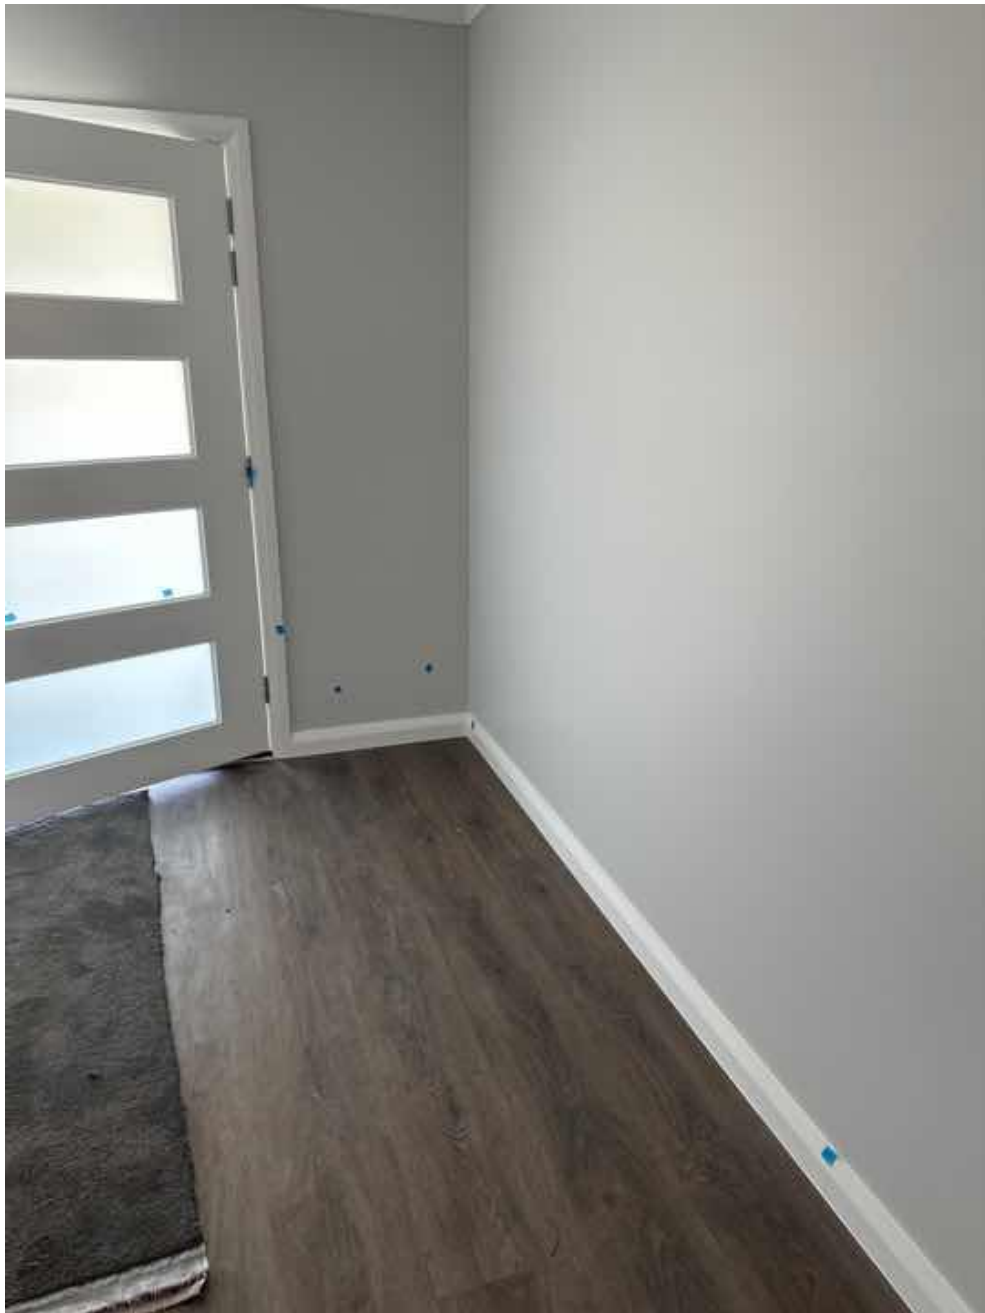
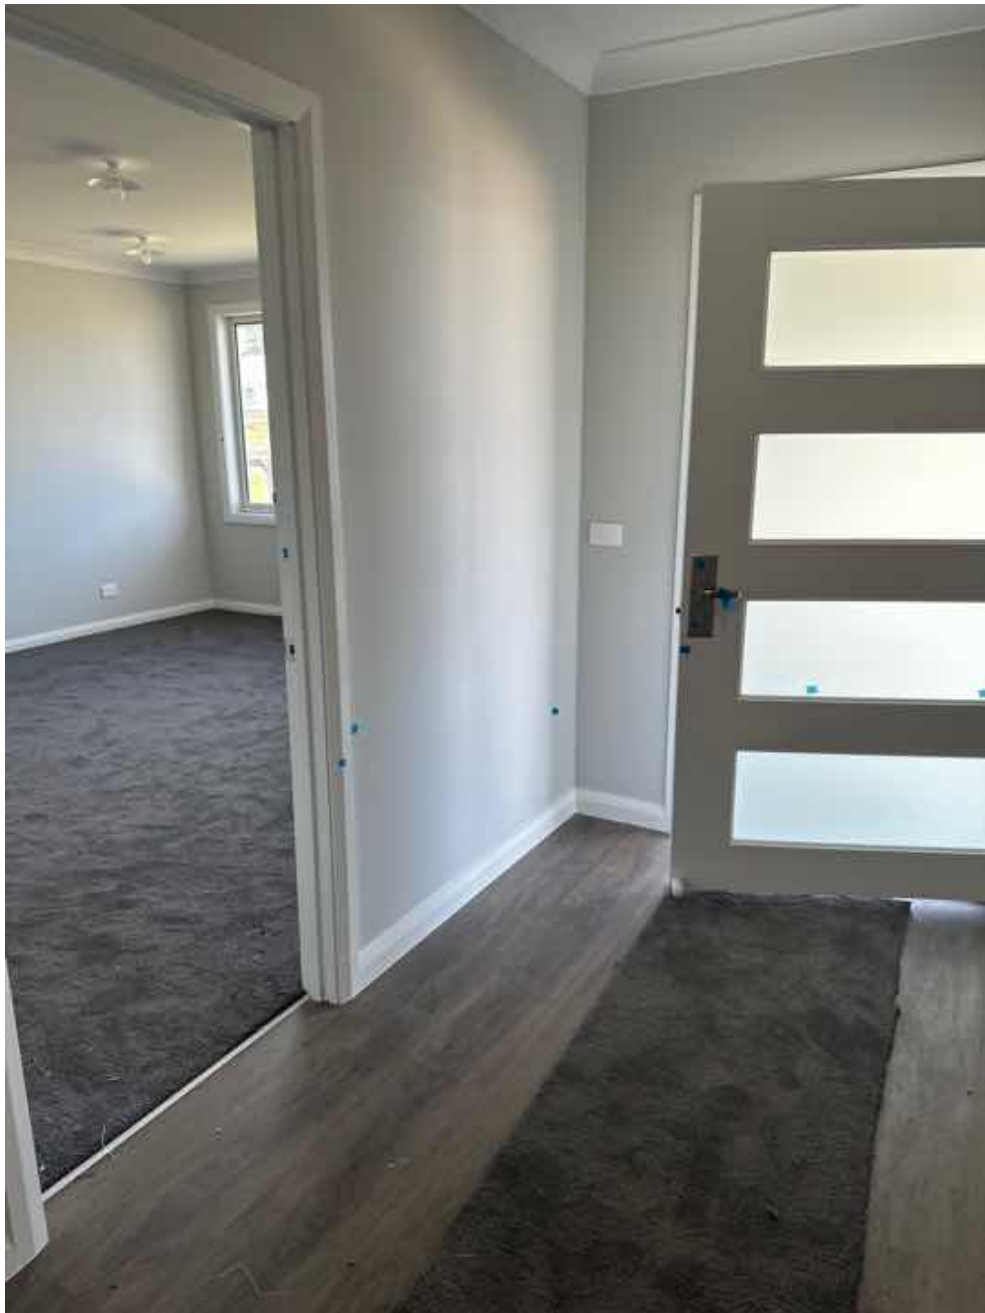
Paint touch ups required. Defects noticeable from normal viewing position. Additional plastering, sanding and painting required.

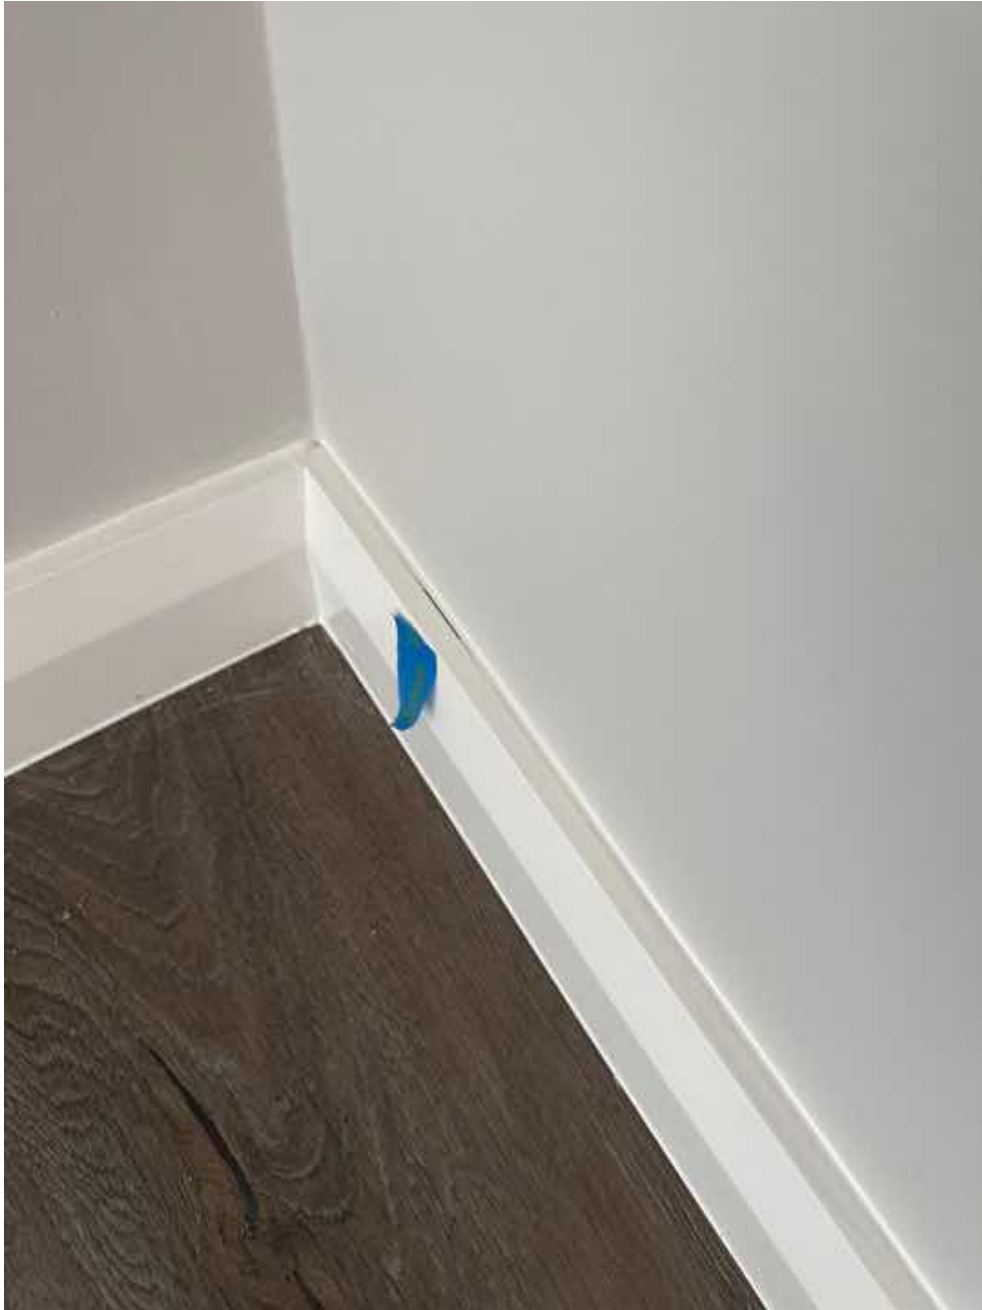
Gaps between skirting and wall noted. NSW Guide to Standards and Tolerances section 11.1 states gaps between mouldings or between mouldings and other fixtures, at mitre or butt joins, or at junctions with walls or other surfaces are defective if they exist at handover and are visible from a normal viewing position.

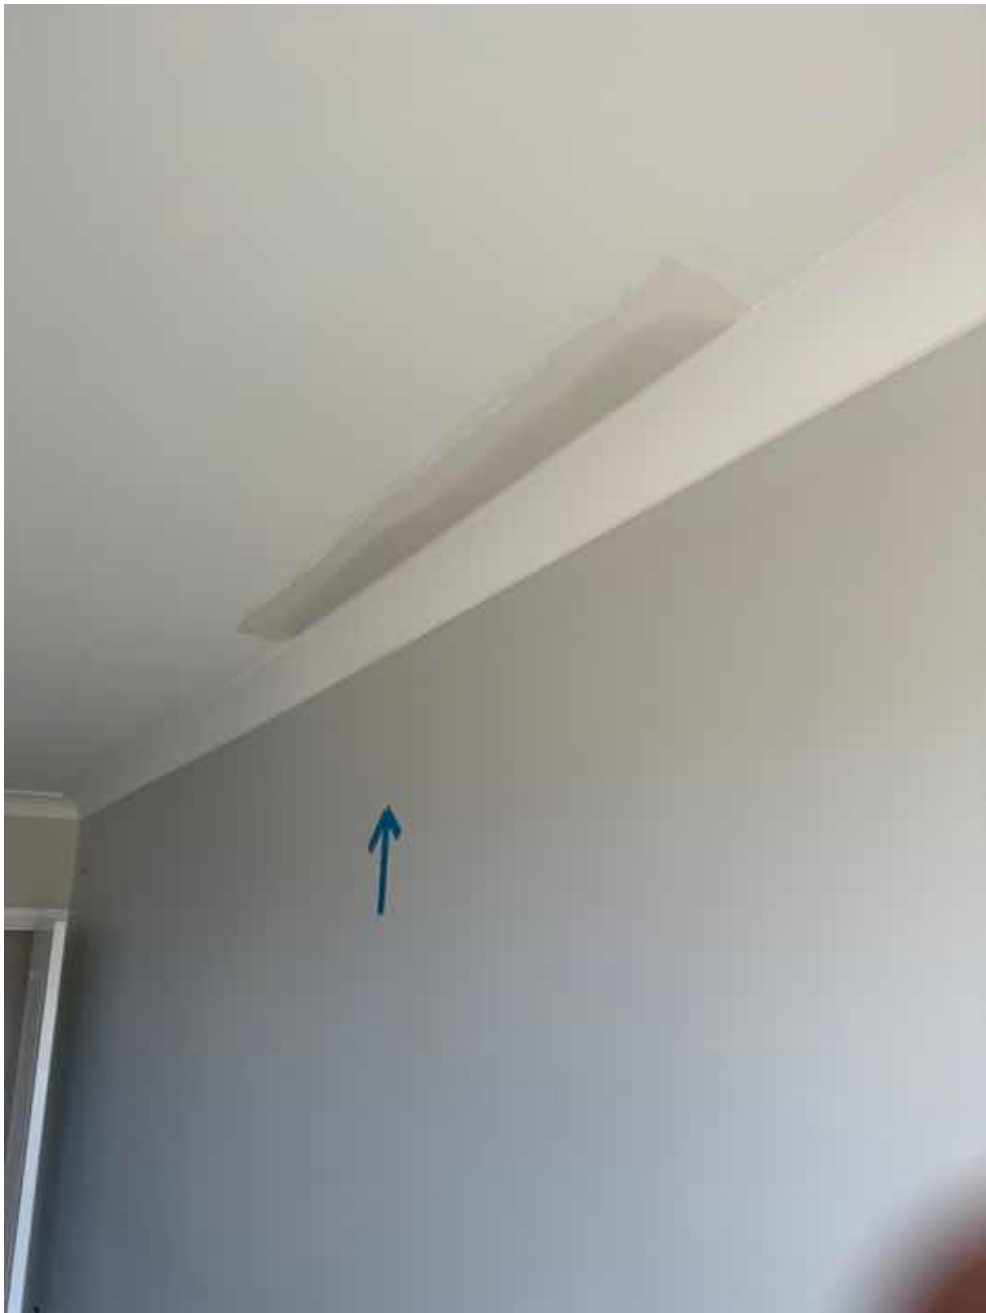
Patch and paint required.

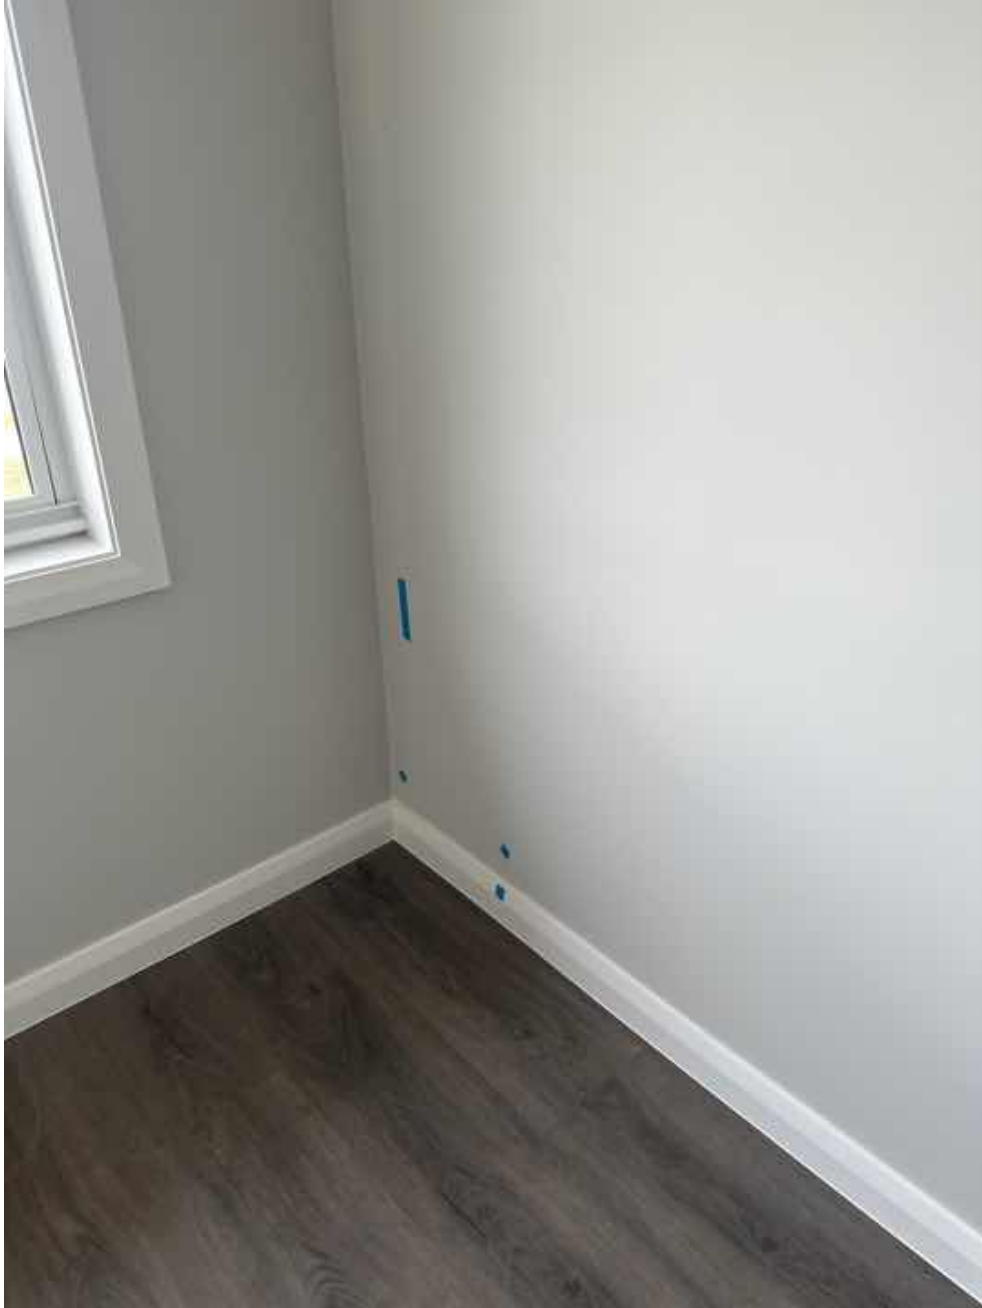
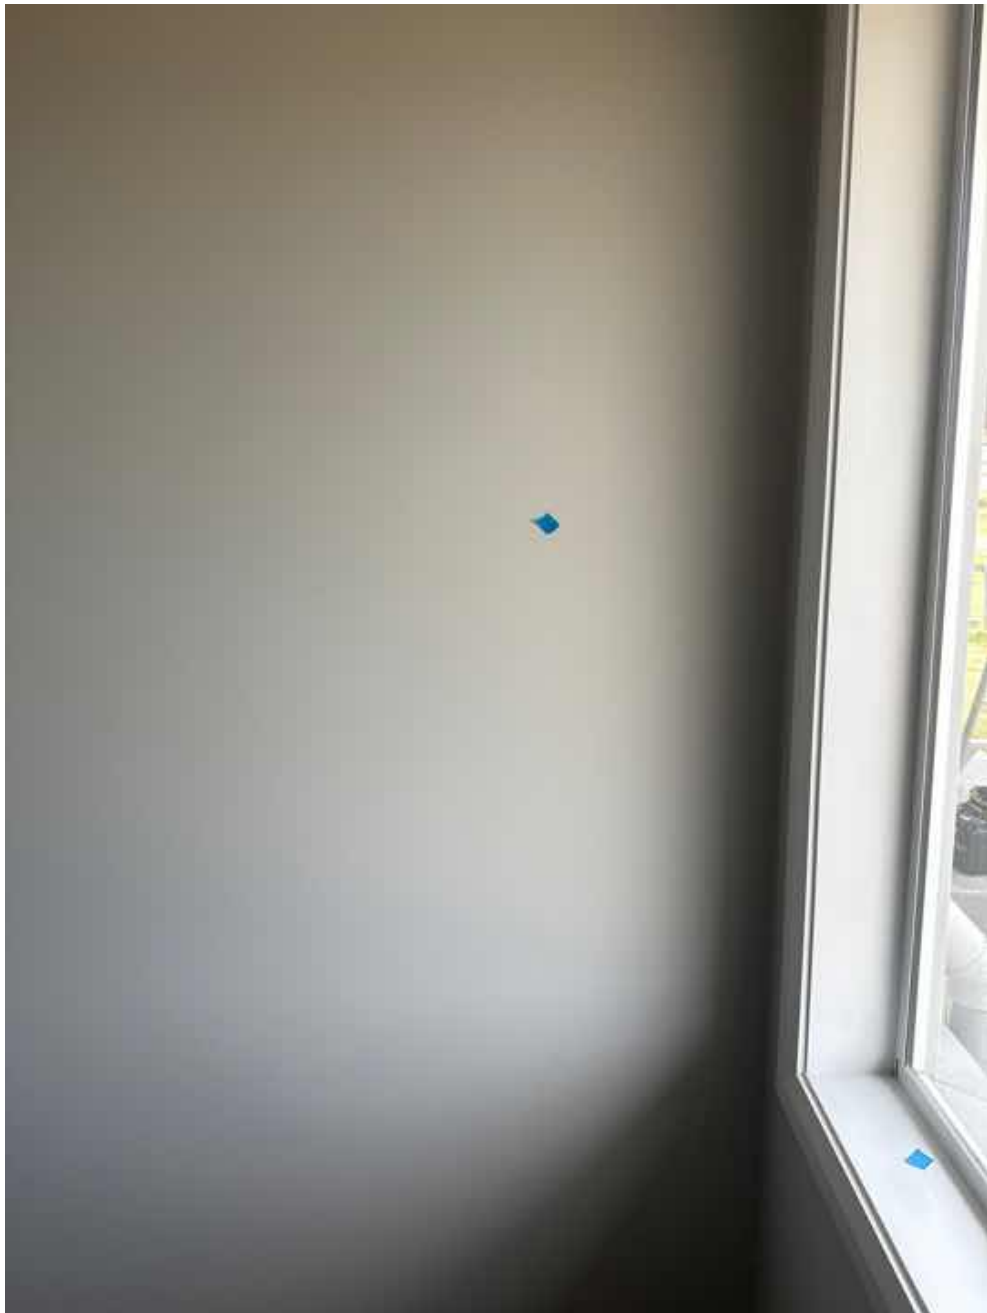
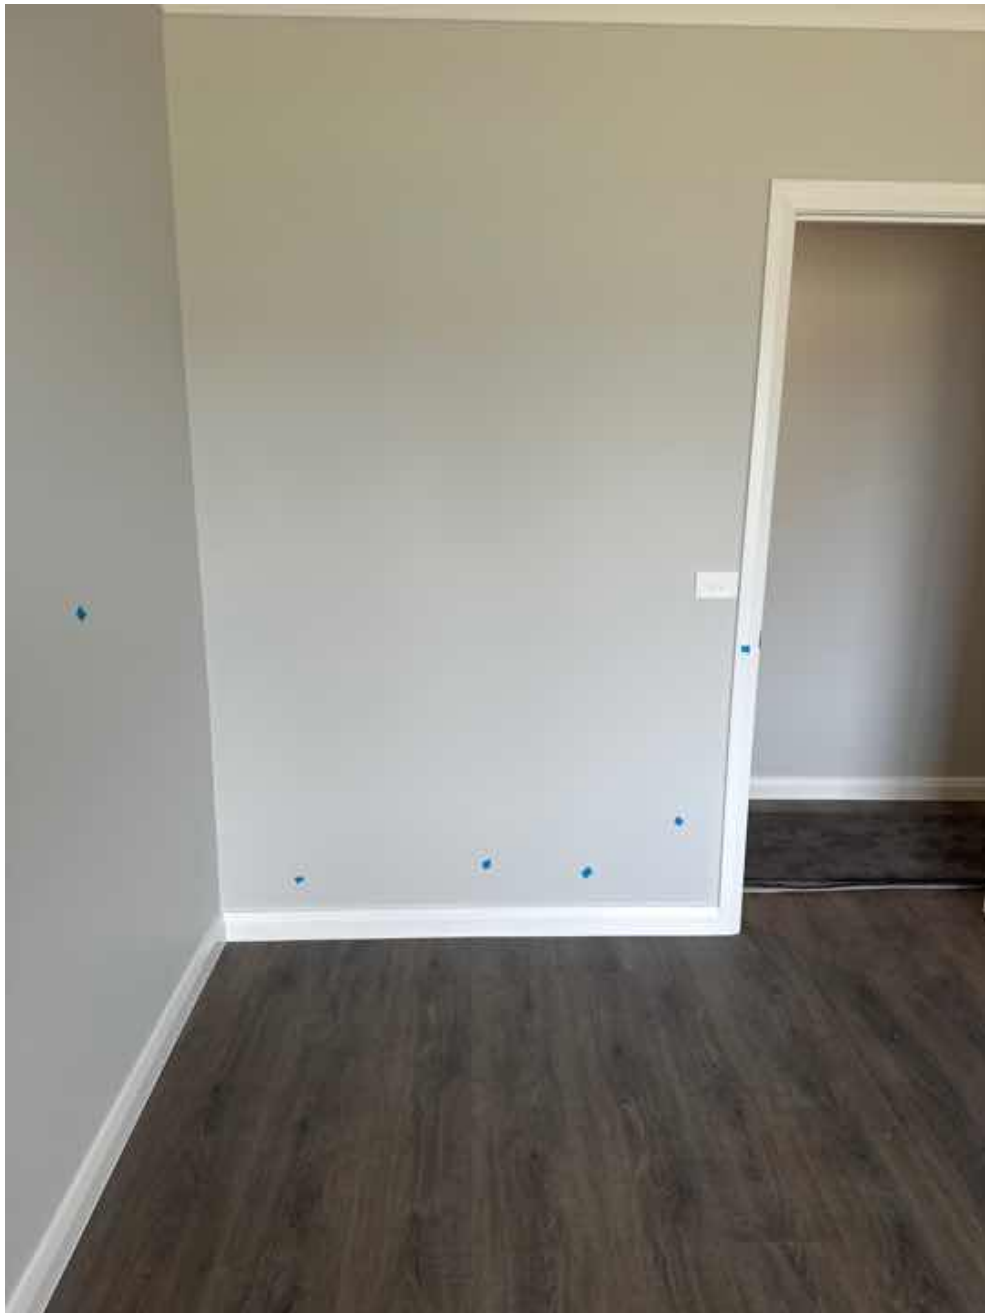
Paint touch ups required. Defects noticeable from normal viewing position. Additional plastering, sanding and painting required.

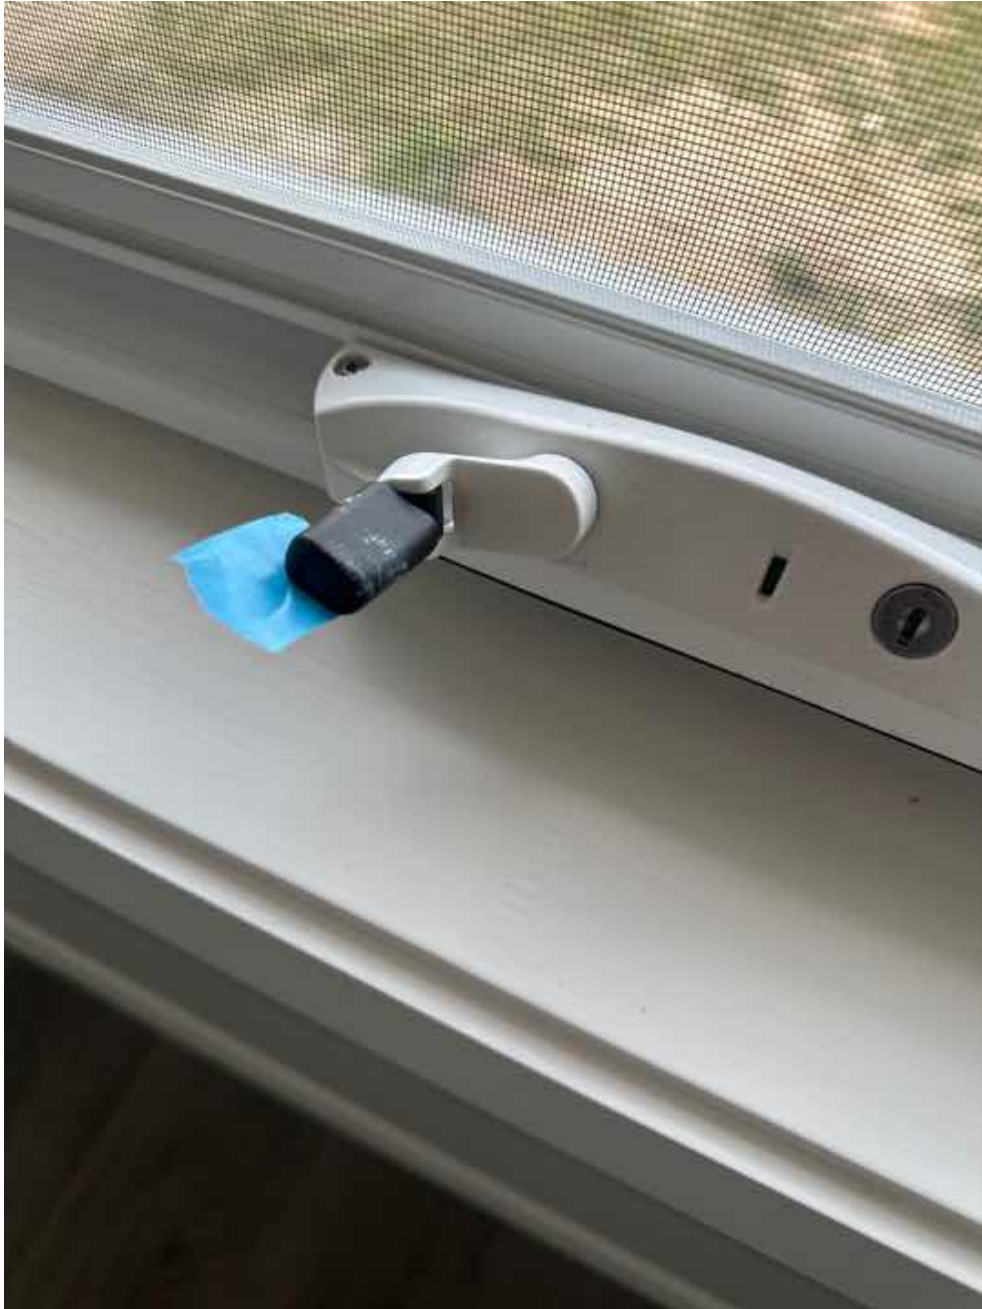
Paint / stain on windows.

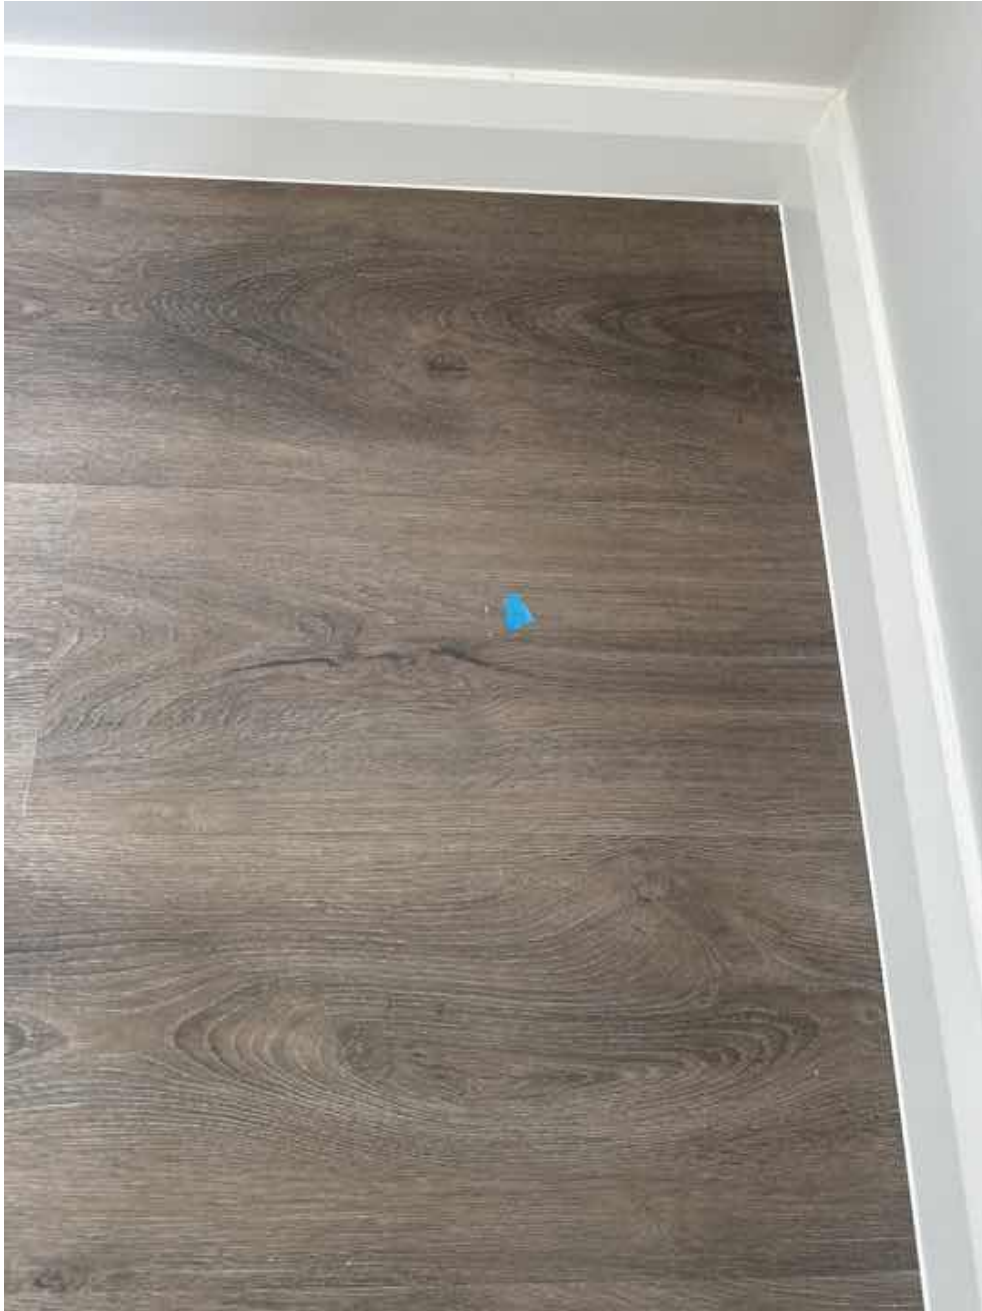
Paint, glue or grout on flooring. Requires cleaning.

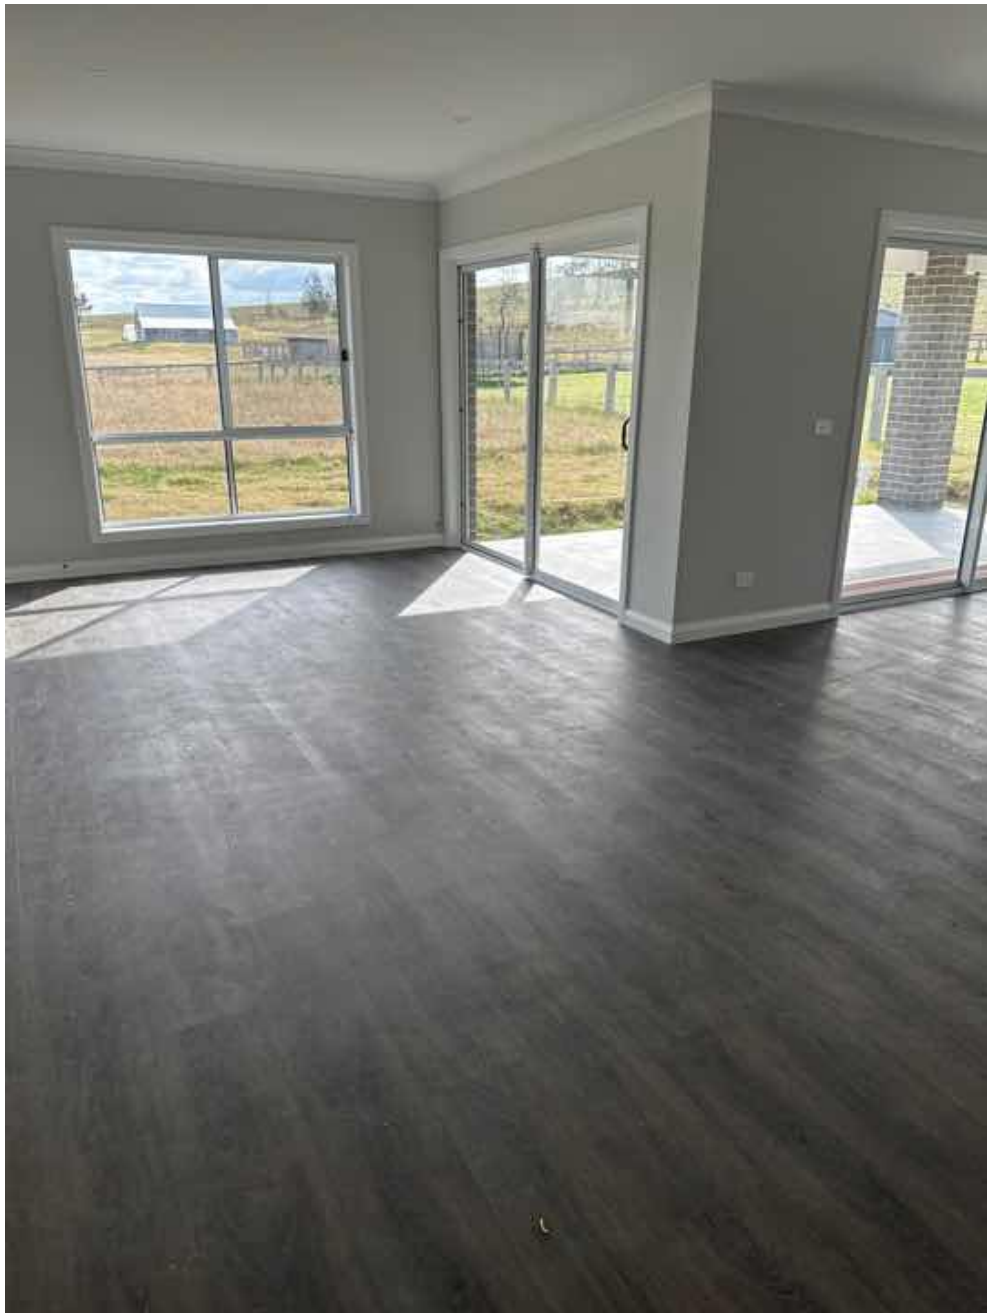
A builders clean is required.

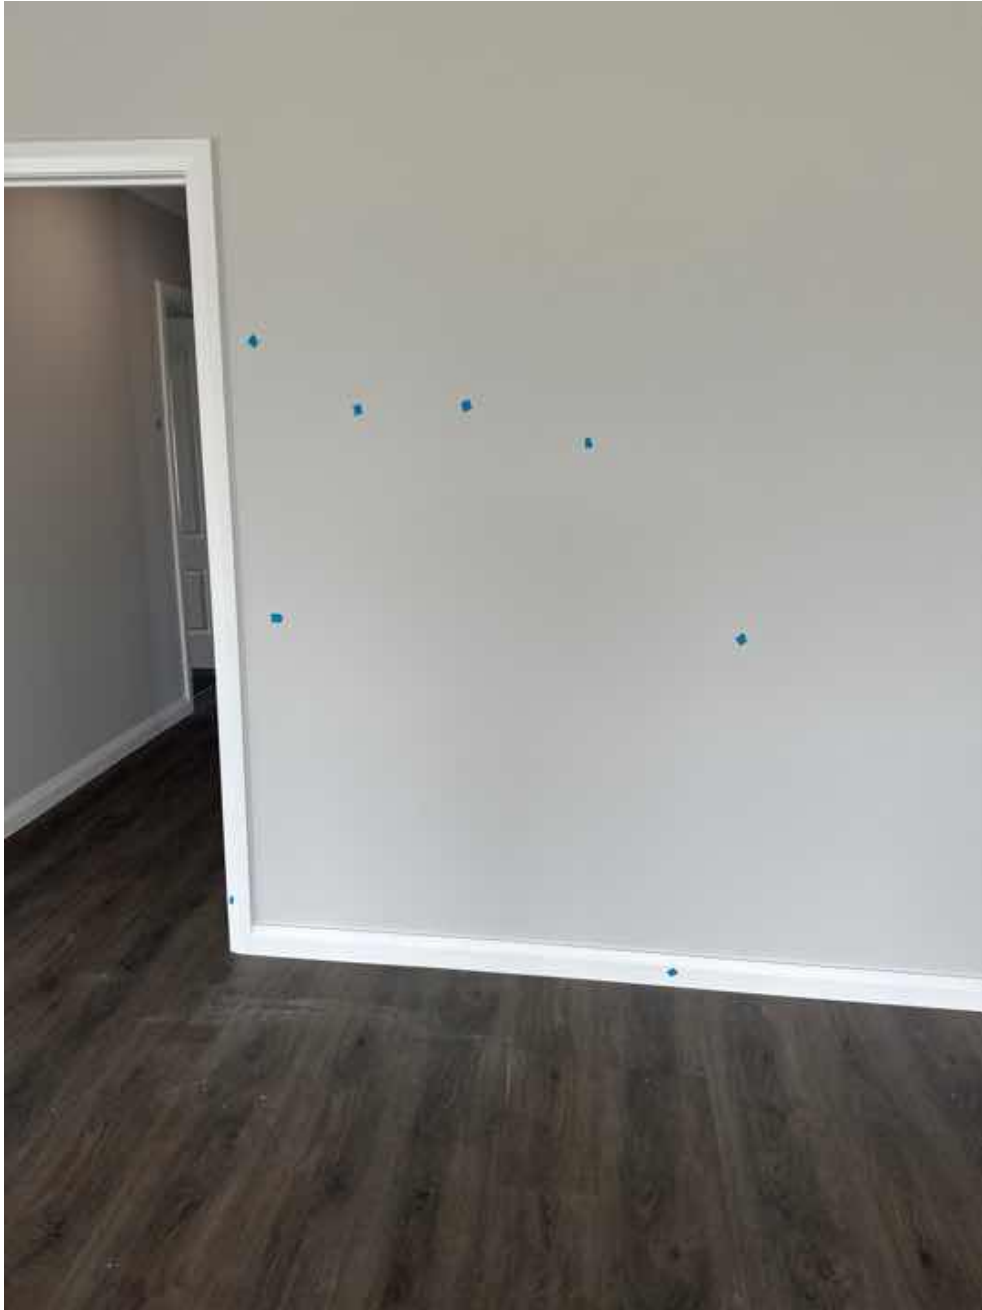
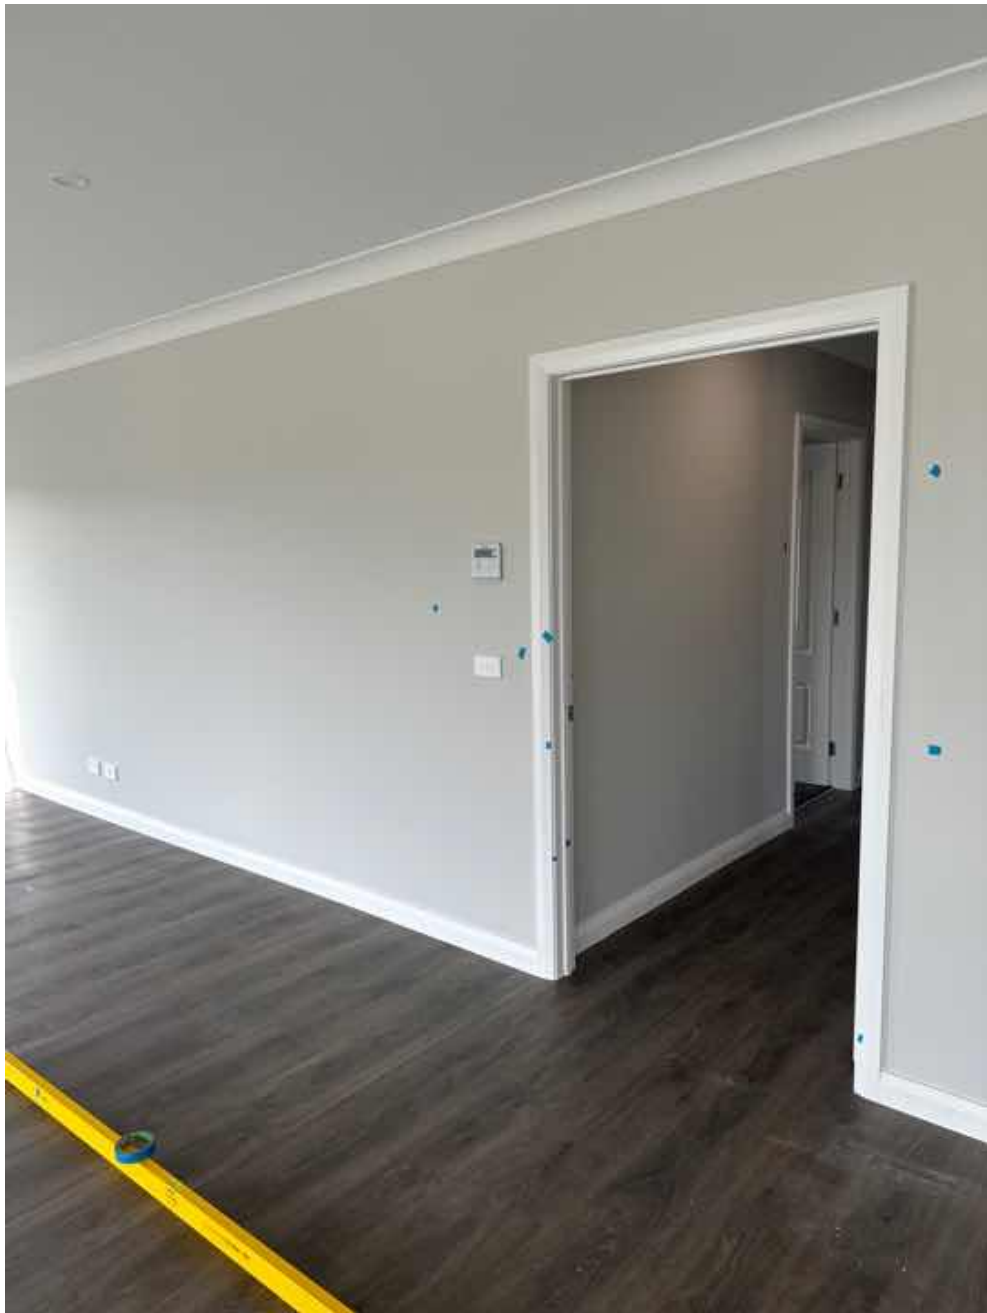
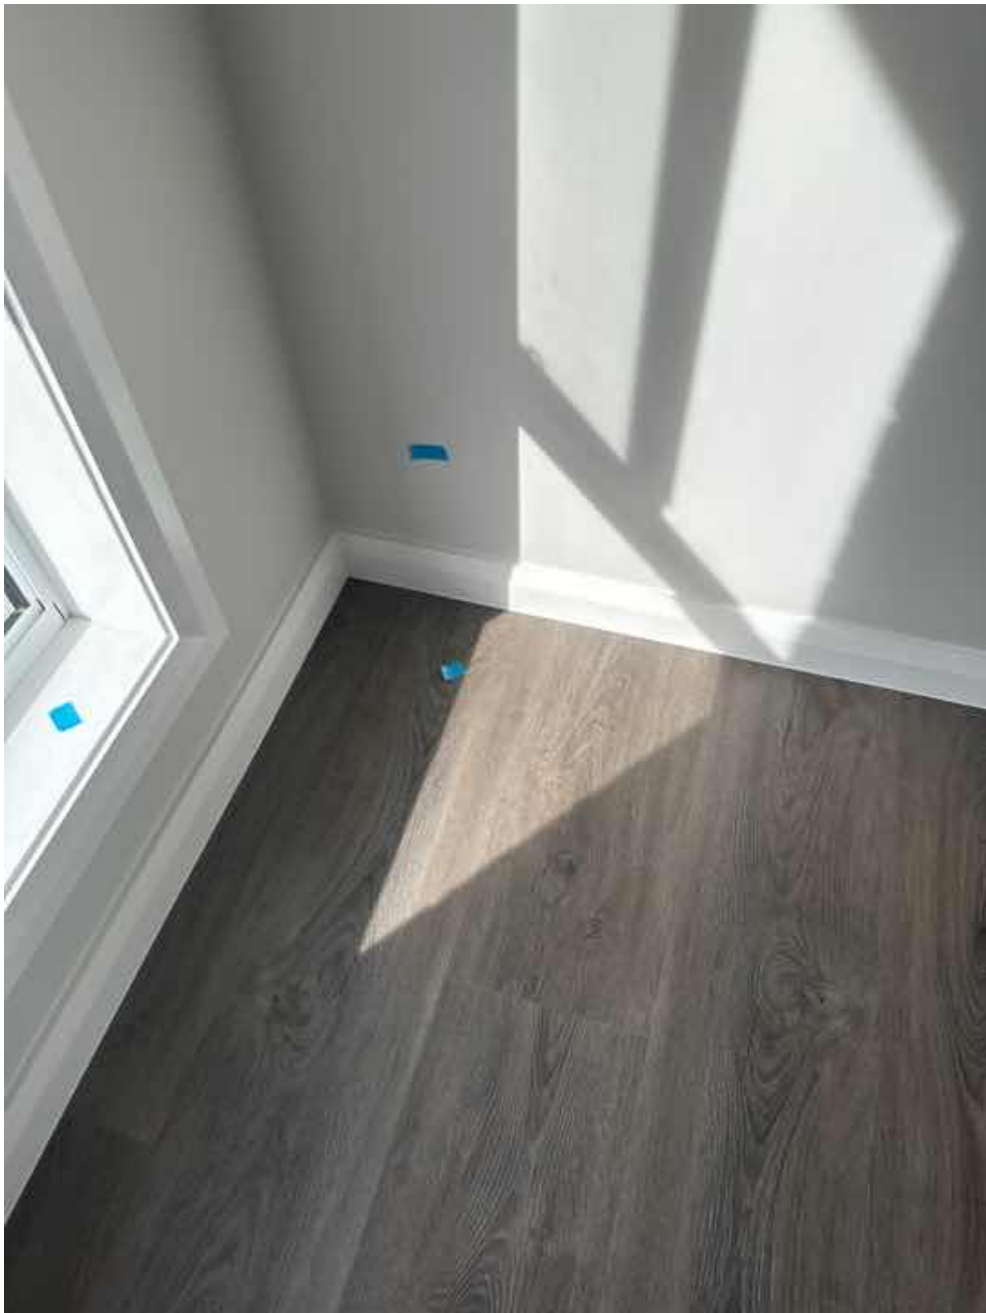
Paint touch ups required. Defects noticeable from normal viewing position. Additional plastering, sanding and painting required.

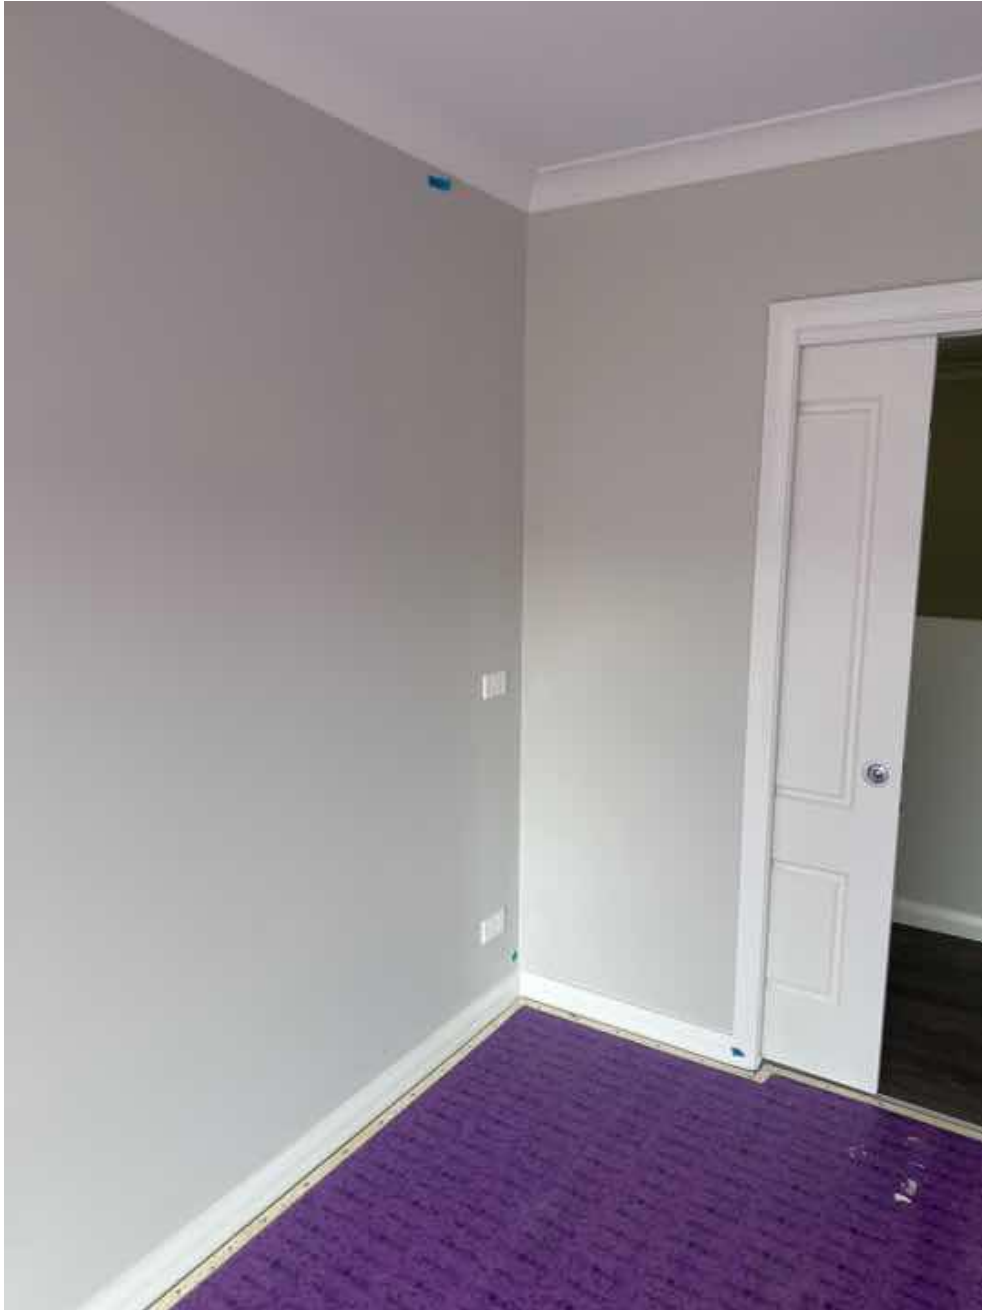
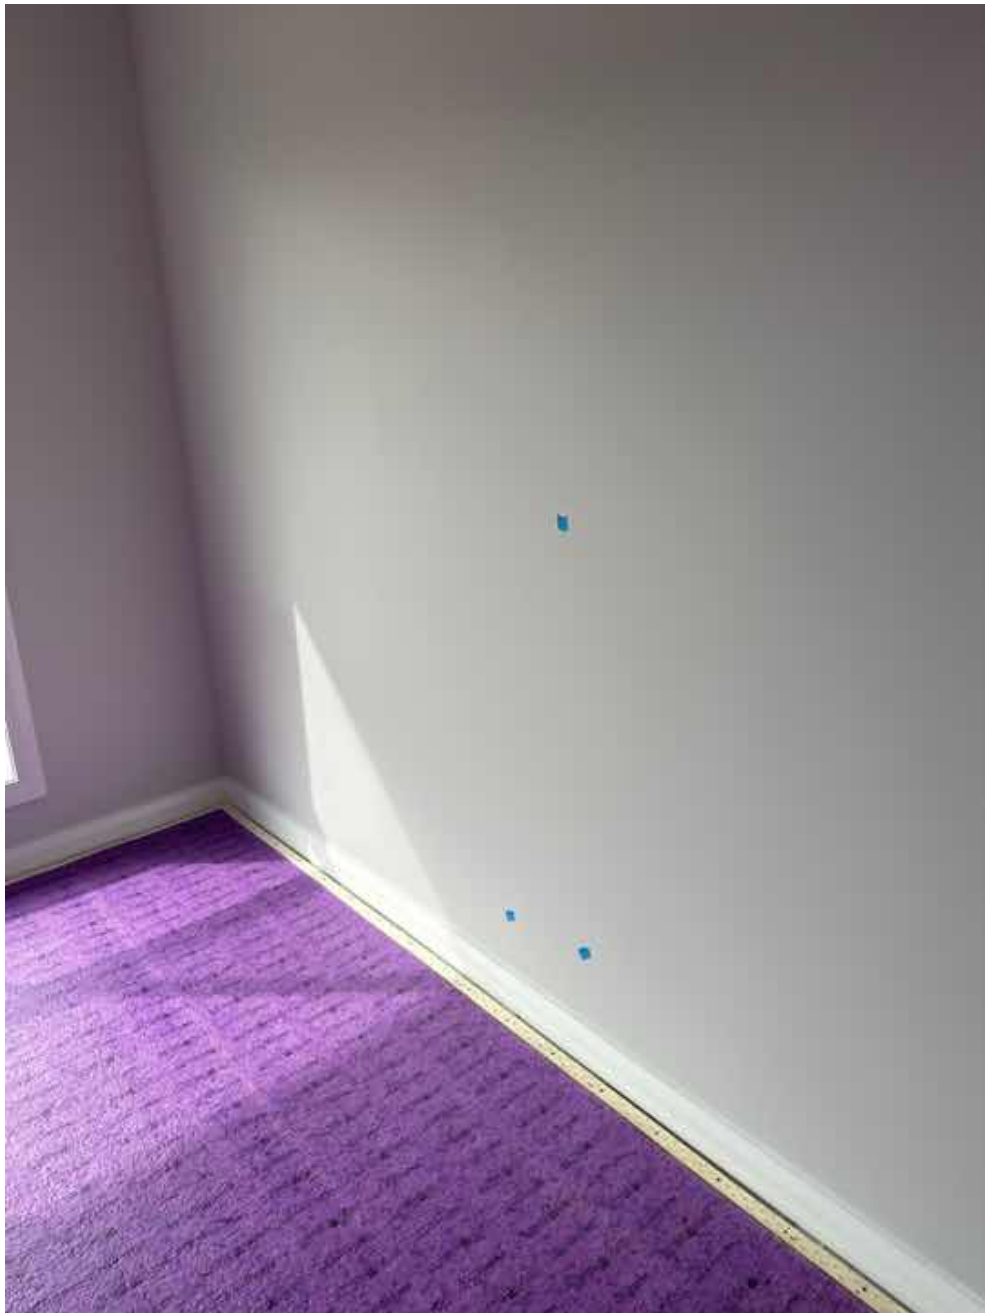
Paint touch ups required. Defects noticeable from normal viewing position. Additional plastering, sanding and painting required.

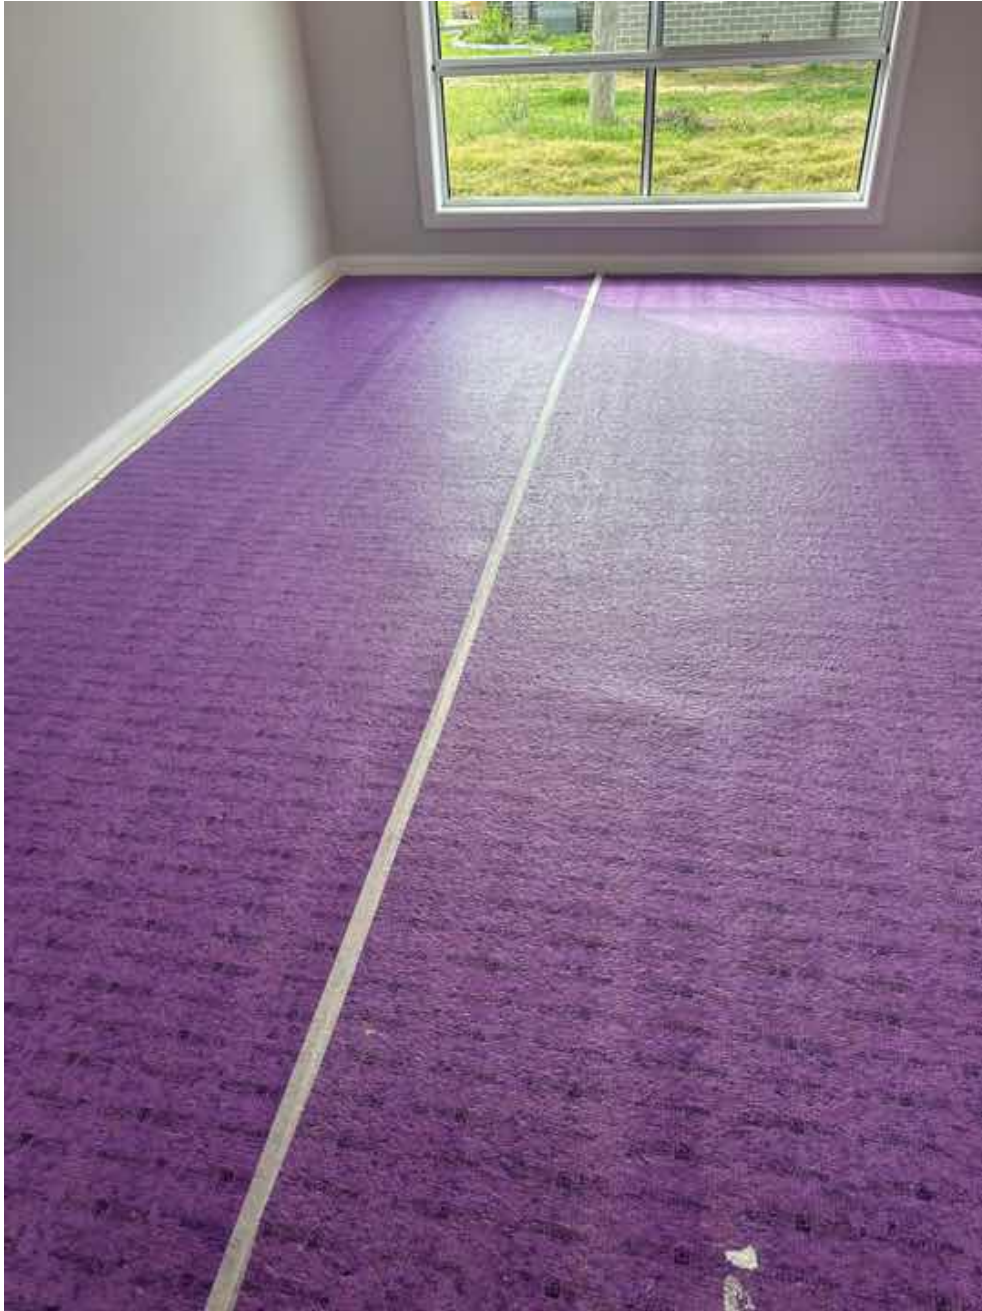
Incomplete installation of carpeting.
