# Inspection Report

**UNCOVER**  
BUILDING AND PEST INSPECTIONS

**1 Sample St , Sample, Nsw, 2281**

### Handover Inspection

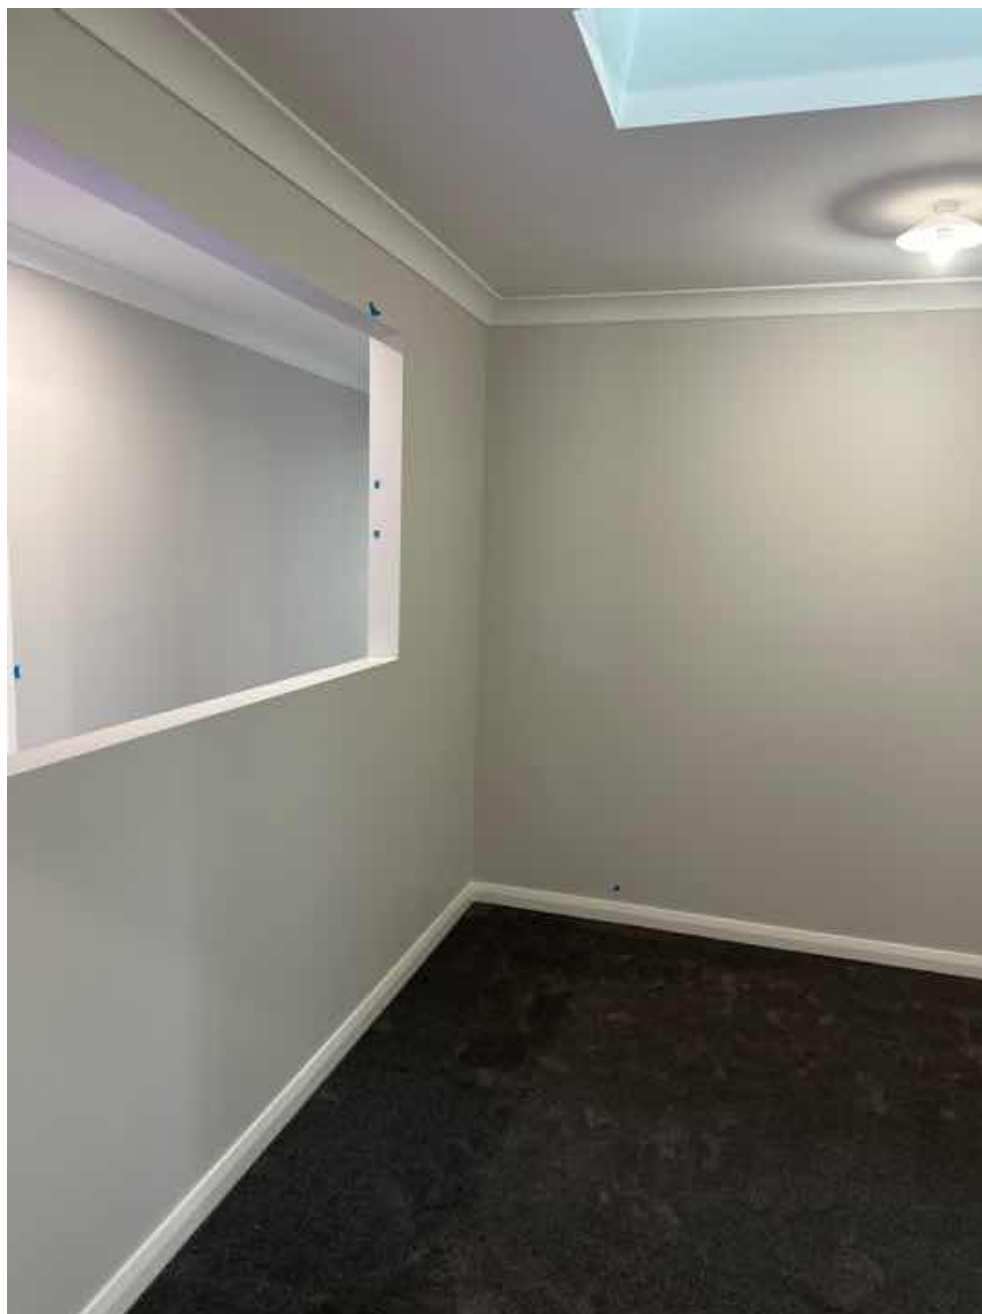
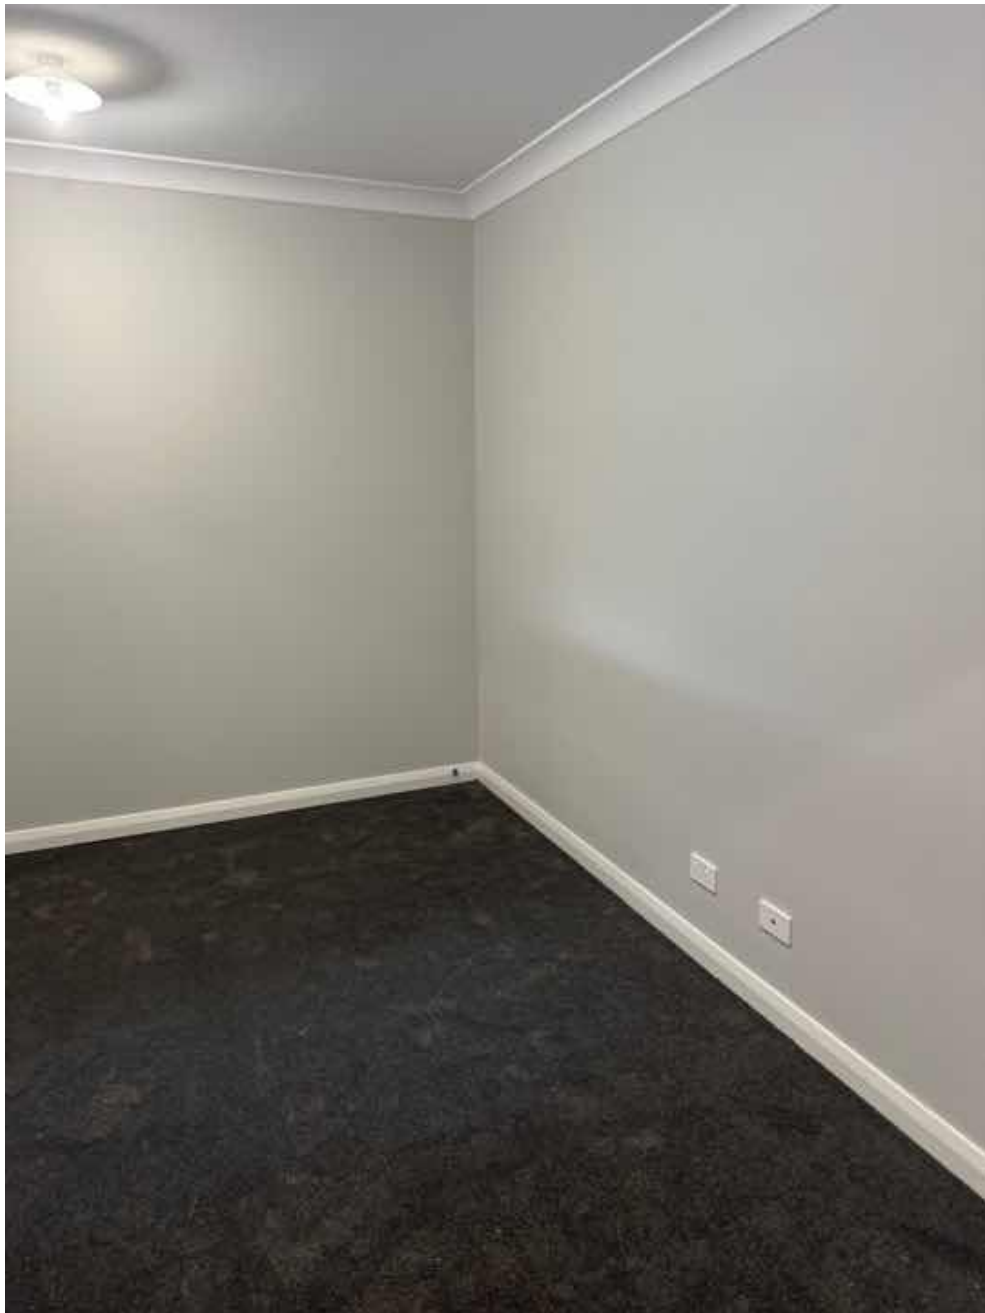
Paint touch ups required. Defects noticeable from normal viewing position. Additional plastering, sanding and painting required.

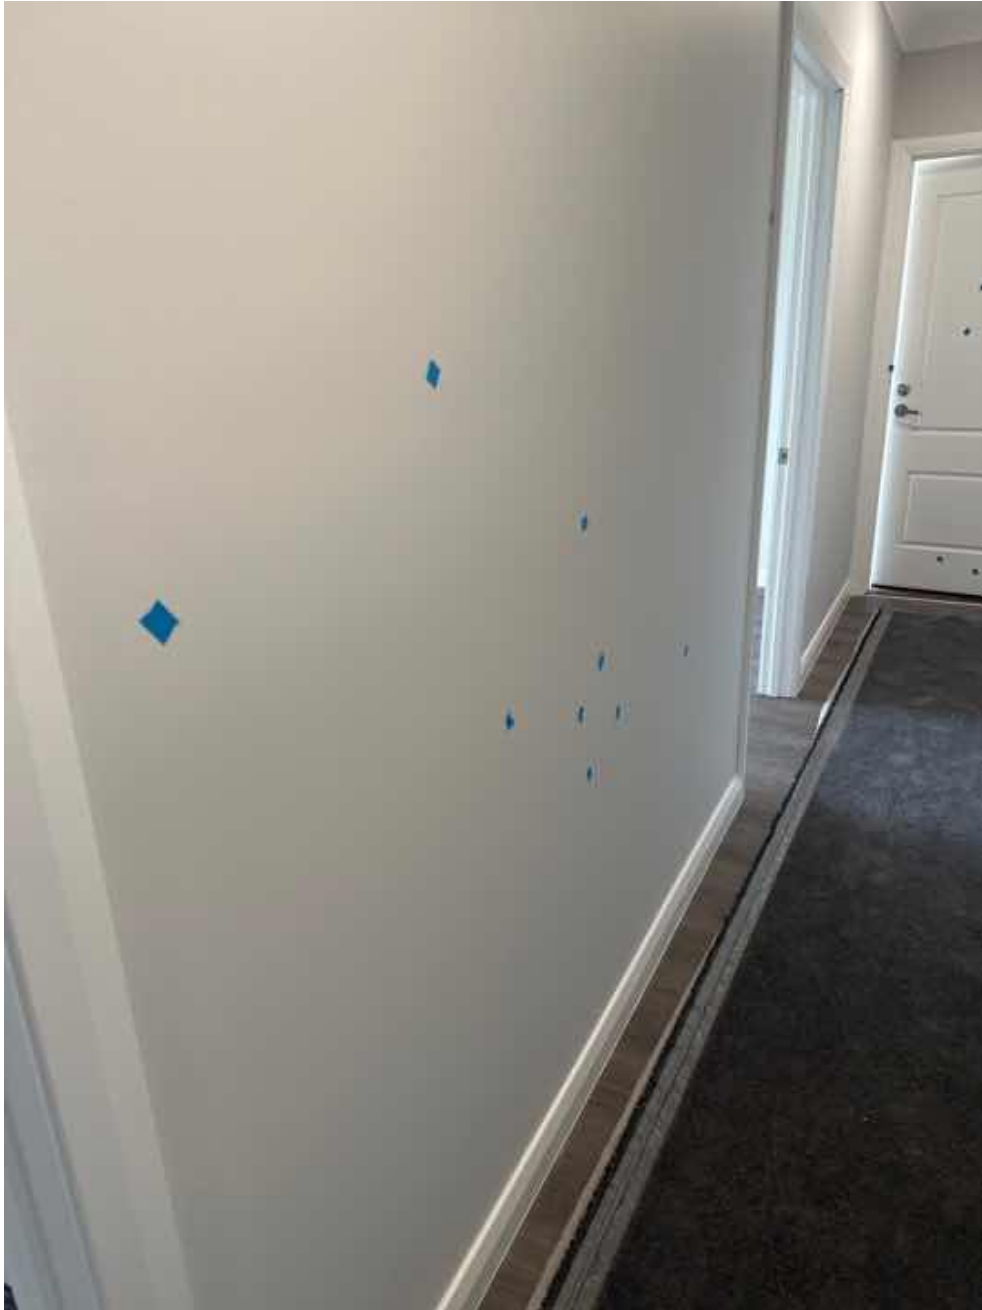
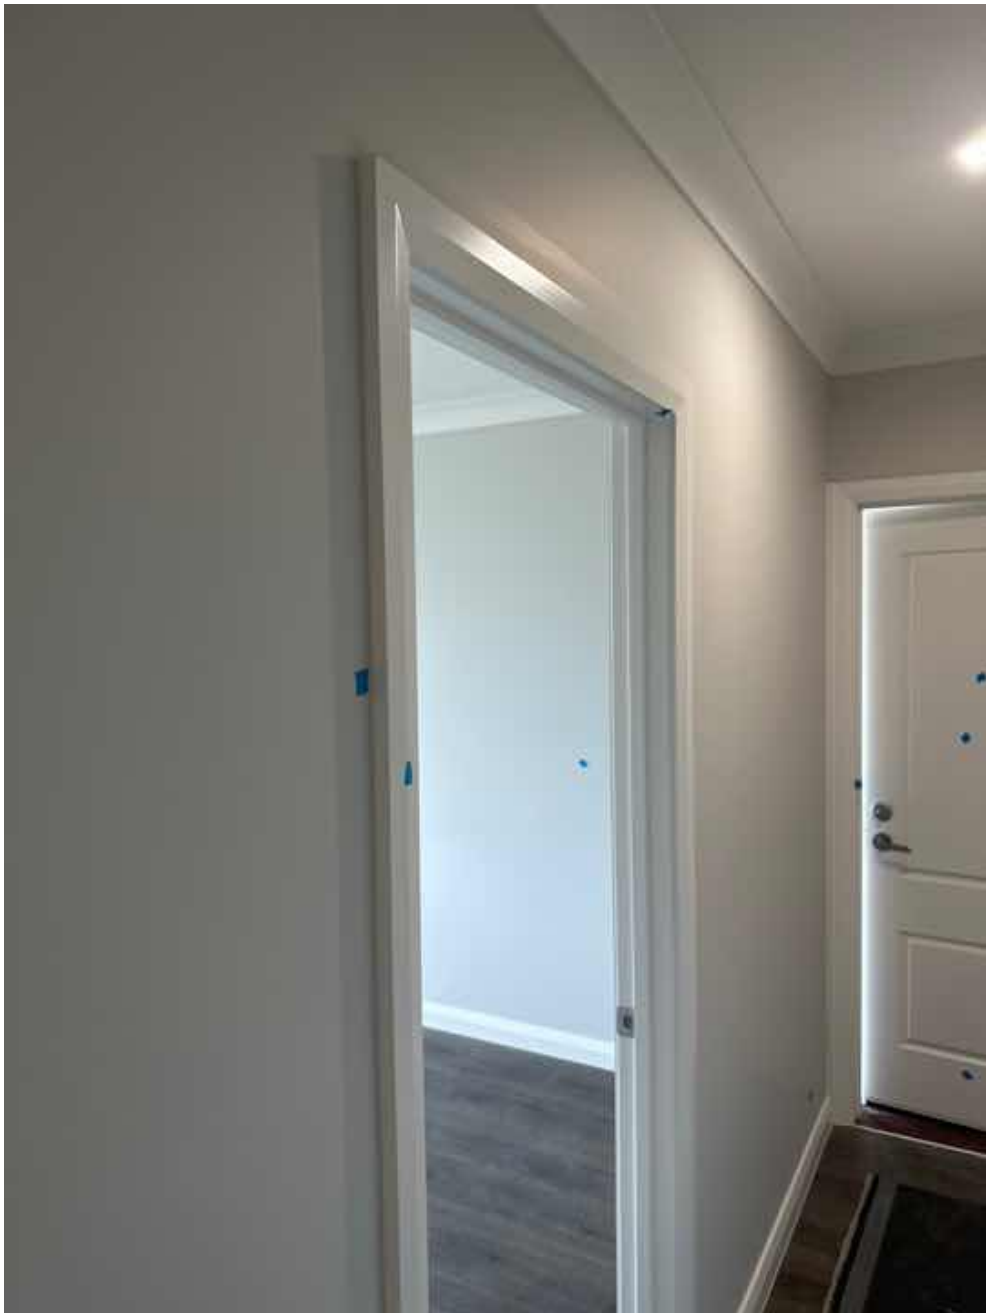
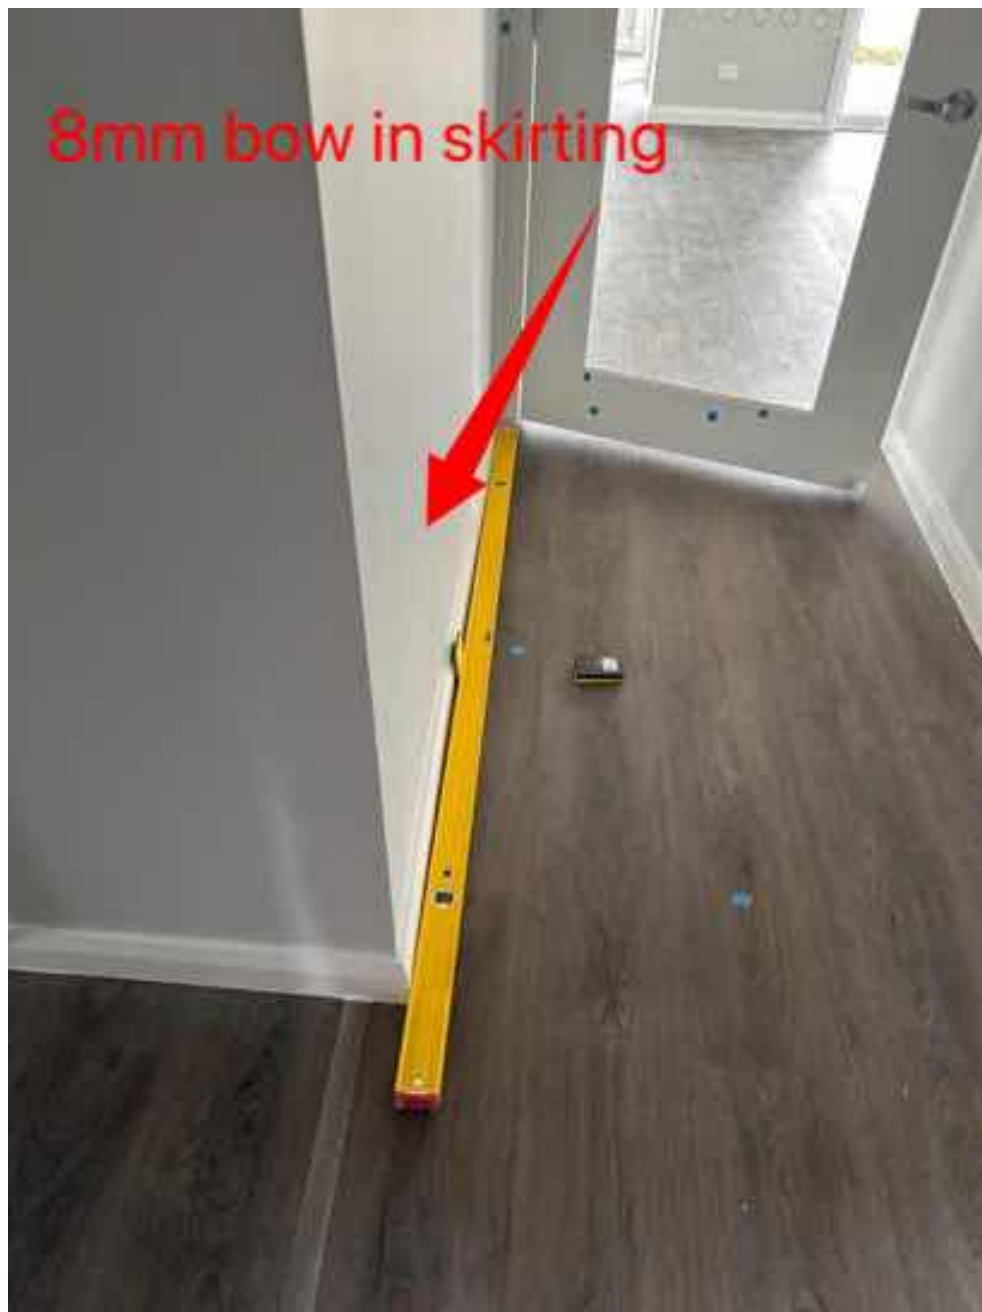
Paint touch ups required. Defects noticeable from normal viewing position. Additional plastering, sanding and painting required.

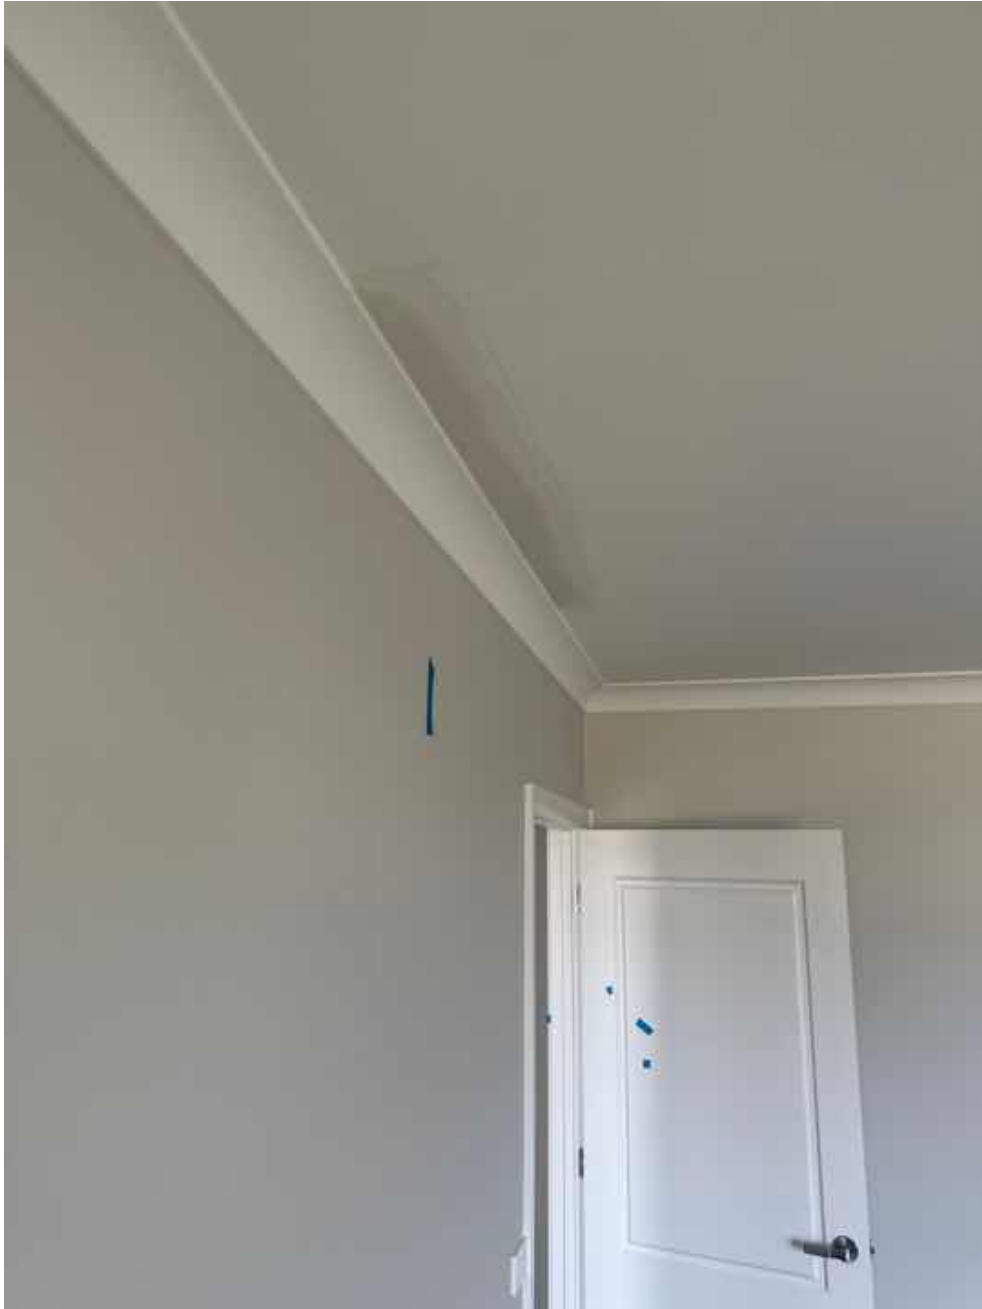
Paint touch ups required.

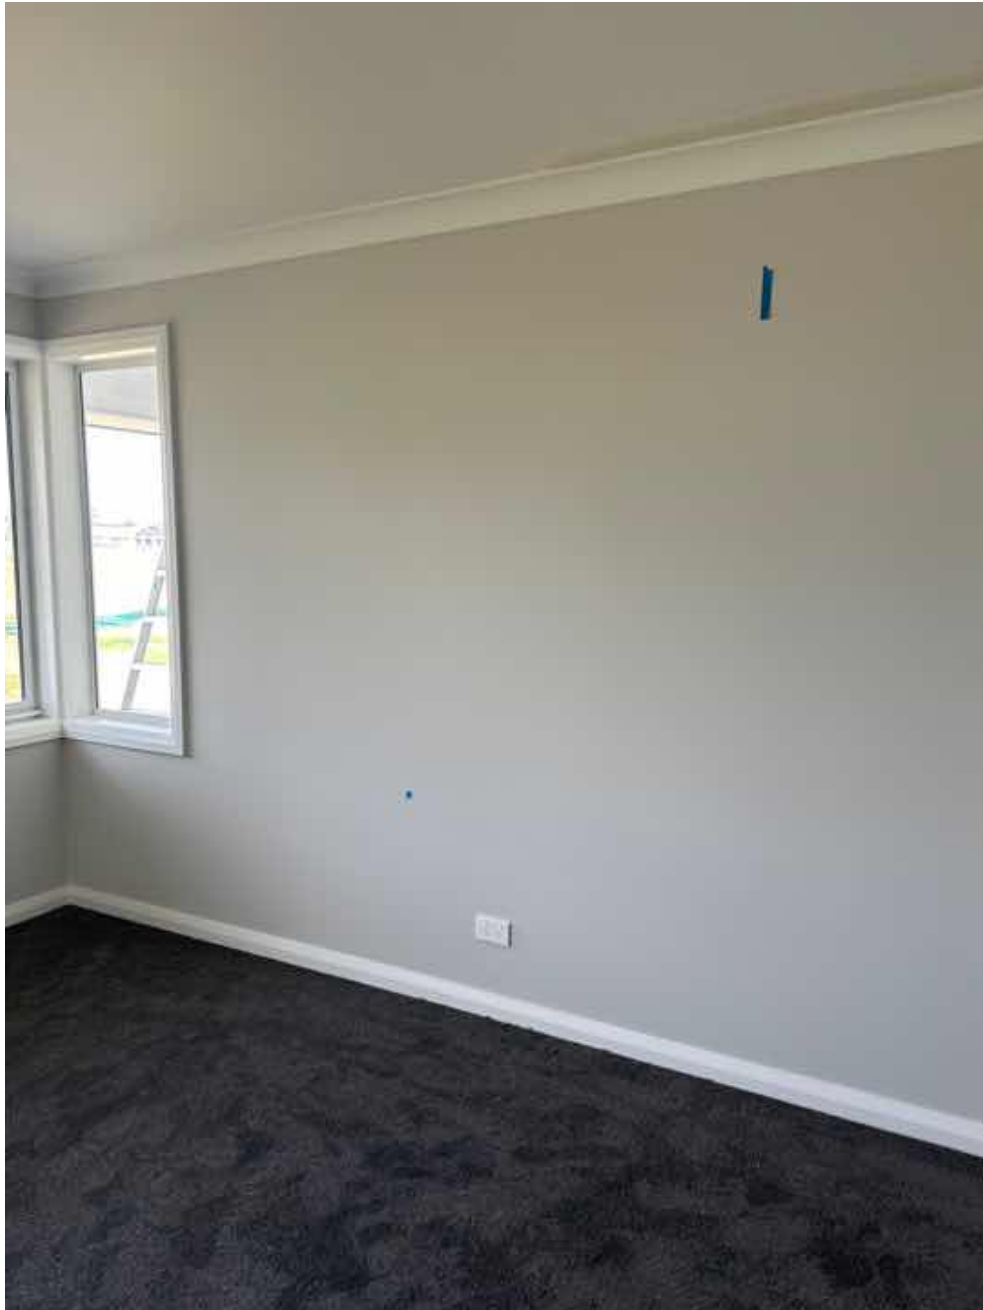
Paint touch ups required. Defects noticeable from normal viewing position. Additional plastering, sanding and painting required.

The paint cover to areas of this room are thin and see through in areas. Re painting of entire wall required in some areas.

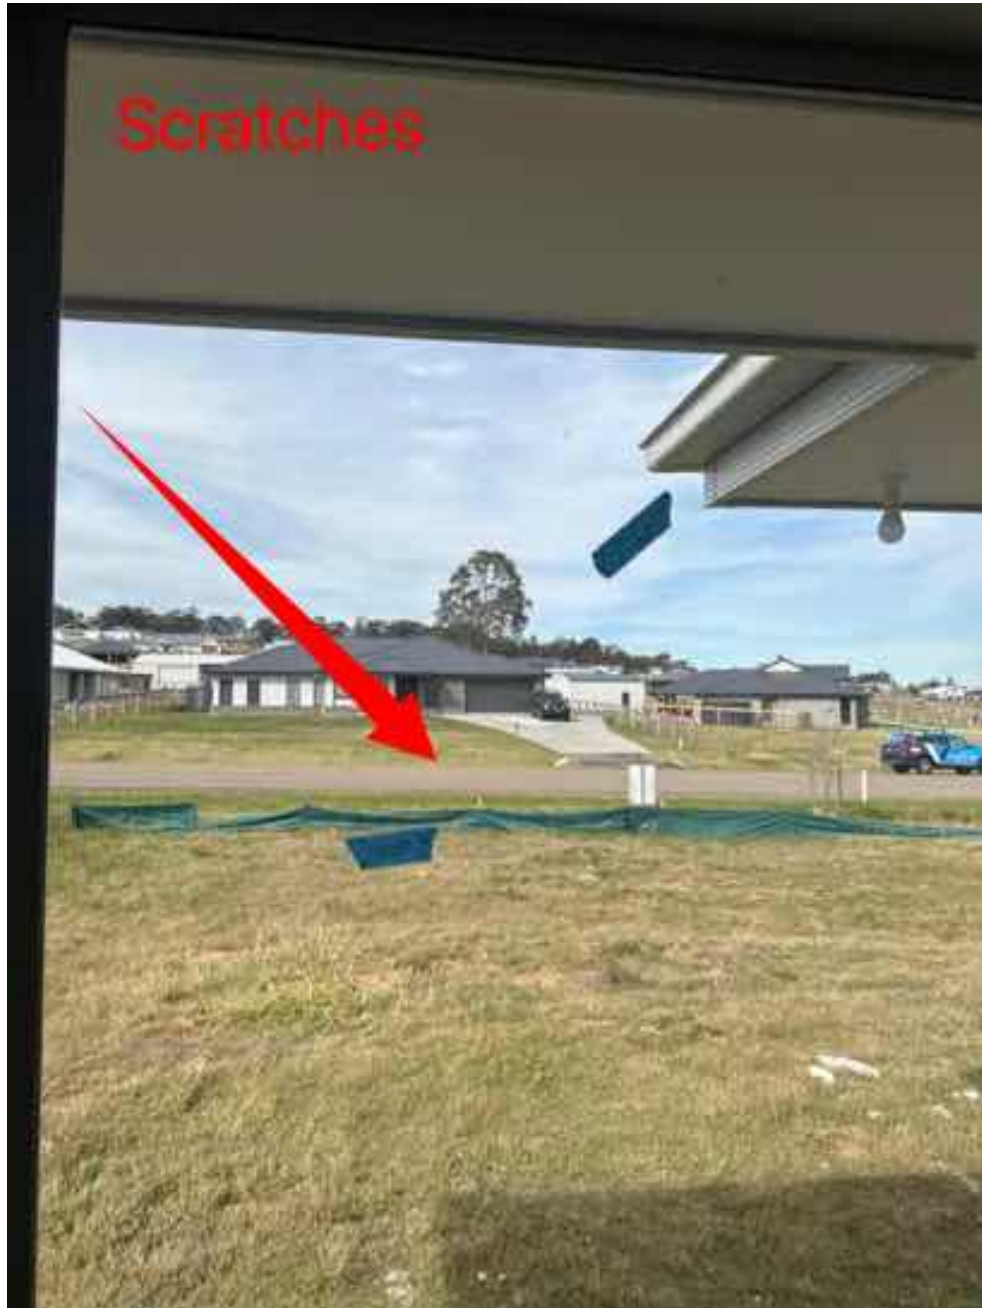
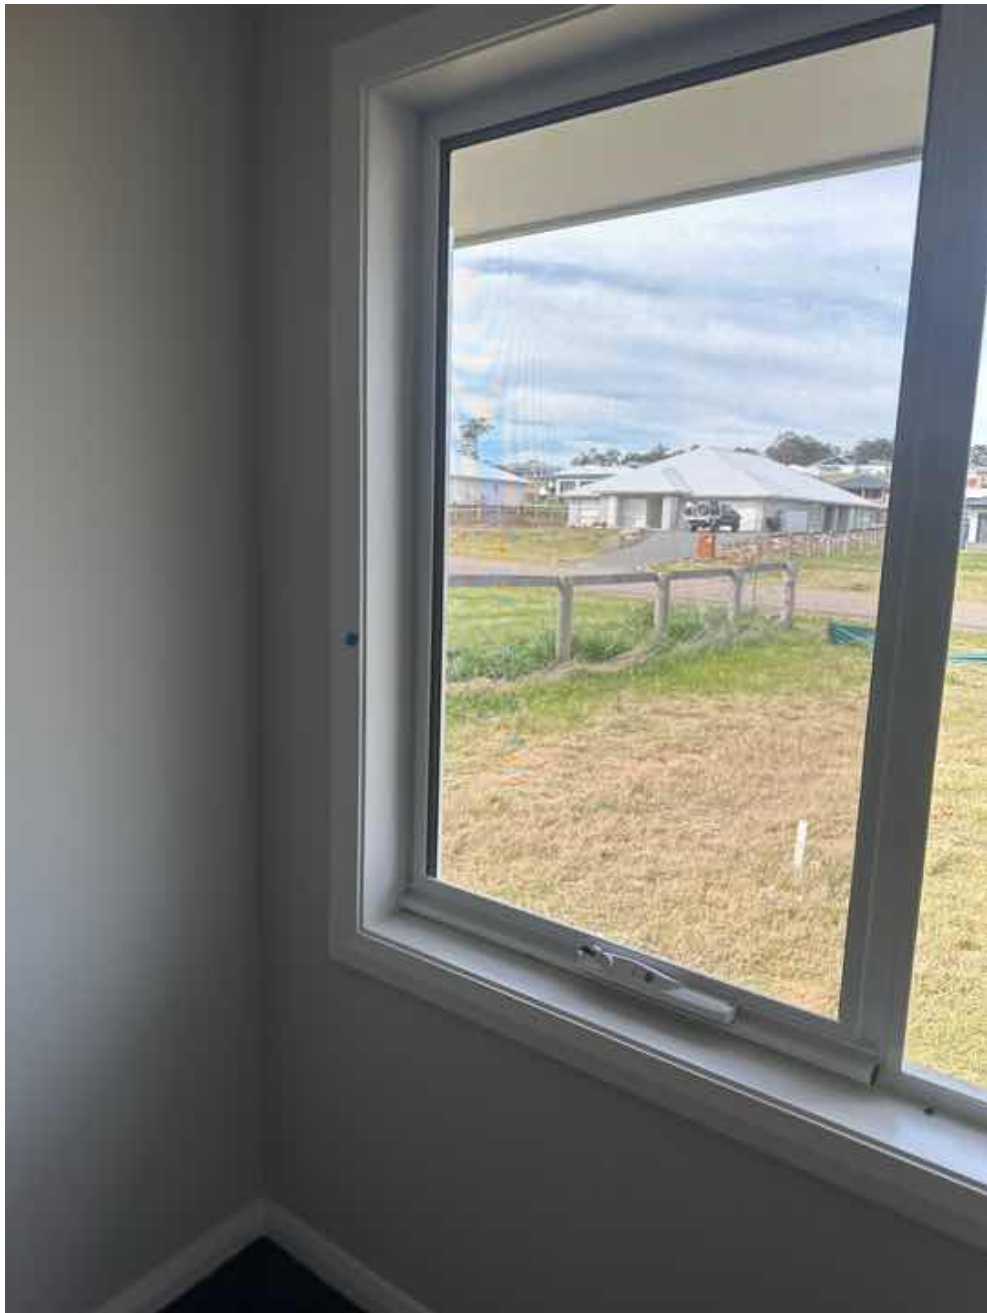
Paint touch ups required.

There are scratches on the glass, require glass replacement or glass polishing.

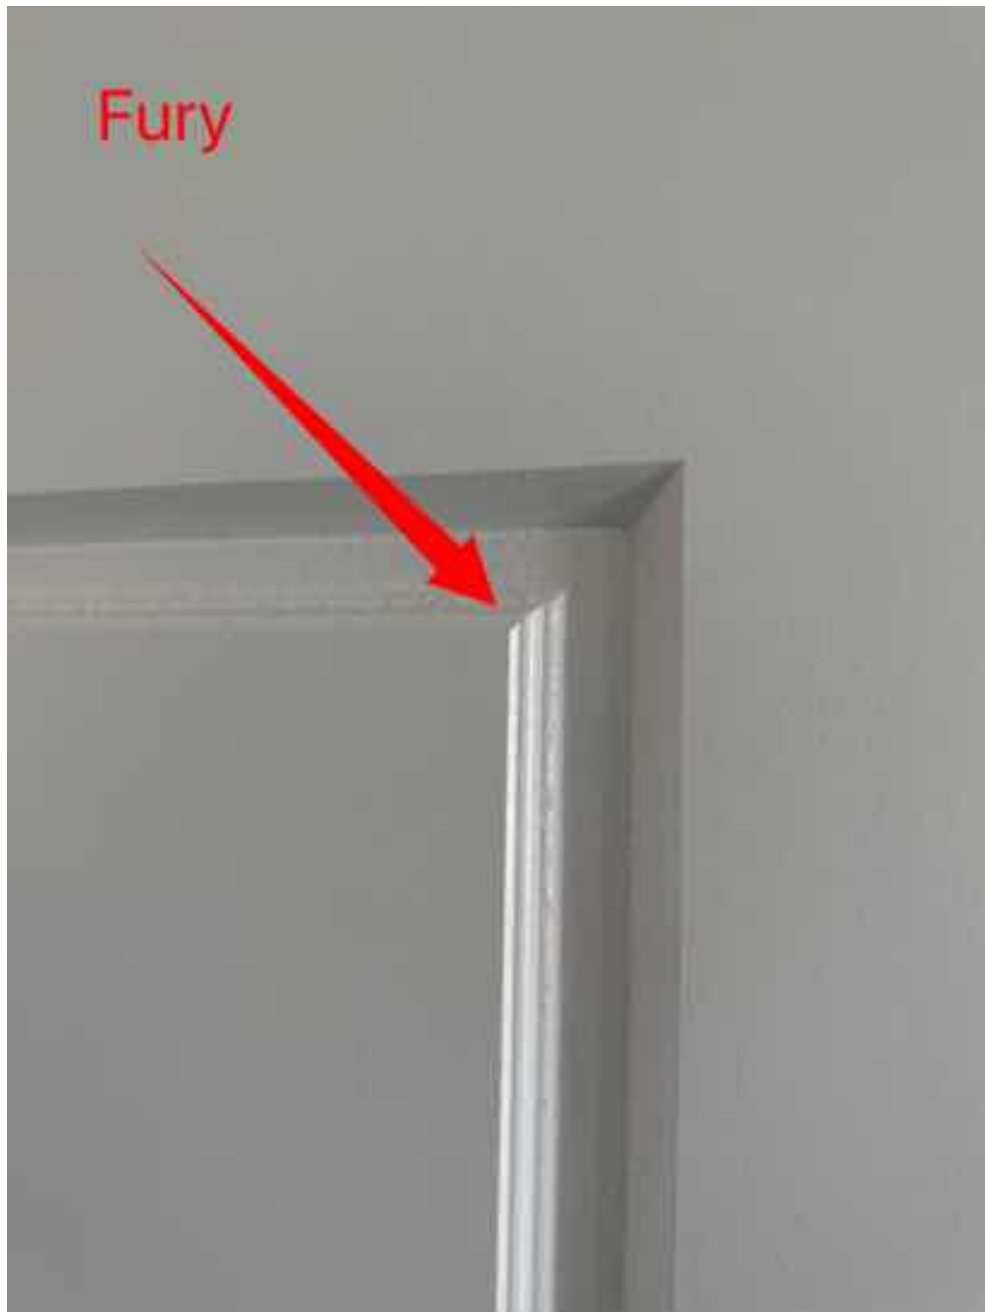
The door face router detail has not been sanded between coats. This detail is fuzzy in appearance from a normal viewing position of 1.5m and is rough to touch. Requires a light sand and re painting.

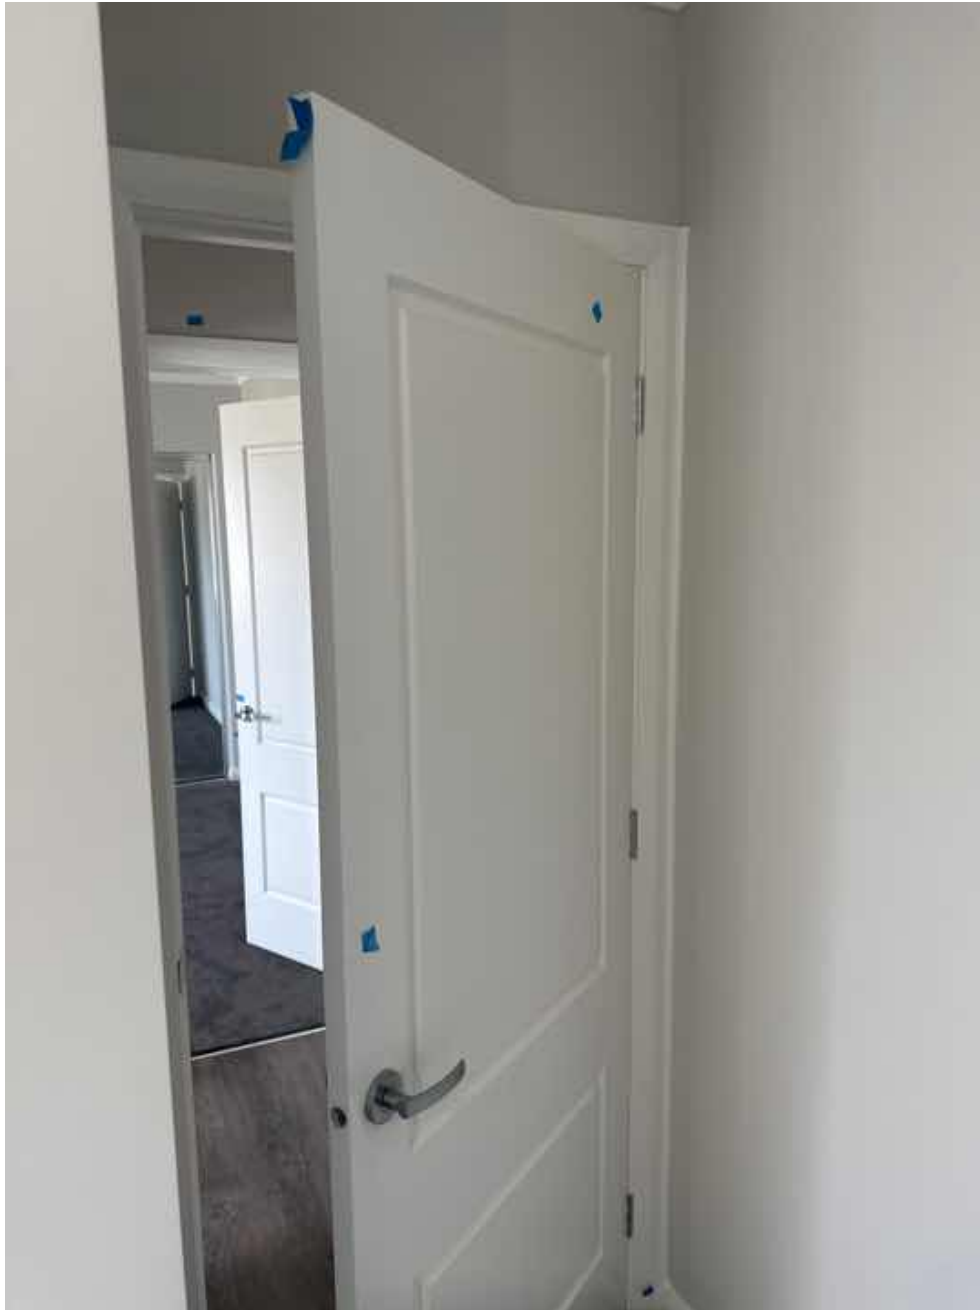
Paint touch ups required as indicated by markers

The door face router detail has not been sanded between coats. This detail is fuzzy in appearance from a normal viewing position of 1.5m and is rough to touch. Requires a light sand and re painting.

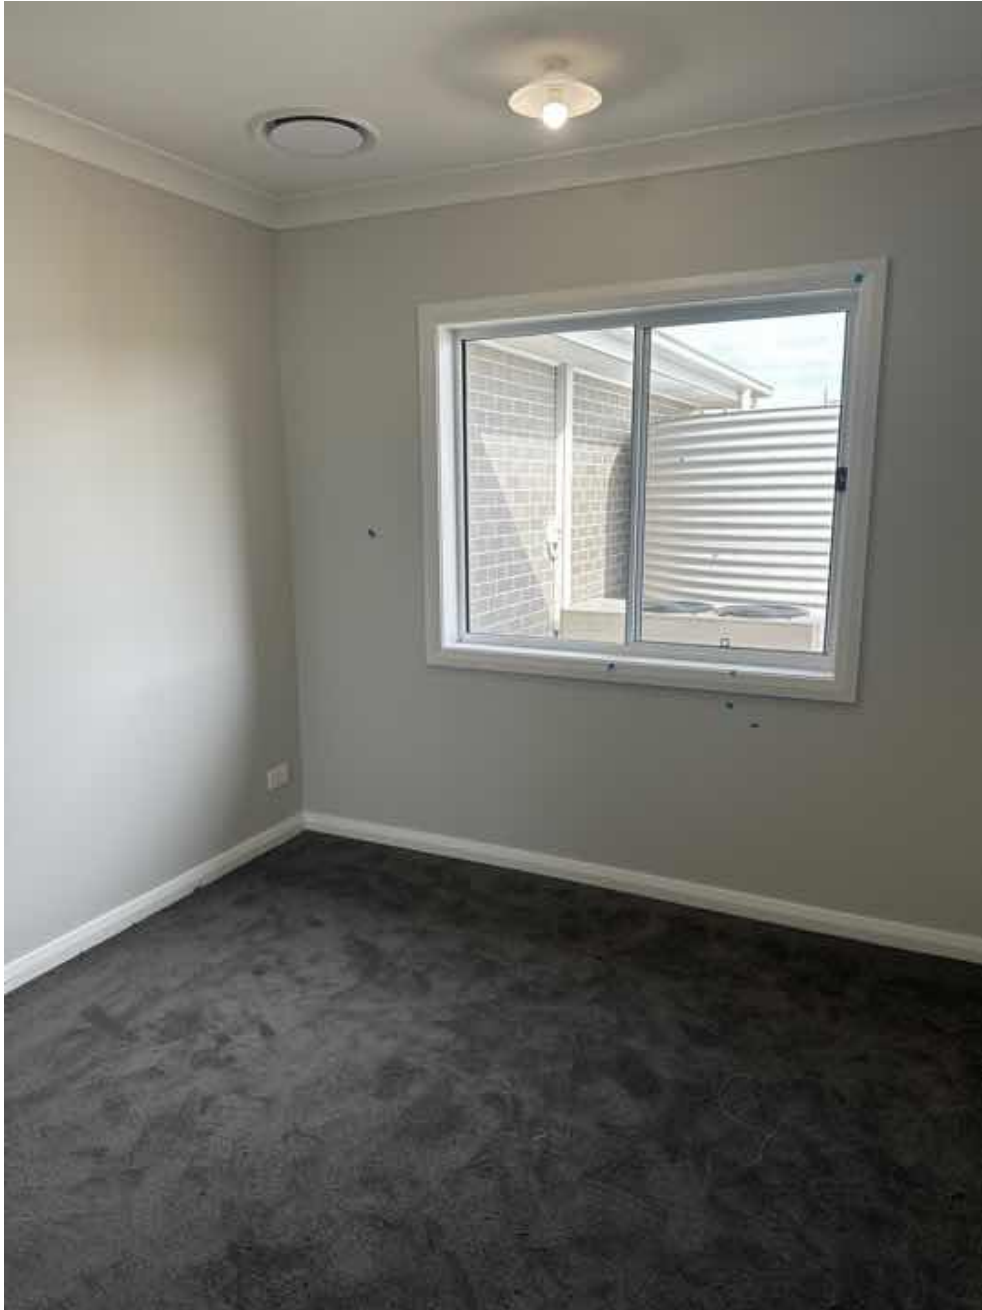
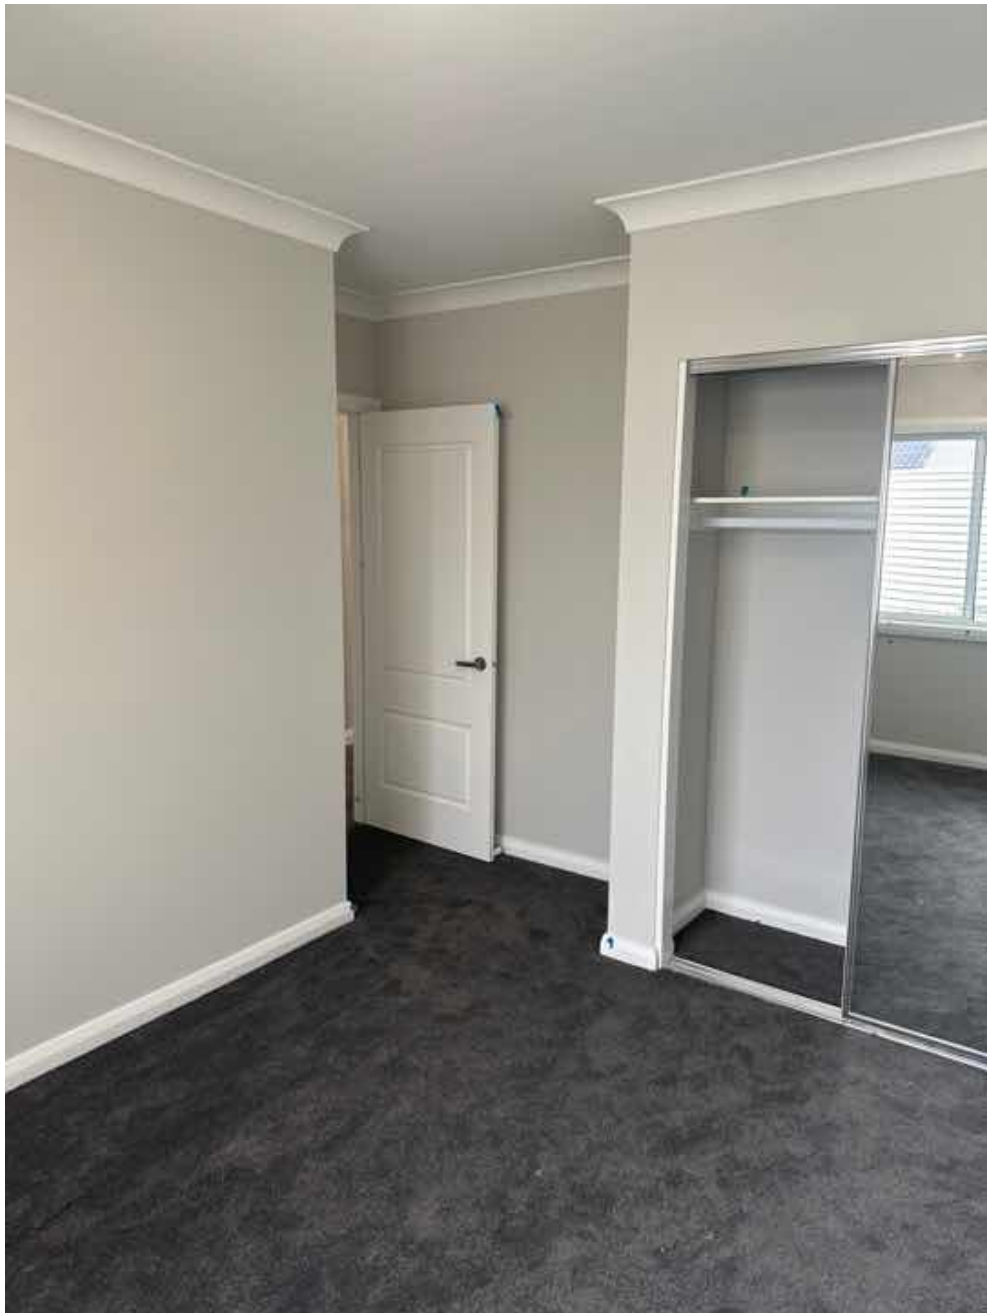
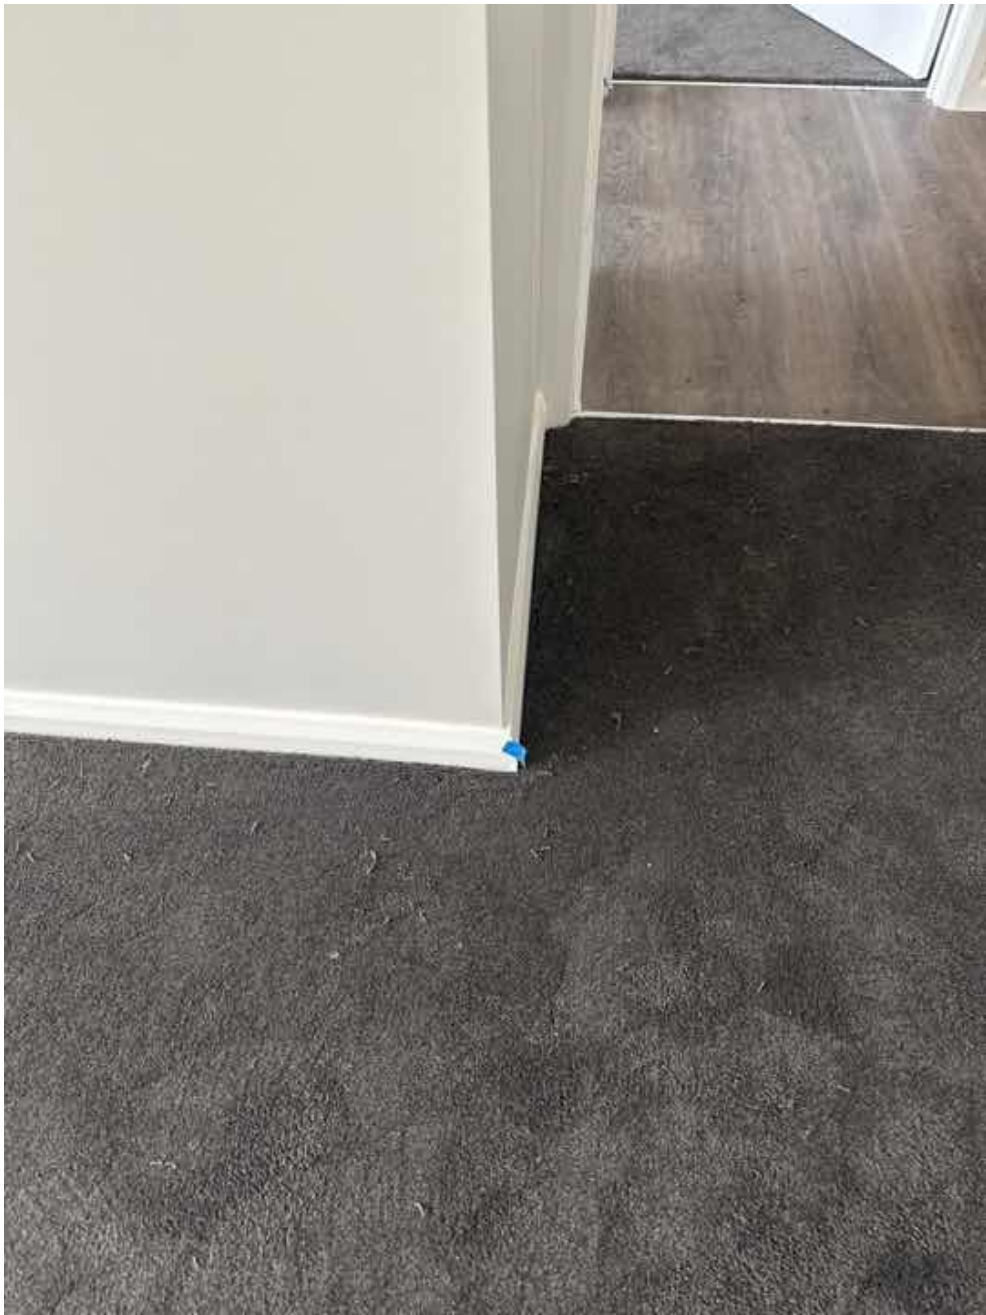
Paint touch ups required. Defects noticeable from normal viewing position. Additional plastering, sanding and painting required.

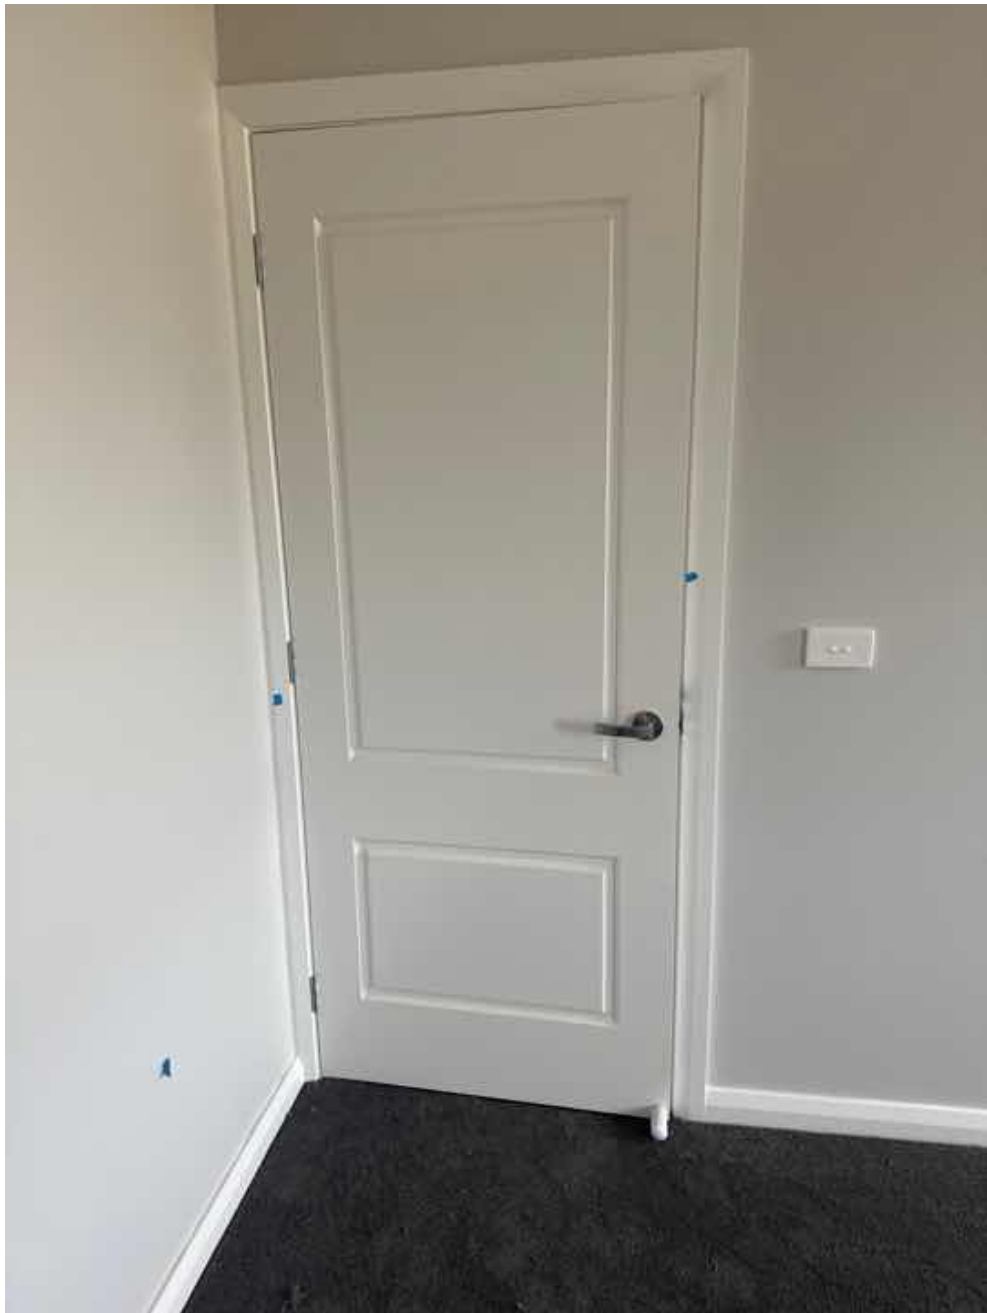
Paint touch ups required as indicated by markers  
Door rattles, stricter requires adjustment

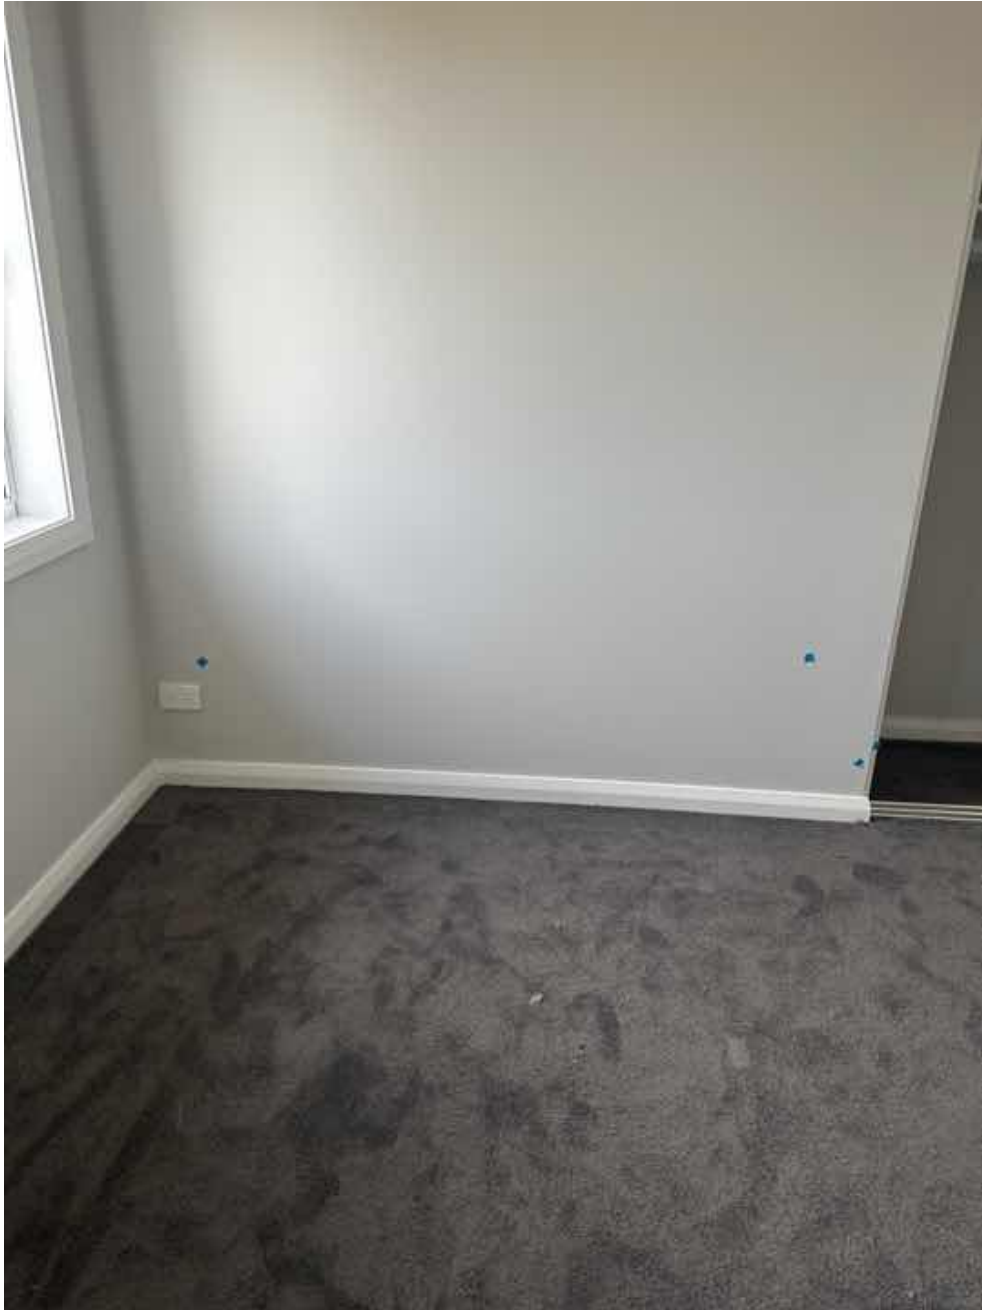
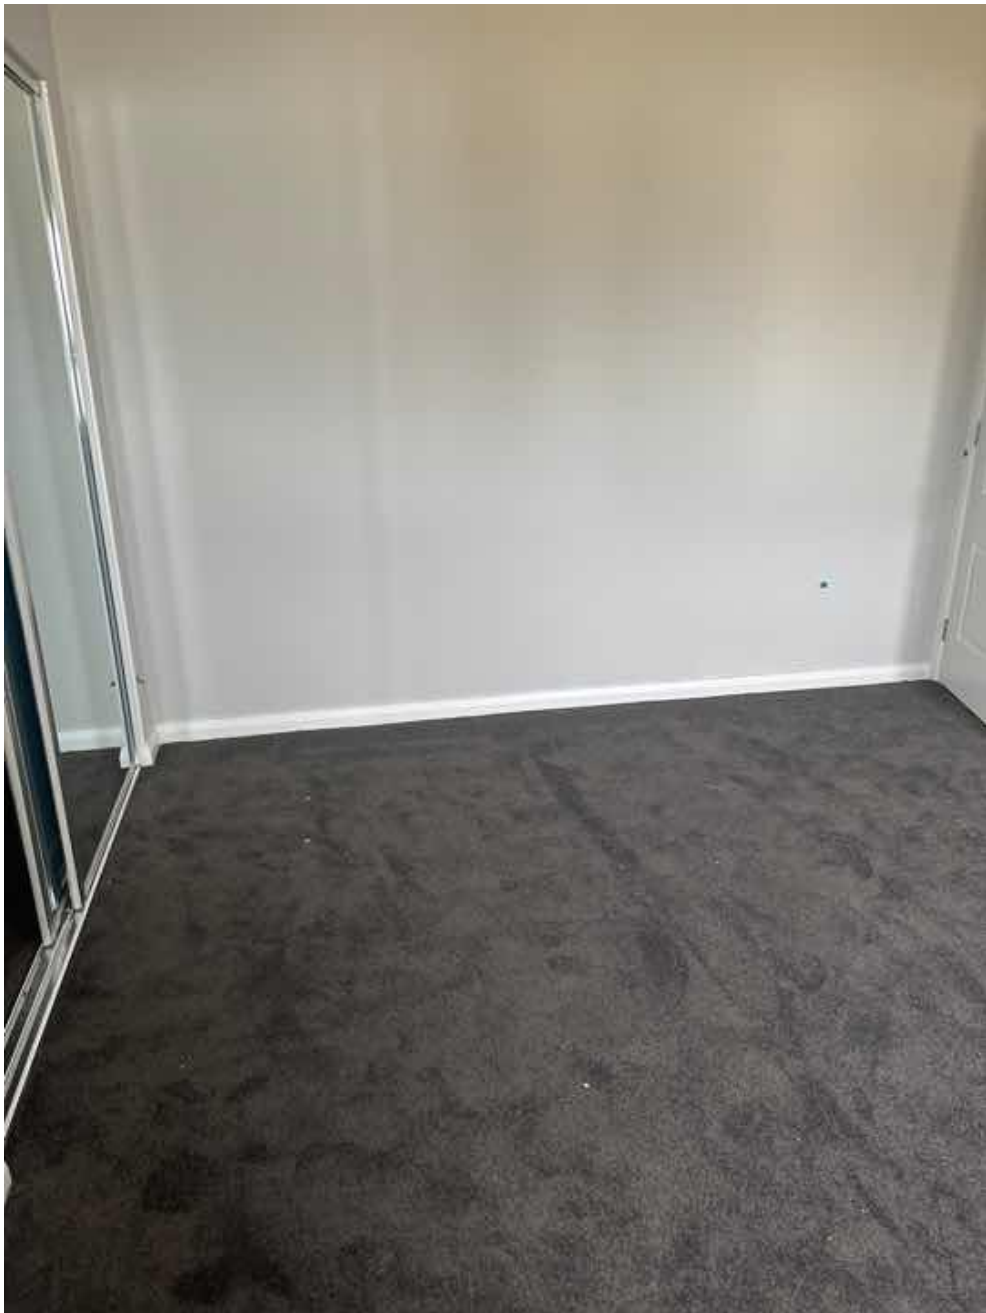
Paint touch ups required. Defects noticeable from normal viewing position. Additional plastering, sanding and painting required.
