# Inspection Report

**UNCOVER**  
BUILDING AND PEST INSPECTIONS

**1 Sample St , Sample, Nsw, 2281**

### Handover Inspection

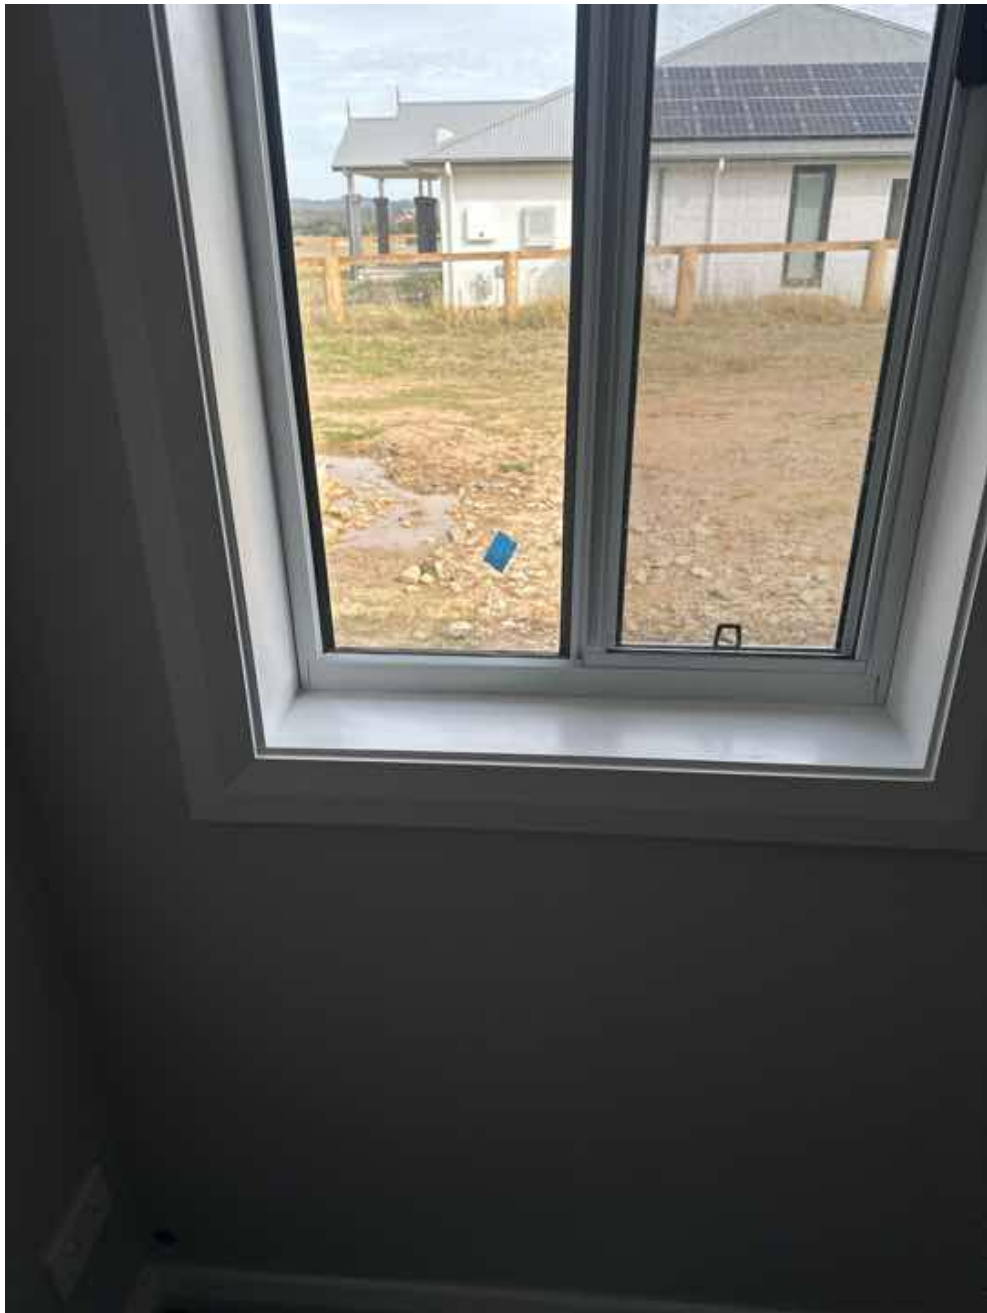
Stickers / marks on glass

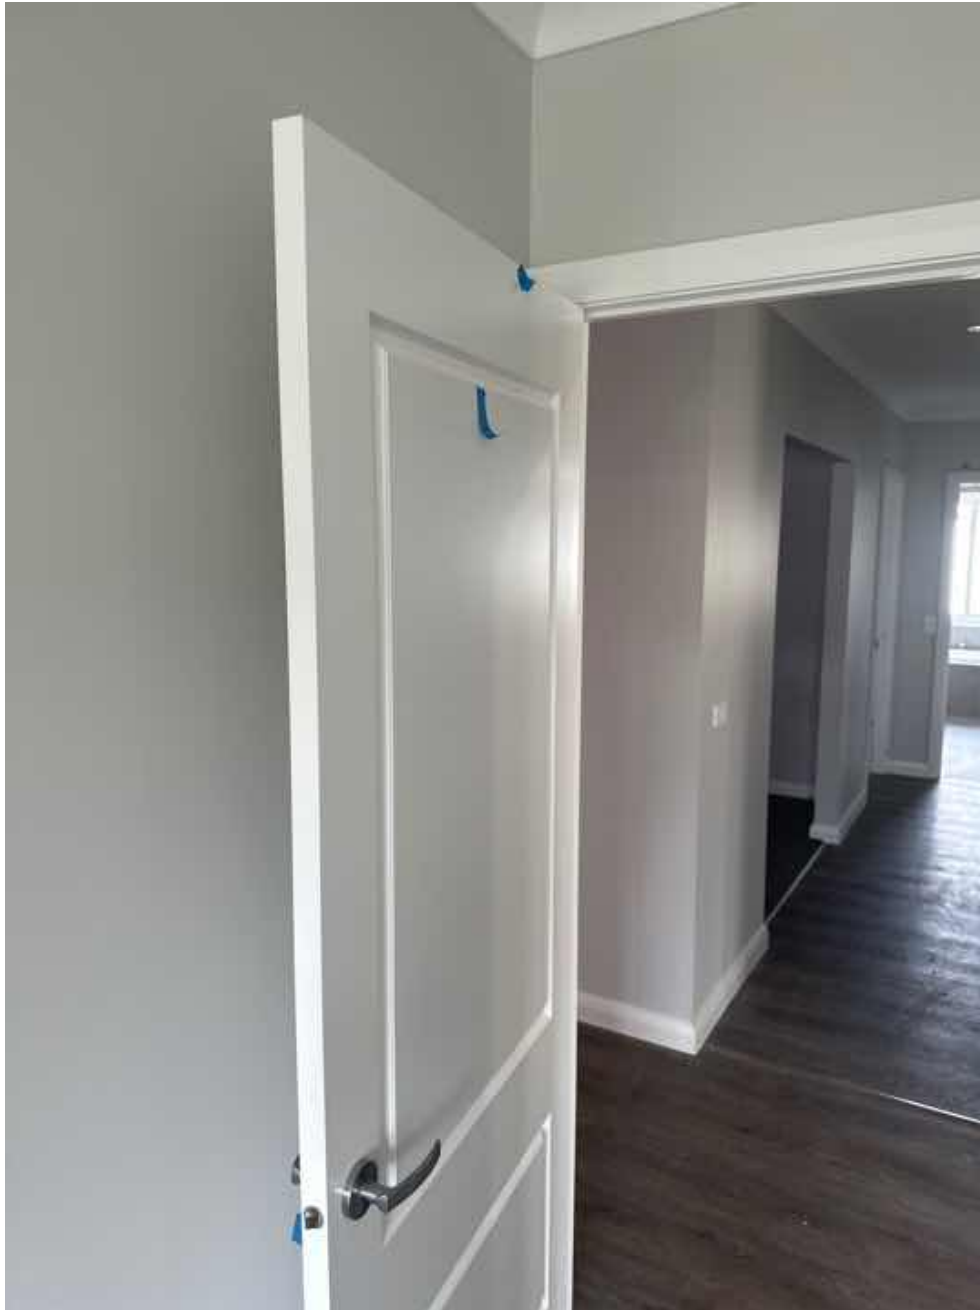
Paint touch ups required as indicated by markers

The door face router detail has not been sanded between coats. This detail is fuzzy in appearance from a normal viewing position of 1.5m and is rough to touch. Requires a light sand and re painting.

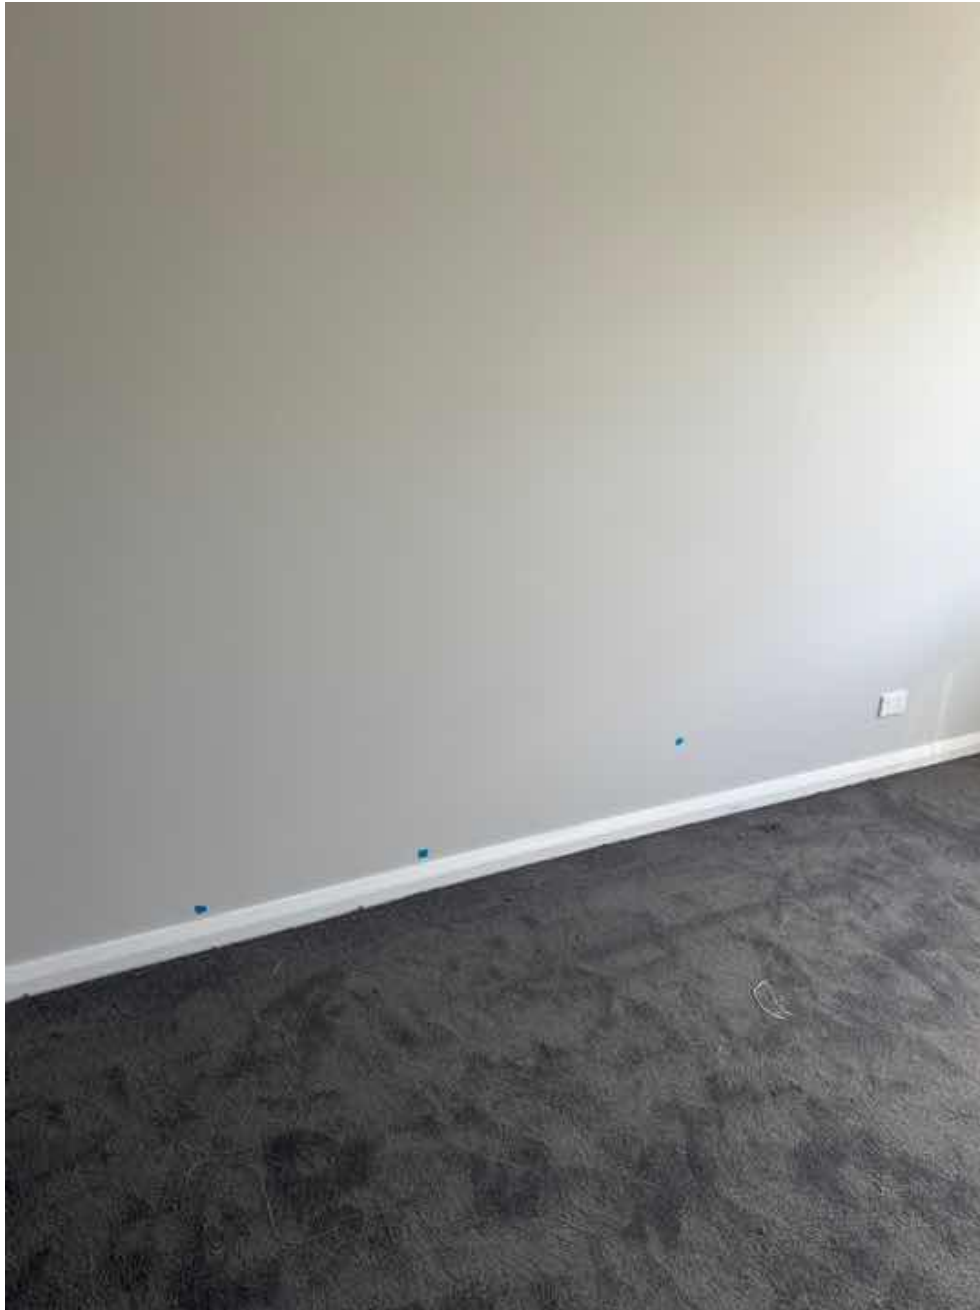
Paint touch ups required. Defects noticeable from normal viewing position. Additional plastering, sanding and painting required.

Bowed square set. Bowed approx 6mm over 2m. Rectification required.

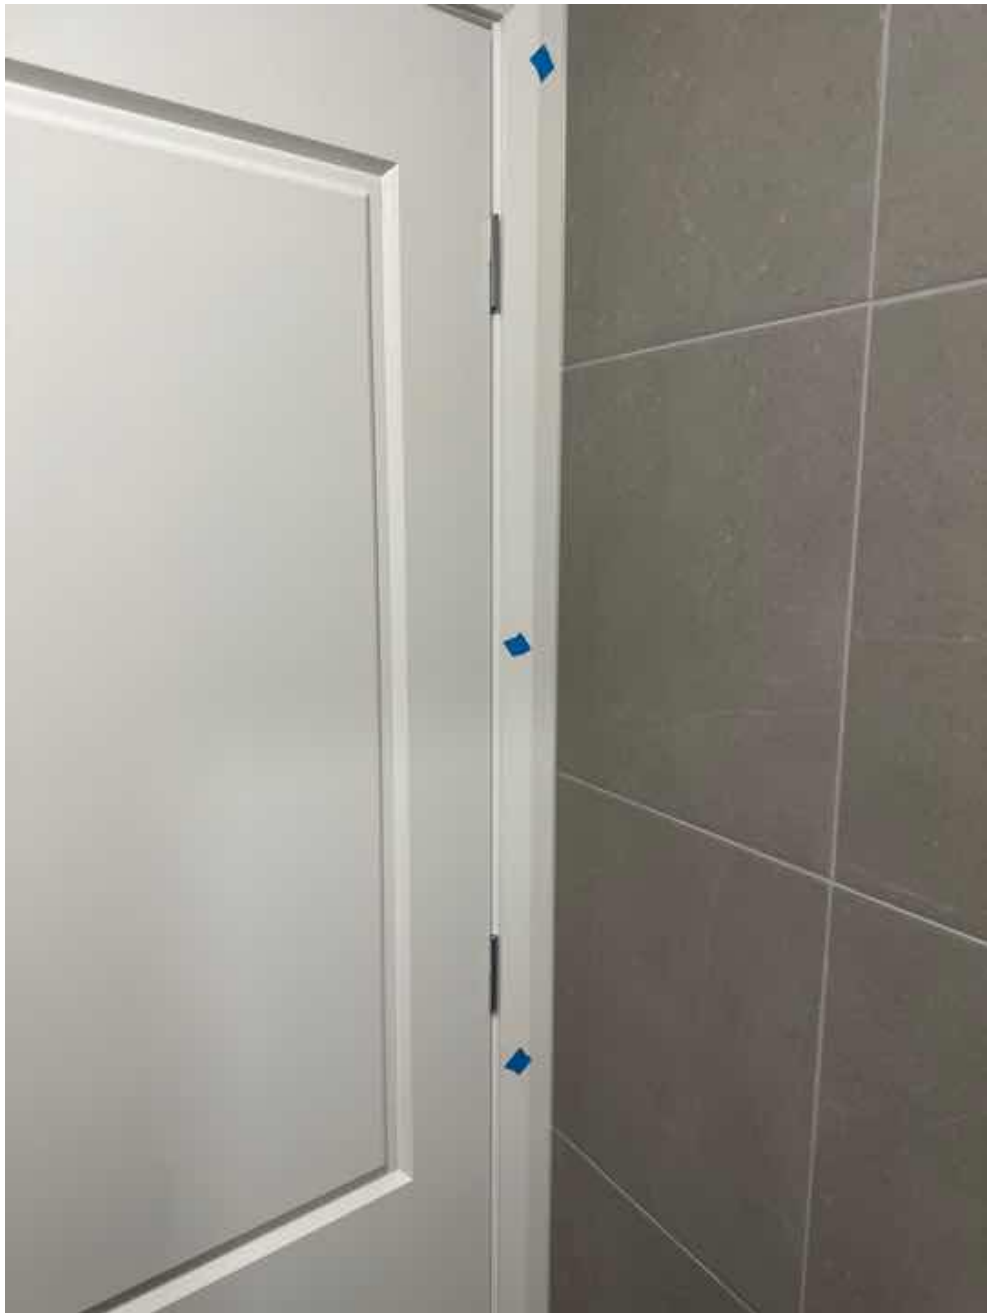
The door face router detail has not been sanded between coats. This detail is fuzzy in appearance from a normal viewing position of 1.5m and is rough to touch. Requires a light sand and re painting.

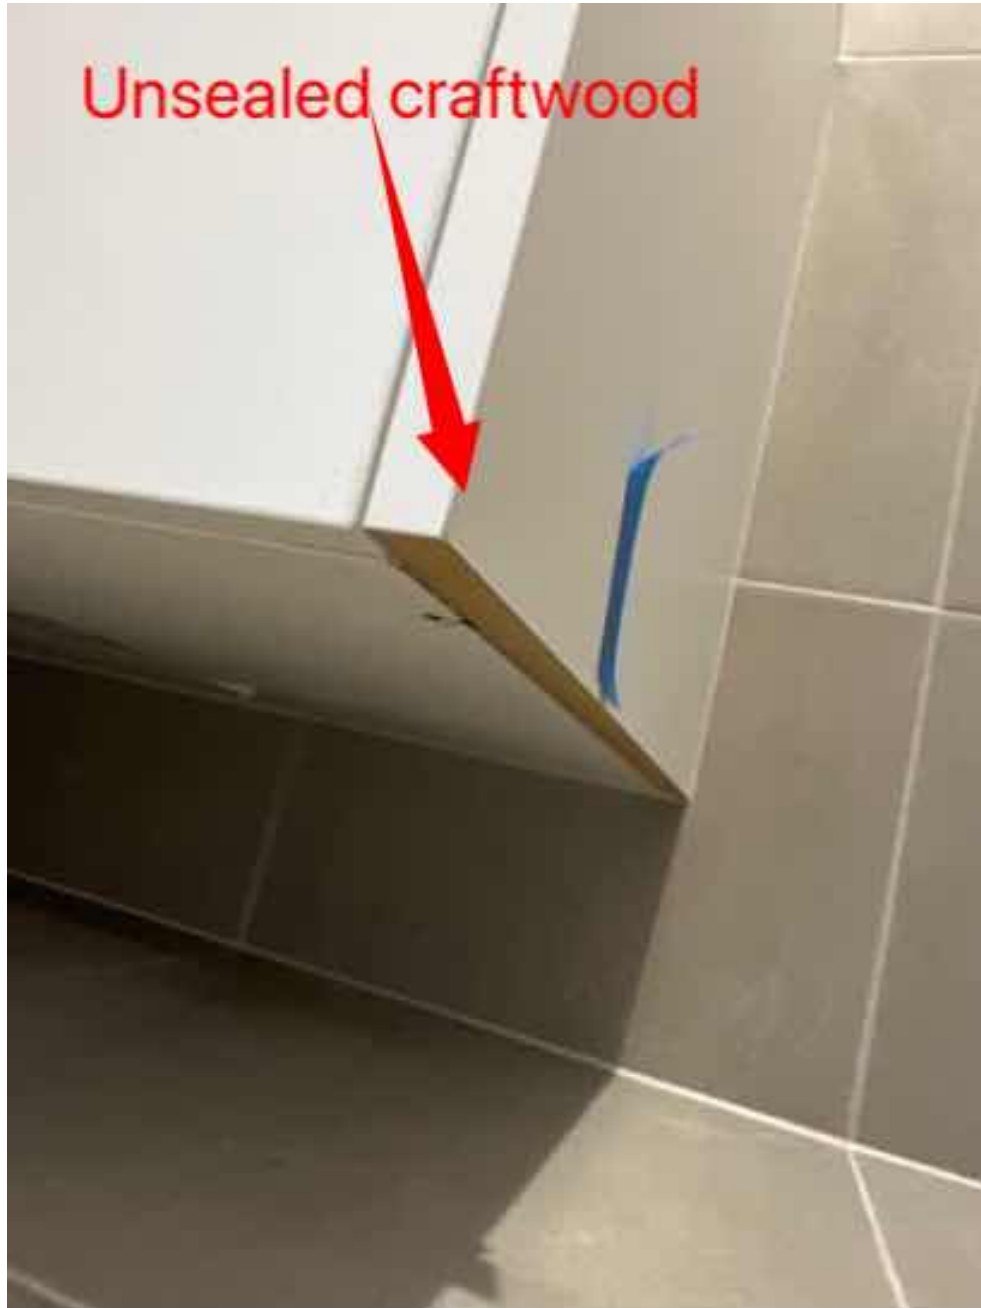
The vanity has unsealed exposed craftwood. This will absorb moisture in the bathroom area and prematurely degrade. Amendment required.

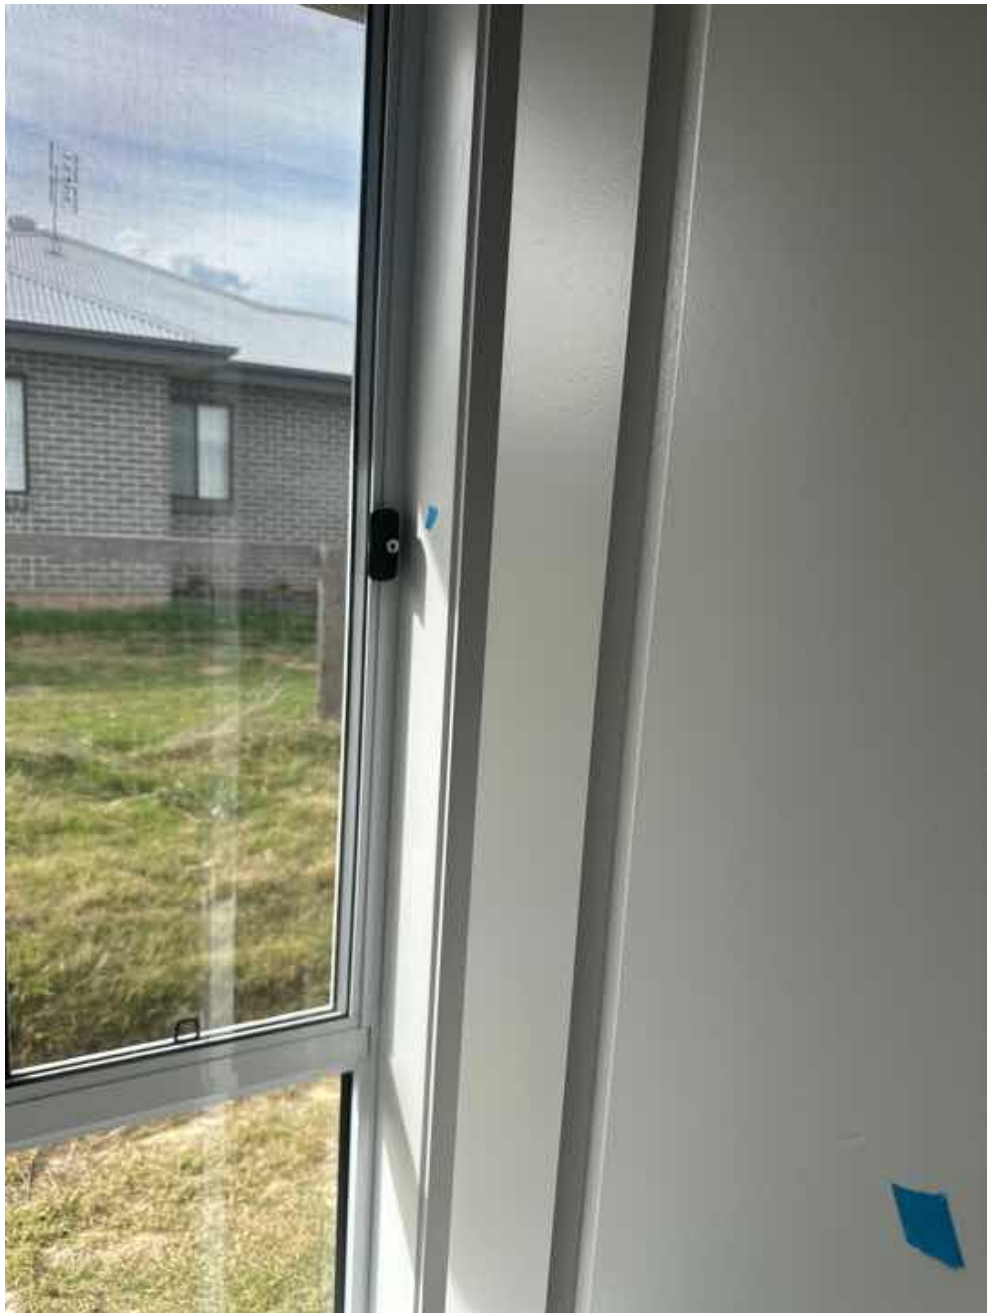
Paint touch ups required.

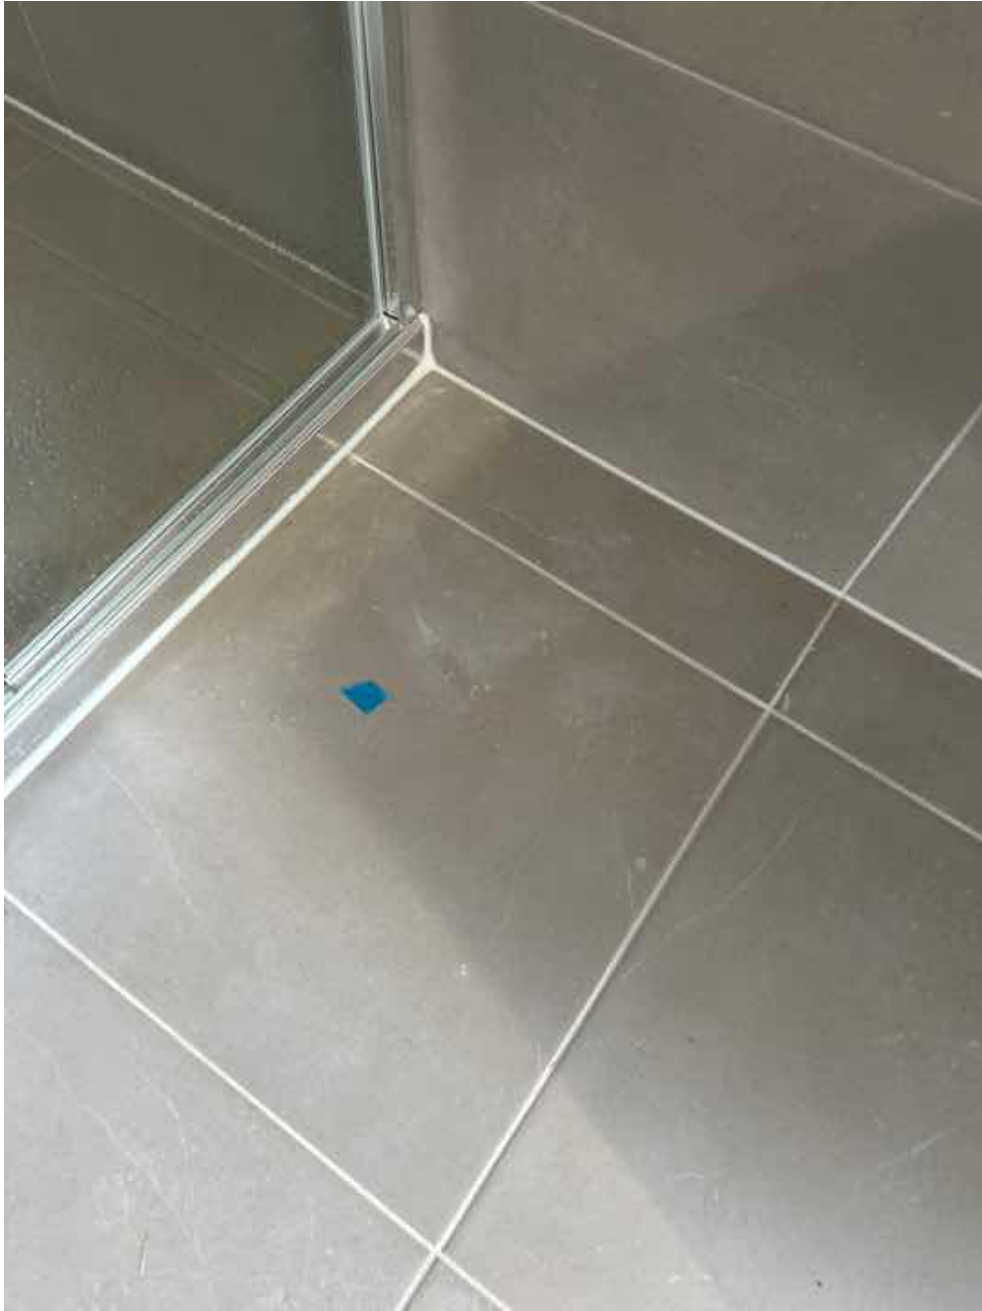
Grout haze noted. Cleaning required

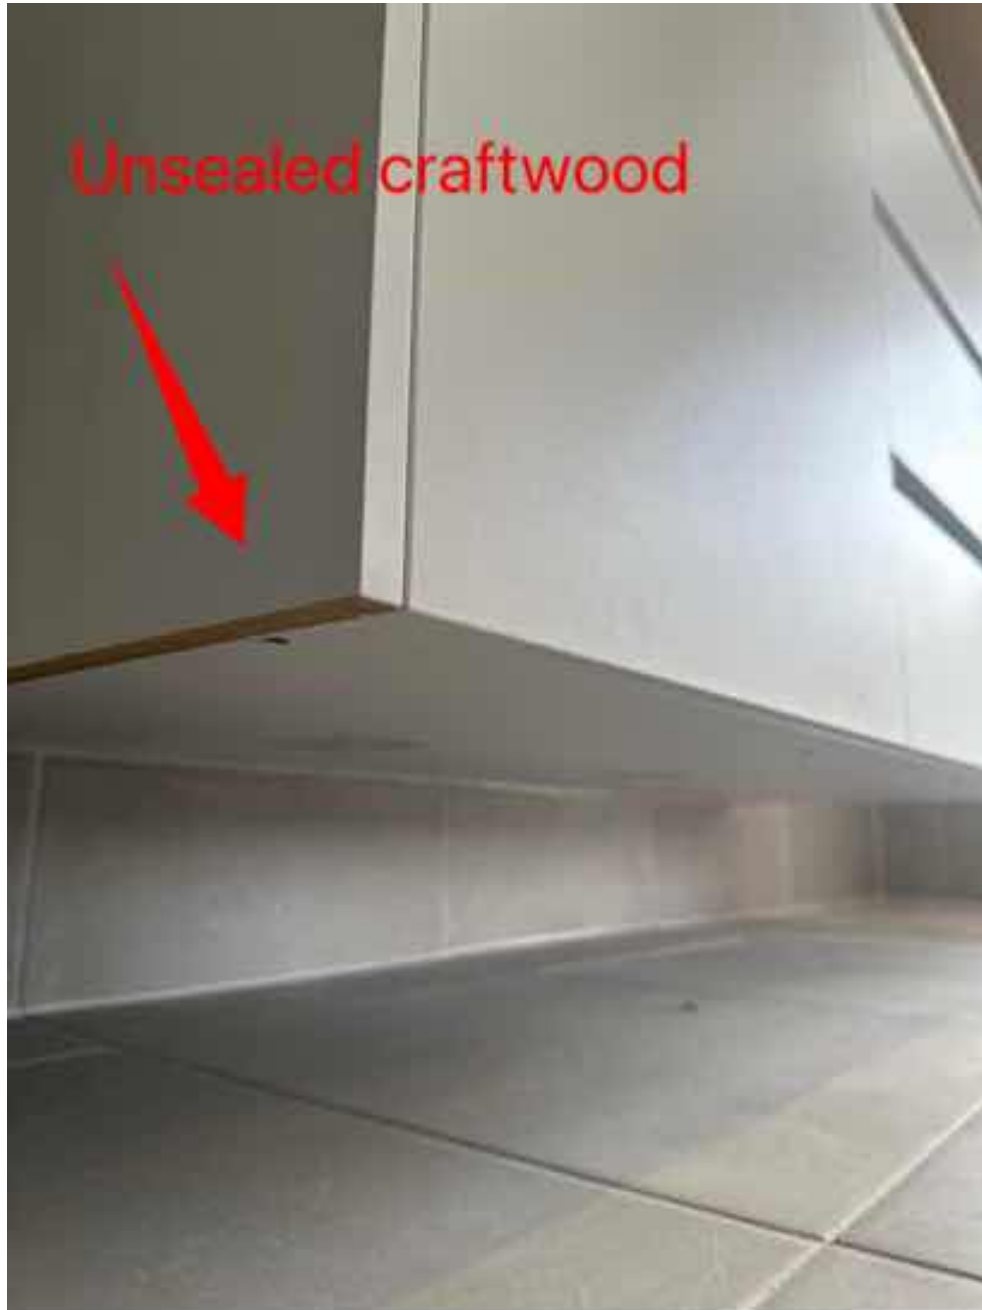
The vanity has unsealed exposed craftwood. This will absorb moisture in the bathroom area and prematurely degrade. Amendment required.

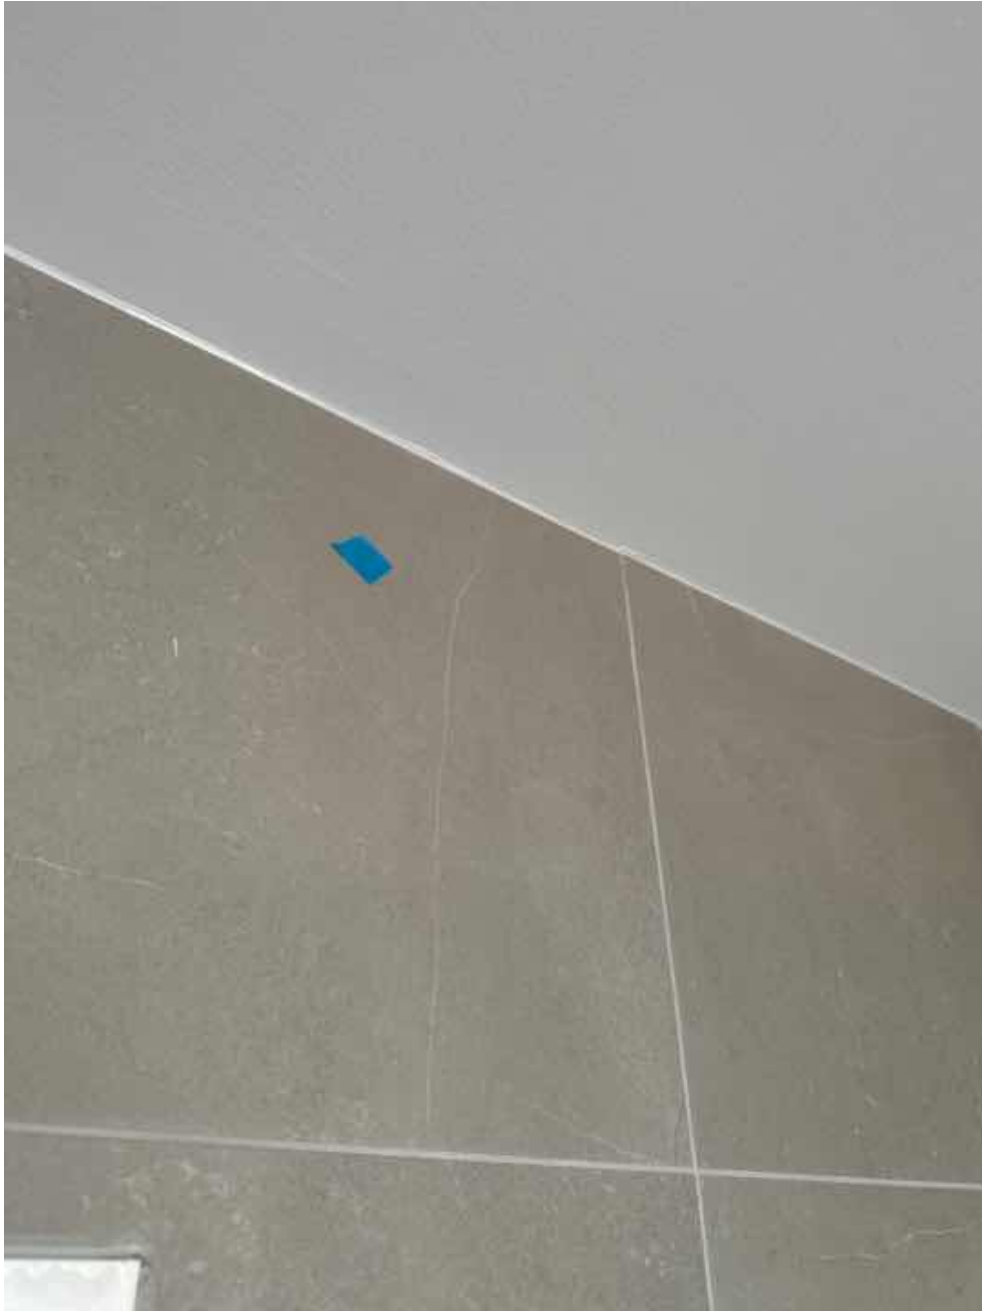
Paint touch ups required.

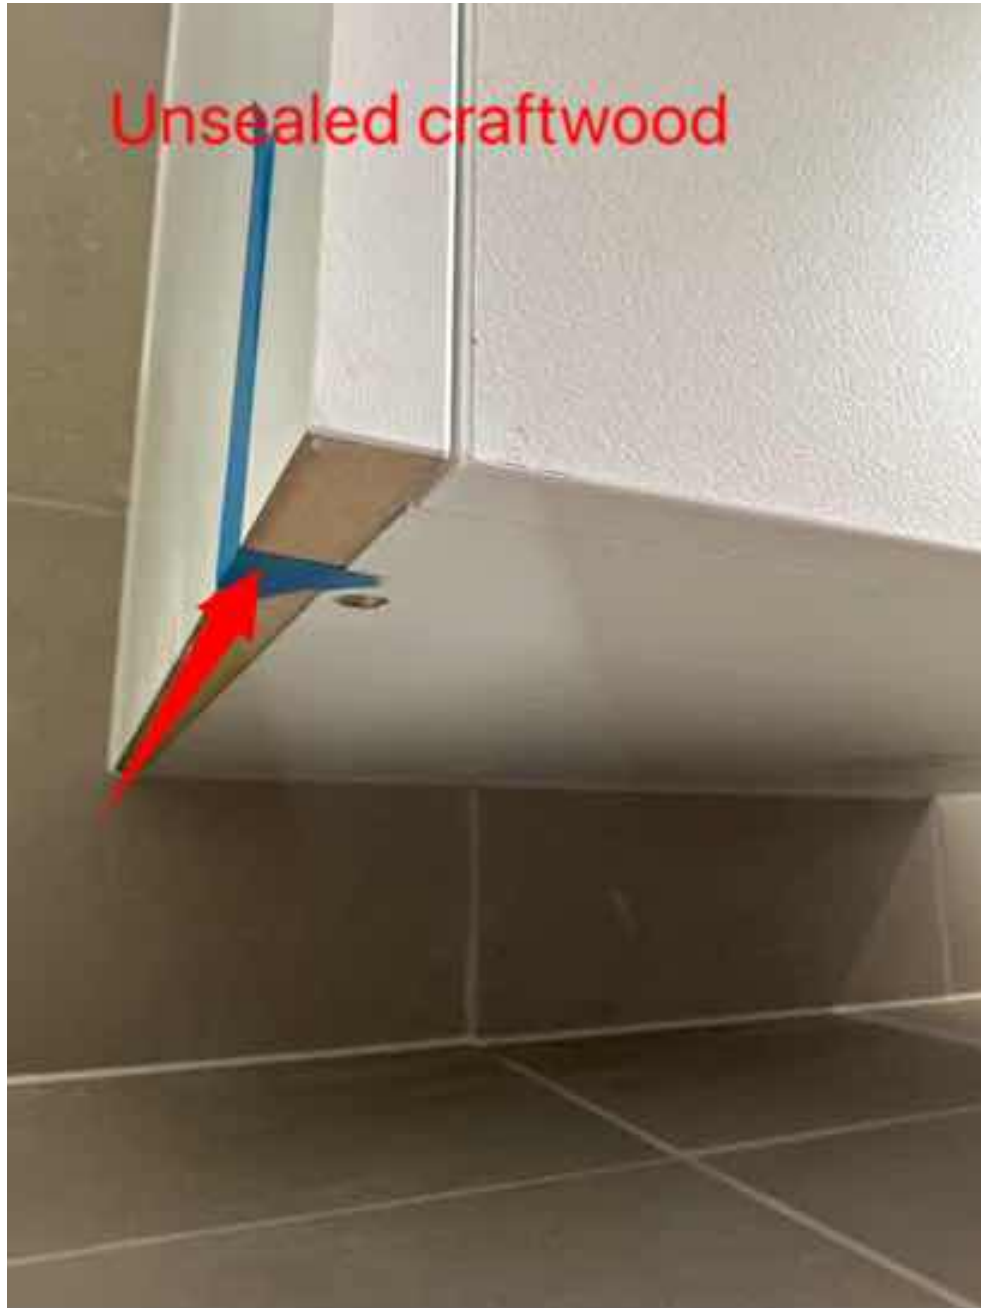
The vanity has unsealed exposed craftwood. This will absorb moisture in the bathroom area and prematurely degrade. Amendment required.

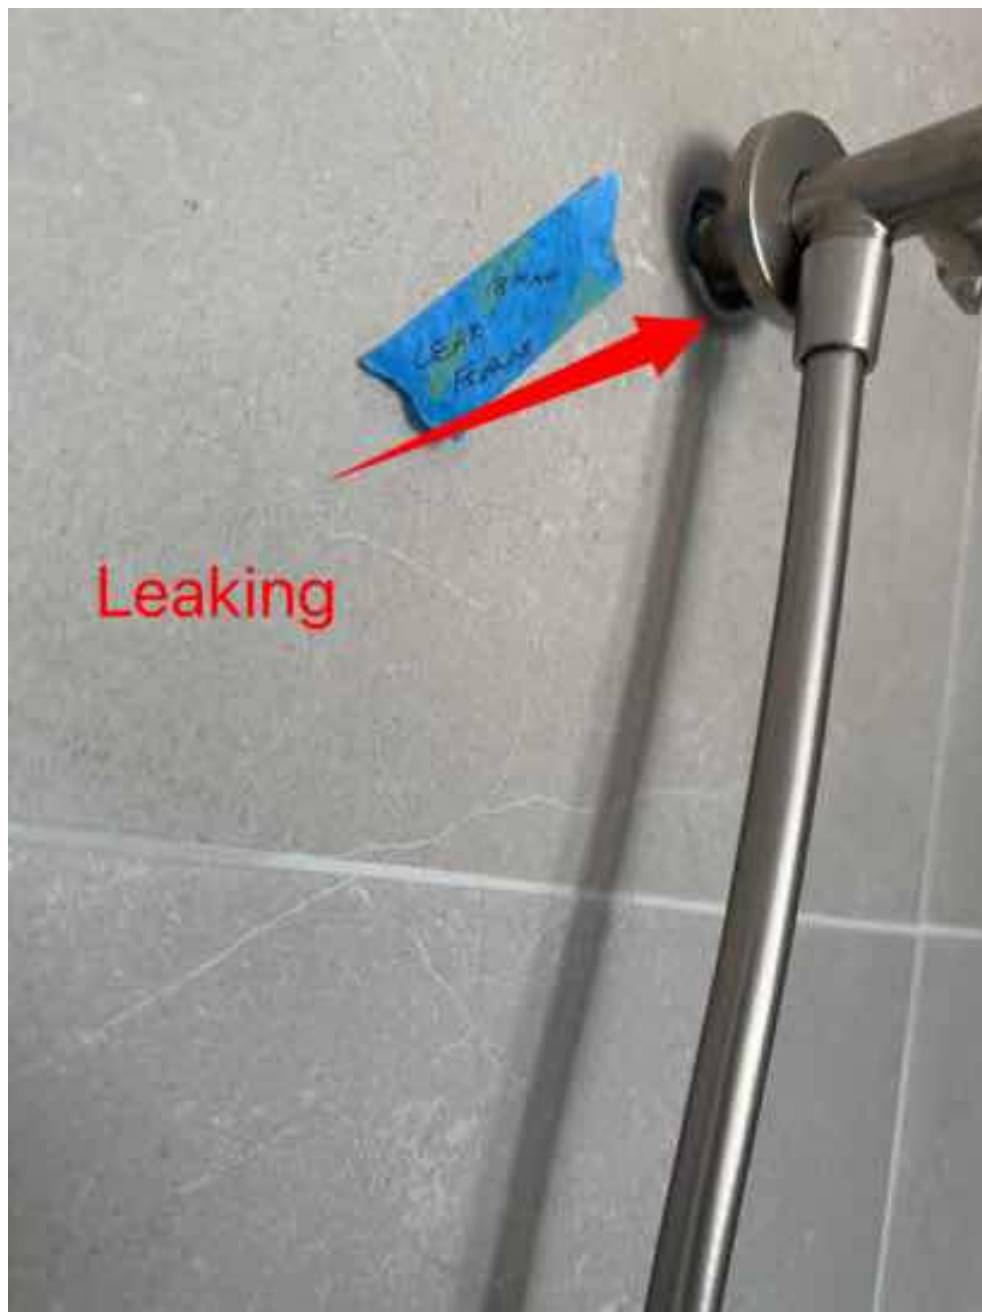
Shower head is leaking.

Bath spout loose.

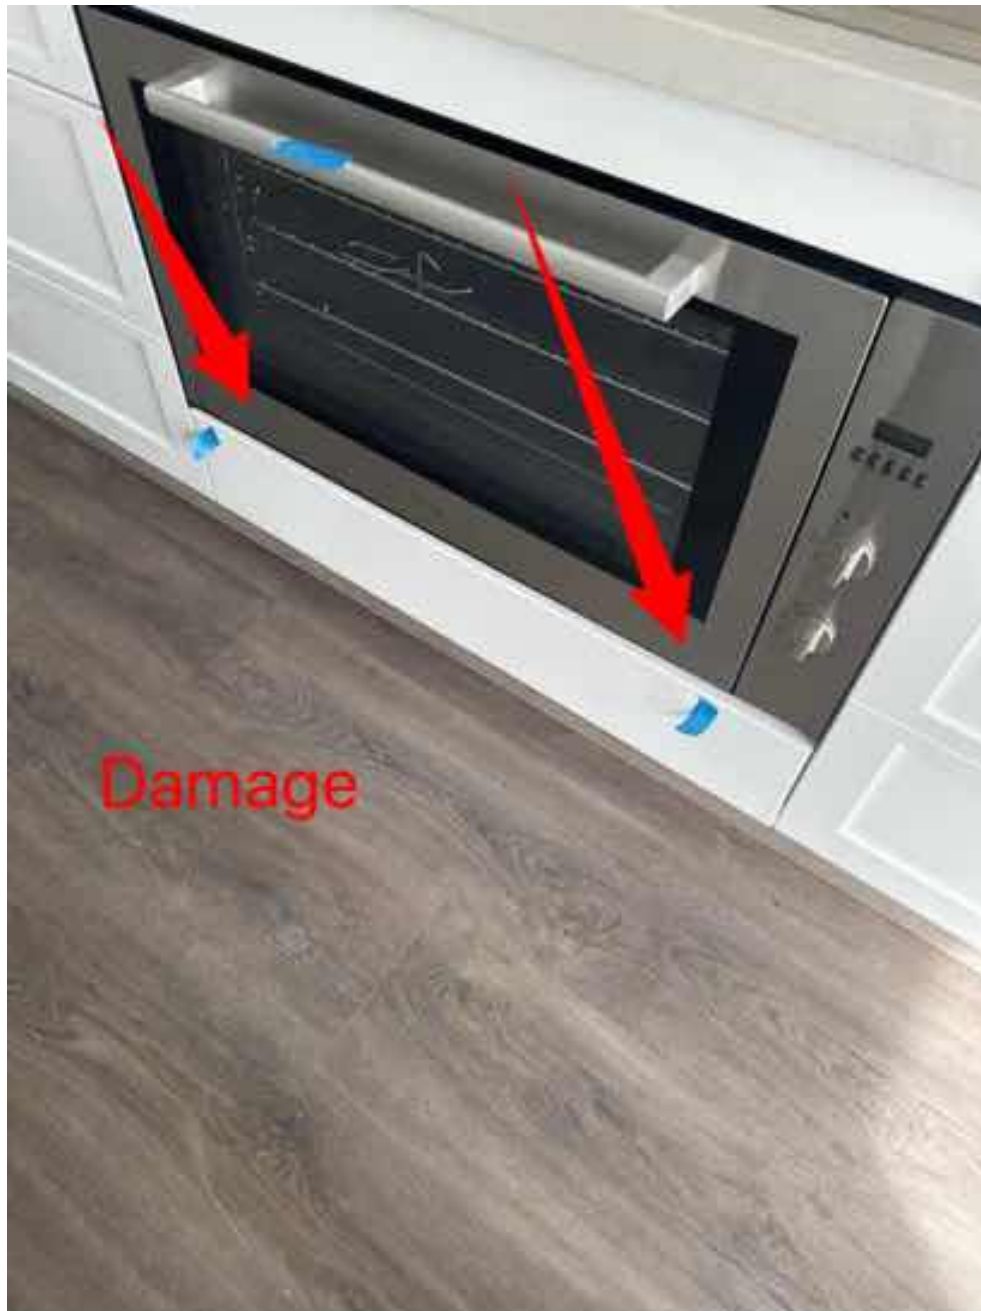
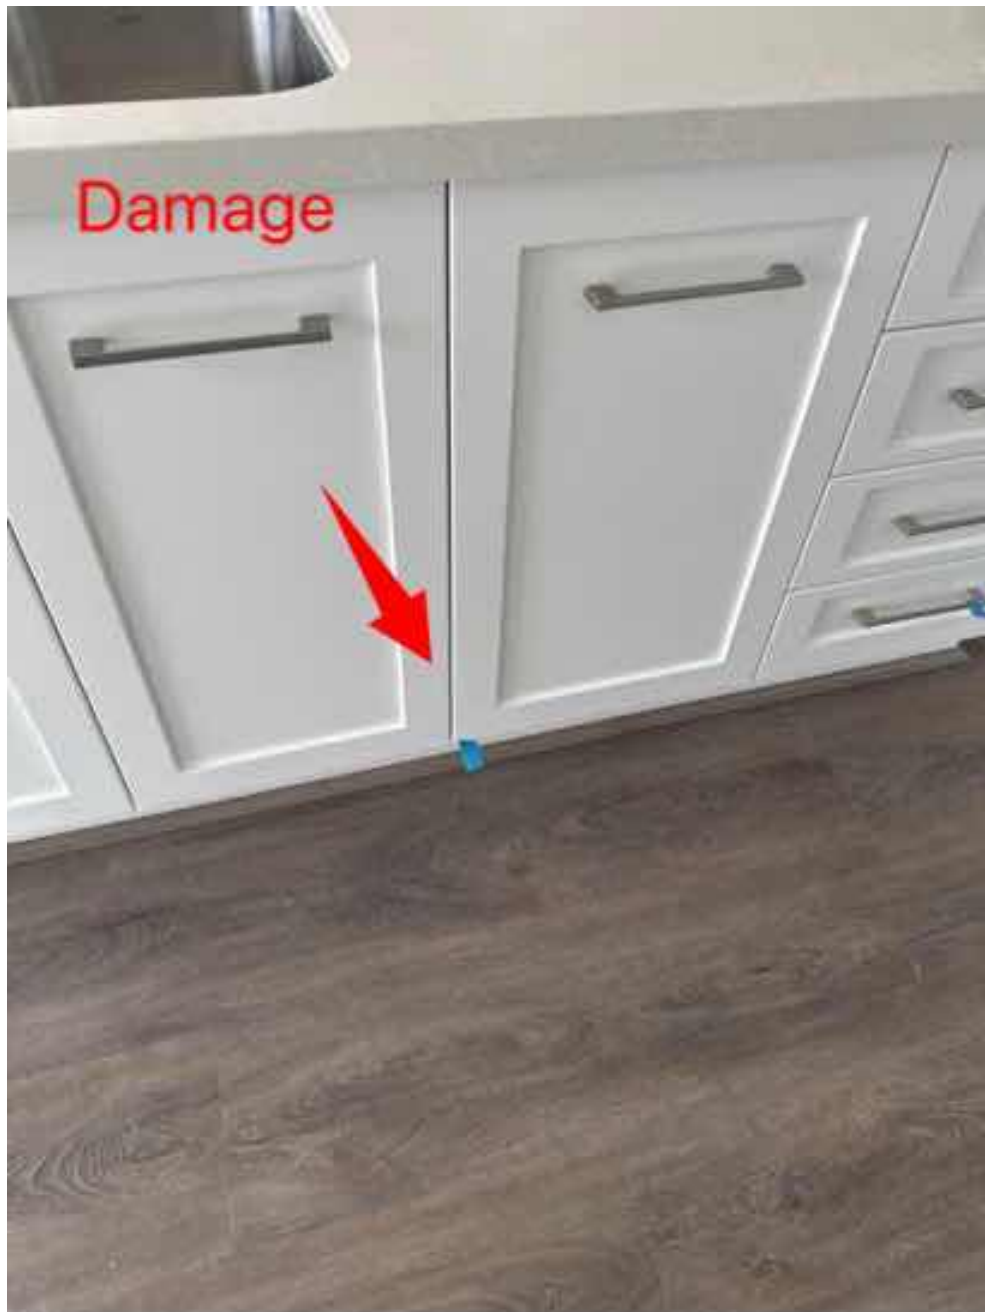
Chips/Damage/Dents was noted to the cabinets from a normal viewing position which is 600mm. Rectification required.

Cabinet doors/drawers require adjusting for consistent gaps. NSW Guide for Standards and Tolerances 2017 -section 11.4 "cabinet door and draw fronts are defective if they are not aligned, or do not have consistent gaps between them at handover"

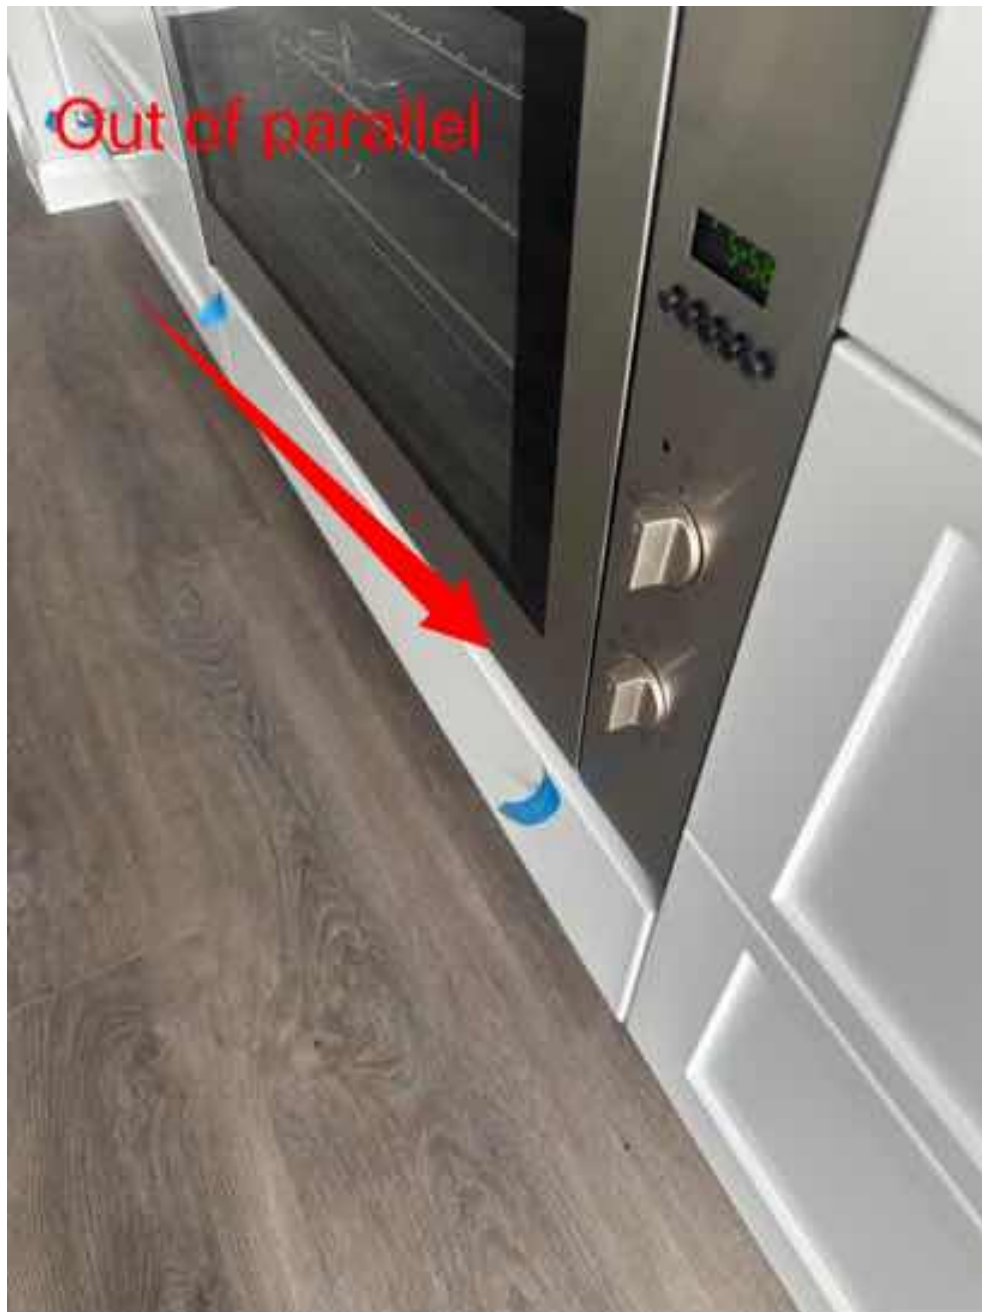
The oven is not installed correctly. It is out of parallel with the joinery. Amendment required.
