Inspection Report

UNCOVER
BUILDING AND PEST INSPECTIONS

1 Sample Street, Sampletown, NSW, 2280

Pest And Building Inspection

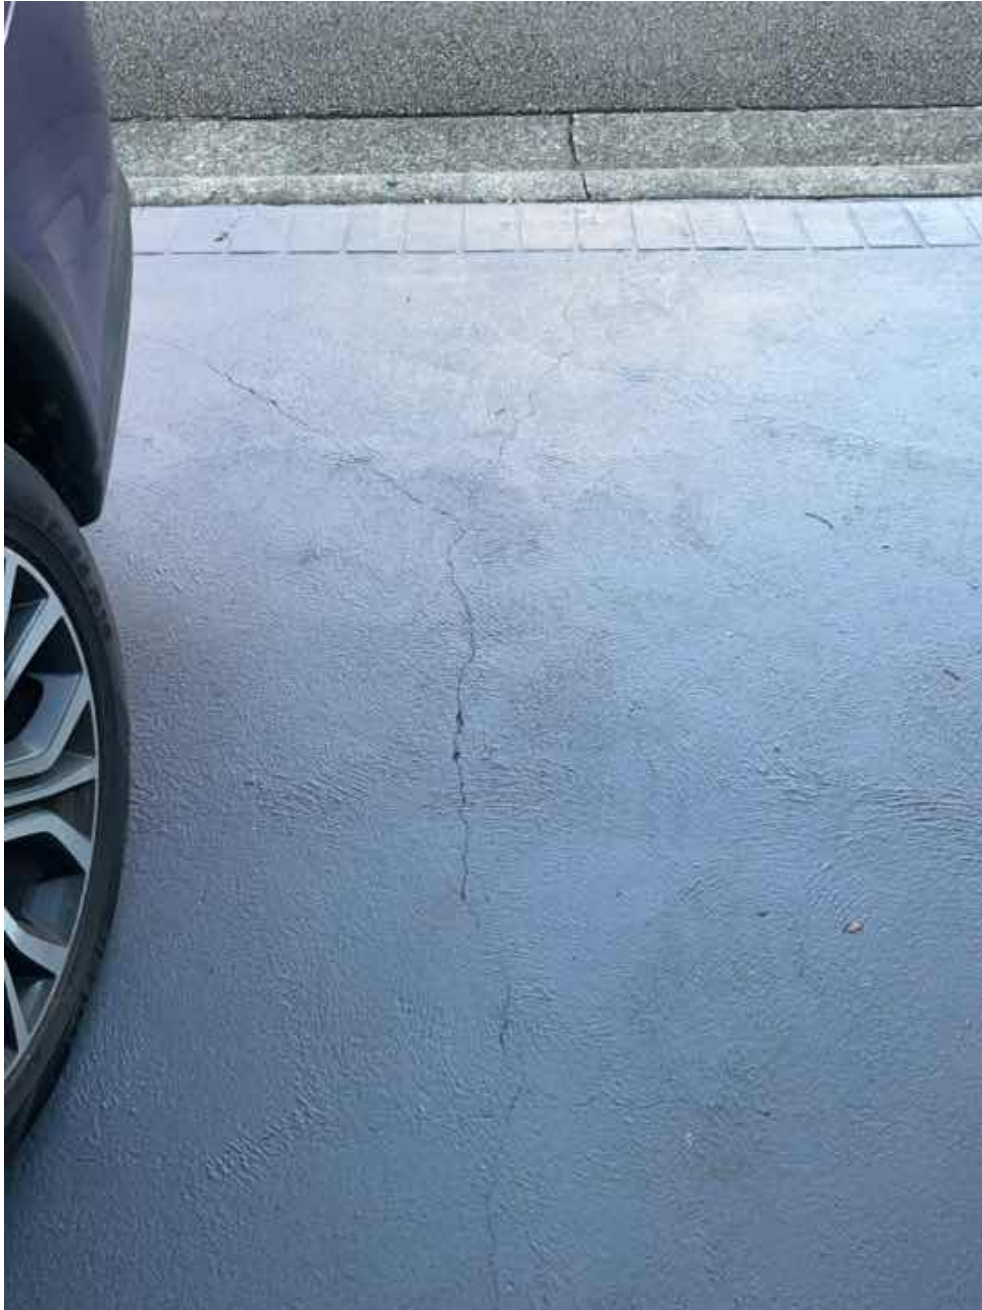
Driveway Condition

Common cracks were observed on the driveway. Whilst these cracks appeared to be typical at the time of inspection, we recommend you monitor these cracks and if worsening occurs contact a concreter for further advice.

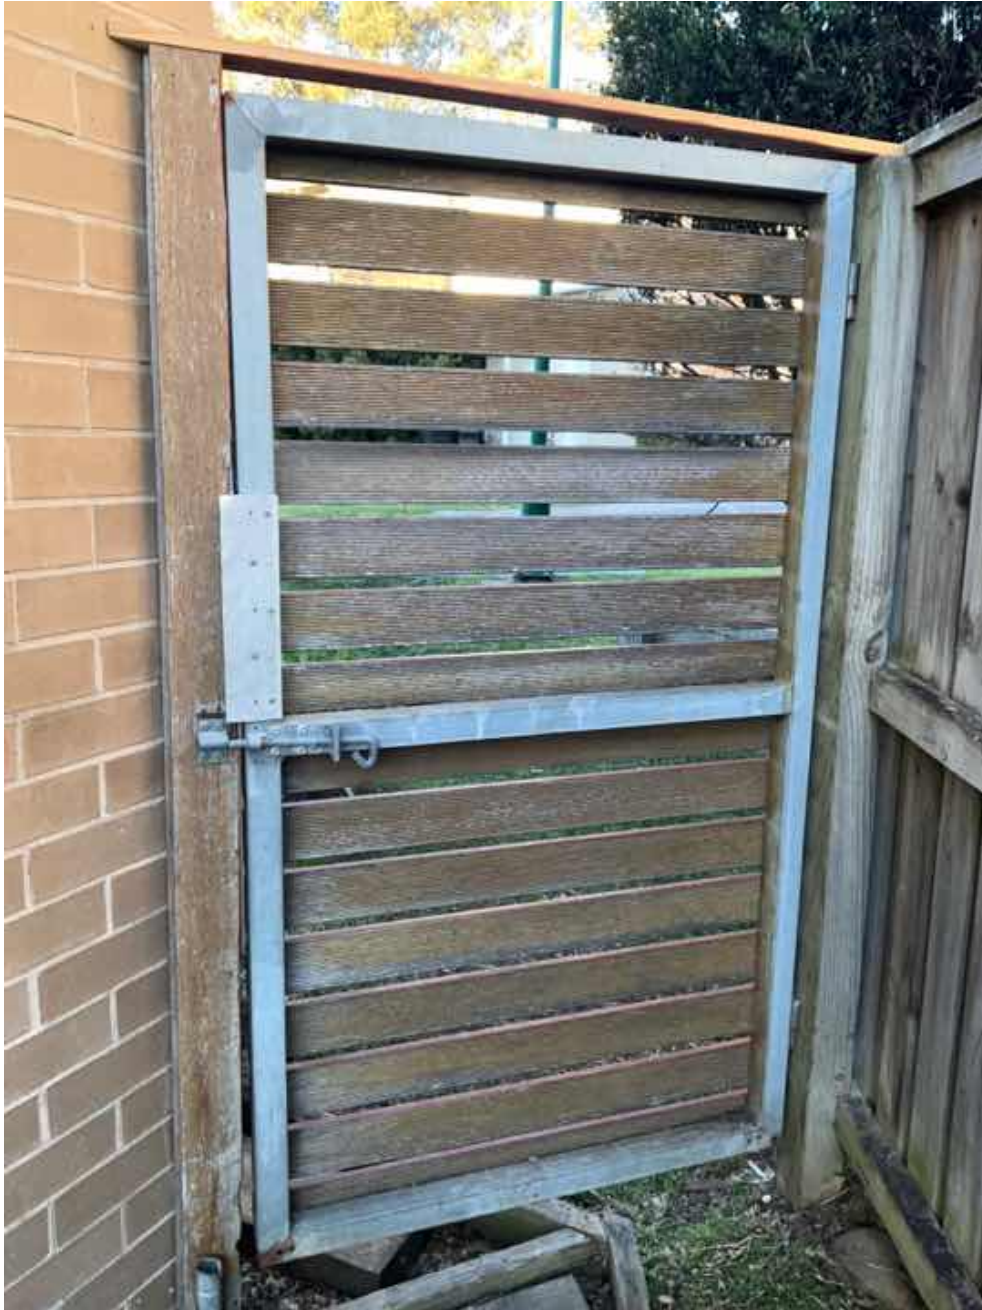
The gate does not latch. Have repaired by a qualified fencer.

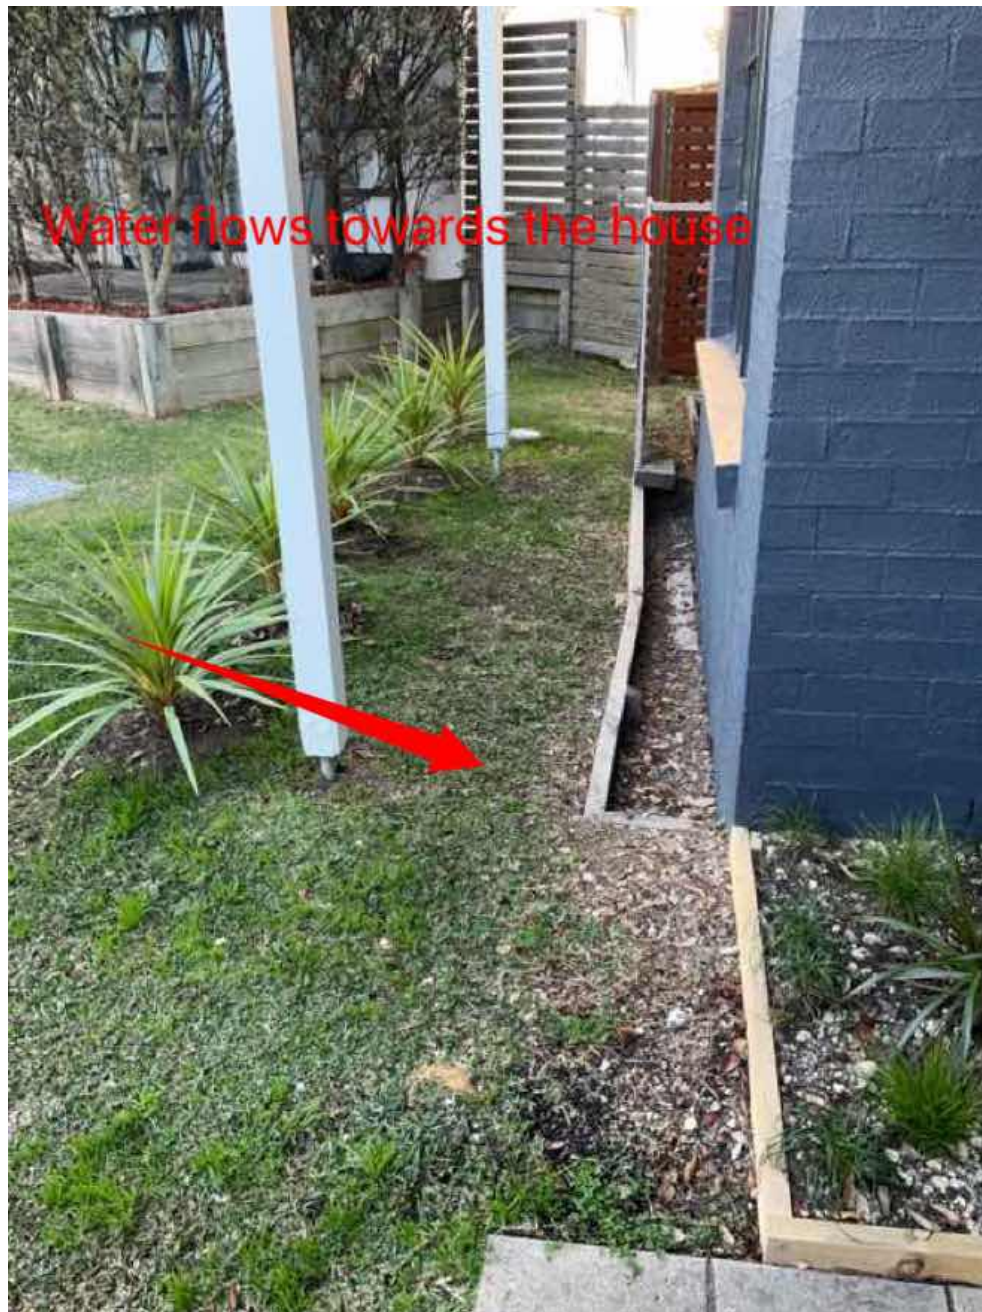
The drain to the front of the property is not sufficient to remove water away from the front of the property. Water is flowing into the subfloor. Recommend a qualified landscaper to further advise.

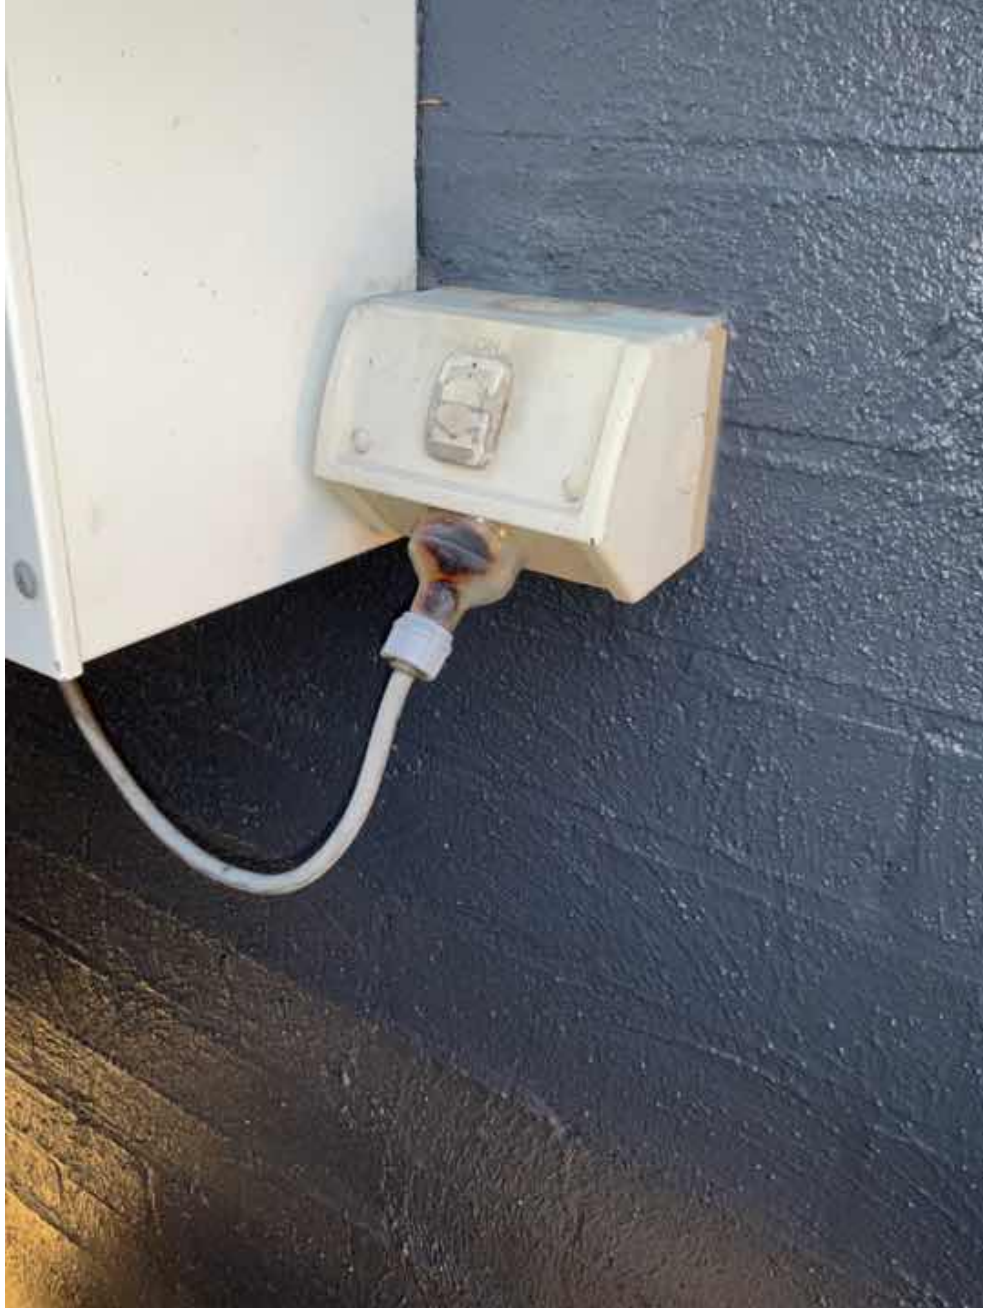
Hot Water Unit Findings

Although I am not an electrician, the power cord for the hot water unit is showing signs of overheating and burning. Recommend having an electrician inspect this immediately

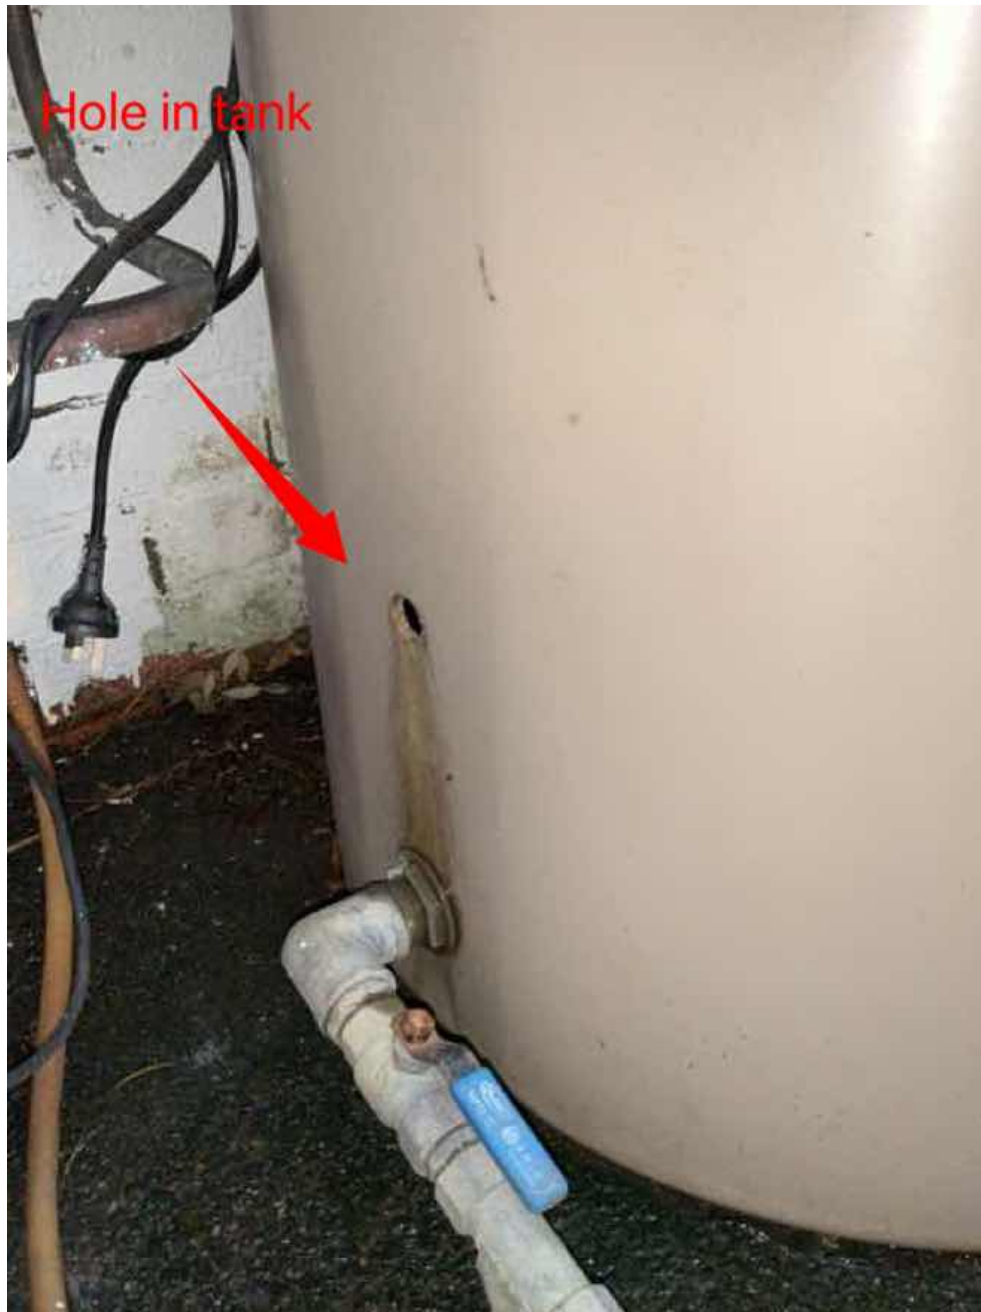
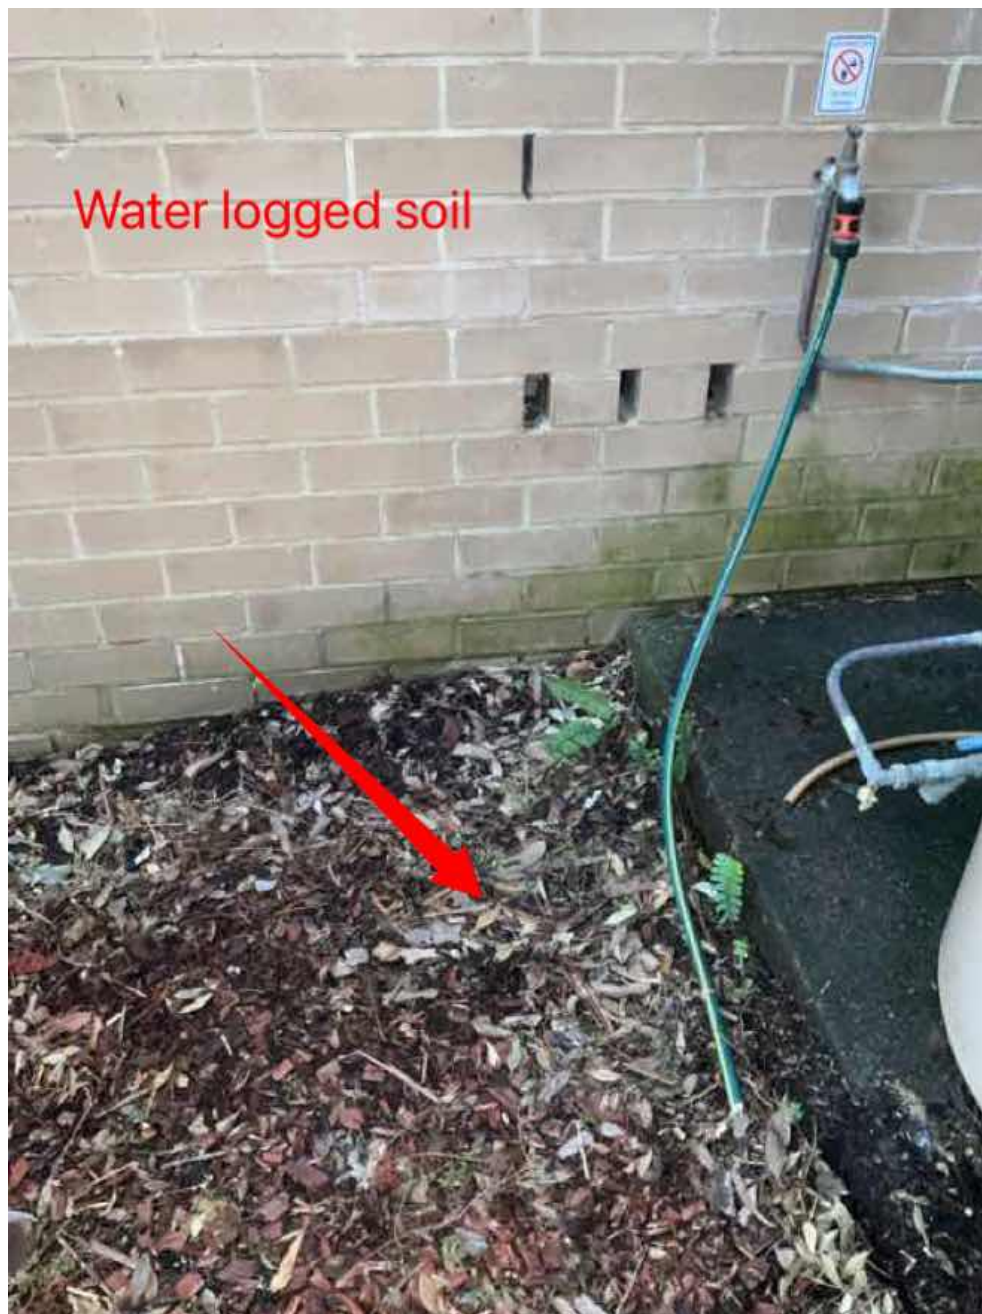
Water Tank Condition

There is an open hole in the side of the last water tank. These tanks will not hold water. Recommend a qualified plumber to further advise. These water tanks have possibly never held water. The ground around this area is extremely water logged.

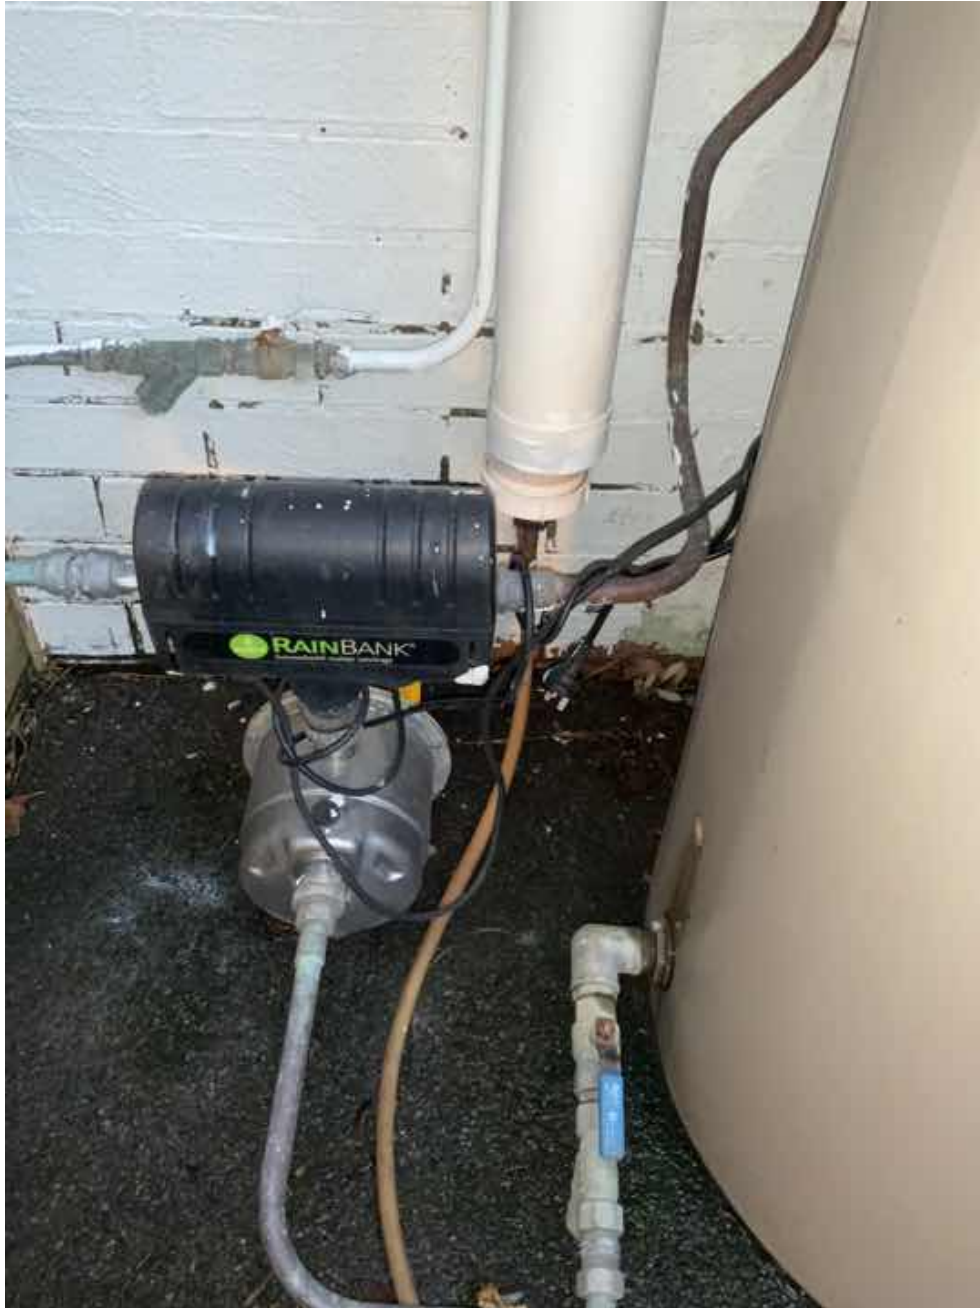
Water Tank Pump

The rainbank (device that controls tank water and town water) and the tank pump are switched off and disconnected, potentially something wrong with the unit or the pump or in some instances occupants just dislike tank water and turn them off. Recommend having this checked by a licensed plumber.

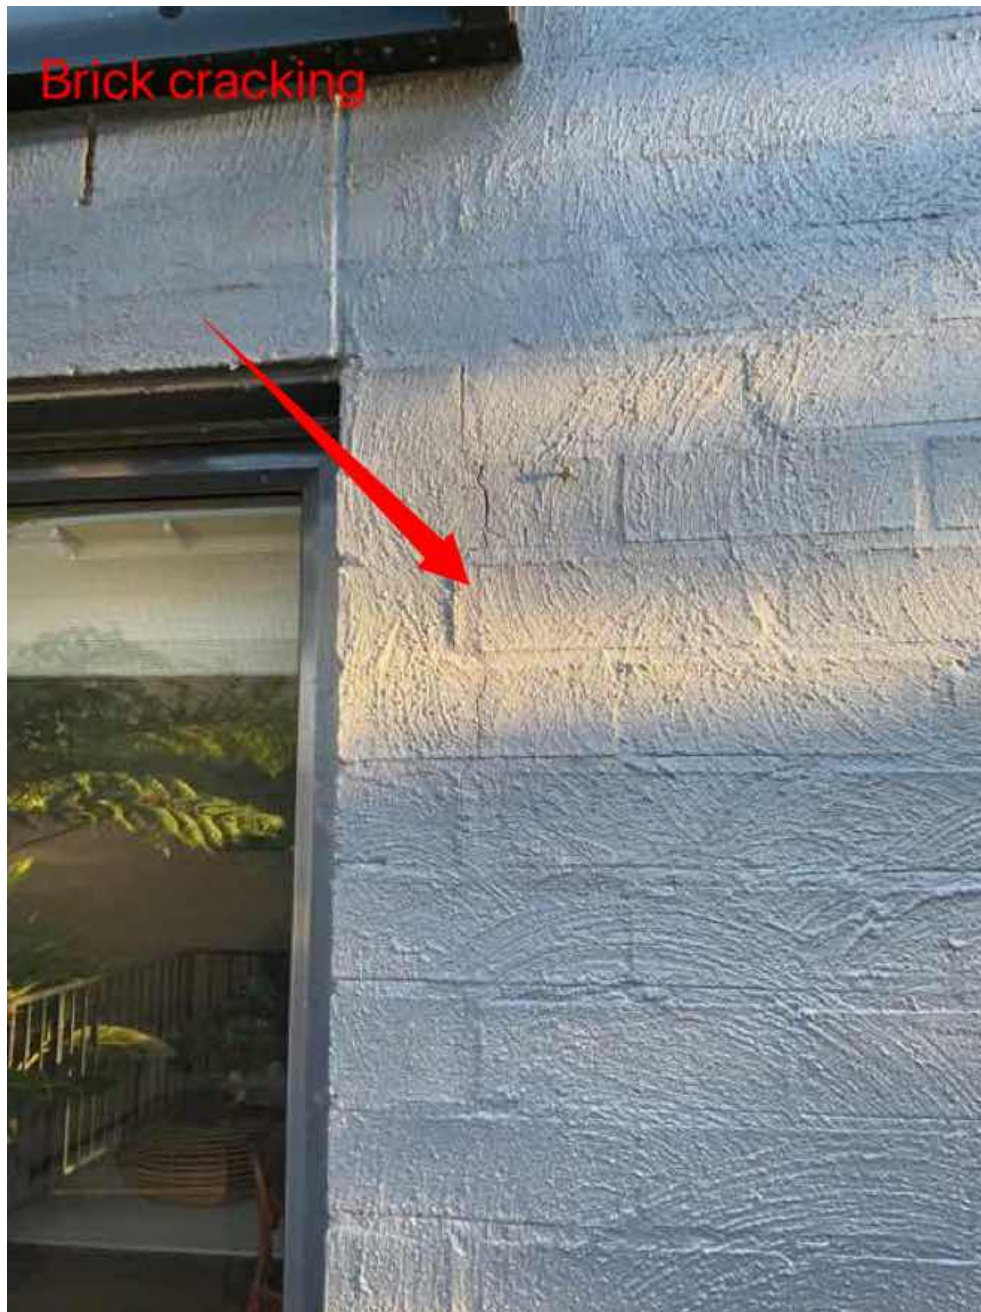
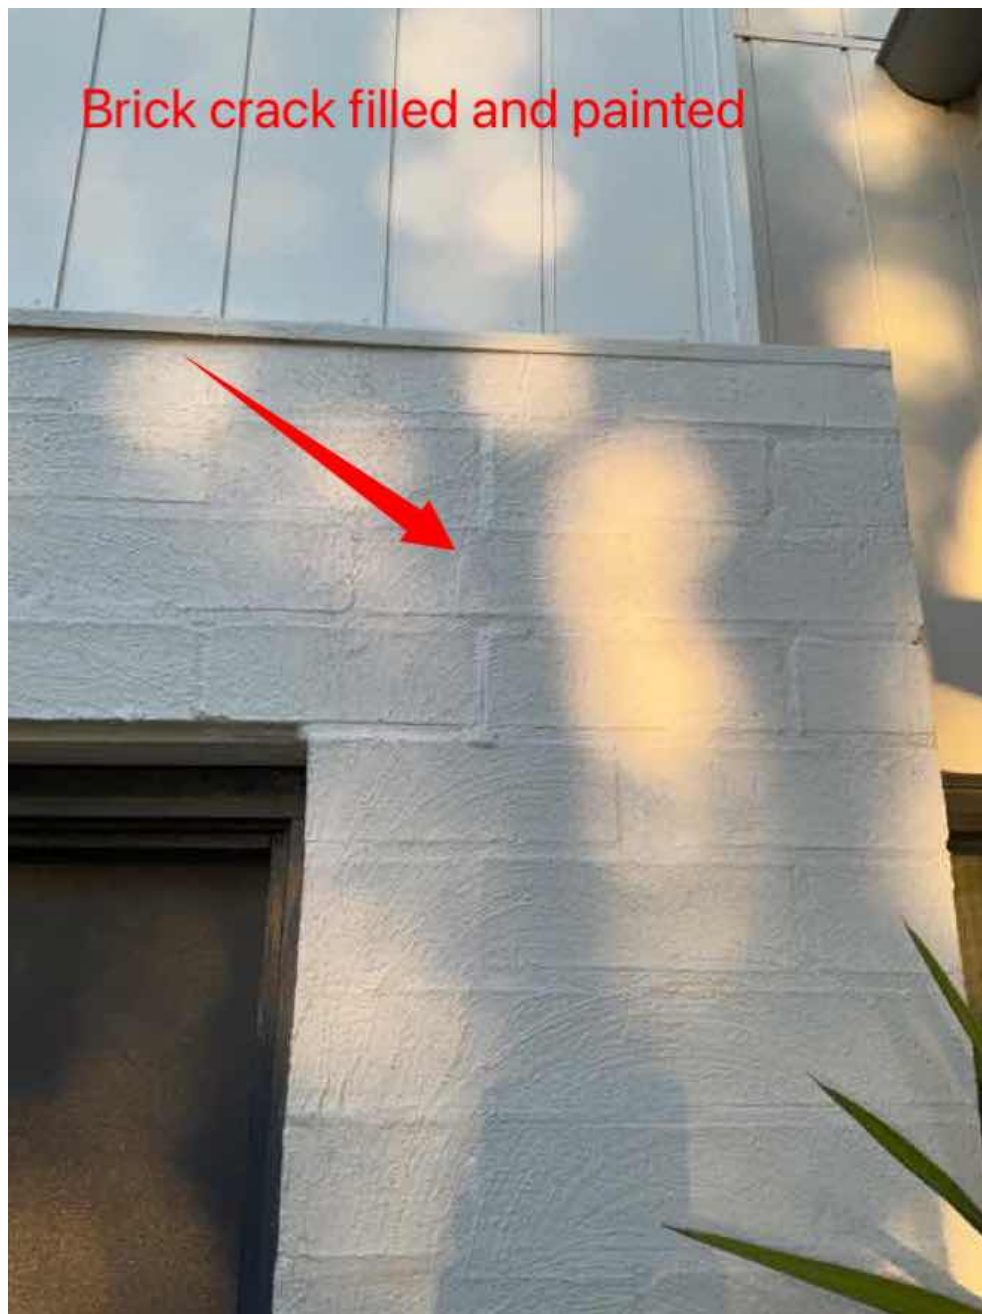
There appears to have been some settlement in the building which has caused some cracking to the walls. These crack are catergorized as 0 to 2. This can also cause some doors to bind or be out of square. In the inspectors opinion these cracks are due to settlement, usually due to ground movement and subsequent movement to building materials can be expected. Any cracks should be monitored and further investigation should be carried out by a structural engineer.

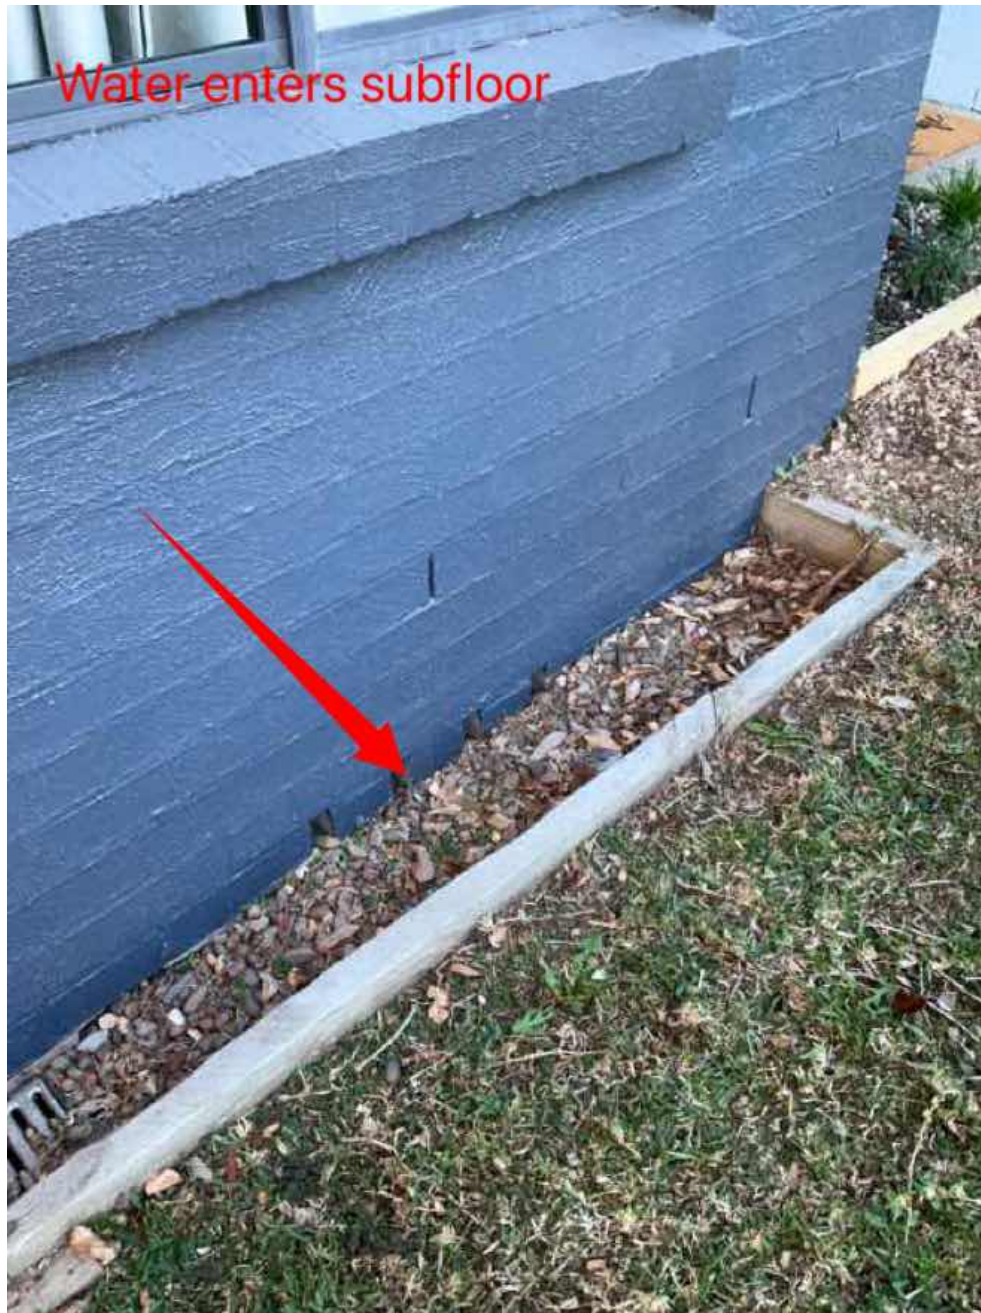
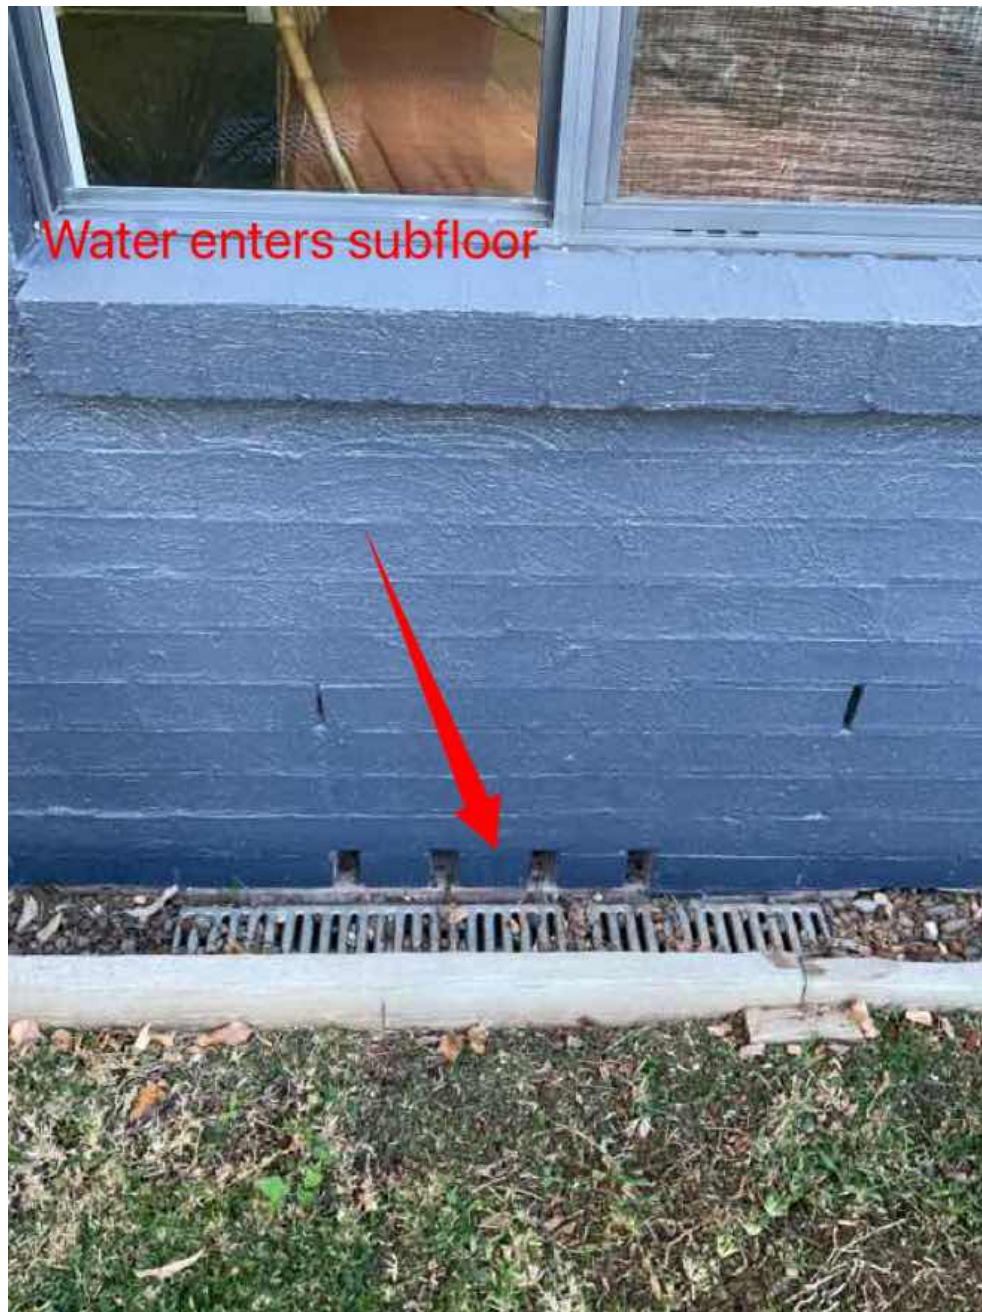
The vents to the subfloor in some areas are close to the ground. This may let water flow into the subfloor in times of heavy rain or storms. The recommended clearance for subfloor vents (openings) from the ground level is 75mm-150mm. Recommend monitoring these vents during heavy rain and if water is entering the subfloor amend the heights of the vents or lower the ground level. Recommend a qualified bricklayer for further advice and repair if required.

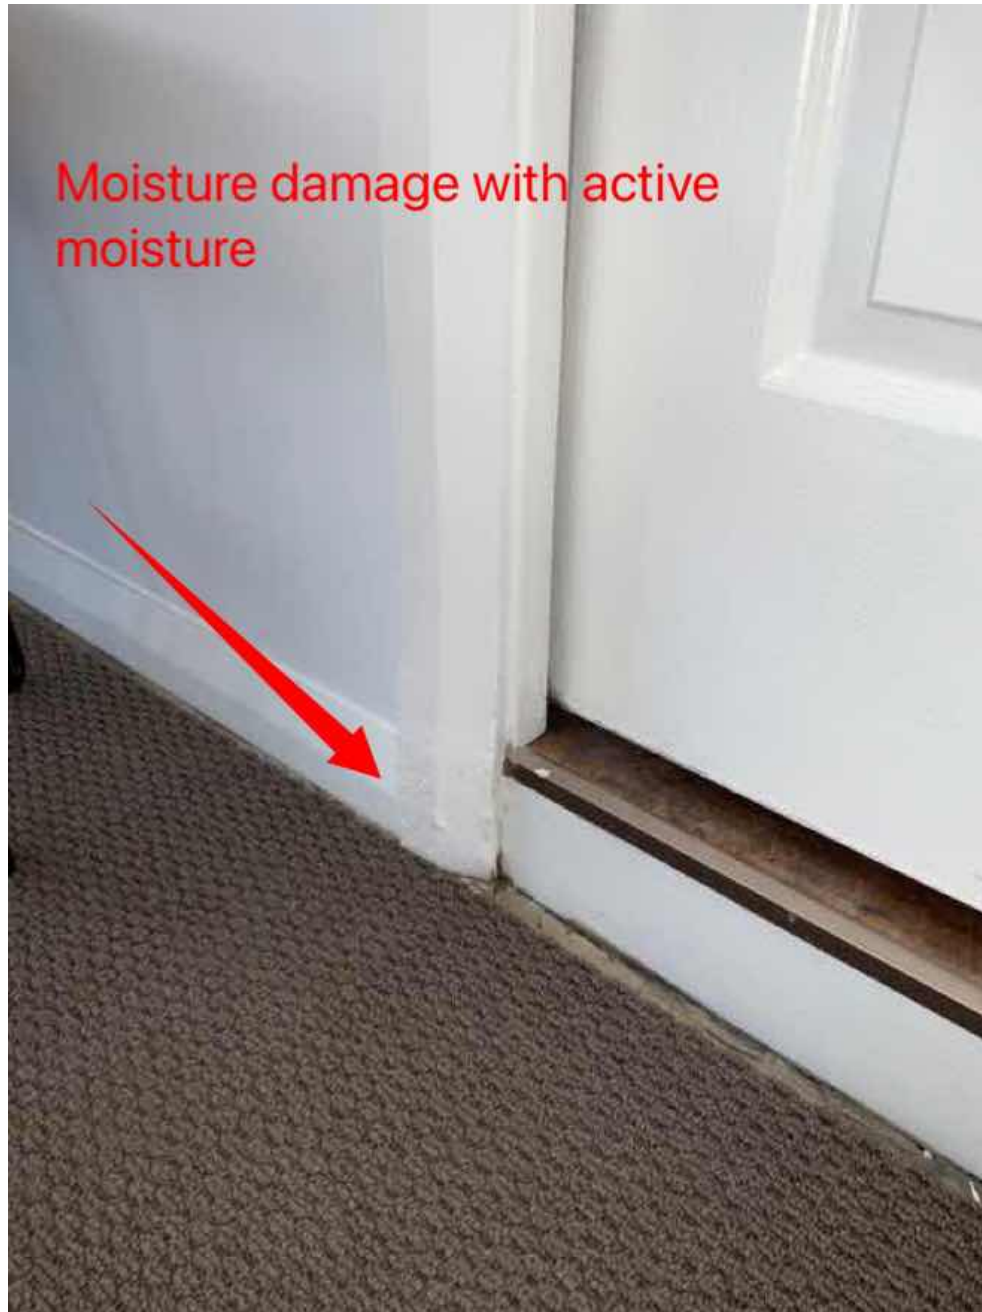
GARAGE - CARPORT	Garaging	Internal Wall Findings	Architrave and/or skirting moisture damage. High moisture readings taken during the inspection. This appears to be related to the dampness within the subfloor. Recommend a qualified carpenter for further advice and repair.
STAIRS- PERGOLA- BALCONIES- DECKS- VERANDAH	Decking Findings	Decking Timber	The decking is broken and aged at the top of the stairs. This is a safety hazard and should be repaired immediately. Recommend a qualified carpenter to further advise and repair.
INTERIORS	Combined Living and Dining	Walls	Architrave and/or skirting moisture damage. High moisture readings taken during the inspection. This appears to be related to the dampness within the subfloor and mortar blocking the brick cavity and transferring moisture onto the bearer. Recommend a qualified carpenter for further advice and repair.
INTERIORS	Hallways	Windows	Timber fungal decay observed in window/frame. High moisture readings taken at the time of the inspection. This is most probably linked to a leaking window, architraves, skirtings and flooring in this area are swollen from moisture damage. Recommend a carpenter for further advice and repairs.

Architrave and/or skirting moisture damage. High moisture readings taken during the inspection. This appears to be related to the dampness within the subfloor. Recommend a qualified carpenter for further advice and repair.

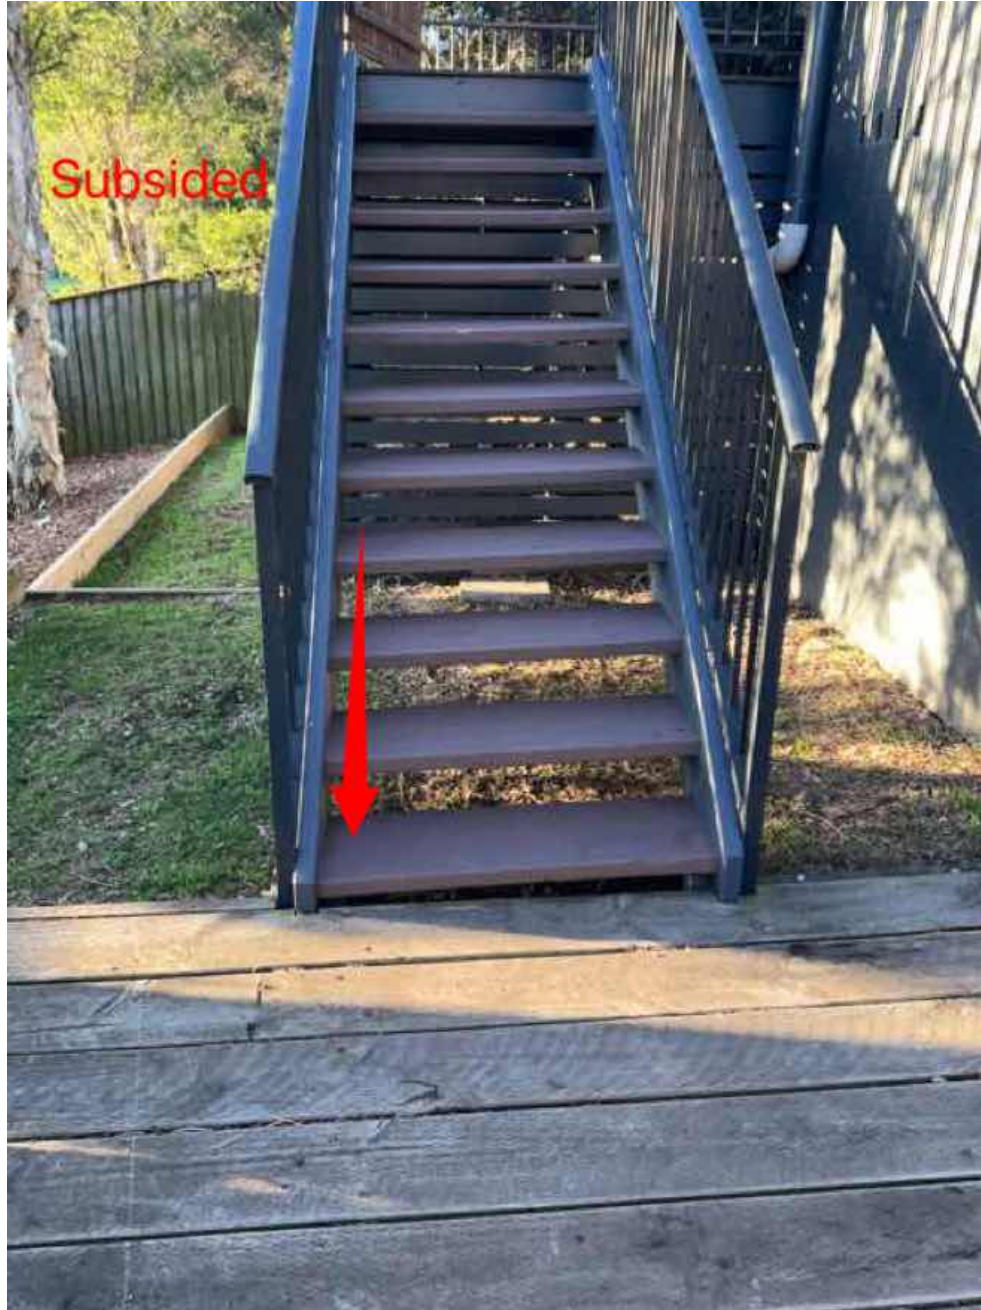
The stairs have subsided on one side and are now out of level. Recommend a qualified carpenter to further advise and repair.

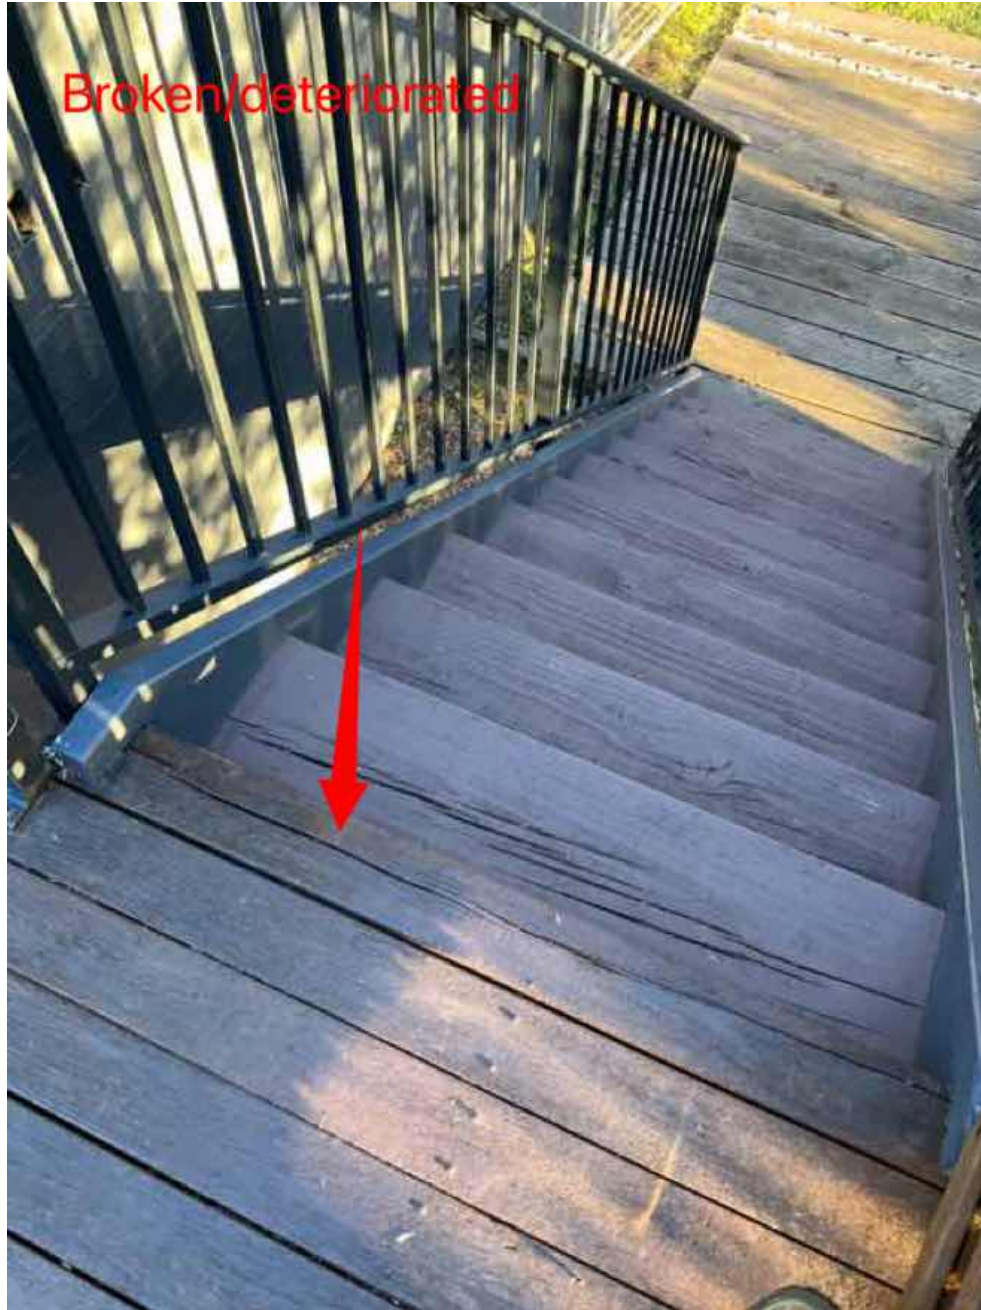
Decking Timber

The decking is broken and aged at the top of the stairs. This is a safety hazard and should be repaired immediately. Recommend a qualified carpenter to further advise and repair.

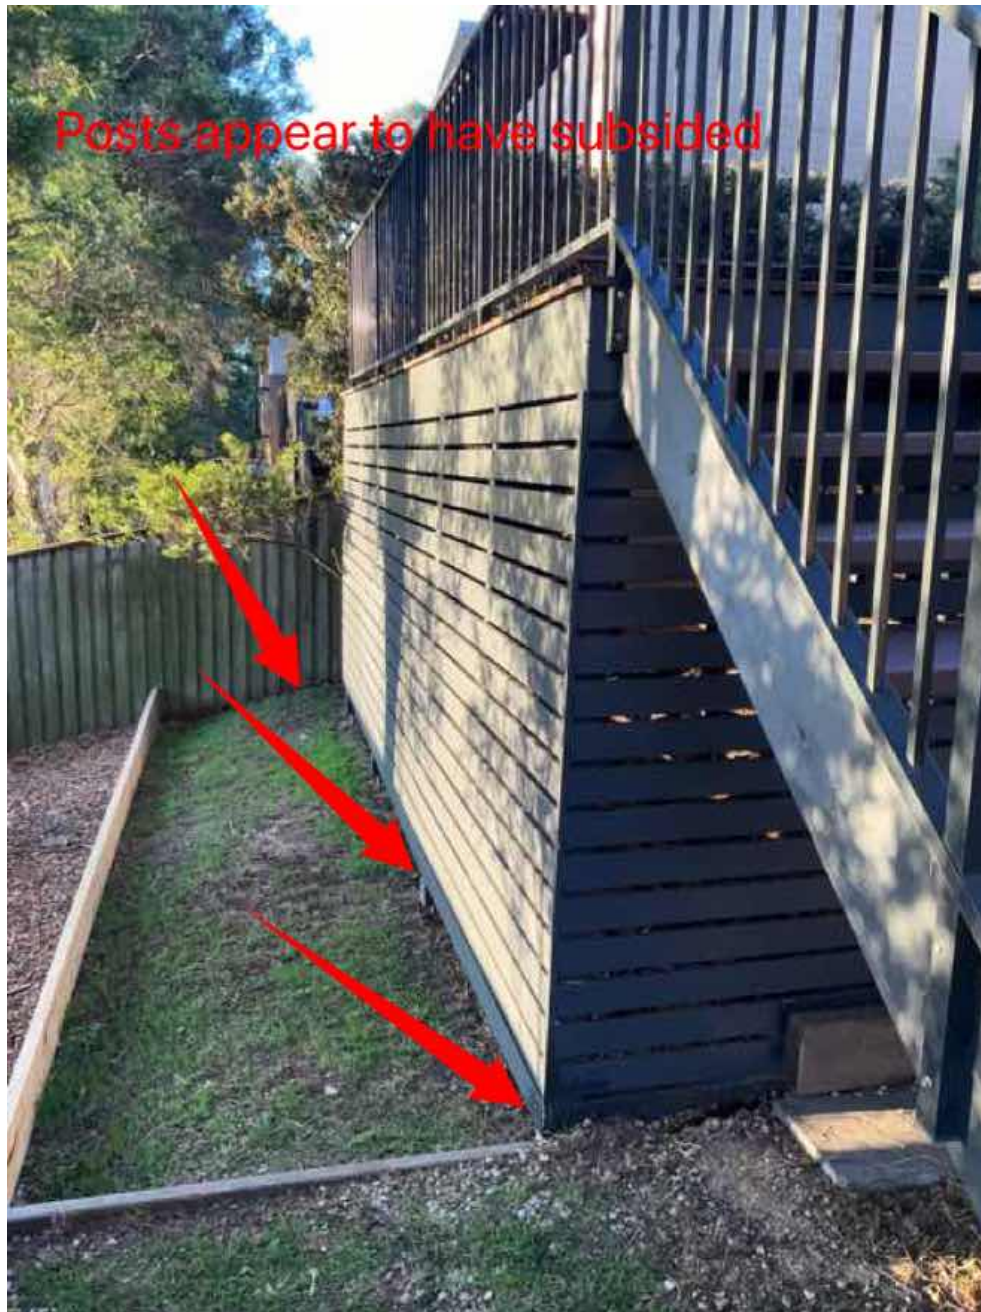
Decking Posts

The front row of deck posts appear to of subsided, potentially this is just poor workmanship. Recommend monitoring and if the deck becomes further out of level, recommend a qualified carpenter to further advise and repair.

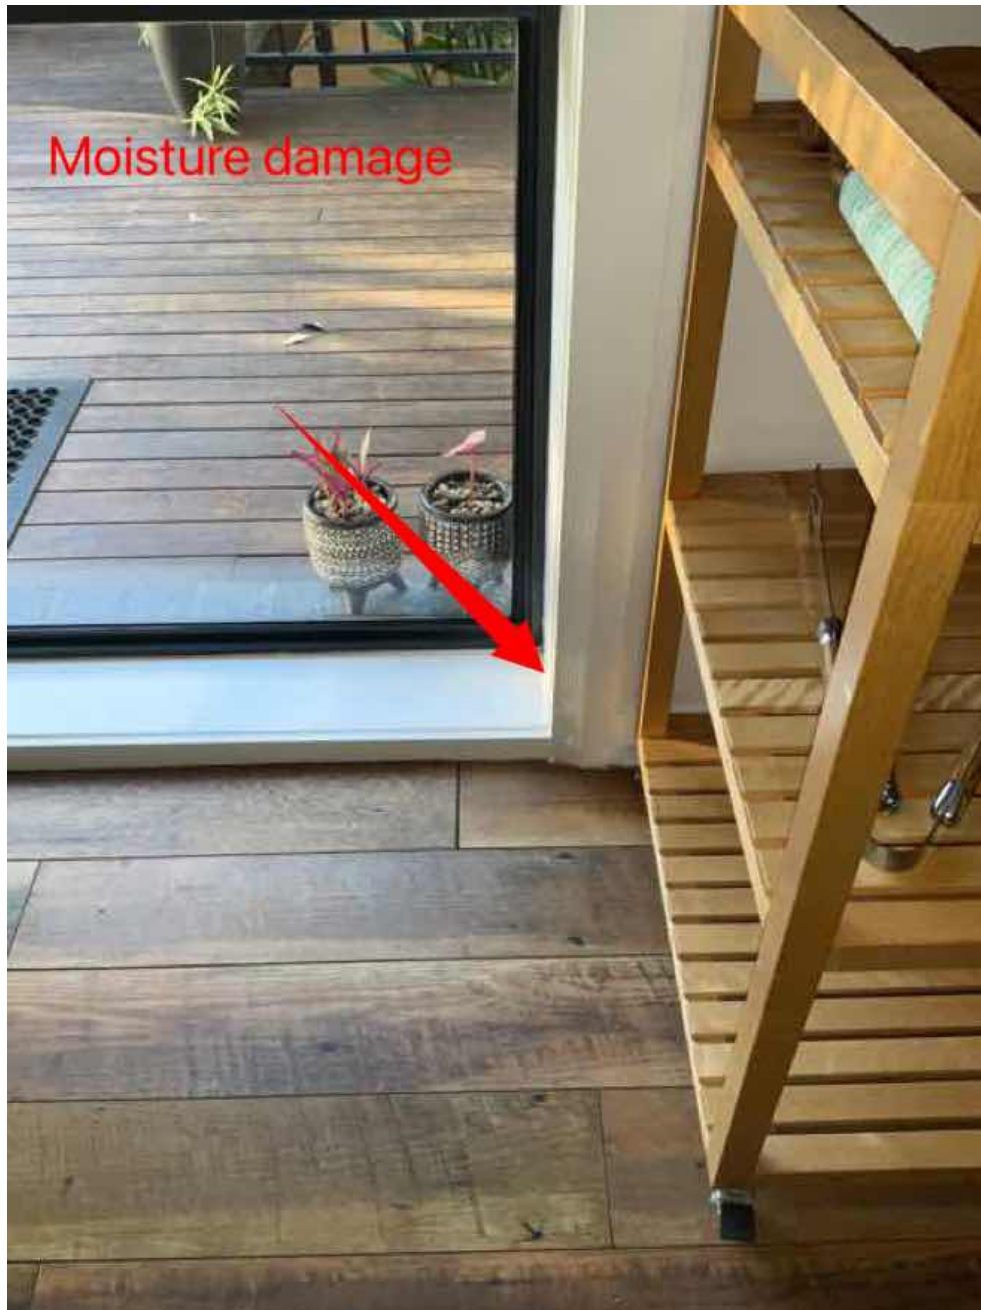
Architrave and/or skirting moisture damage. High moisture readings taken during the inspection. This appears to be related to the dampness within the subfloor and mortar blocking the brick cavity and transferring moisture onto the bearer. Recommend a qualified carpenter for further advice and repair.
