Inspection Report

UNCOVER
BUILDING AND PEST INSPECTIONS

1 Sample Street, Sampletown, NSW, 2280

Pest And Building Inspection

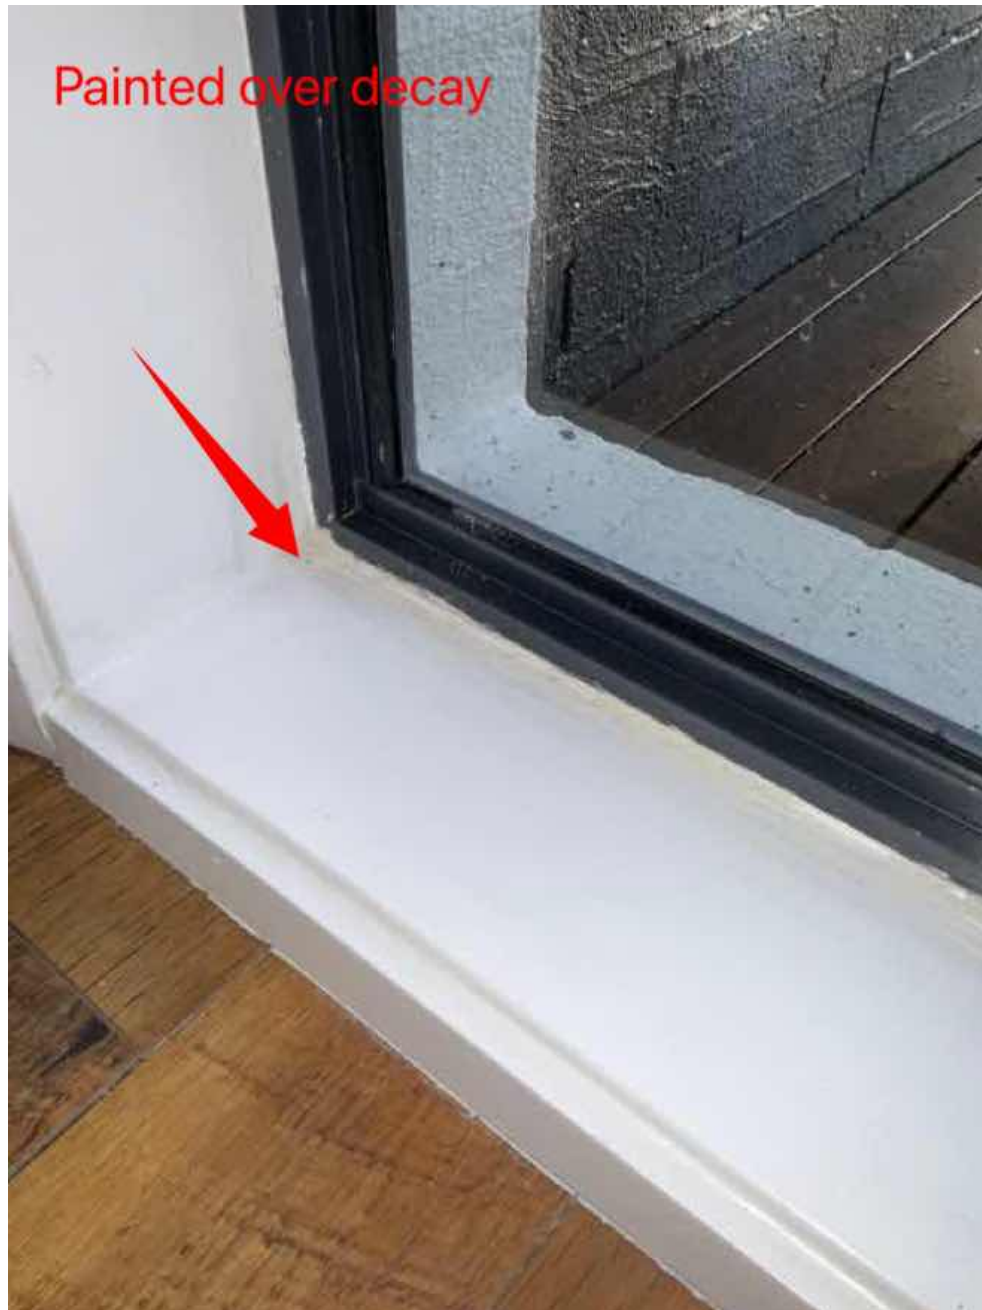
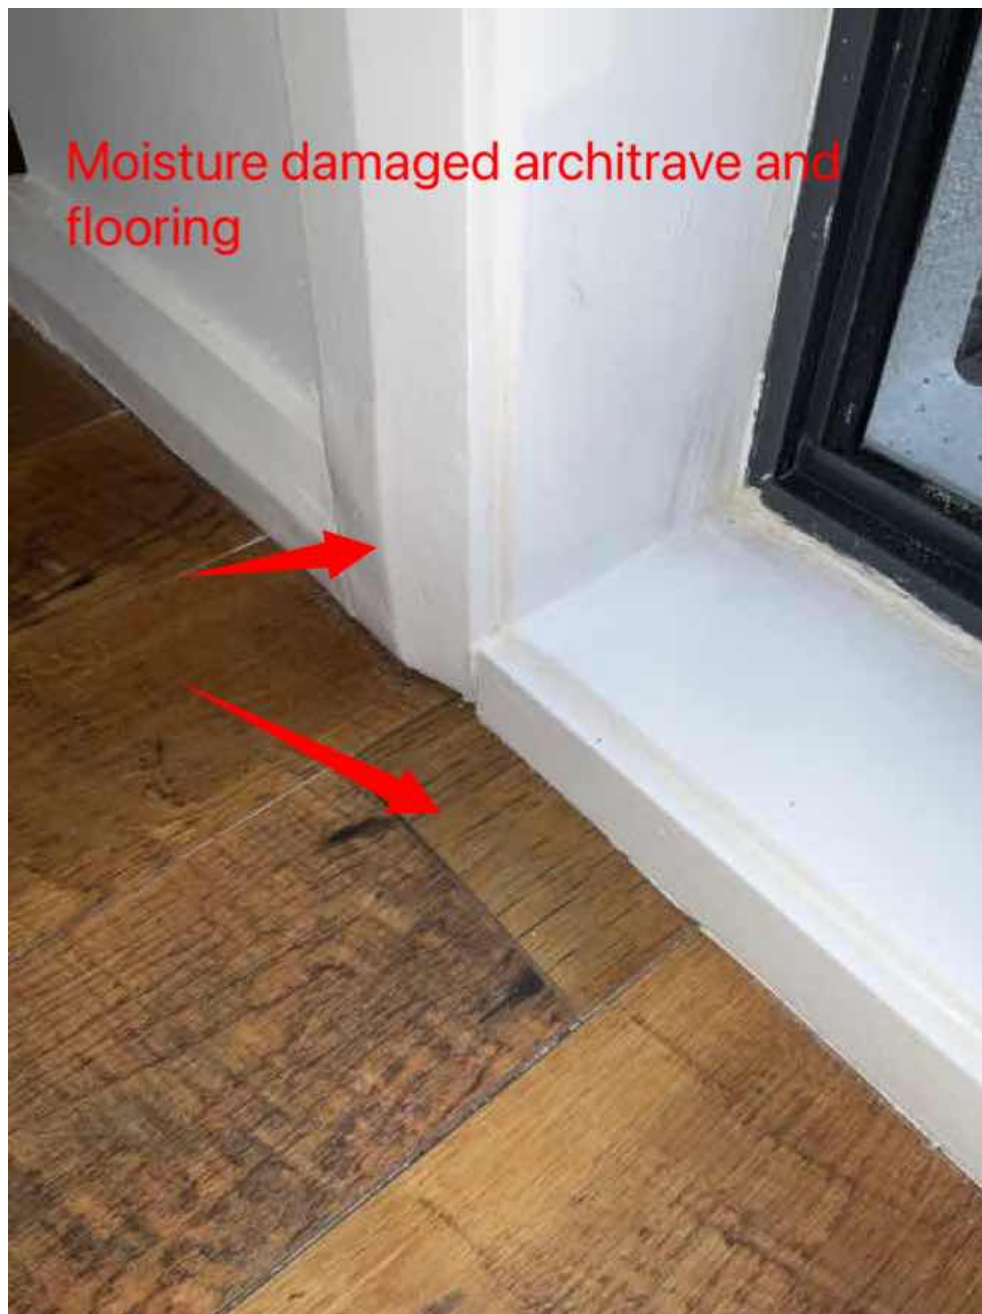
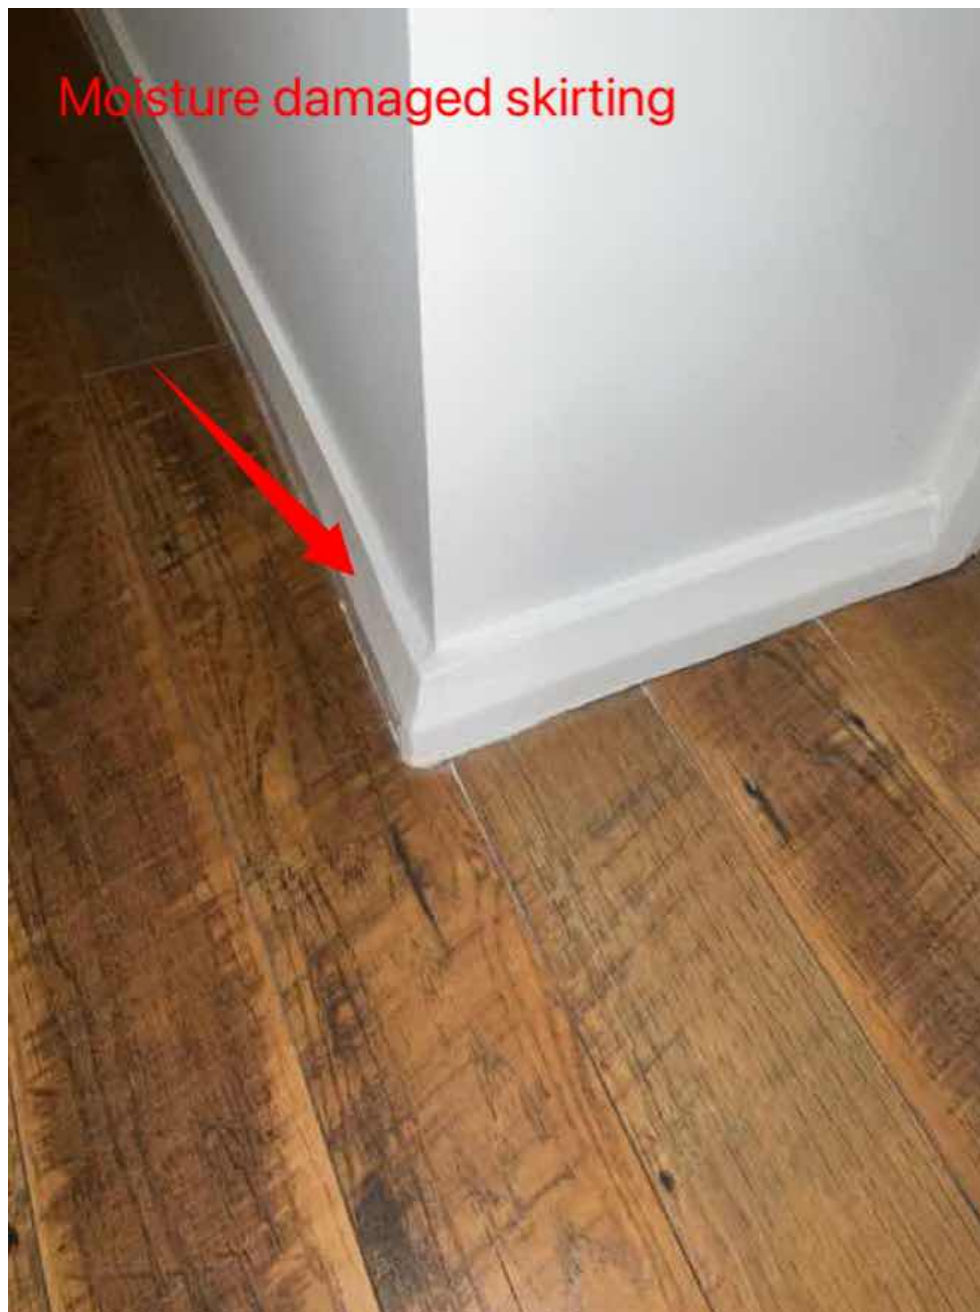
Timber fungal decay observed in window/frame. High moisture readings taken at the time of the inspection. This is most probably linked to a leaking window, architraves, skirtings and flooring in this area are swollen from moisture damage. Recommend a carpenter for further advice and repairs.

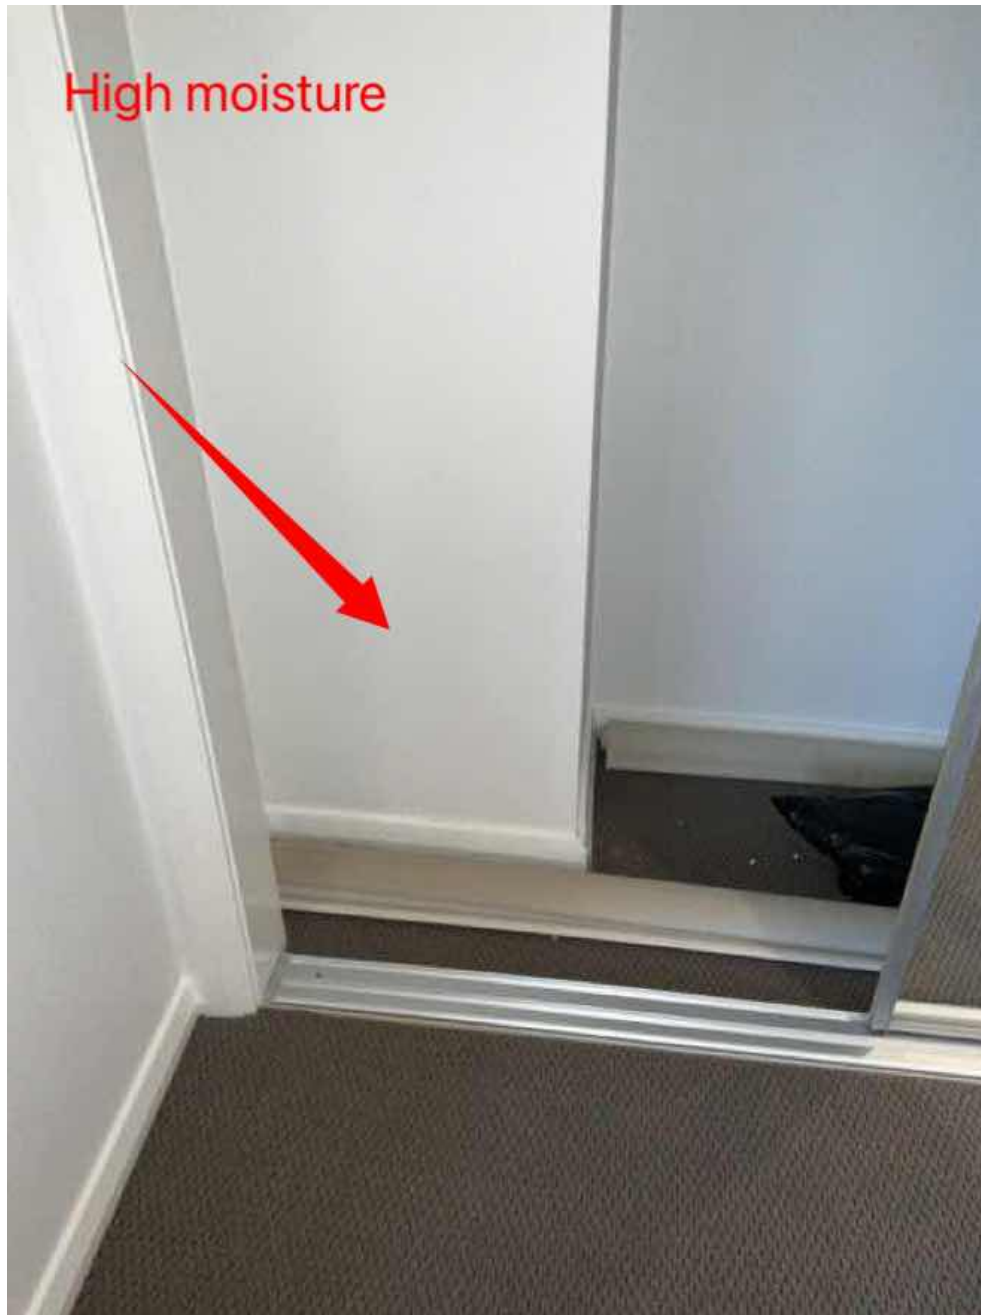
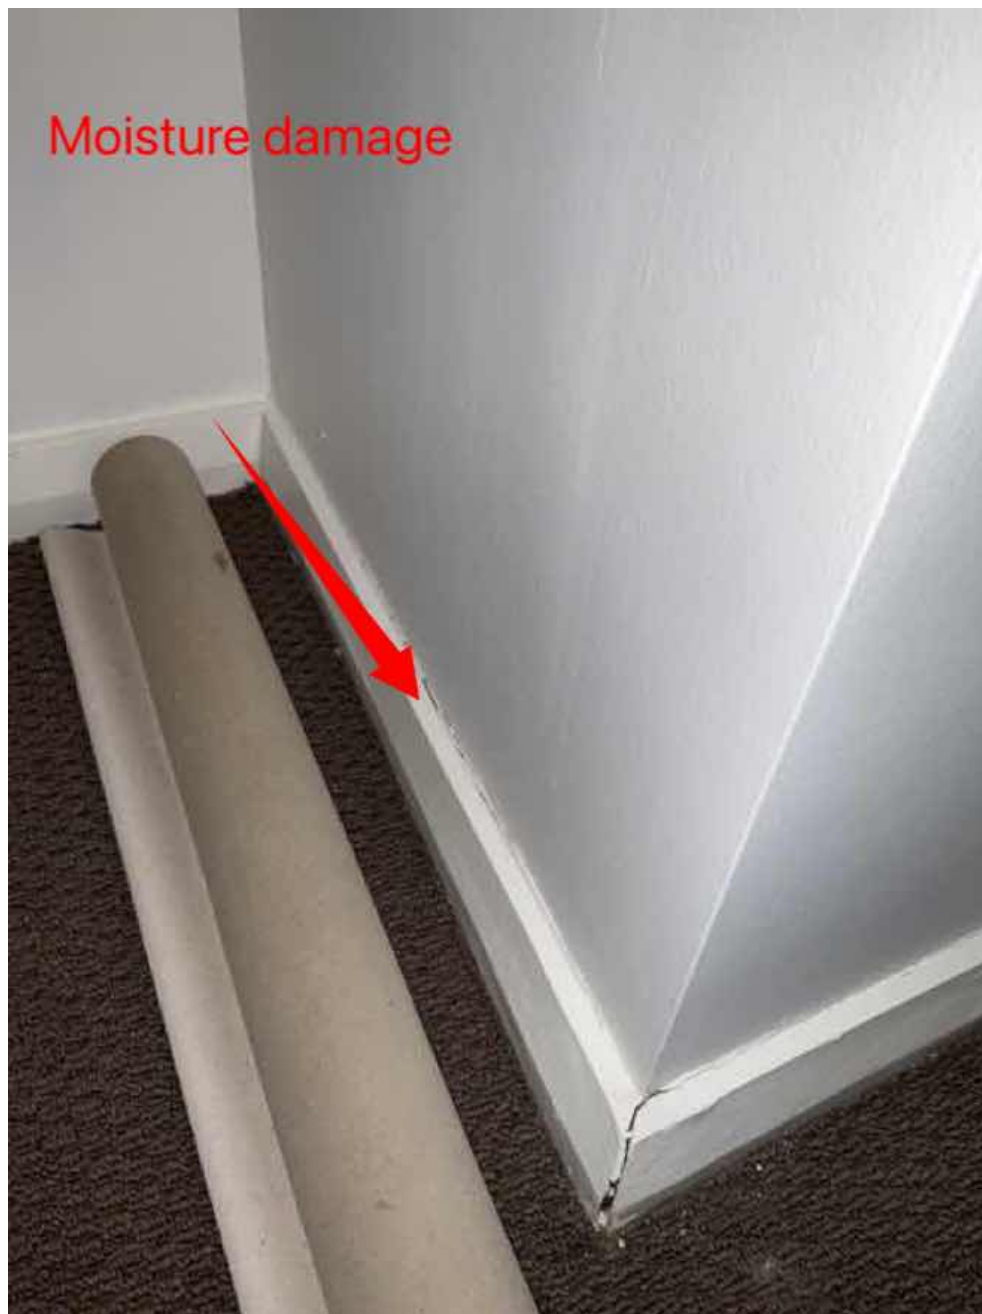
INTERIORS	Bedroom 1	Wardrobe	There is moisture damage in the wardrobe. High moisture readings taken. Appear to be a leak from the sewer stack pipe, upstairs bathroom or a leaking pipe. Recommend an invasive inspection by putting a hole in the plasterboard and inserting a camera. Being in a wardrobe a snap vent might be able to be cut into the plasterboard to provide an inspection hole.

There is moisture damage in the wardrobe. High moisture readings taken. Appear to be a leak from the sewer stack pipe, upstairs bathroom or a leaking pipe. Recommend an invasive inspection by putting a hole in the plasterboard and inserting a camera. Being in a wardrobe a snap vent might be able to be cut into the plasterboard to provide an inspection hole.

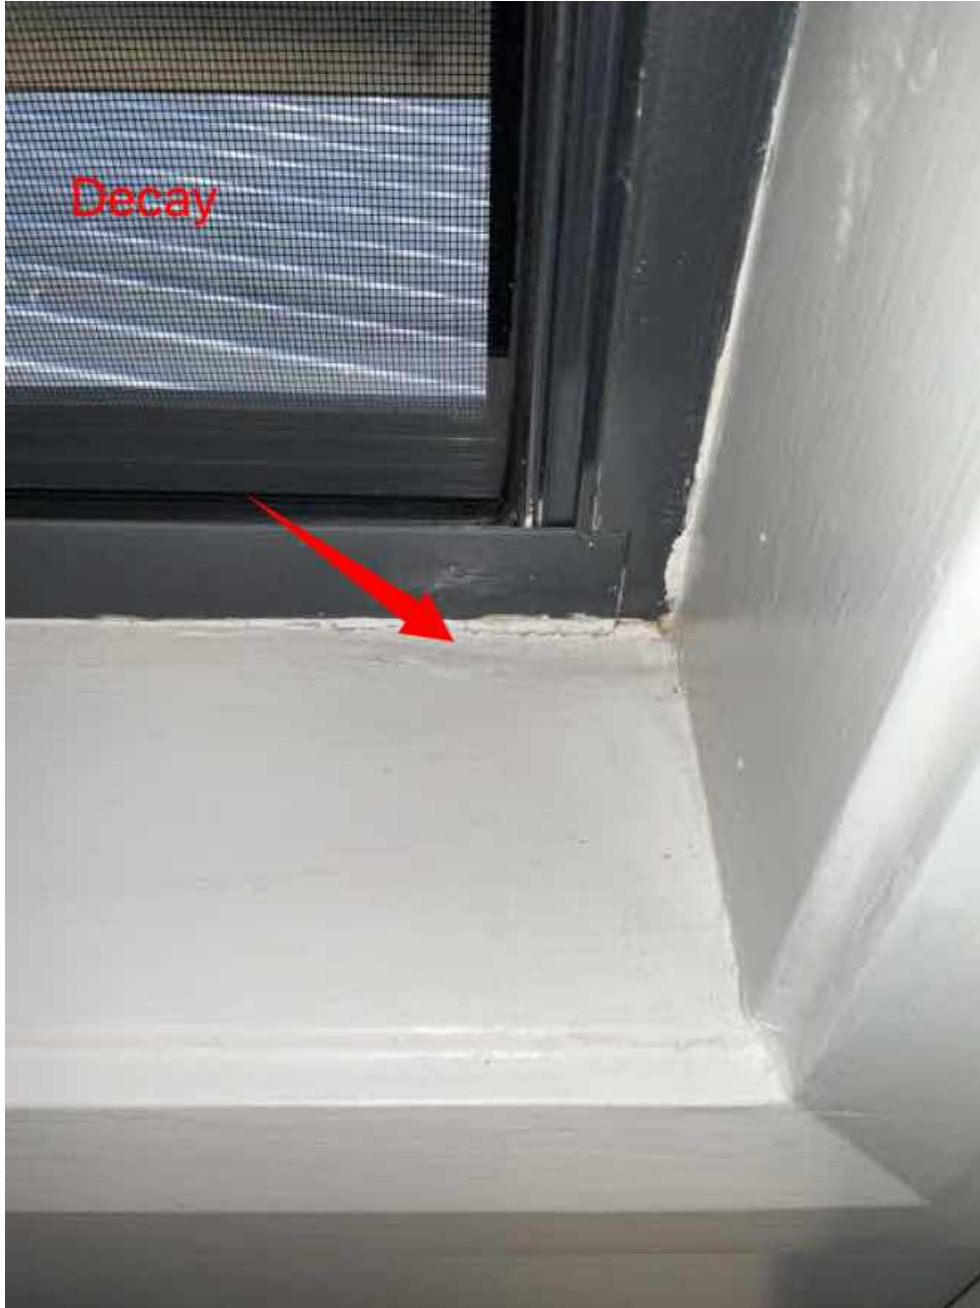
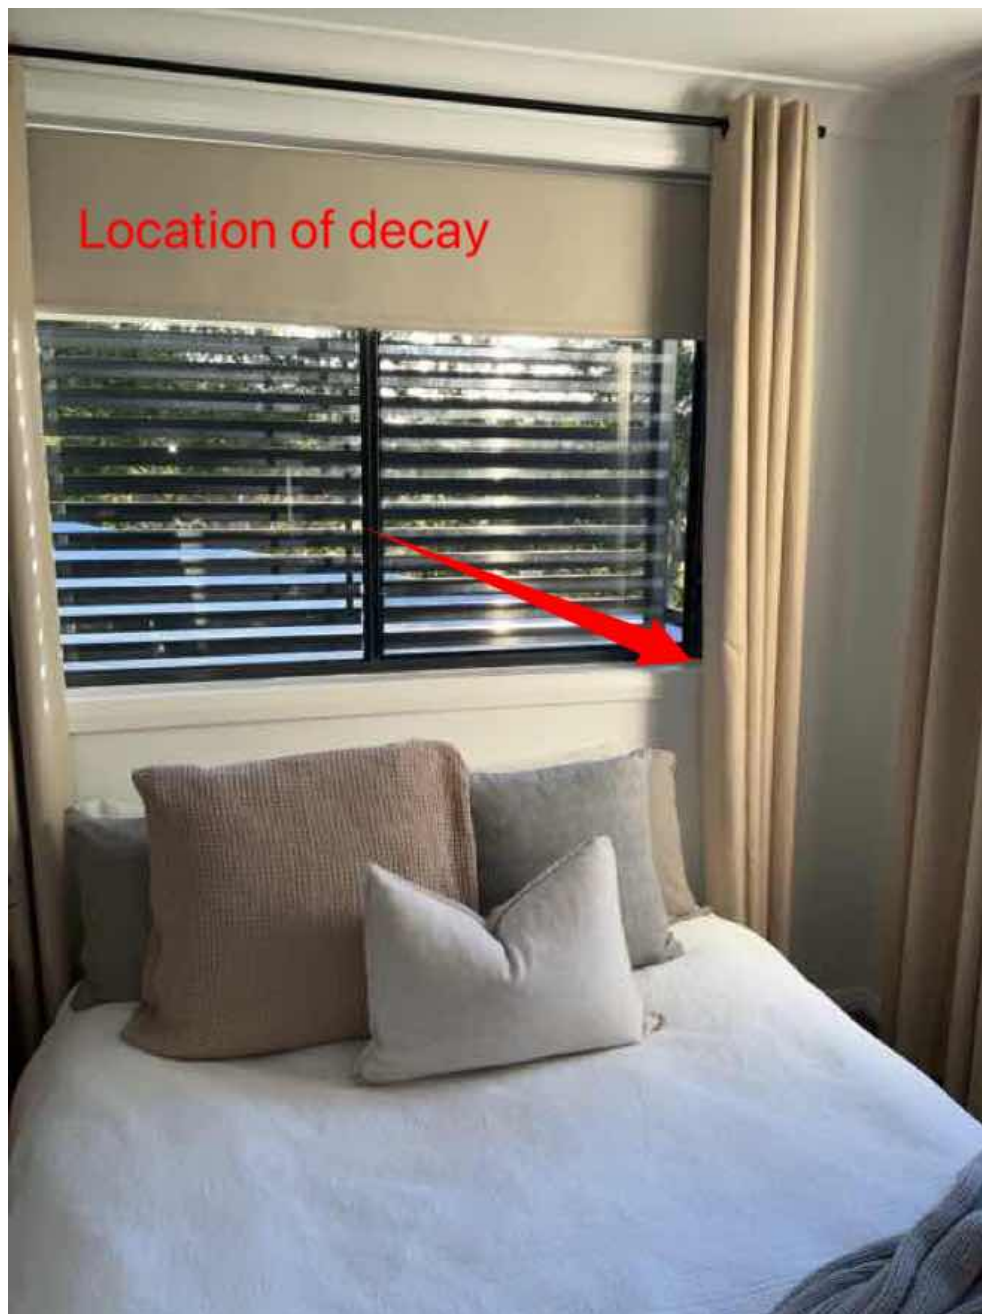
INTERIORS	Bedroom 2	Windows	Timber fungal decay observed in window/frame. High moisture readings taken. Related to a leaking window. The decay has been painted over. Recommend a carpenter for further advice and repairs.
INTERIORS	Bedroom 3	Walls	Architrave and/or skirting moisture damage. High moisture readings taken during the inspection. This appears to be related to the the sliding door installation leaking. Recommend a qualified carpenter for further advice and repair. Note: This damage does not happen from getting wet once from a door left open. This has been getting wet for a long period of time.
BATHROOM(S)	Bathroom 1	Door	The architrave has signs of water damage/swollen. High moisture readings taken at time of inspection. Appears to be related to a membrane failure in the shower area. The floors appear to have had a temporary waterproofing treatment to the floorswithin this room. There is epoxy grout between the floor tiles but not under the vanity, indicating that it has been installed as a patch or repair. Recommend discussing with the current owner.

Timber fungal decay observed in window/frame. High moisture readings taken. Related to a leaking window. The decay has been painted over. Recommend a carpenter for further advice and repairs.

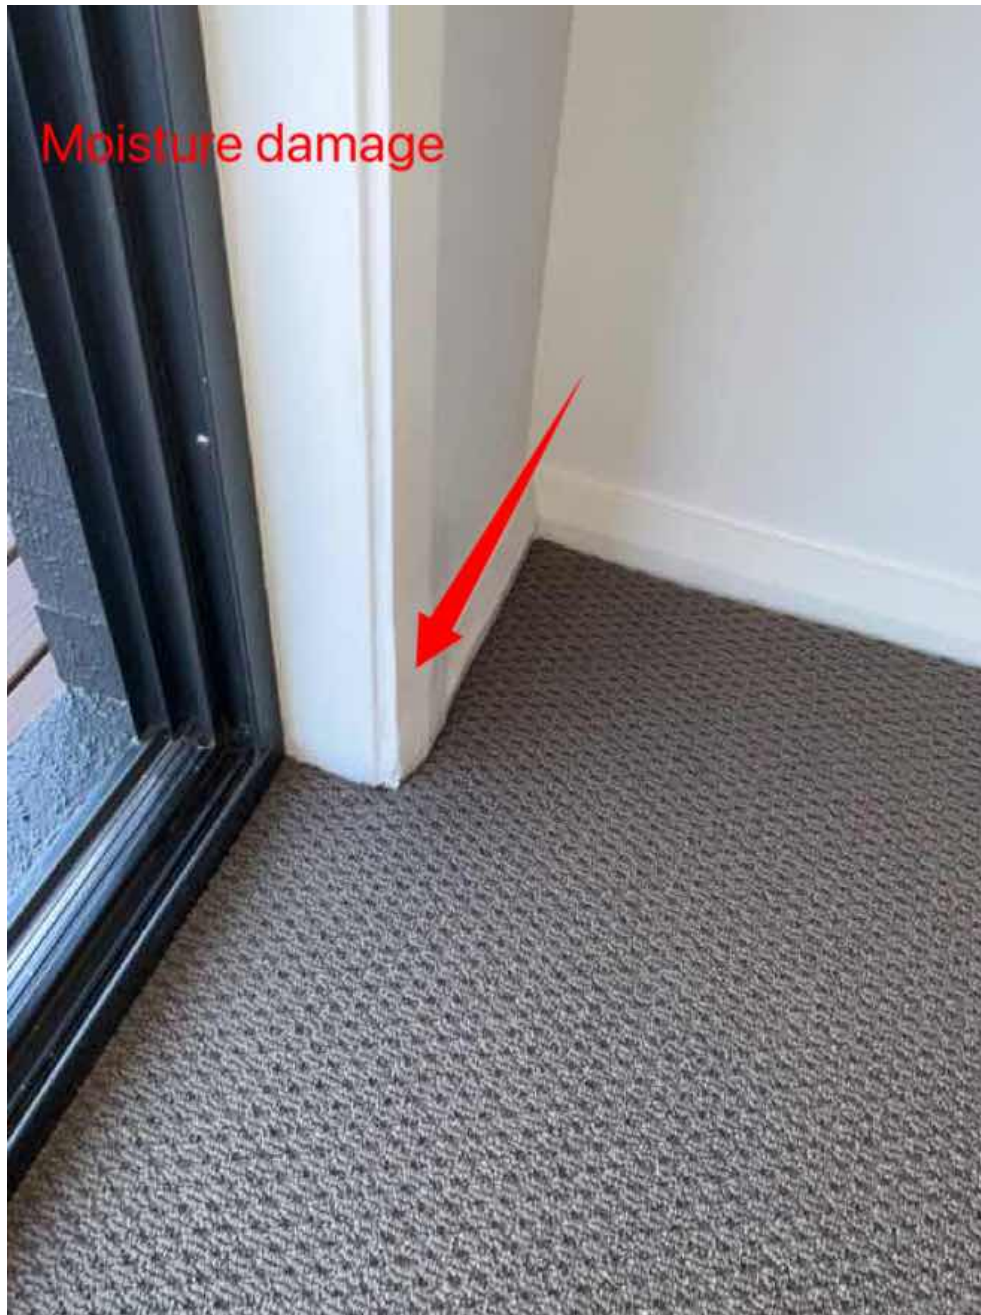
Architrave and/or skirting moisture damage. High moisture readings taken during the inspection. This appears to be related to the the sliding door installation leaking. Recommend a qualified carpenter for further advice and repair. Note: This damage does not happen from getting wet once from a door left open. This has been getting wet for a long period of time.

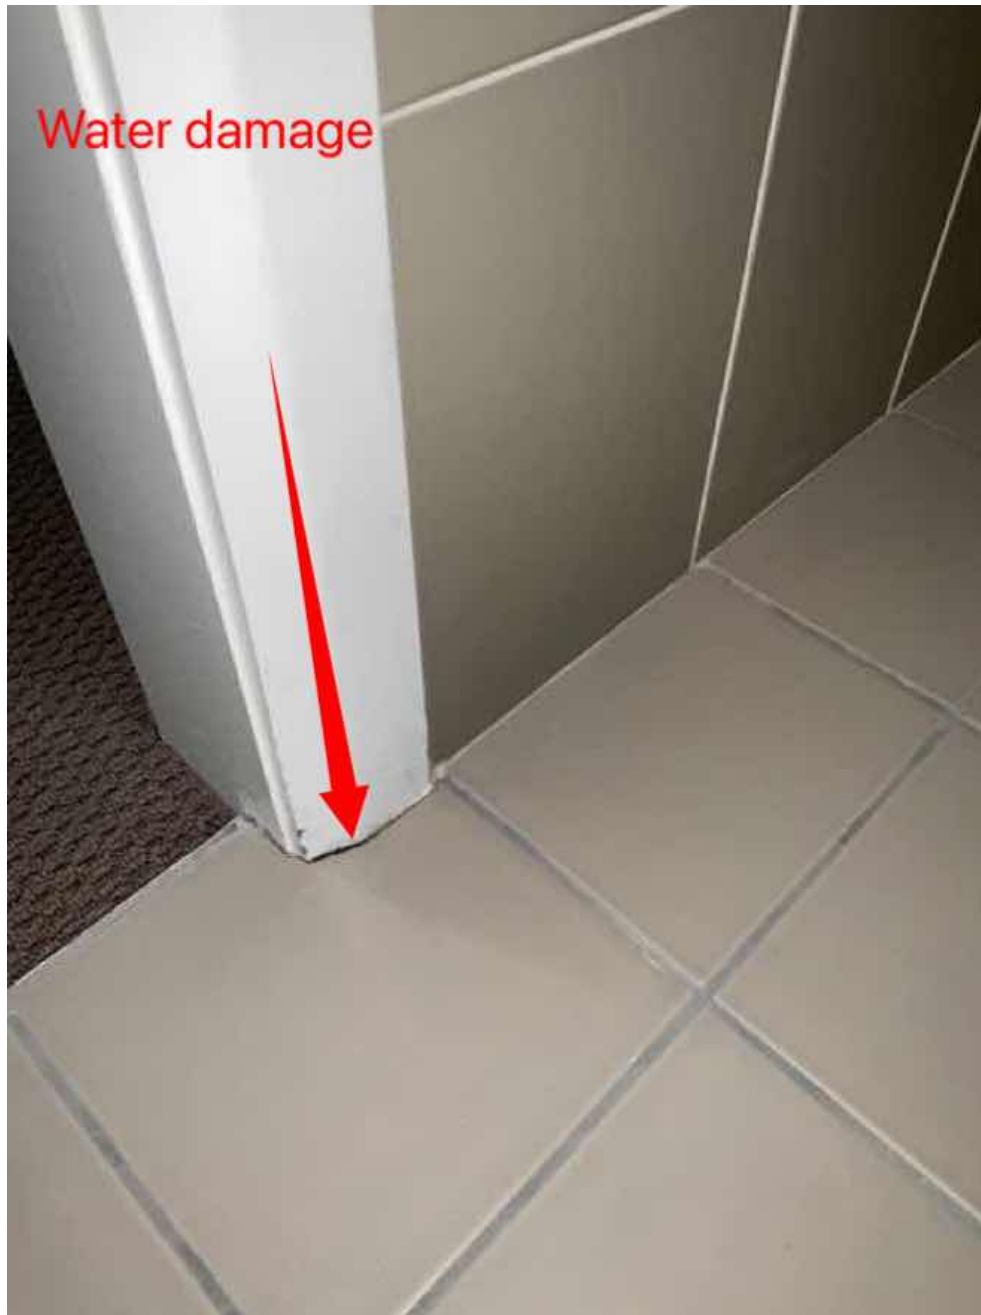
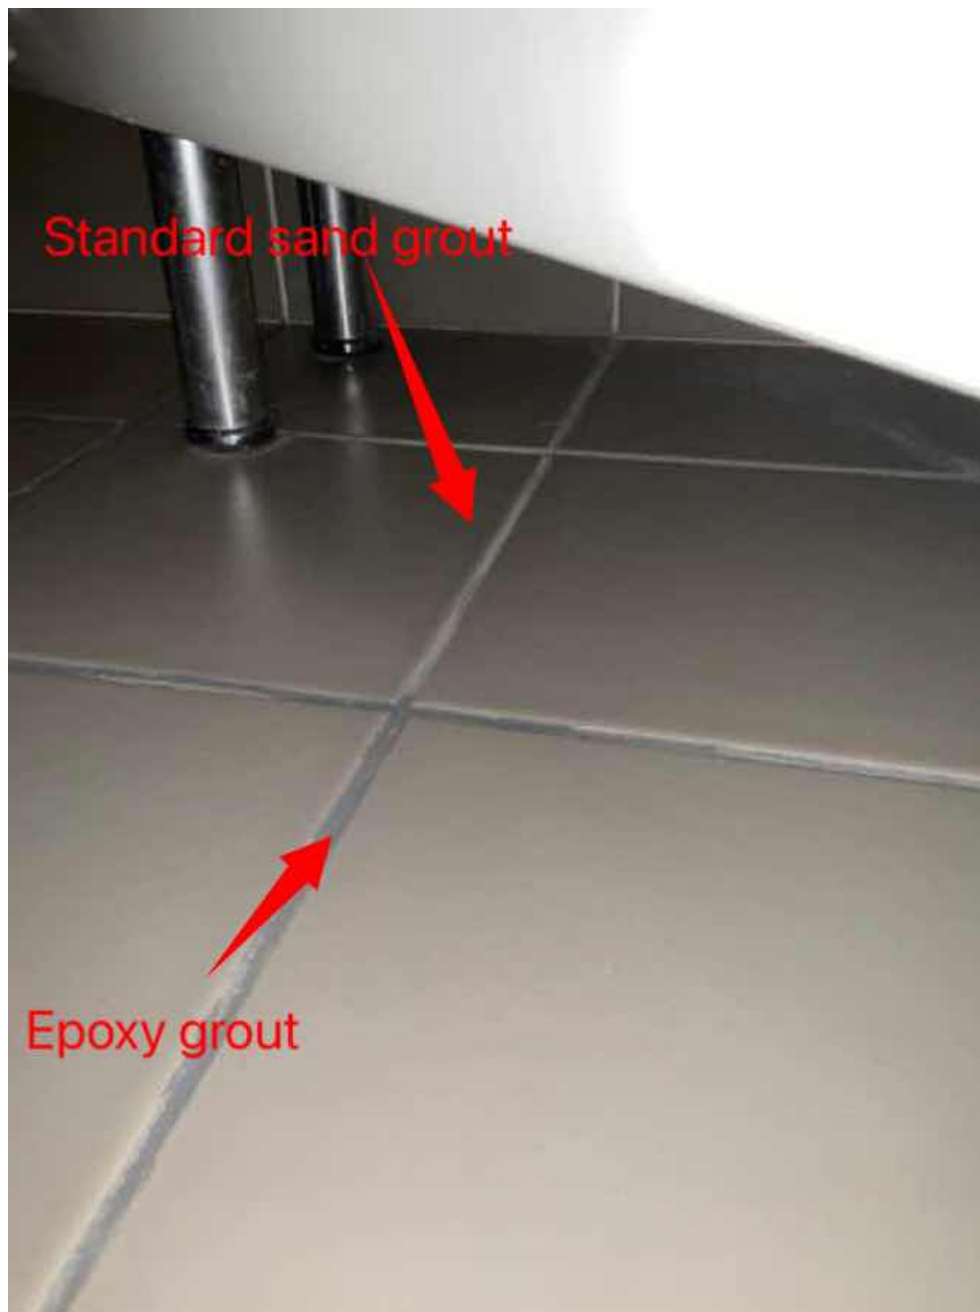
The architrave has signs of water damage/swollen. High moisture readings taken at time of inspection. Appears to be related to a membrane failure in the shower area. The floors appear to have had a temporary waterproofing treatment to the floors within this room. There is epoxy grout between the floor tiles but not under the vanity, indicating that it has been installed as a patch or repair. Recommend discussing with the current owner.

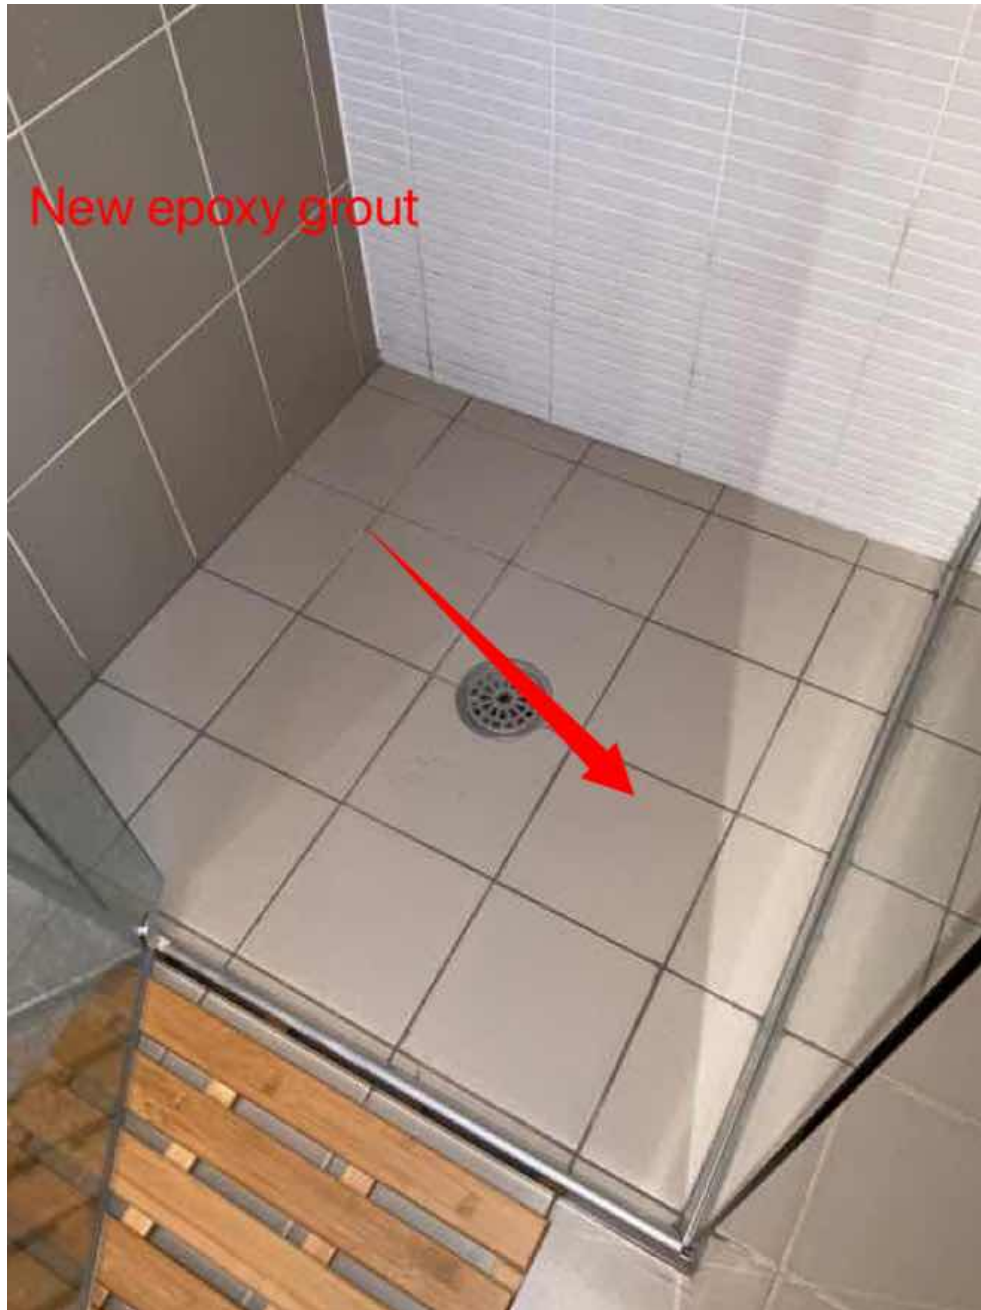
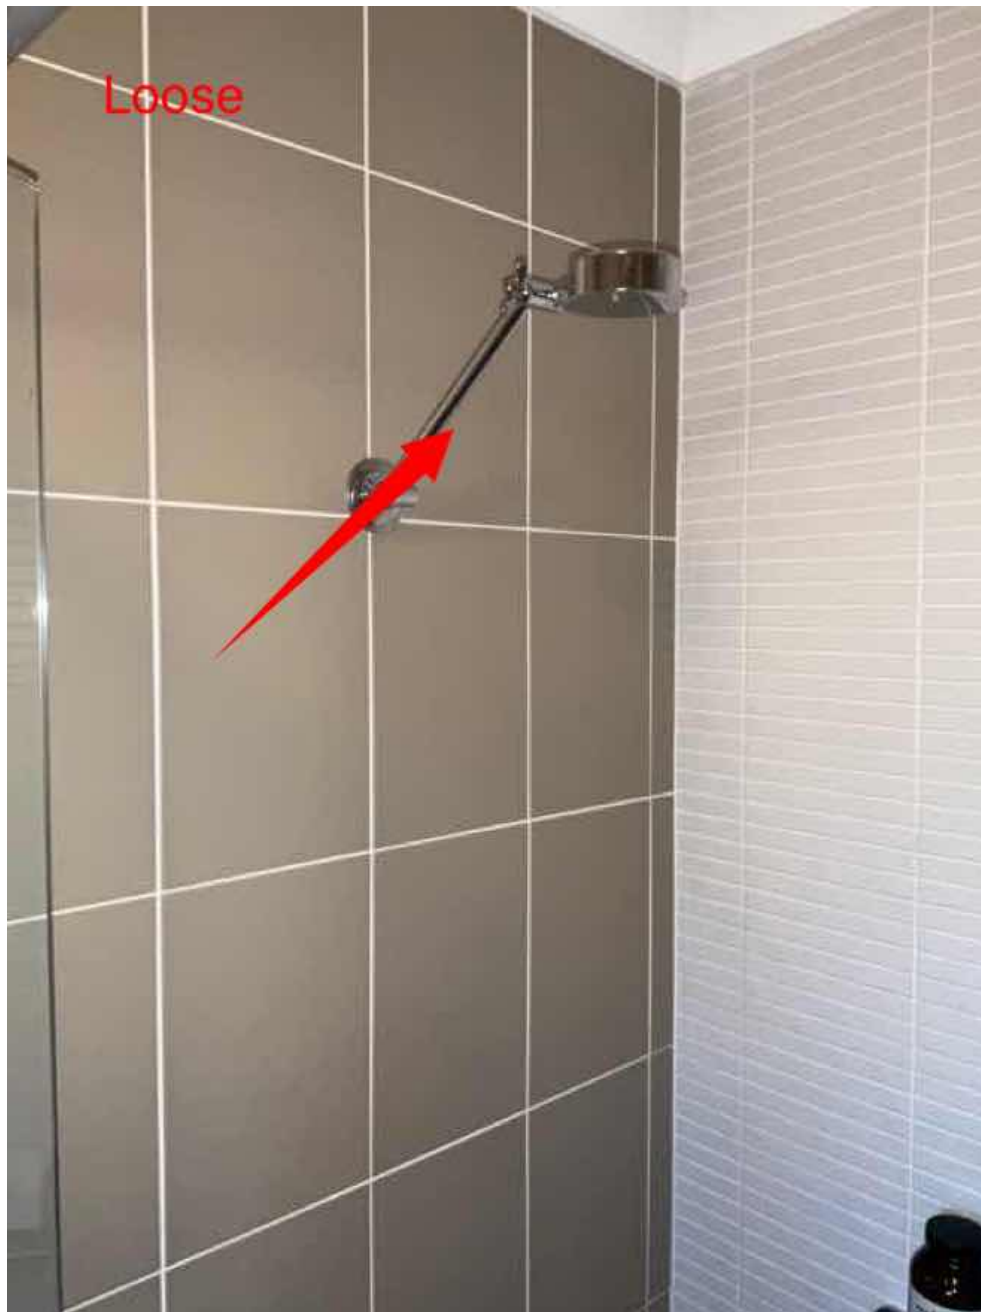
Shower head is loose. Recommend a qualified plumber for further advice and recommendations.

The shower recess has been re grouted with epoxy grout. This is normally done to extend the life of a bathroom that has been leaking. In some instances this patch/repair will last the life of the bathroom. Recommend discussing with the current owner as to why it was re grouted.

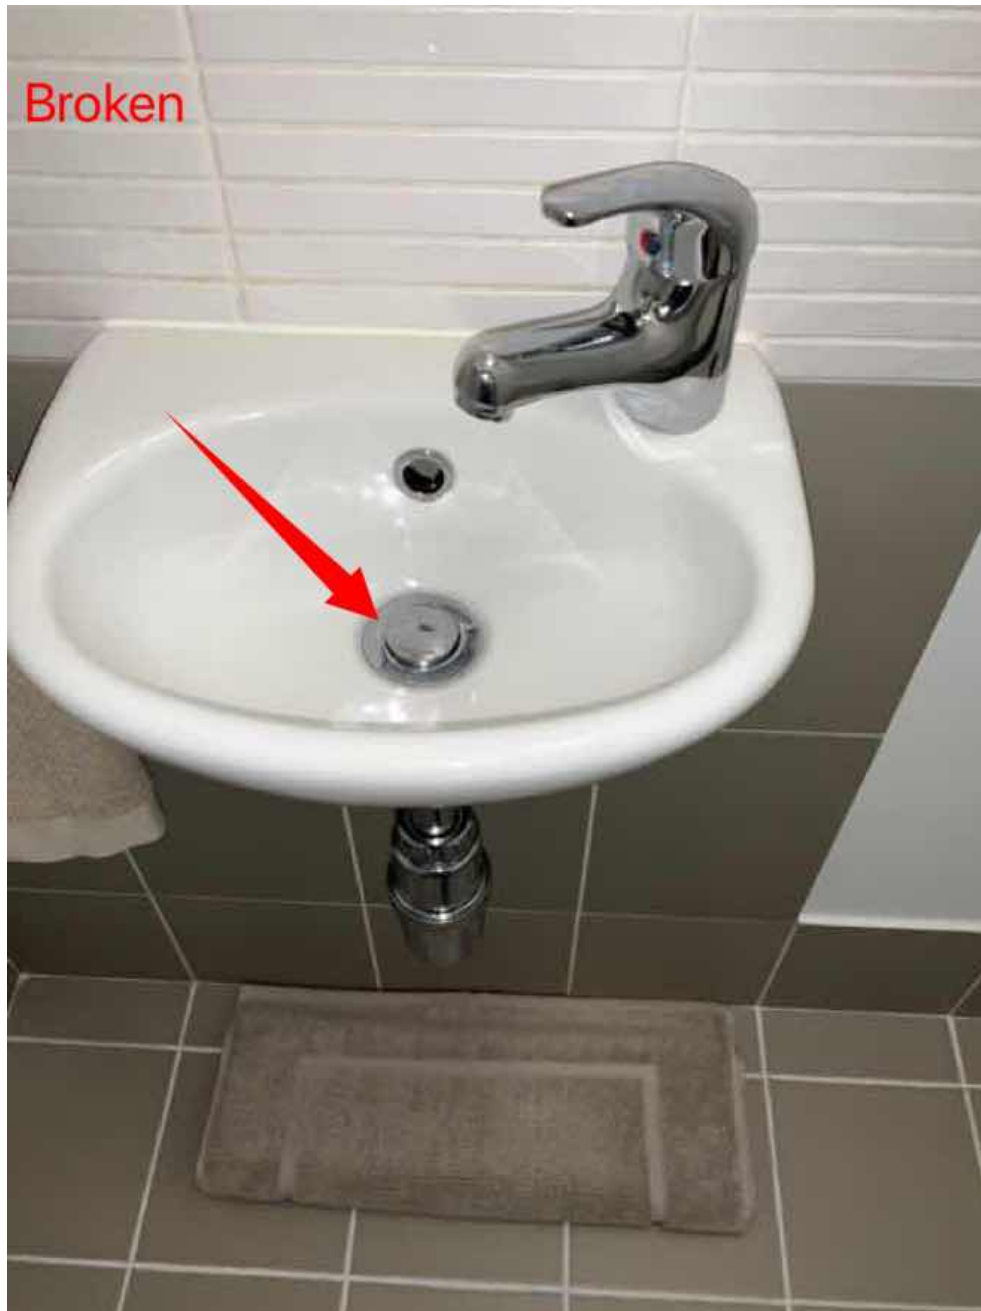
Vanity/Sink/Taps

The push plug does not function. Recommend a qualified plumber to replace as deemed necessary.

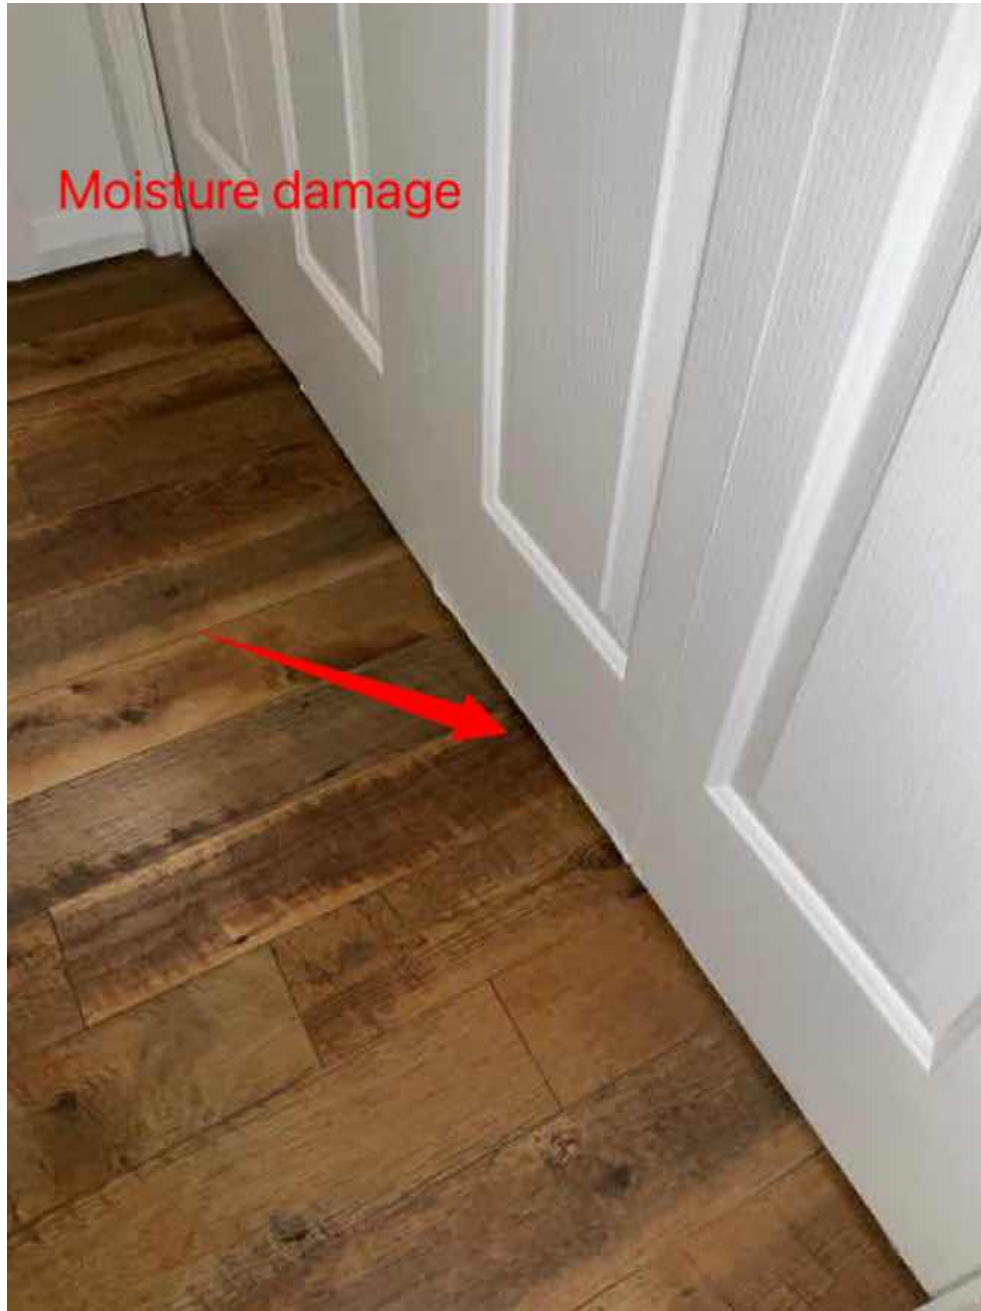
Moisture damage to the bottom of the door. Recommend a qualified carpenter to repair as deemed necessary.

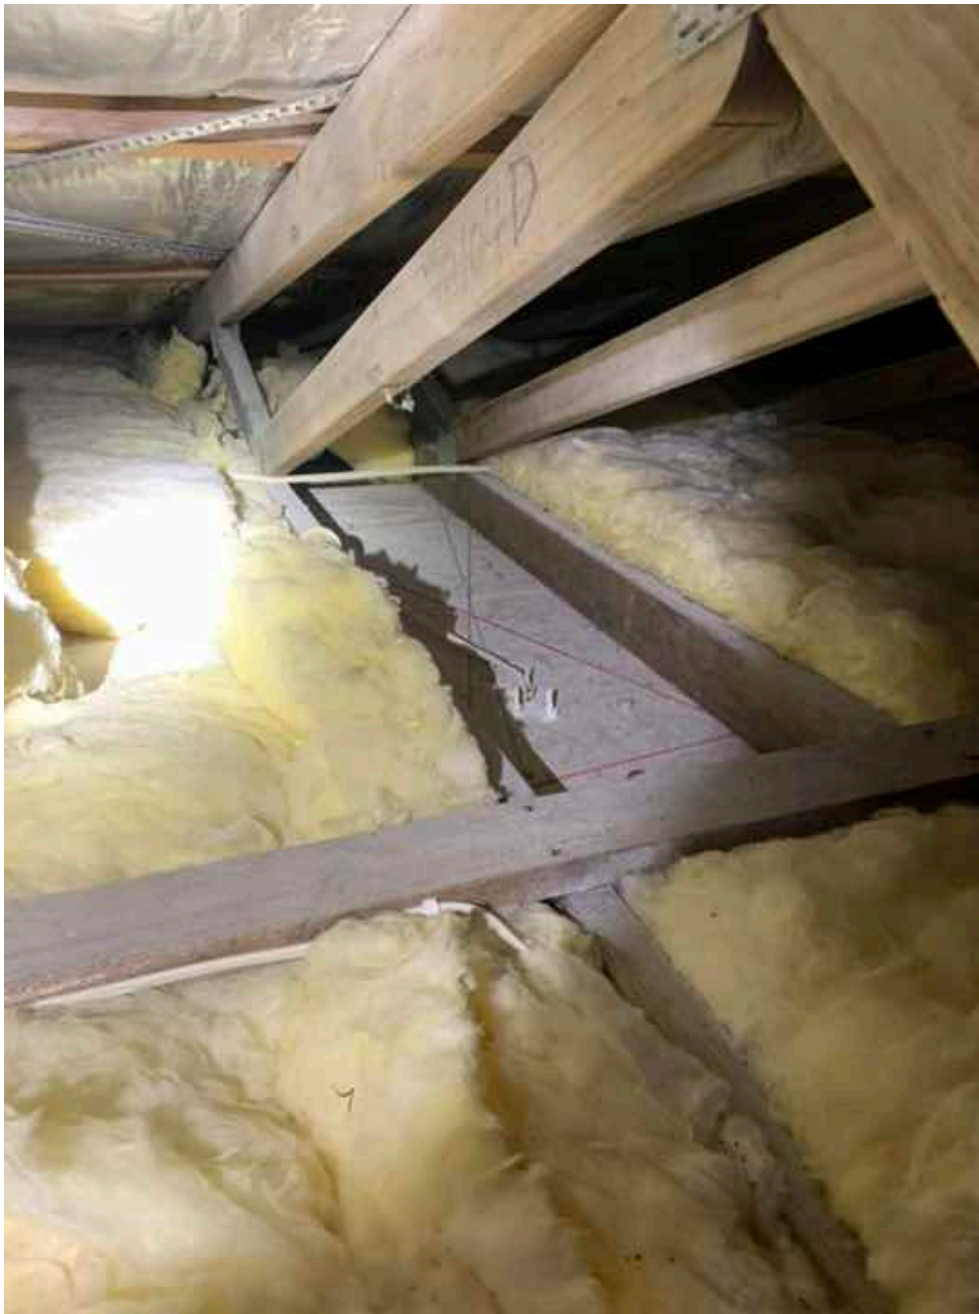
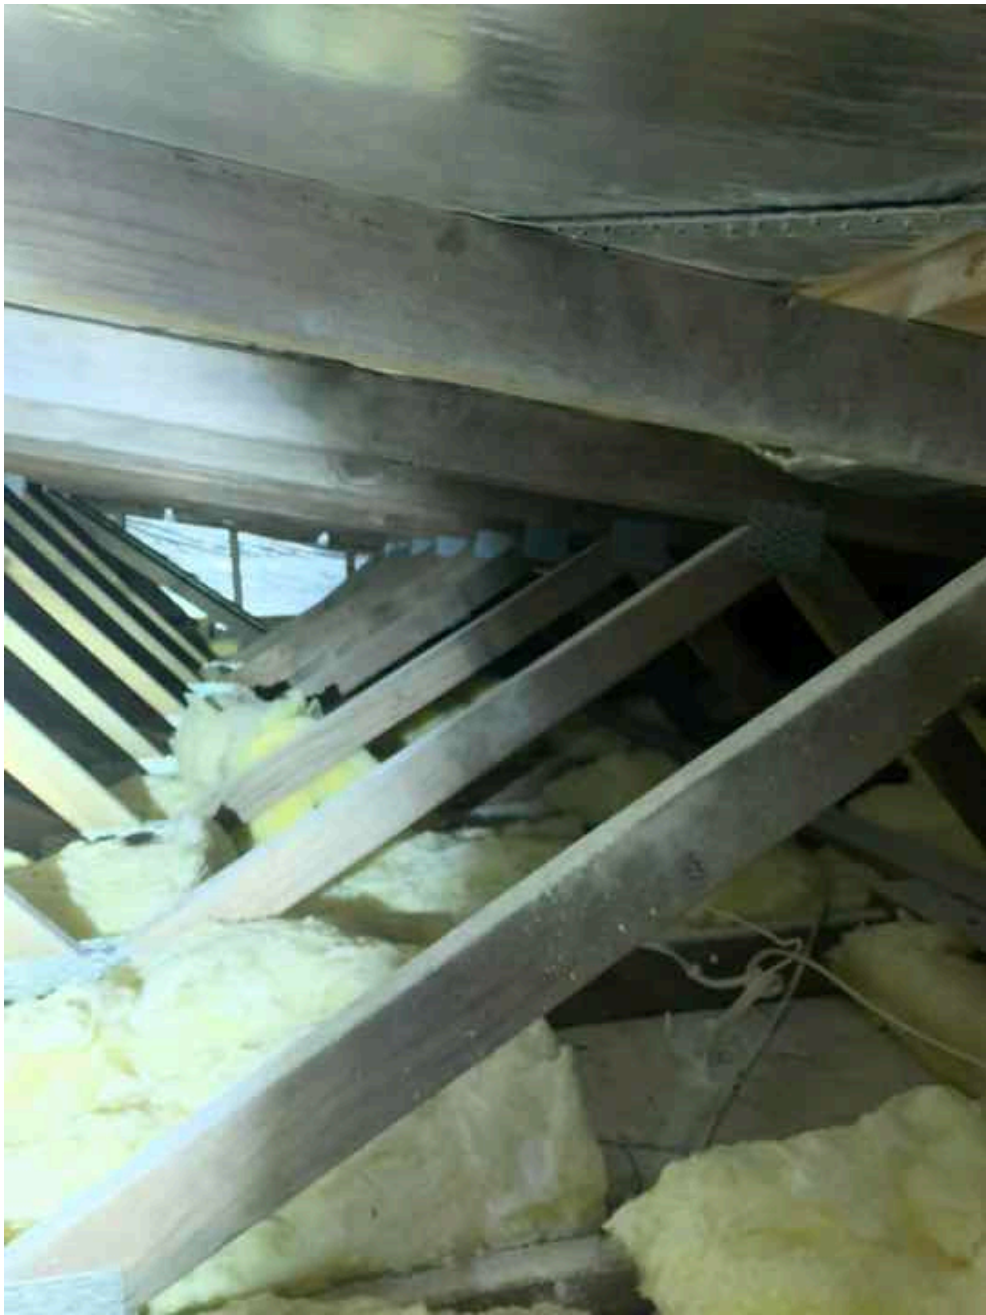
Restricted Areas

There is low clearance in areas throughout the roof void which is preventing a full/thorough visual inspection taking place. It is strongly recommended that full access be granted to enable a thorough inspection to take place as it could be harbouring timber pest activity, damage or defects.
