Inspection Report

UNCOVER
BUILDING AND PEST INSPECTIONS

1 Sample Street, Sampletown, NSW, 2280

Pest And Building Inspection

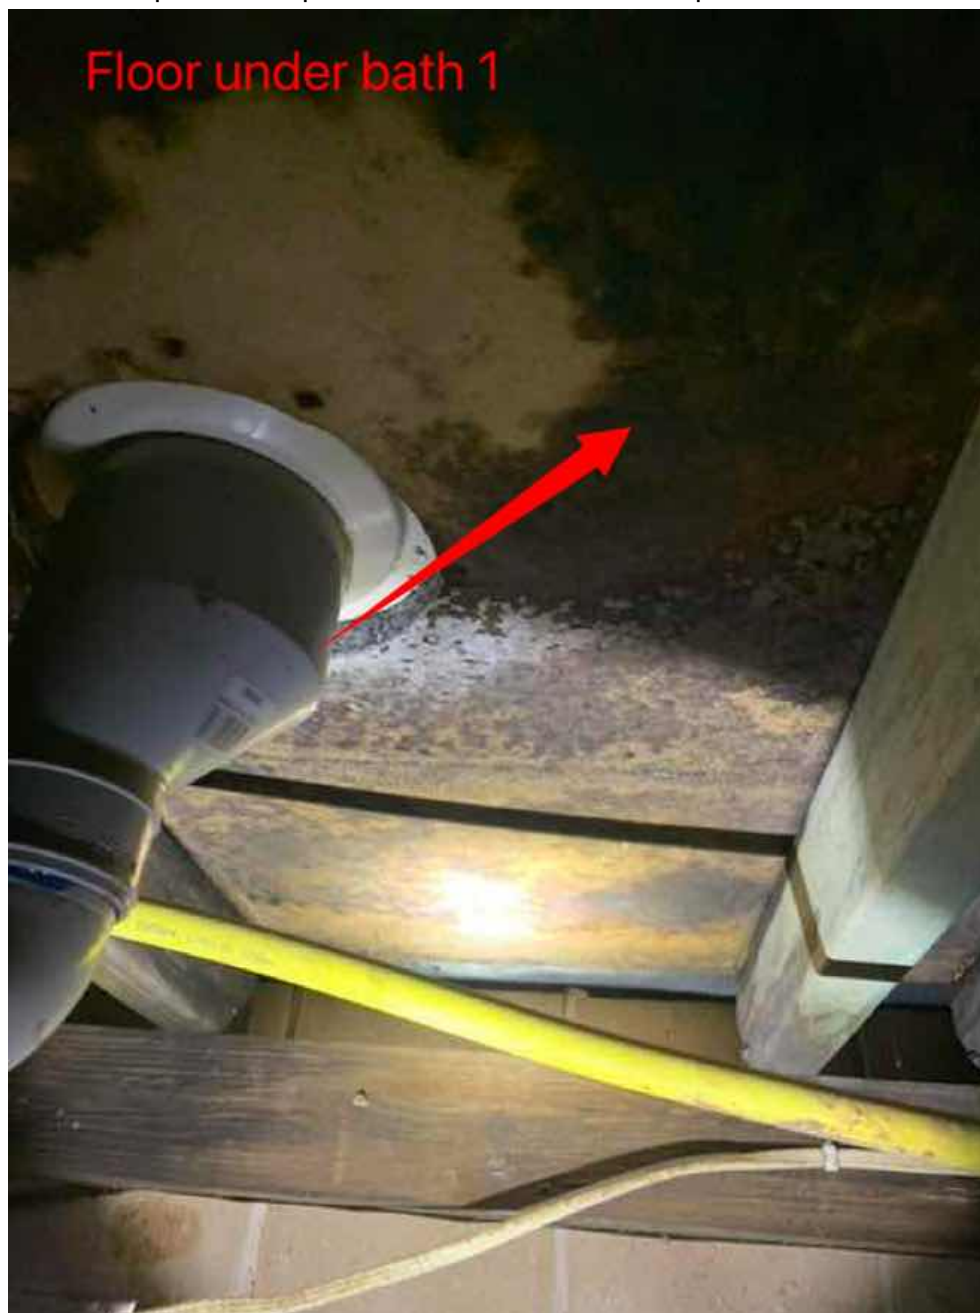
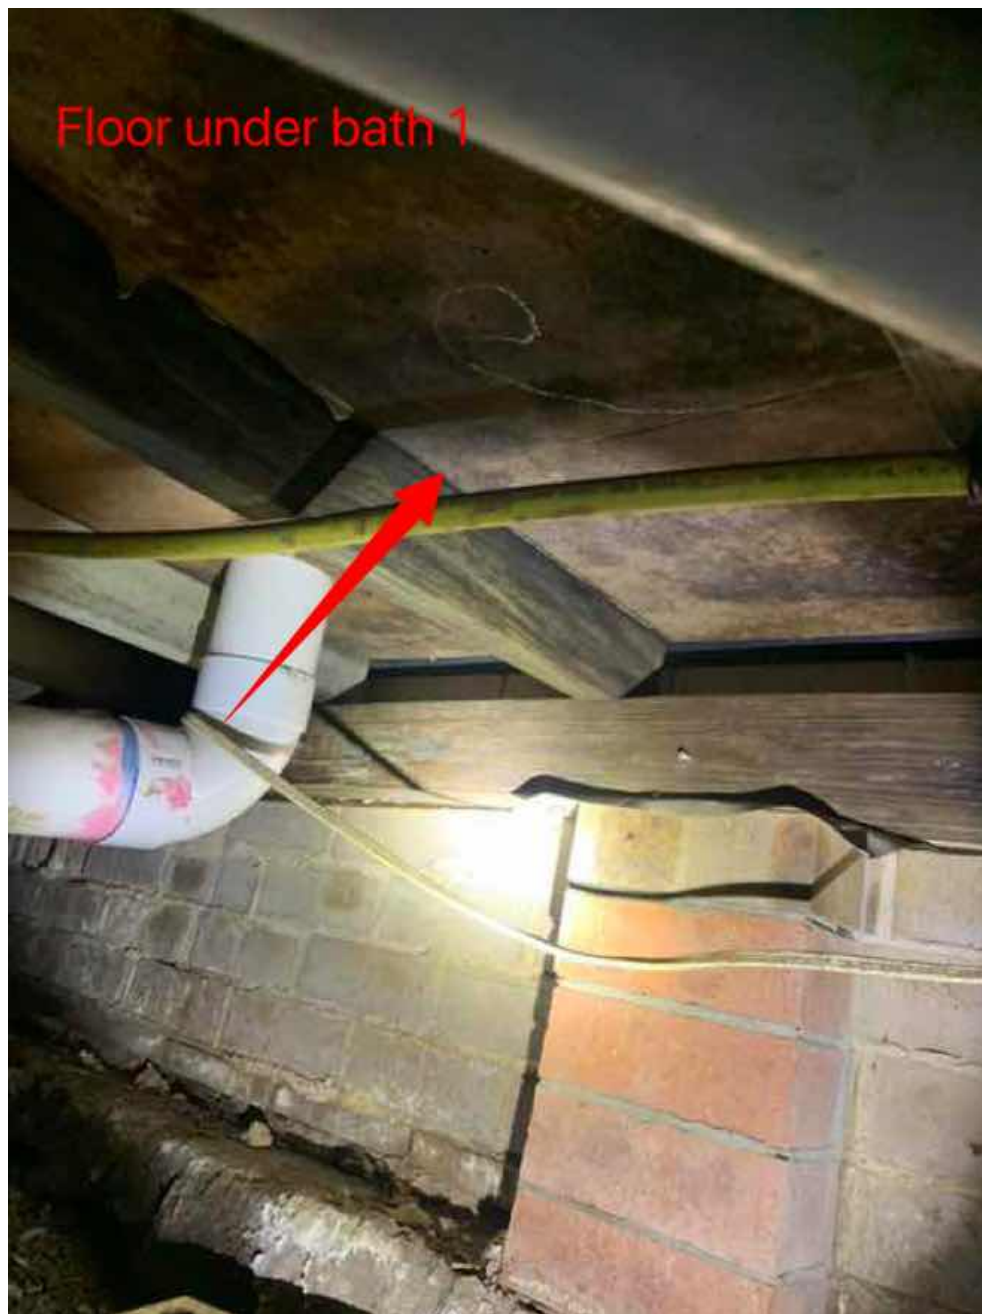
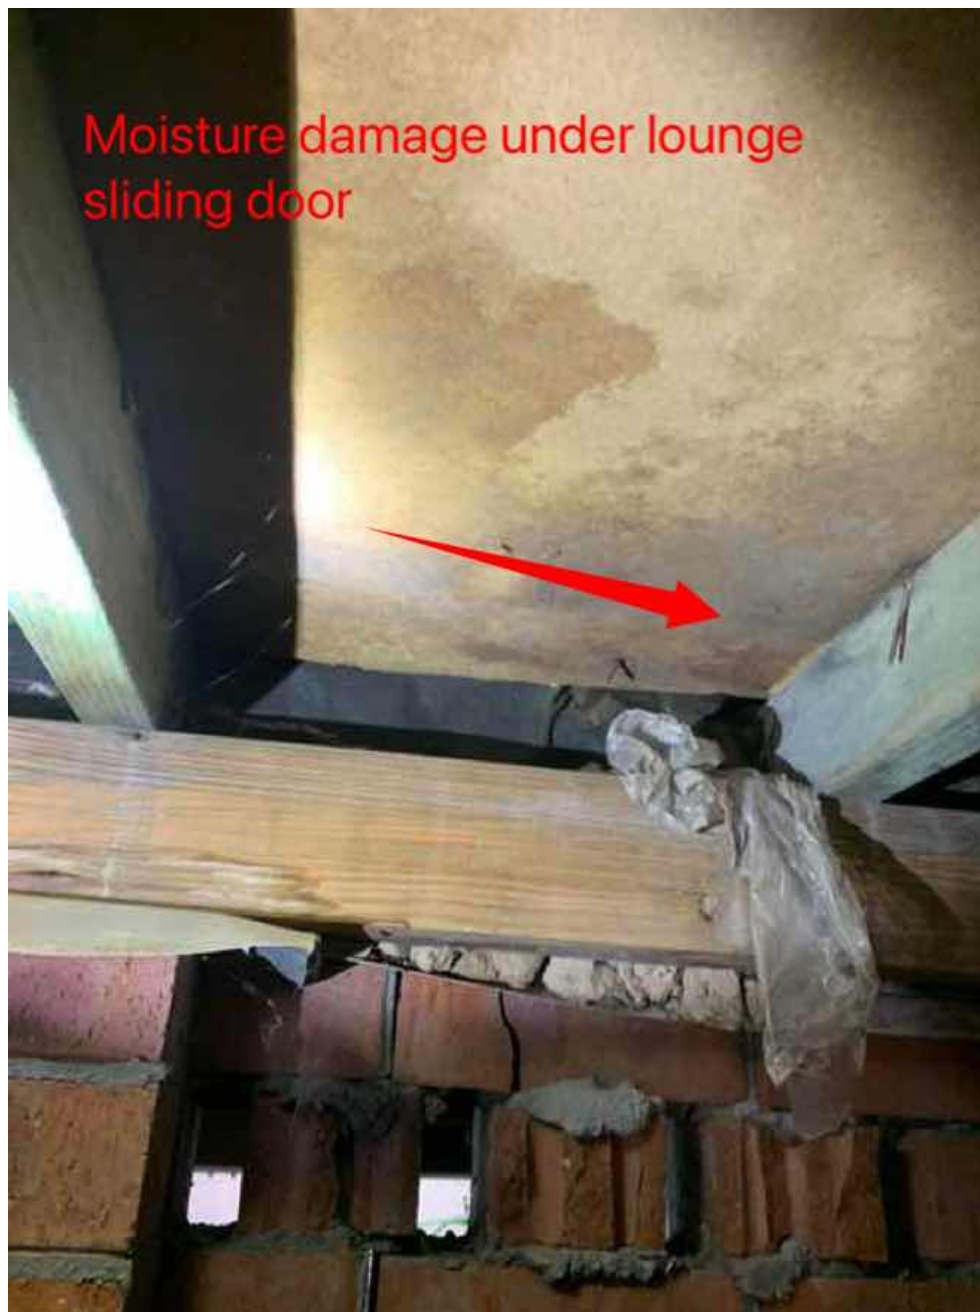
SUBFLOOR	Sub-Floor Observation.	Flooring	Damp/Moisture damage noted. This damage is probably related to a failed waterproofing membrane or leaking pipe. A qualified waterproofer/tiler should be engaged for further advice and repair in relation to the leaking wet area. Note: there are companies like "Megasealed" that can re waterproof leaking shower recesses without tile removal. This may be an option. The bathroom already appears to have been patched by one of these companies.
SUBFLOOR	Sub-Floor Observation.	Flooring	Moisture damage to flooring under the main sliding door to access the deck. This appears to be related to poor installation. Recommend a qualified carpenter to further advise and repair.
SUBFLOOR	Sub-Floor Observation.	Joists	Timber fungal decay evident in to the joists. Recommendations: This is due to high humidity within the subfloor from poor ventilation and water entering the subfloor. These Timbers do not require replacement if the ventilation is addressed immediately. A qualified carpenter and bricklayer should be engaged for advice and recommendations.

Damp/Moisture damage noted. This damage is probably related to a failed waterproofing membrane or leaking pipe. A qualified waterproofer/tiler should be engaged for further advice and repair in relation to the leaking wet area. Note: there are companies like "Megasealed" that can re waterproof leaking shower recesses without tile removal. This may be an option. The bathroom already appears to have been patched by one of these companies.

Moisture damage to flooring under the main sliding door to access the deck. This appears to be related to poor installation. Recommend a qualified carpenter to further advise and repair.

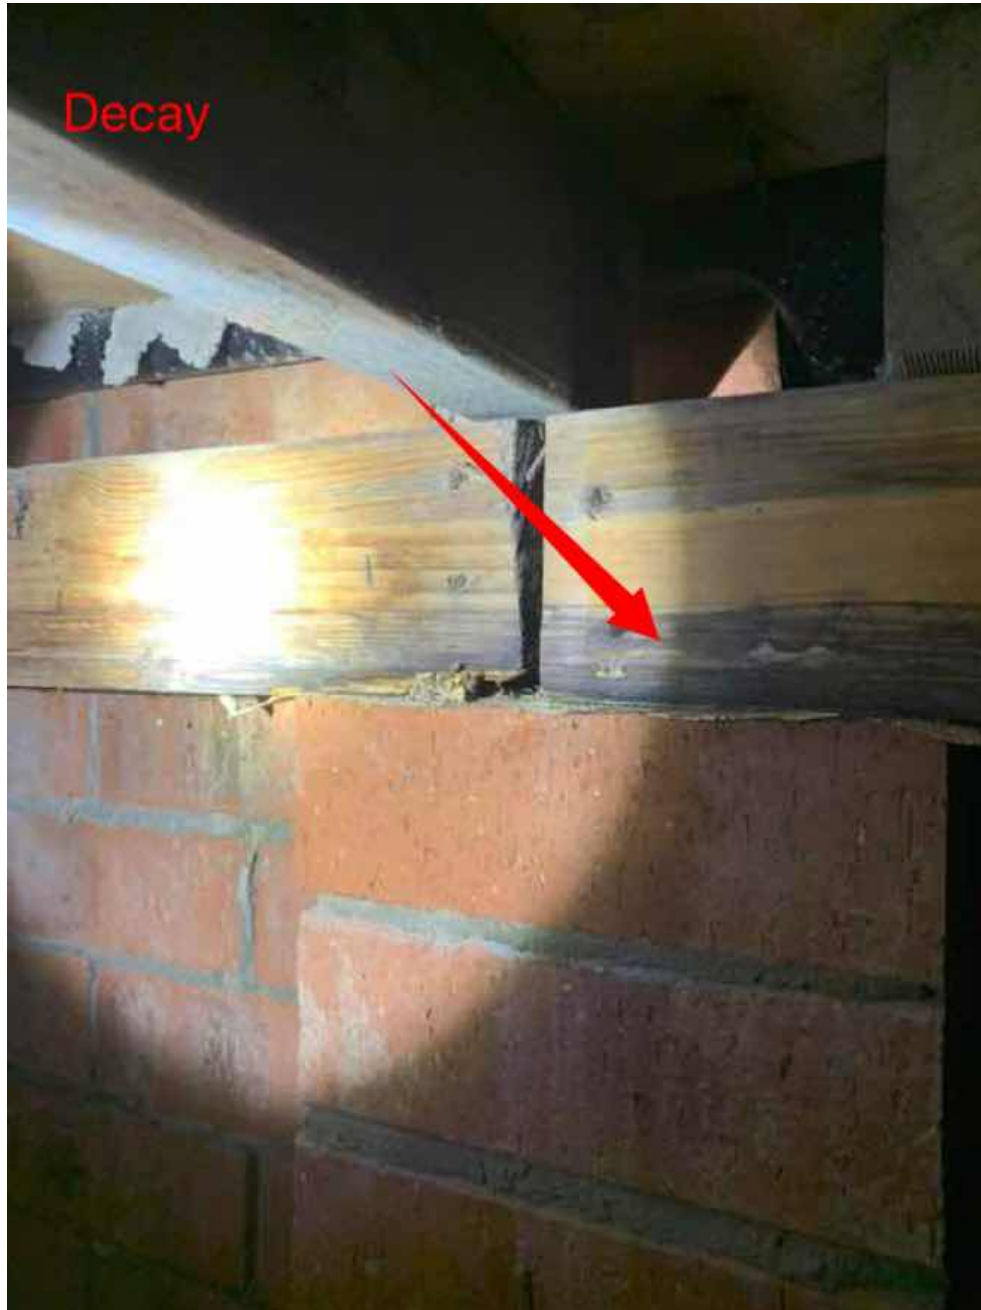
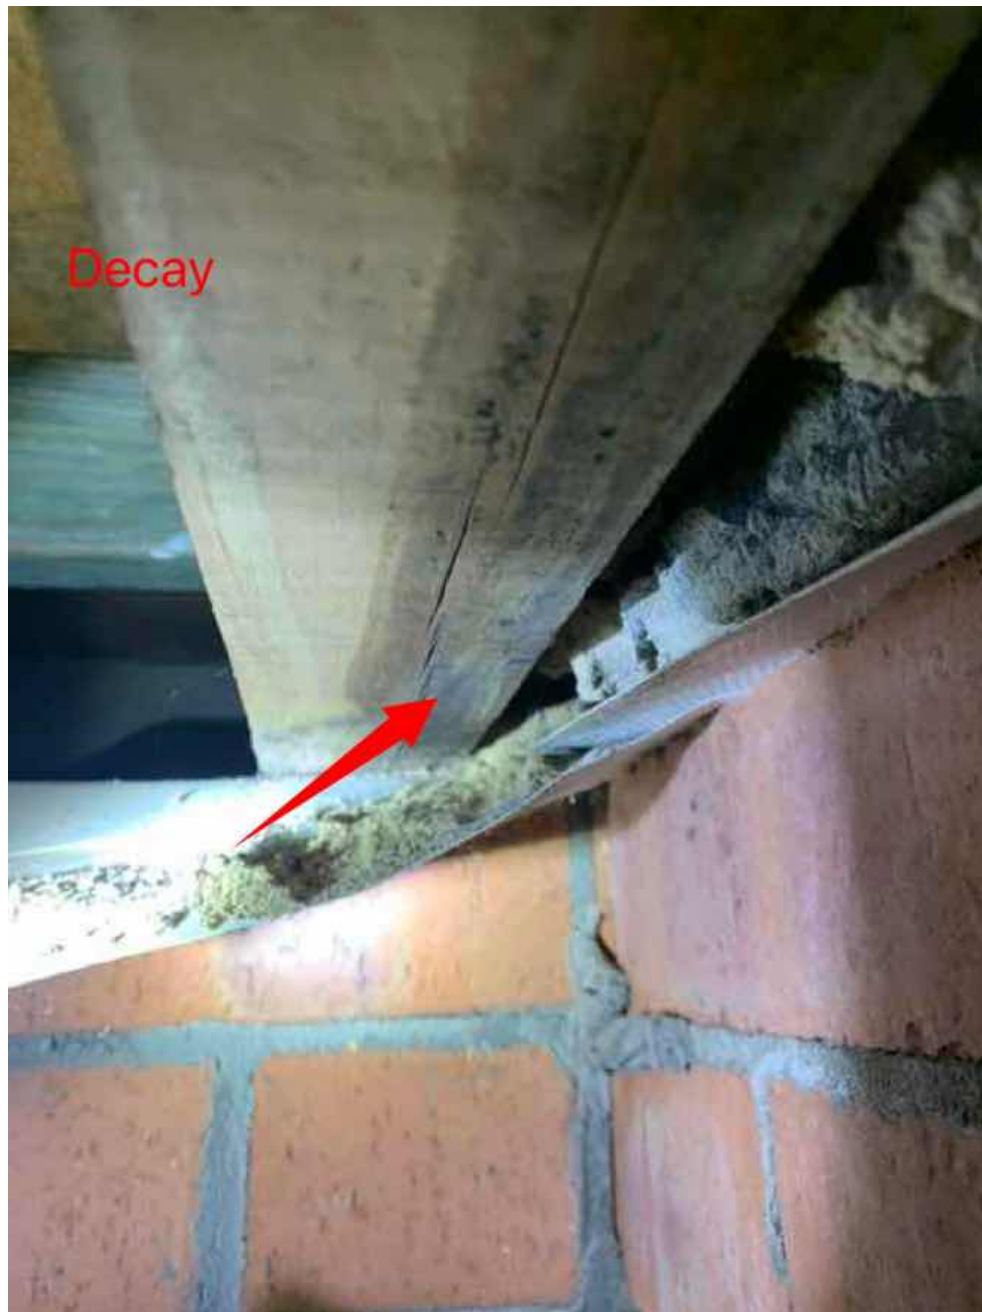
SUBFLOOR	Sub-Floor Observation.	Bearers	Bearer end unsupported not over pier support. A qualified bricklayer should be engaged for advice and recommendations.
SUBFLOOR	Sub-Floor Observation.	Bearers	Timber fungal decay evident in bearers. This appears because of the humid subfloor and poor ventilation as well as motar from the brickwork touching the timber transferring moisture. These Timbers do not require replacement if moisture issues are addressed immediately. A qualified carpenter should be engaged for advice and recommendations.

Timber fungal decay evident in to the joists. Recommendations: This is due to high humidity within the subfloor from poor ventilation and water entering the subfloor. These Timbers do not require replacement if the ventilation is addressed immediately. A qualified carpenter and bricklayer should be engaged for advice and recommendations.

Bearer end unsupported not over pier support. A qualified bricklayer should be engaged for advice and recommendations.

Timber fungal decay evident in bearers. This appears because of the humid subfloor and poor ventilation as well as mortar from the brickwork touching the timber transferring moisture. These Timbers do not require replacement if moisture issues are addressed immediately. A qualified carpenter should be engaged for advice and recommendations.

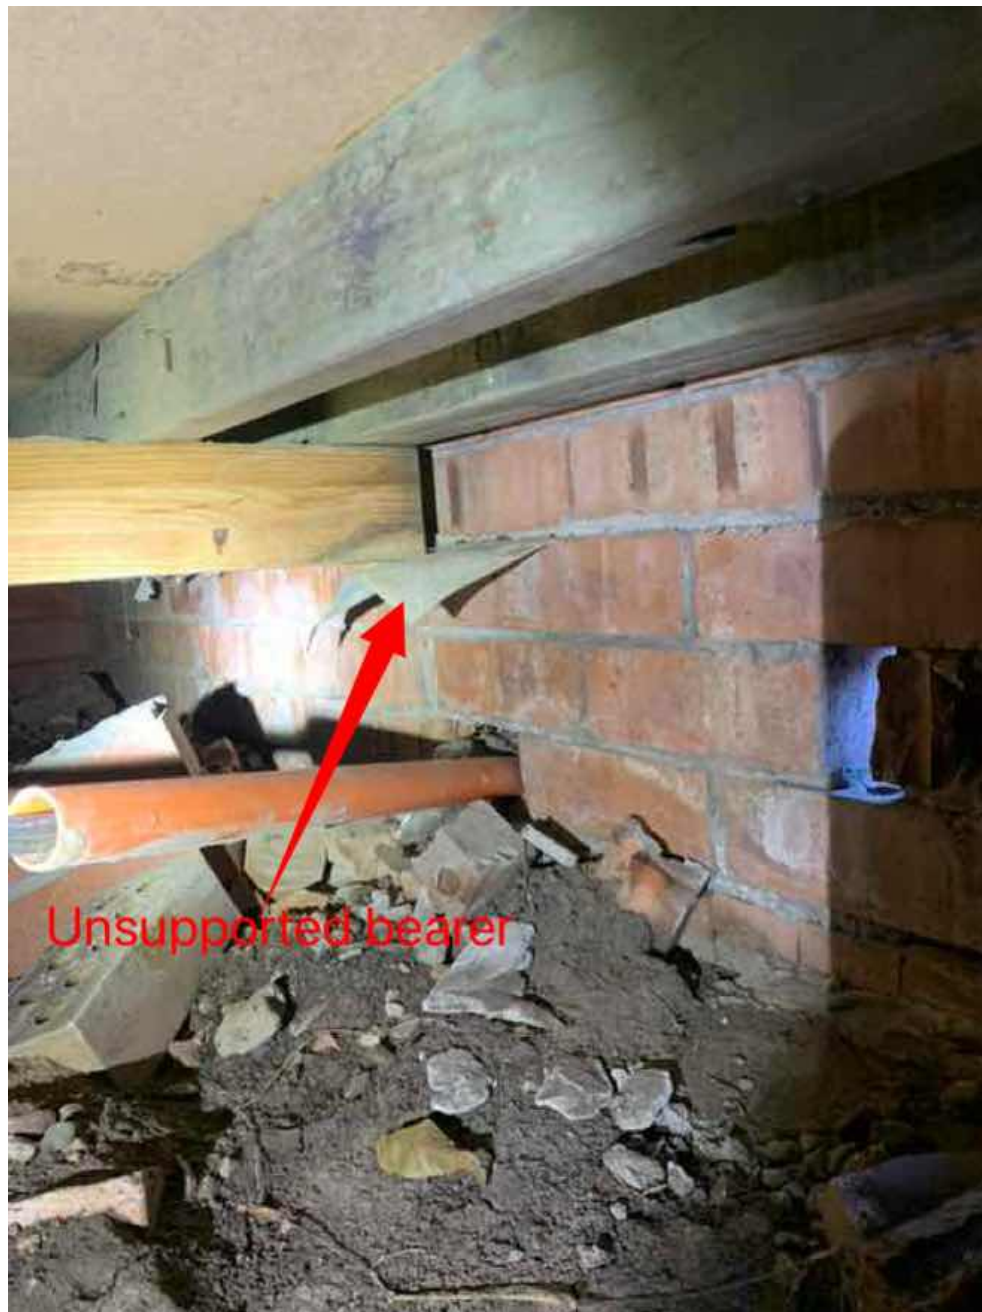
SUBFLOOR	Sub-Floor Observation.	Dampness	Dampness in sub floor soil. Damp sub floor soil should be avoided as it can cause fungal decay, mould and possibly footings problems. Note: we're ventilation is adequate and the ground level is still excessively wet or subject to frequent flooding the use of additional ventilation and sealing the ground within the subfloor with an impervious membrane (builders plastic) as specified in the National Construction Code 3.4.1.2 (e) may be an option. Recommend a qualified drainage plumber should be engaged for further advice and recommendations.
----------	------------------------	----------	---

Dampness in sub floor soil. Damp sub floor soil should be avoided as it can cause fungal decay, mould and possibly footings problems. Note: we're ventilation is adequate and the ground level is still excessively wet or subject to frequent flooding the use of additional ventilation and sealing the ground within the subfloor with an impervious membrane (builders plastic) as specified in the National Construction Code 3.4.1.2 (e) may be an option. Recommend a qualified drainage plumber should be engaged for further advice and recommendations.
