Inspection Report

UNCOVER
BUILDING AND PEST INSPECTIONS

1 Sample Street, Sampletown, NSW, 2280

Pest And Building Inspection

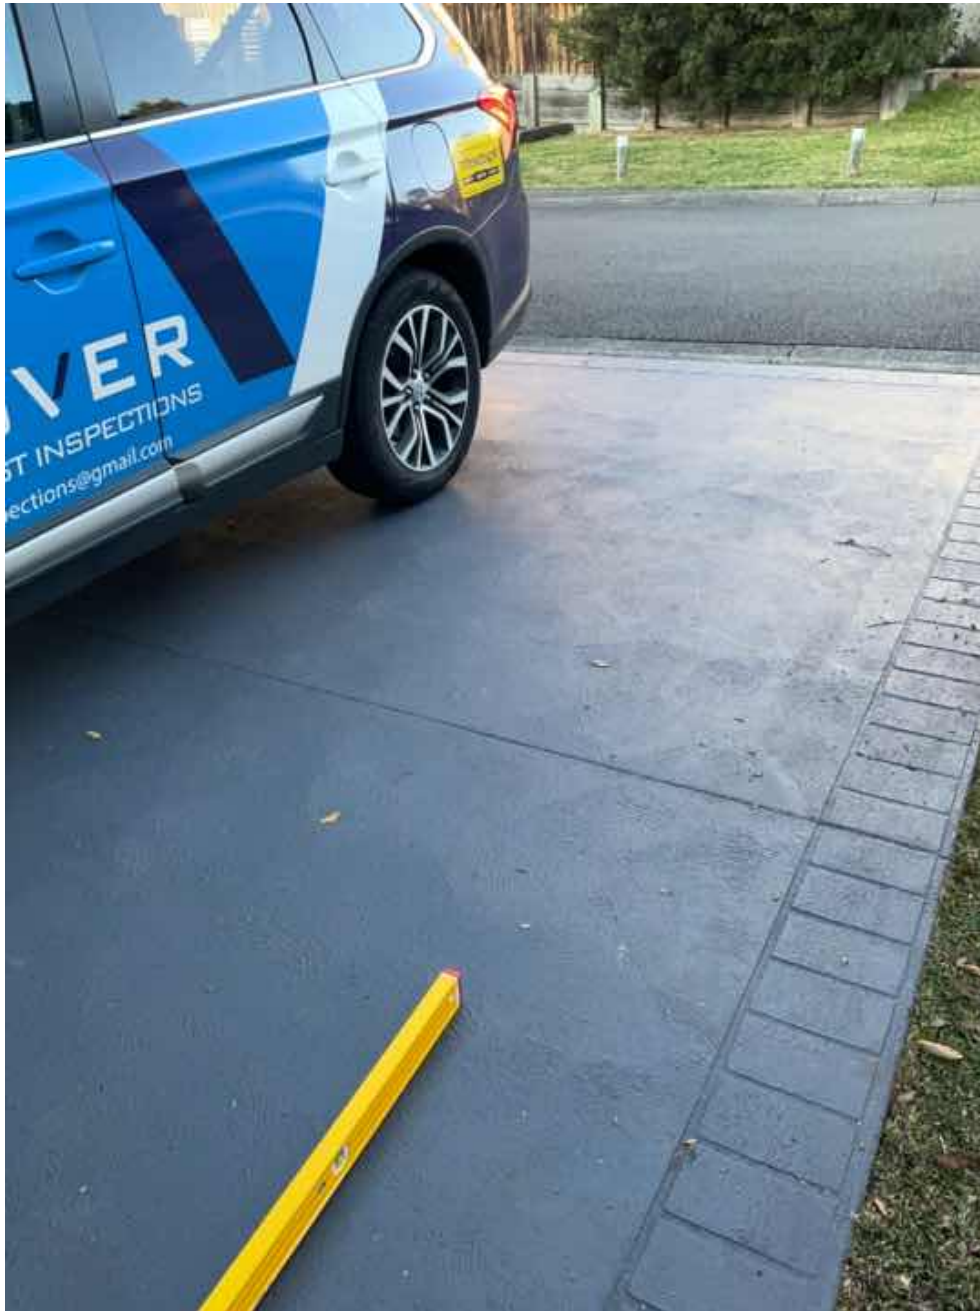
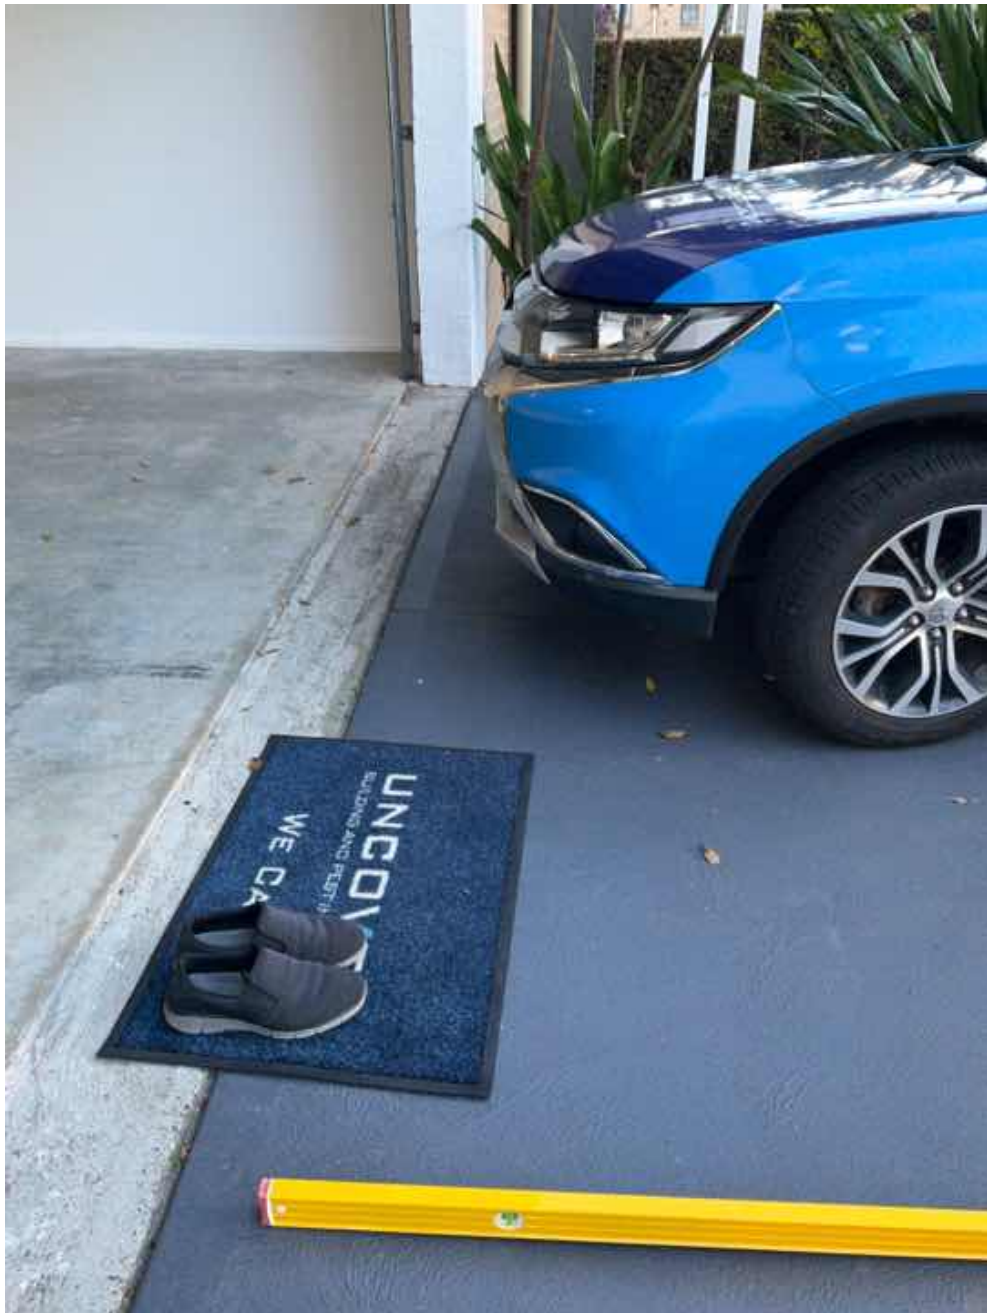
Driveway Condition

Common cracks were observed on the driveway. Whilst these cracks appeared to be typical at the time of inspection, we recommend you monitor these cracks and if worsening occurs contact a concreter for further advice.

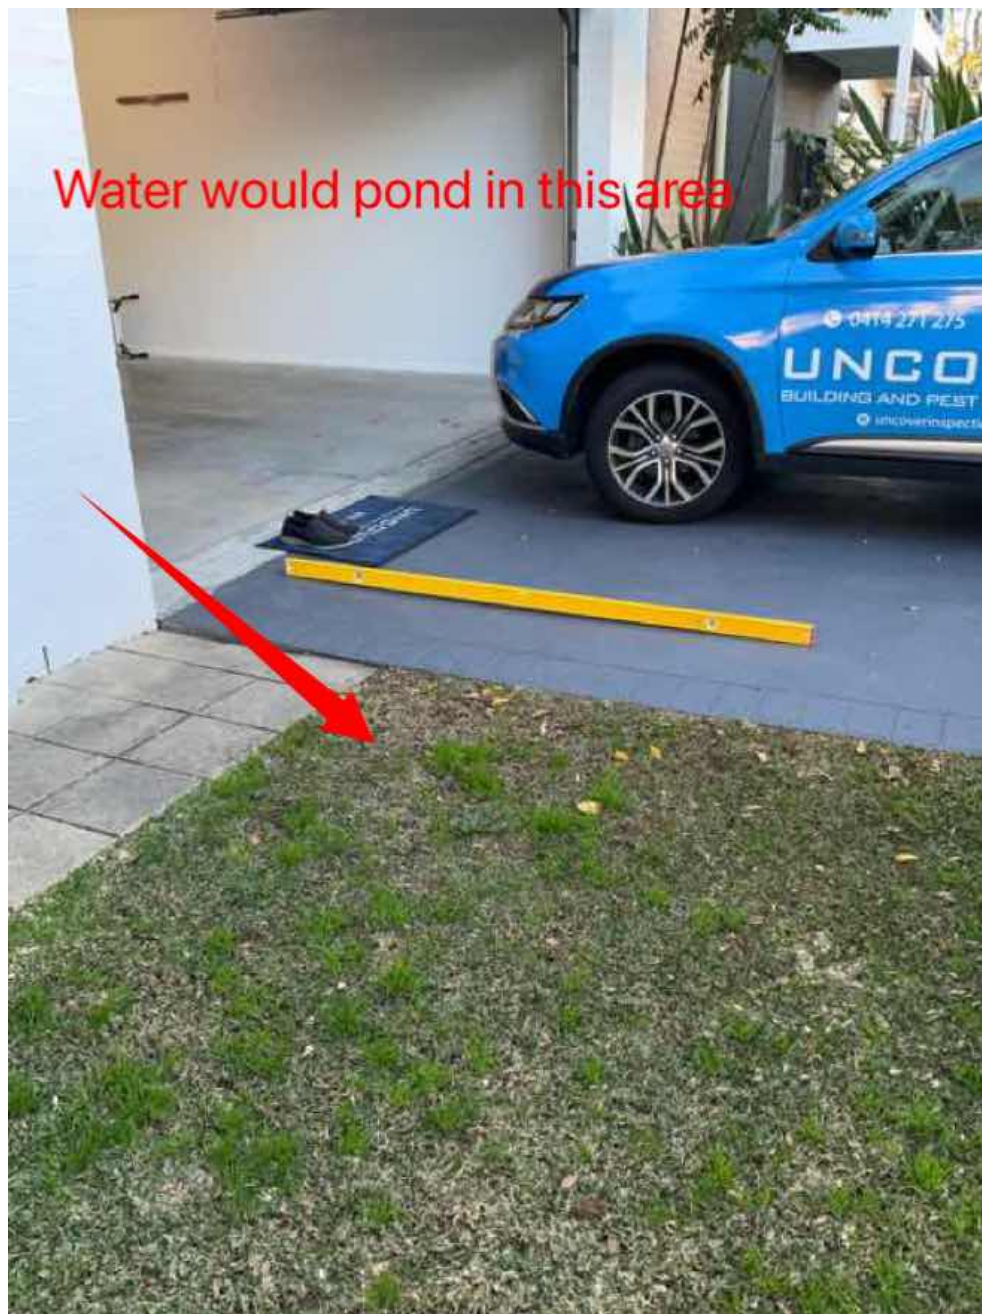
Drains

The drain to the front of the property is not sufficient to remove water away from the front of the property. Water is flowing into the subfloor. Recommend a qualified landscaper to further advise.

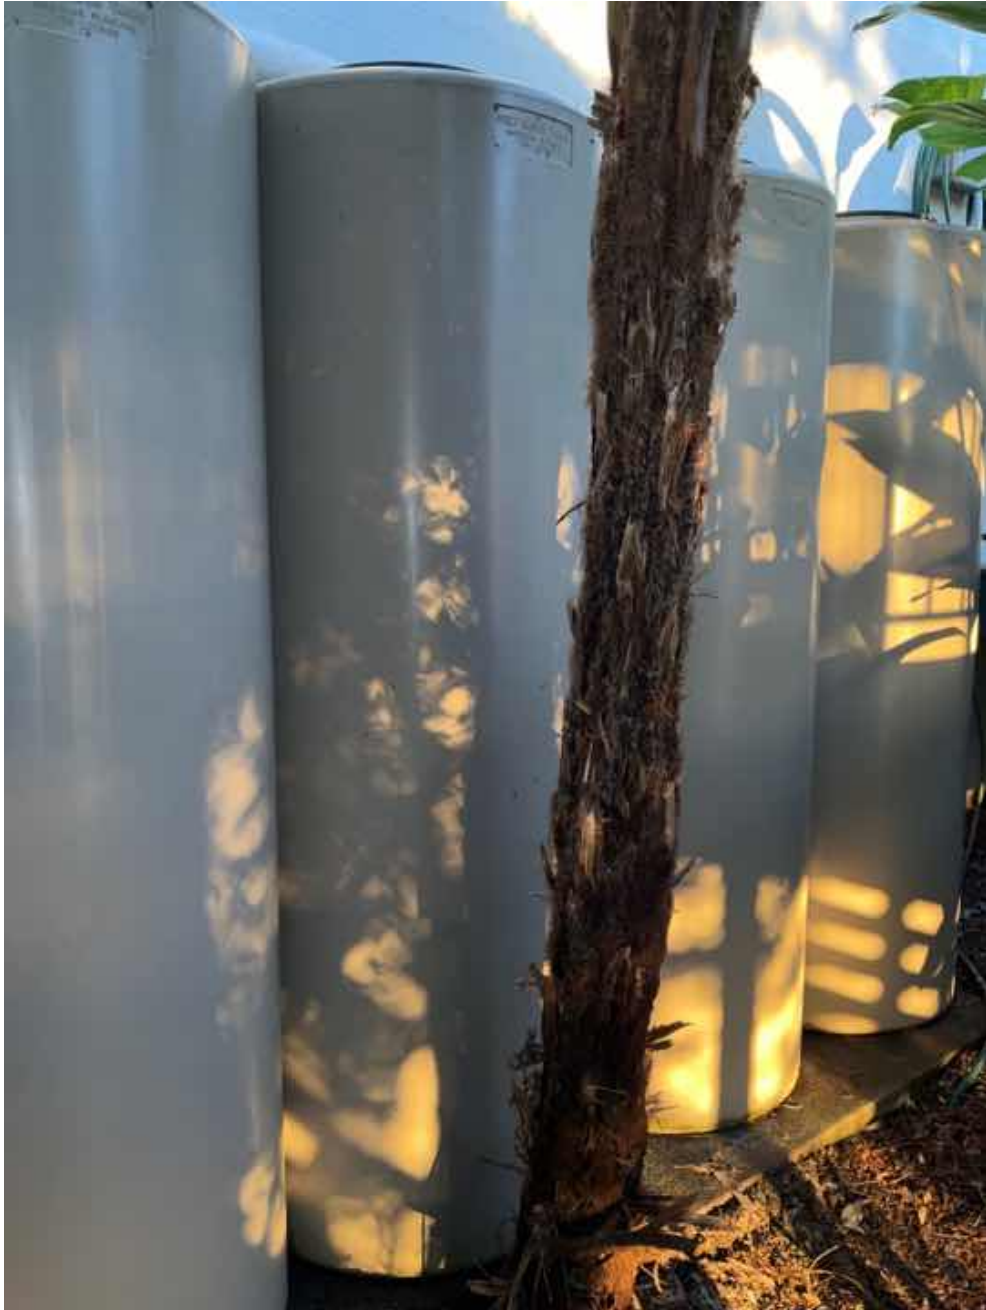
Water Tank Condition

There is an open hole in the side of the last water tank. These tanks will not hold water. Recommend a qualified plumber to further advise. These water tanks have possibly never held water. The ground around this area is extremely water logged.

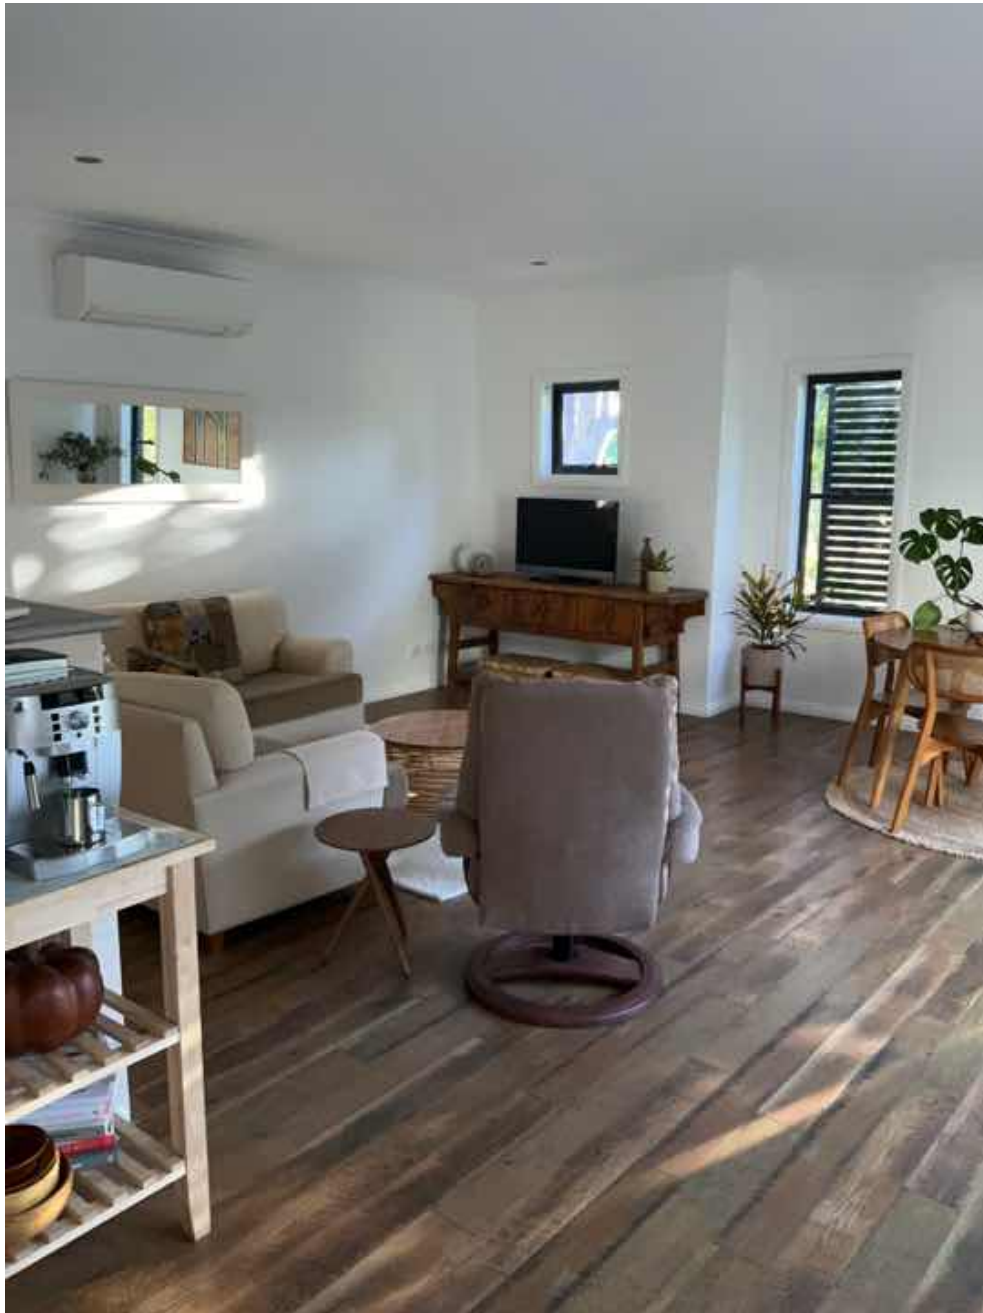
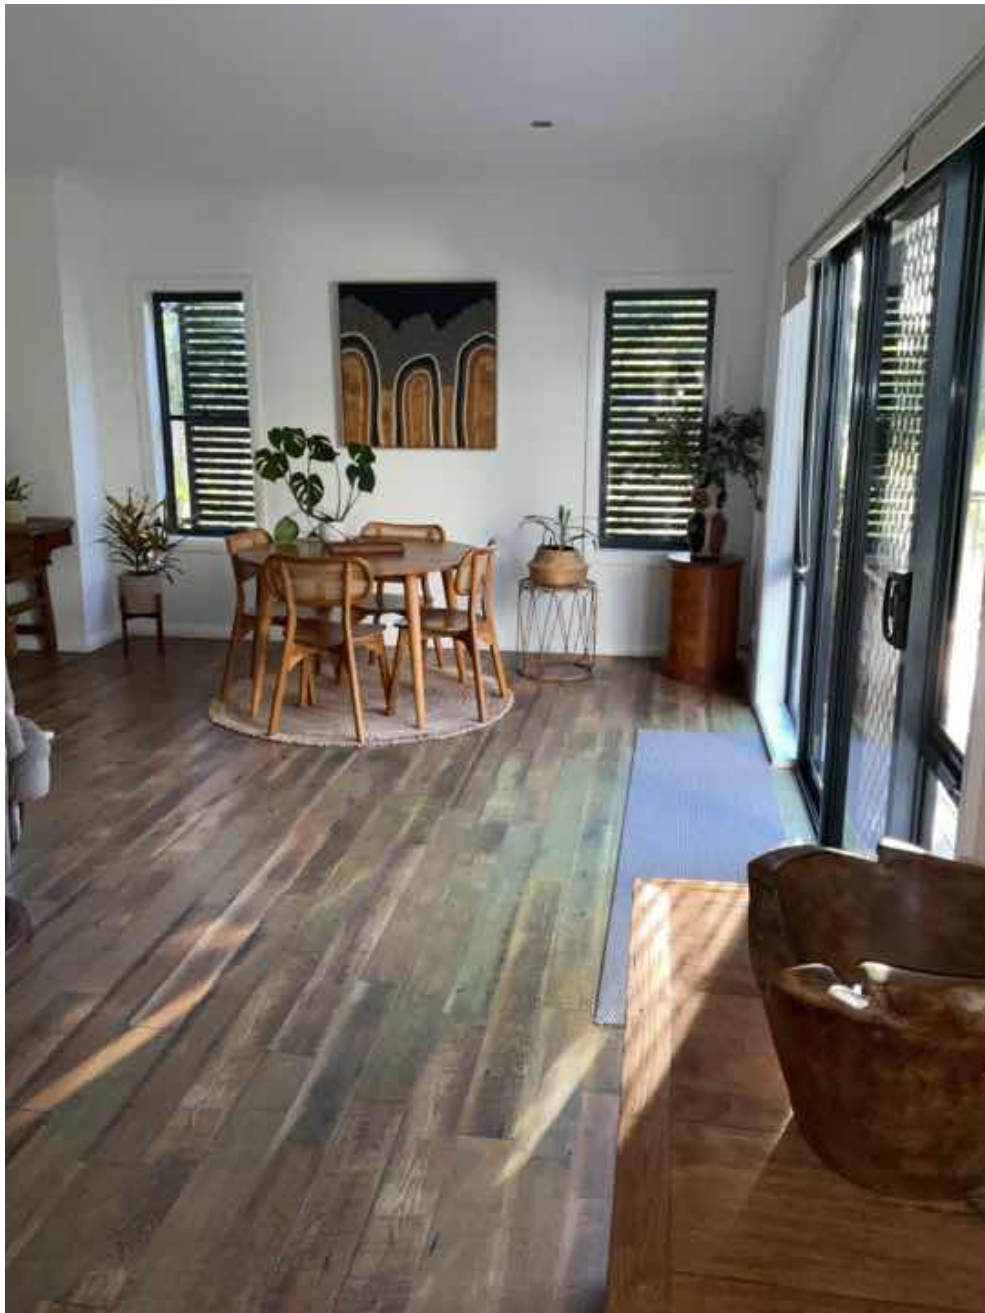
Walls

Architrave and/or skirting moisture damage. High moisture readings taken during the inspection. This appears to be related to the dampness within the subfloor and mortar blocking the brick cavity and transferring moisture onto the bearer. Recommend a qualified carpenter for further advice and repair.

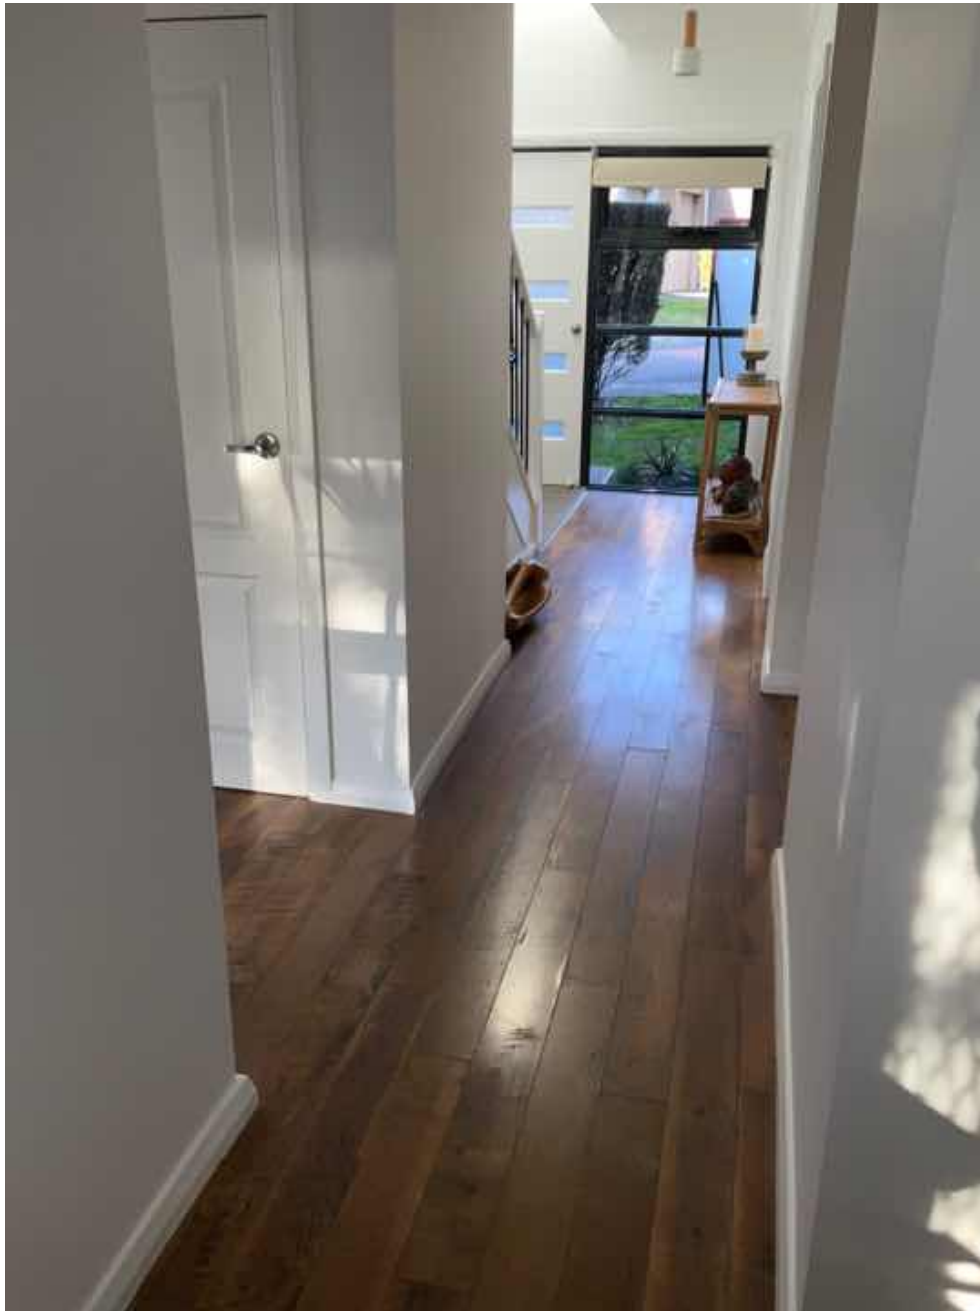
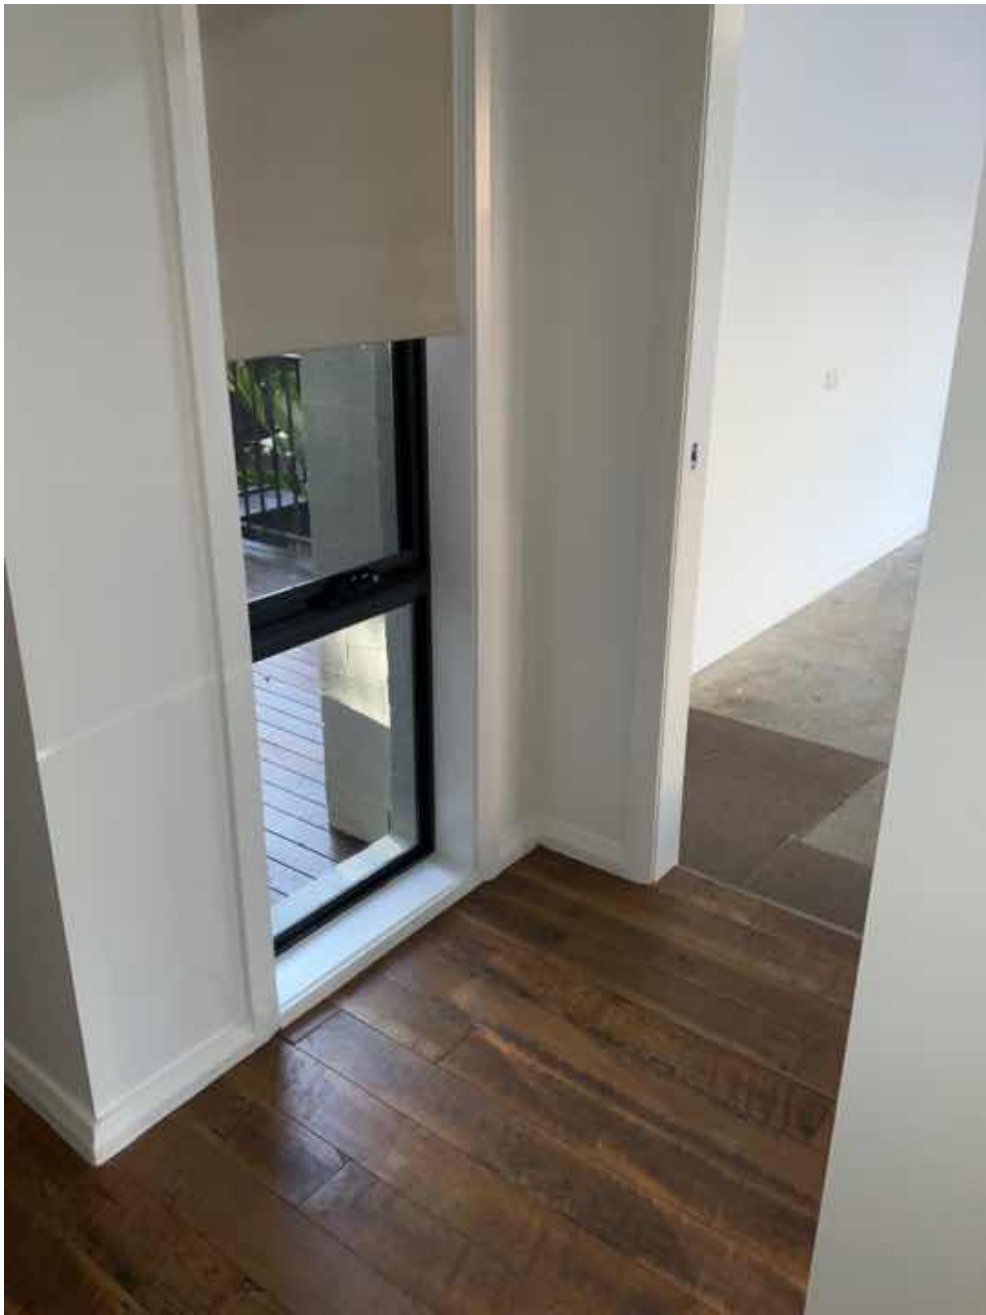
Windows

Timber fungal decay observed in window/frame. High moisture readings taken at the time of the inspection. This is most probably linked to a leaking window, architraves, skirtings and flooring in this area are swollen from moisture damage. Recommend a carpenter for further advice and repairs.

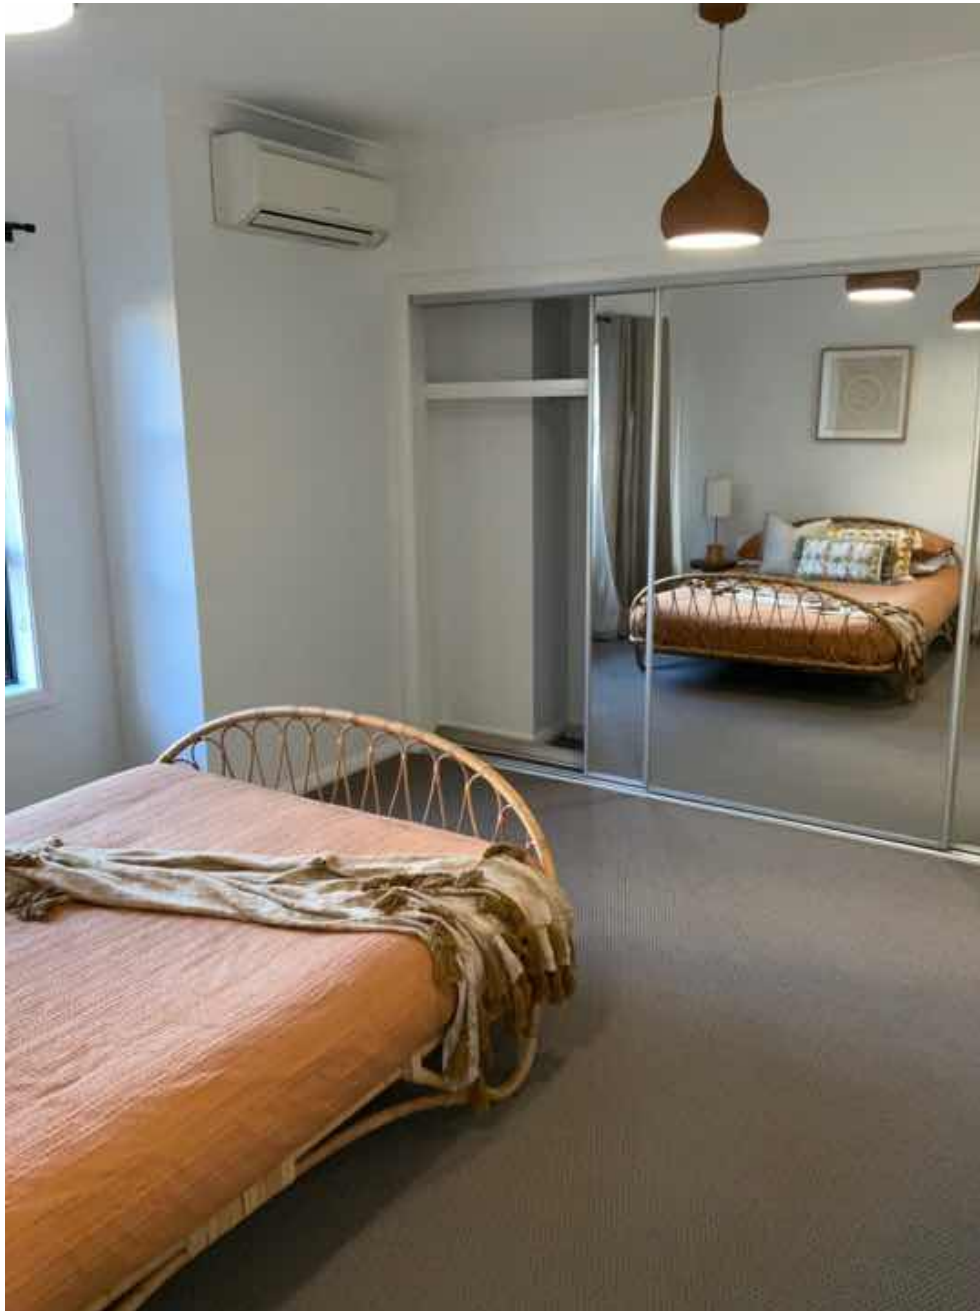
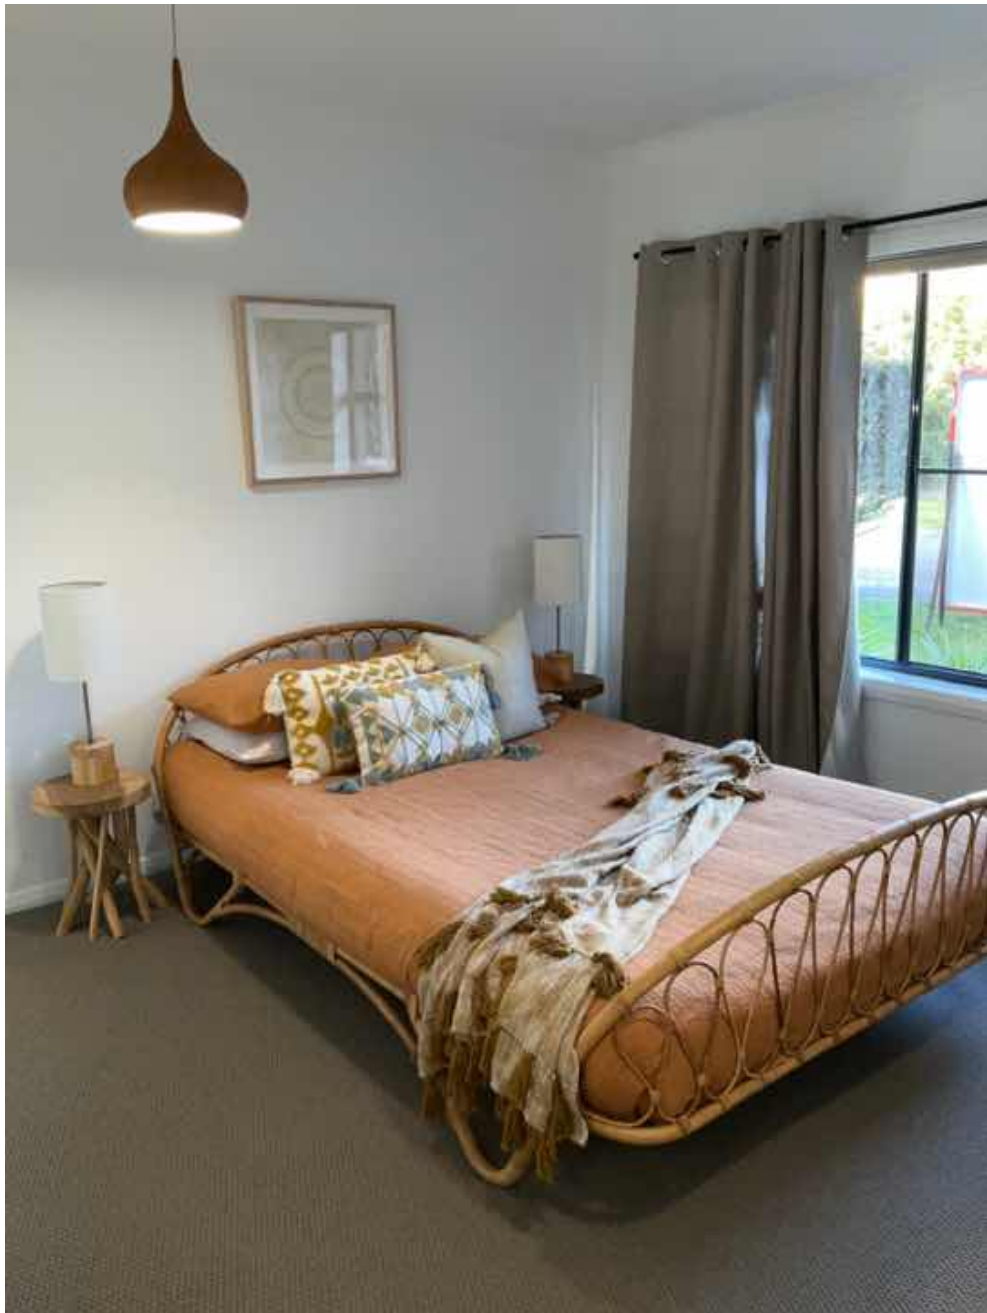
INTERIORS	Bedroom 1	Wardrobe	There is moisture damage in the wardrobe. High moisture readings taken. Appear to be a leak from the sewer stack pipe, upstairs bathroom or a leaking pipe. Recommend an invasive inspection by putting a hole in the plasterboard and inserting a camera. Being in a wardrobe a snap vent might be able to be cut into the plasterboard to provide an inspection hole.

There is moisture damage in the wardrobe. High moisture readings taken. Appear to be a leak from the sewer stack pipe, upstairs bathroom or a leaking pipe. Recommend an invasive inspection by putting a hole in the plasterboard and inserting a camera. Being in a wardrobe a snap vent might be able to be cut into the plasterboard to provide an inspection hole.

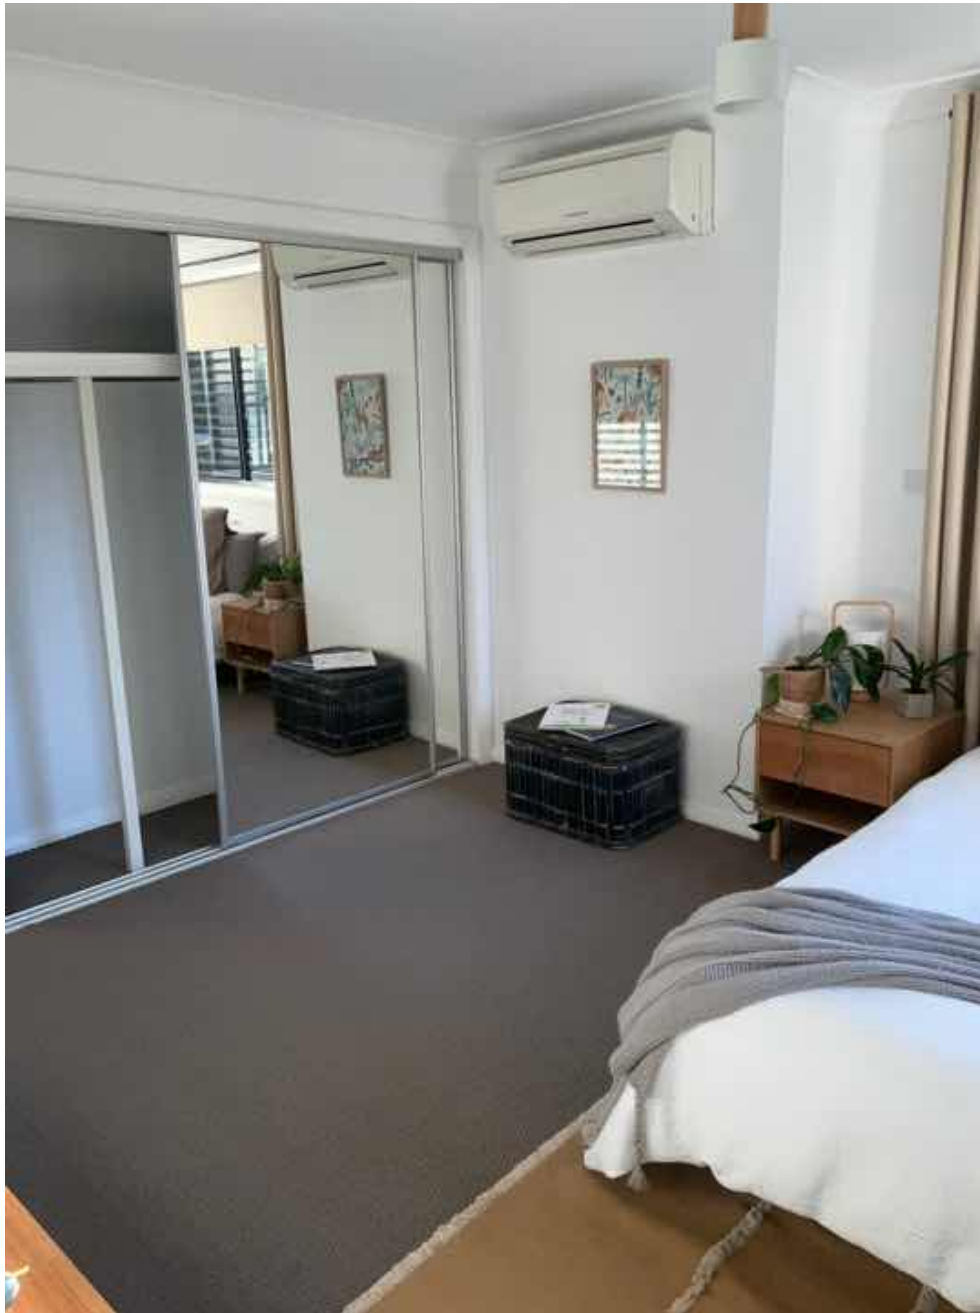
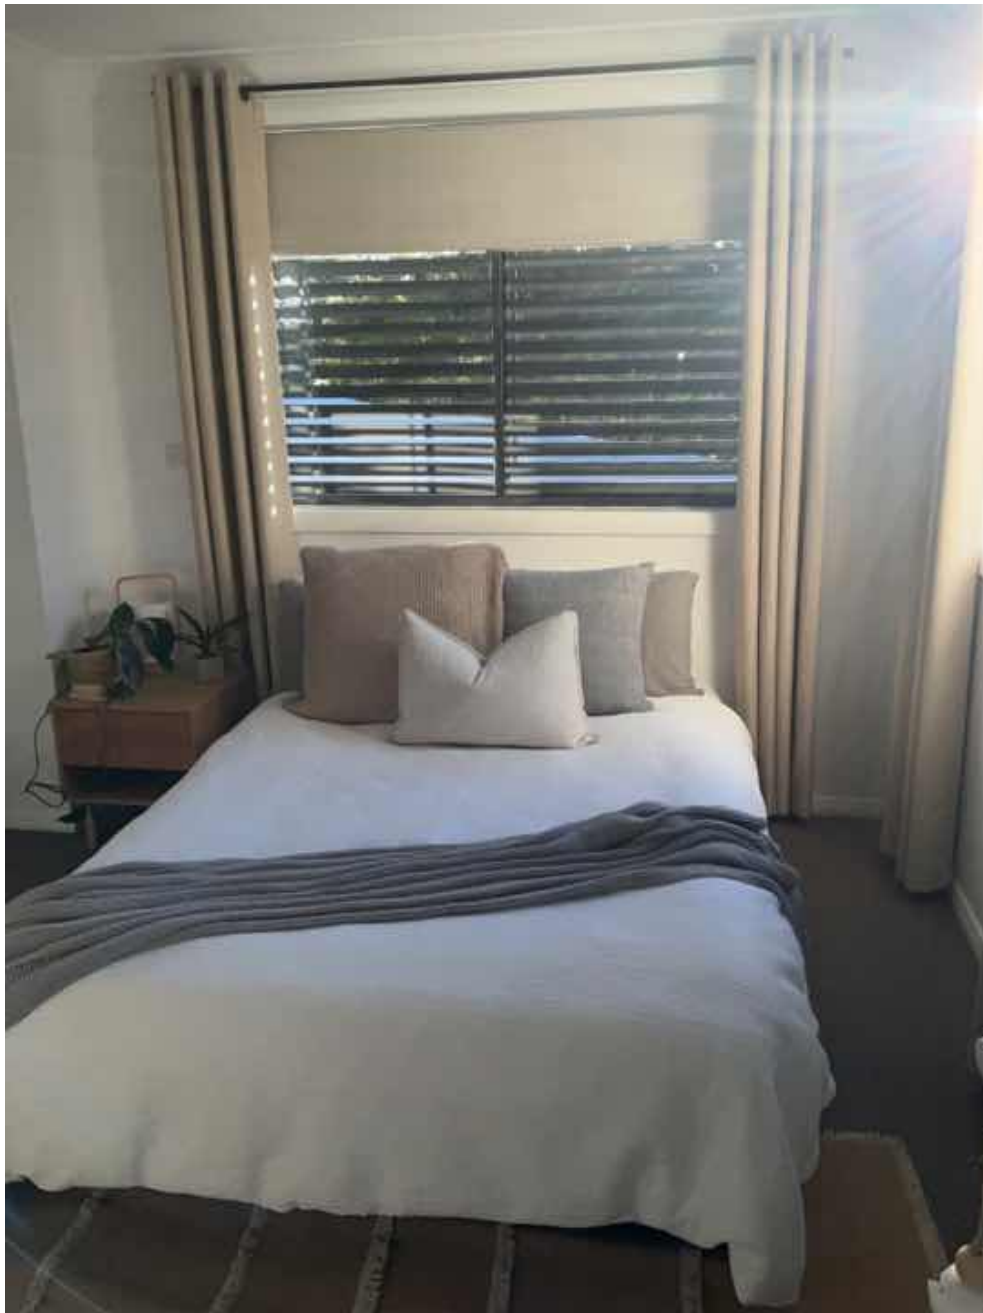
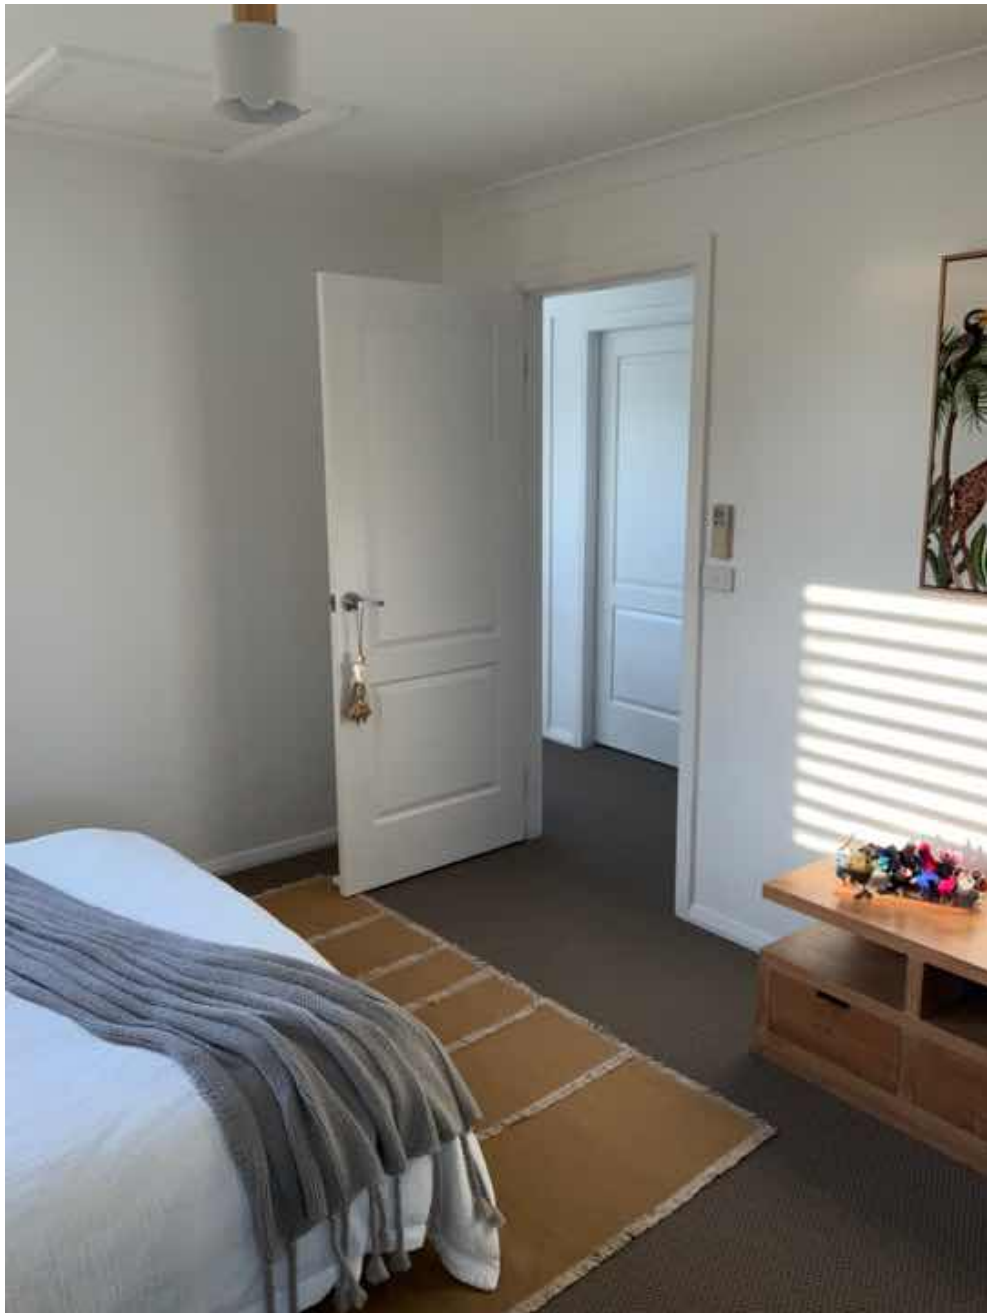
INTERIORS	Bedroom 2	Windows	Timber fungal decay observed in window/frame. High moisture readings taken. Related to a leaking window. The decay has been painted over. Recommend a carpenter for further advice and repairs.
INTERIORS	Bedroom 3	Walls	Architrave and/or skirting moisture damage. High moisture readings taken during the inspection. This appears to be related to the the sliding door installation leaking. Recommend a qualified carpenter for further advice and repair. Note: This damage does not happen from getting wet once from a door left open. This has been getting wet for a long period of time.
BATHROOM(S)	Bathroom 1	Door	The architrave has signs of water damage/swollen. High moisture readings taken at time of inspection. Appears to be related to a membrane failure in the shower area. The floors appear to have had a temporary waterproofing treatment to the floorswithin this room. There is epoxy grout between the floor tiles but not under the vanity, indicating that it has been installed as a patch or repair. Recommend discussing with the current owner.

Timber fungal decay observed in window/frame. High moisture readings taken. Related to a leaking window. The decay has been painted over. Recommend a carpenter for further advice and repairs.

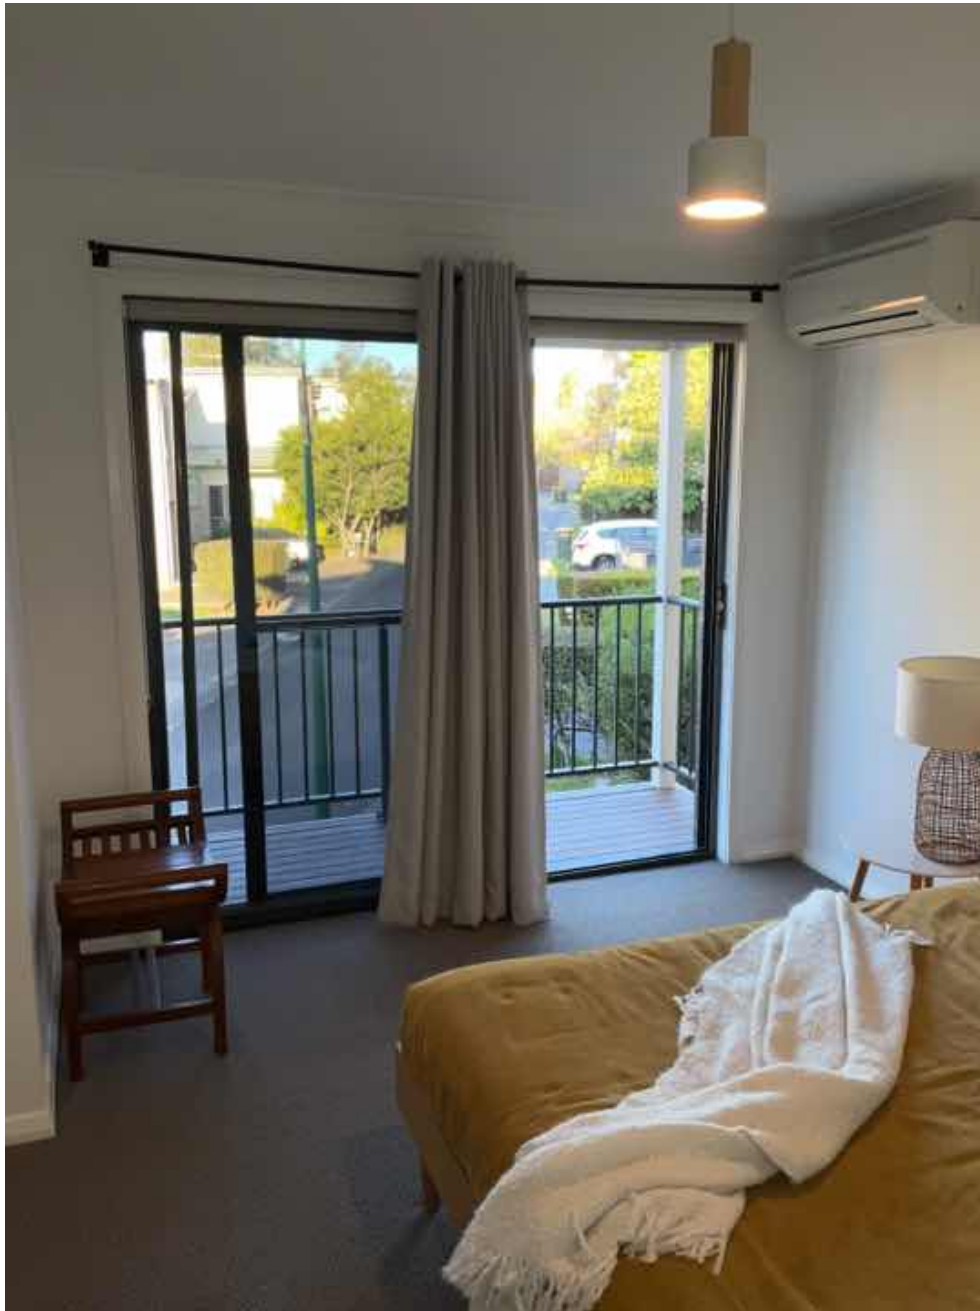
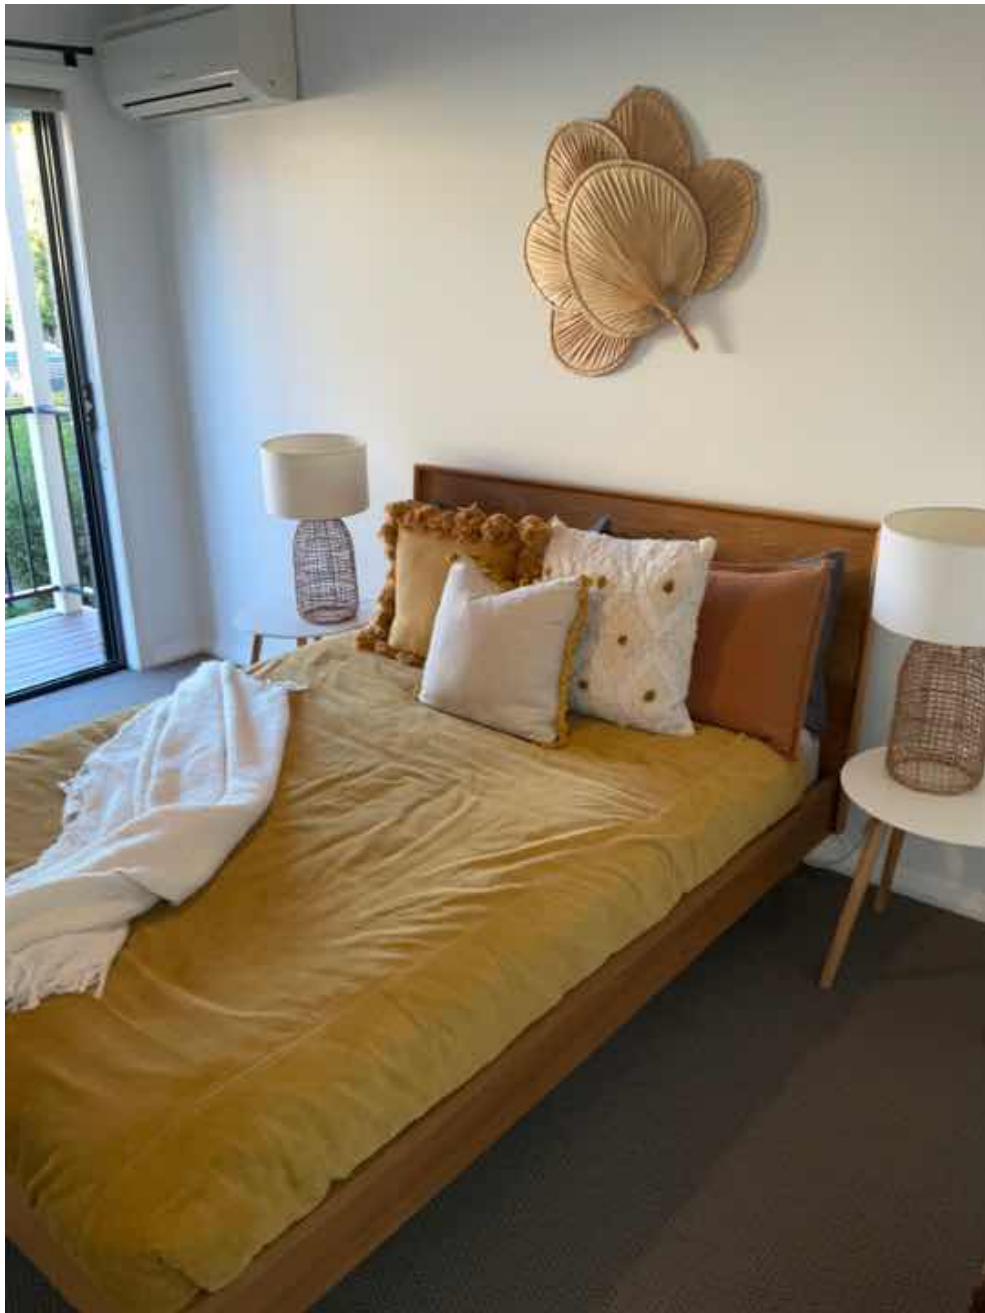
Walls

Architrave and/or skirting moisture damage. High moisture readings taken during the inspection. This appears to be related to the the sliding door installation leaking. Recommend a qualified carpenter for further advice and repair. Note: This damage does not happen from getting wet once from a door left open. This has been getting wet for a long period of time.

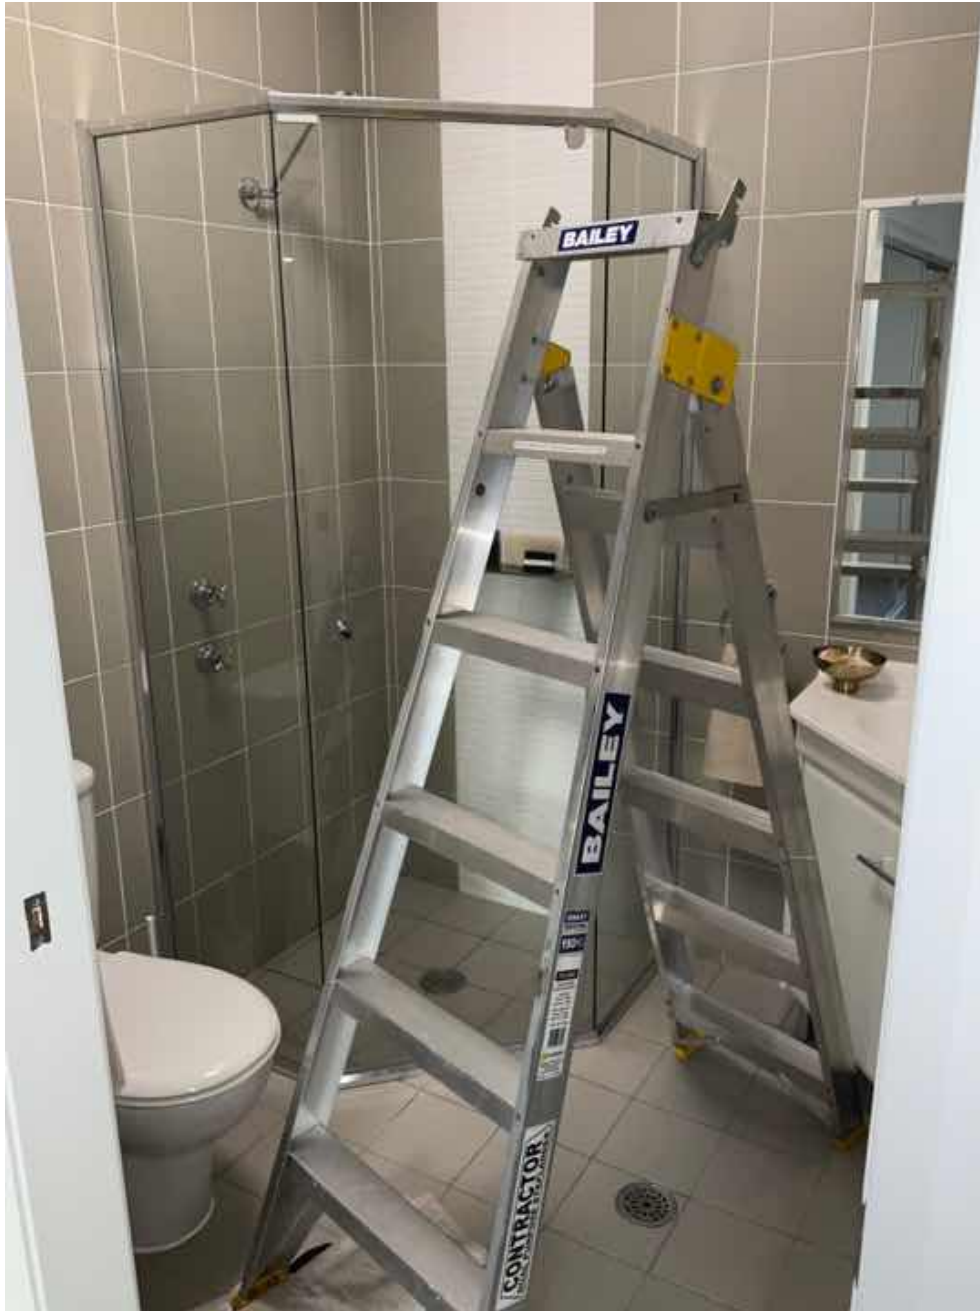
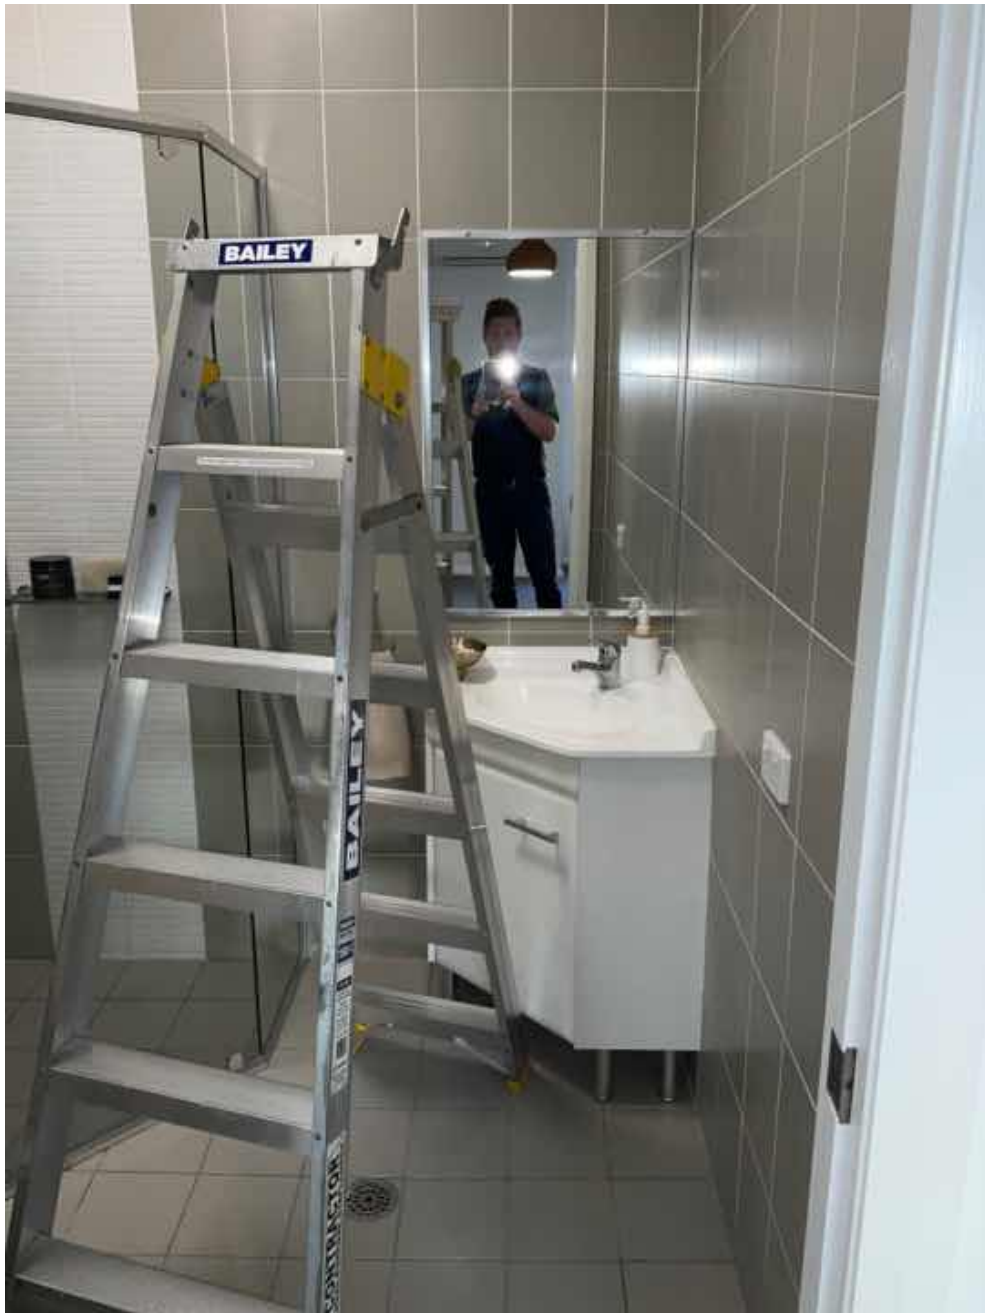
Door

The architrave has signs of water damage/swollen. High moisture readings taken at time of inspection. Appears to be related to a membrane failure in the shower area. The floors appear to have had a temporary waterproofing treatment to the floors within this room. There is epoxy grout between the floor tiles but not under the vanity, indicating that it has been installed as a patch or repair. Recommend discussing with the current owner.
