Inspection Report

UNCOVER
BUILDING AND PEST INSPECTIONS

1 Sample Street, Sampletown, NSW, 2280

Pest And Building Inspection

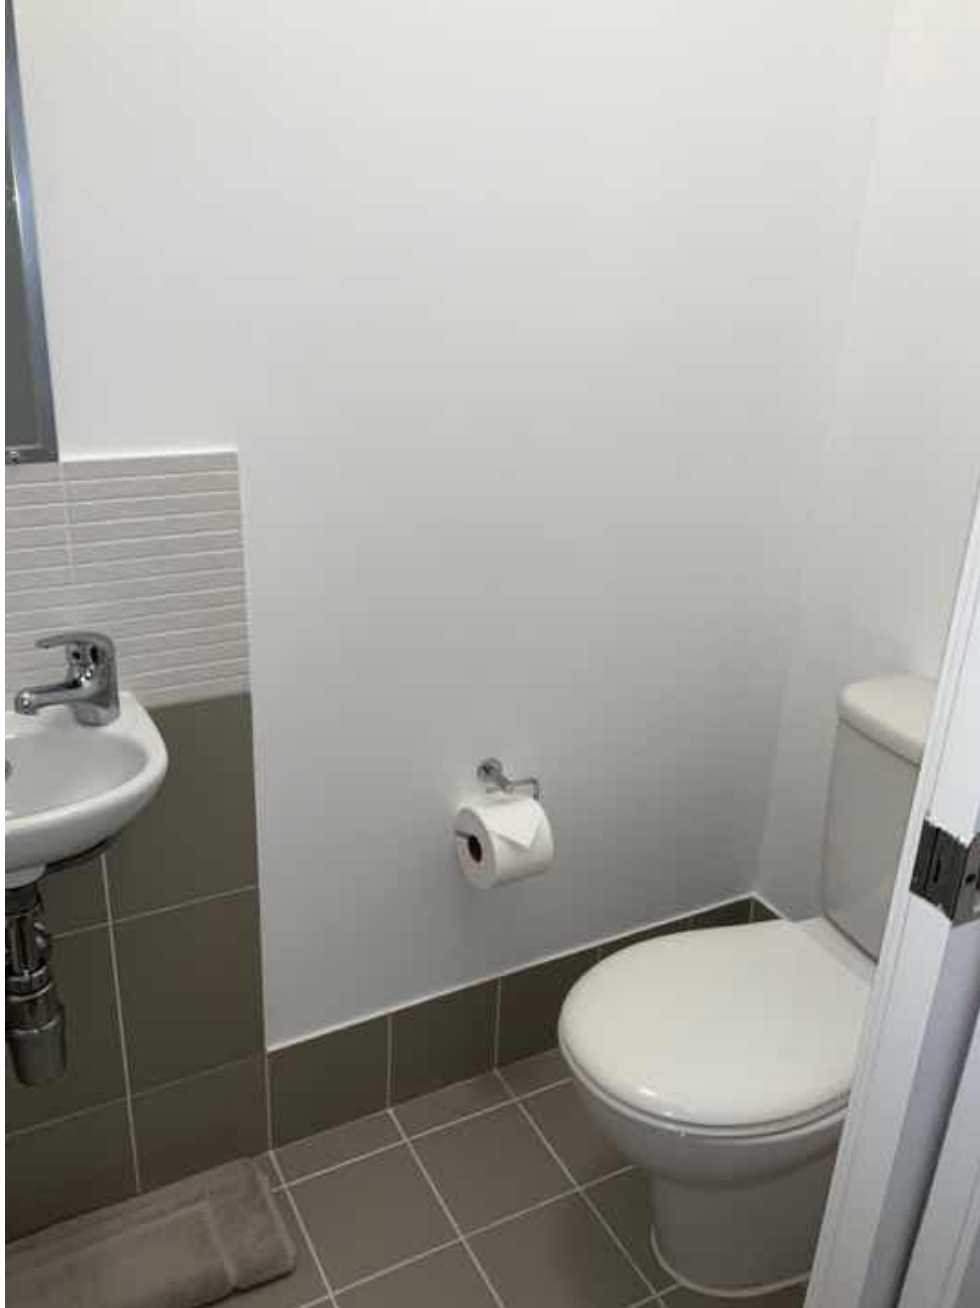
Vanity/Sink/Taps

The push plug does not function. Recommend a qualified plumber to replace as deemed necessary.

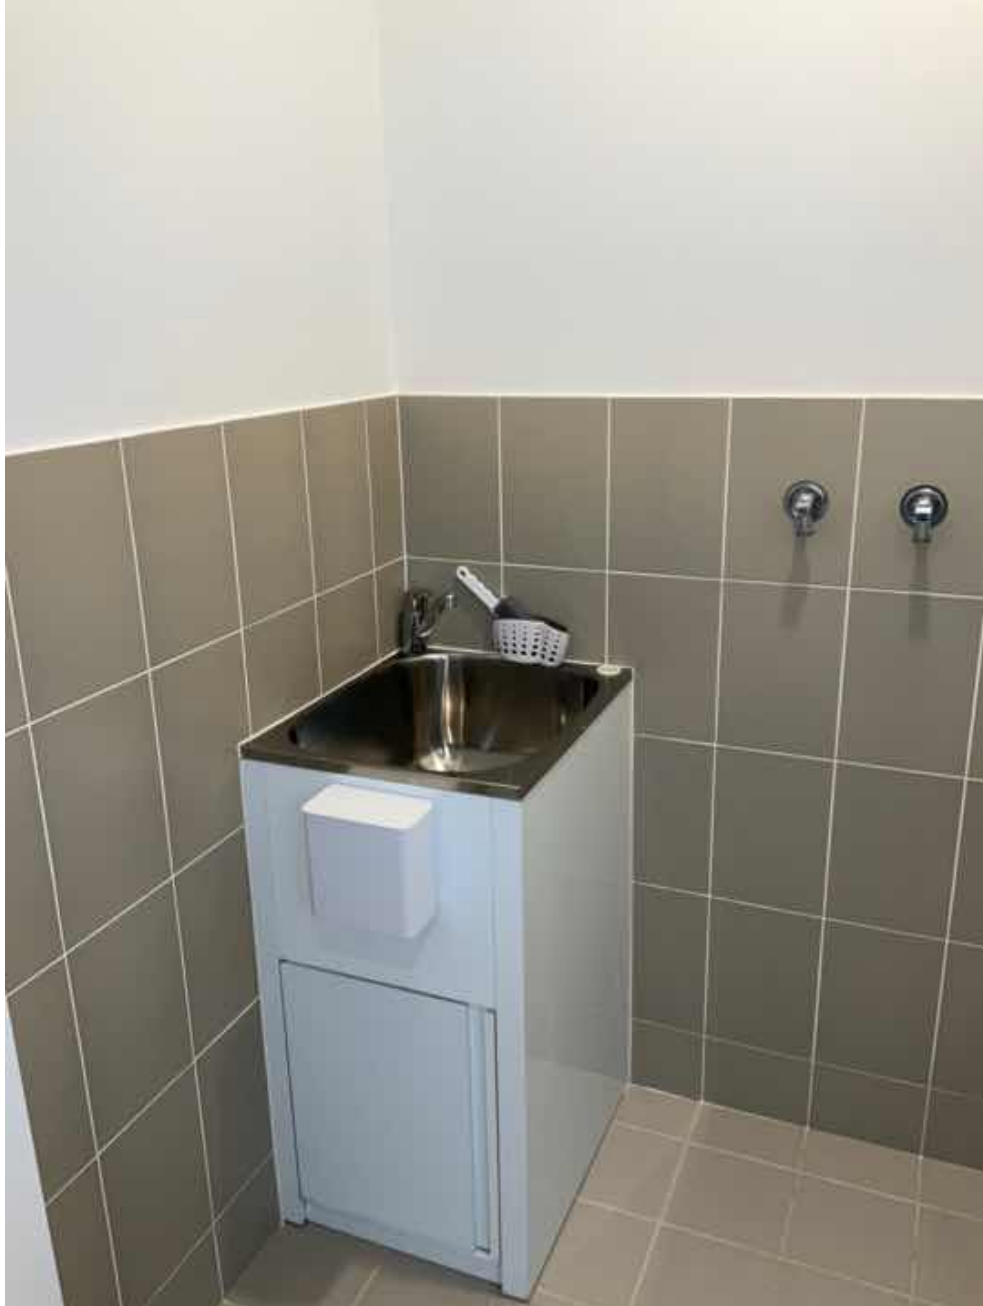
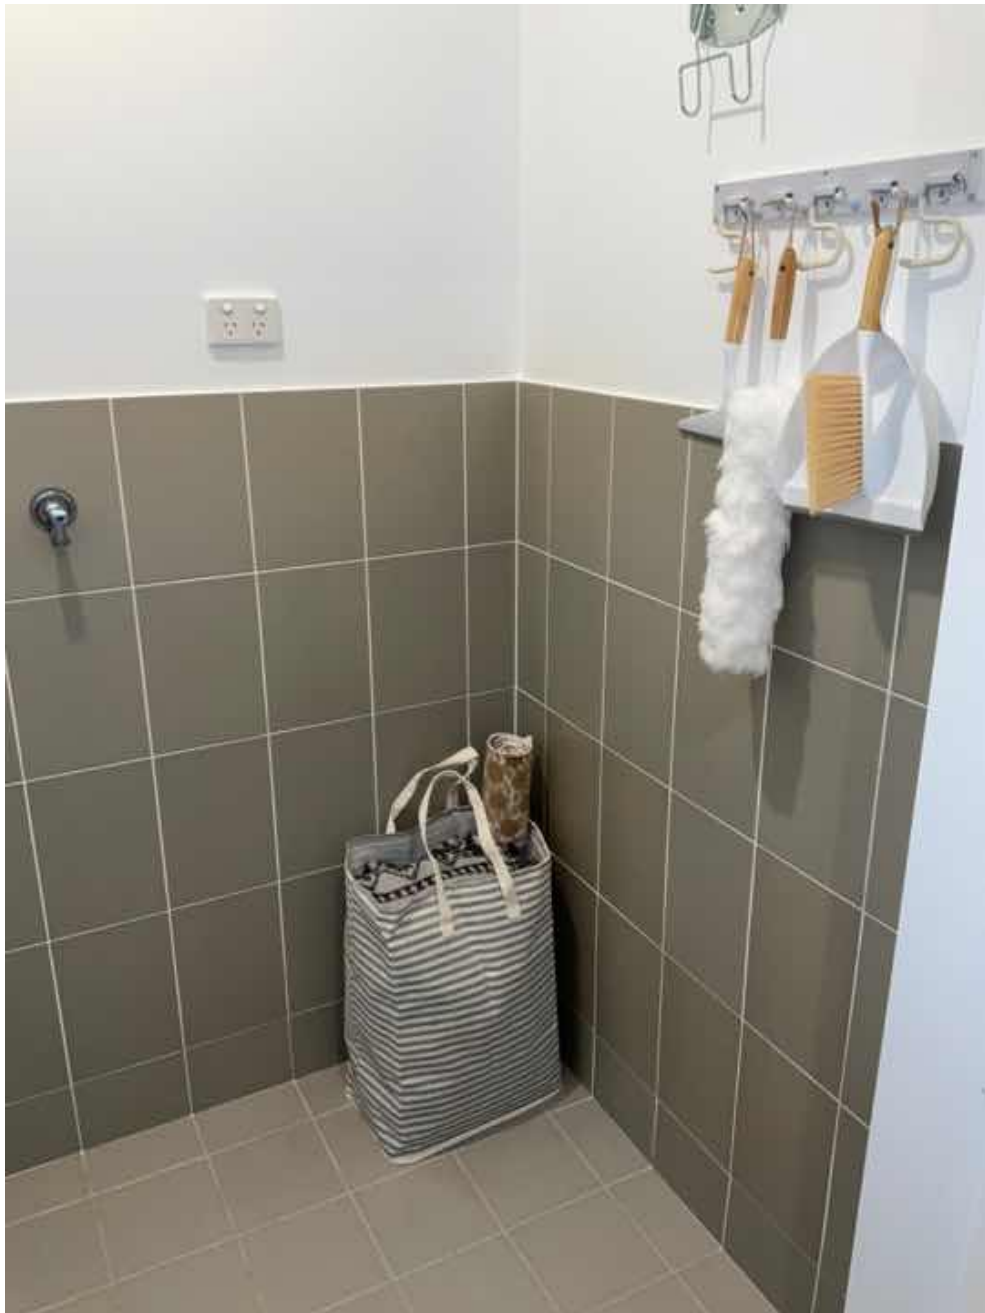
Moisture damage to the bottom of the door. Recommend a qualified carpenter to repair as deemed necessary.

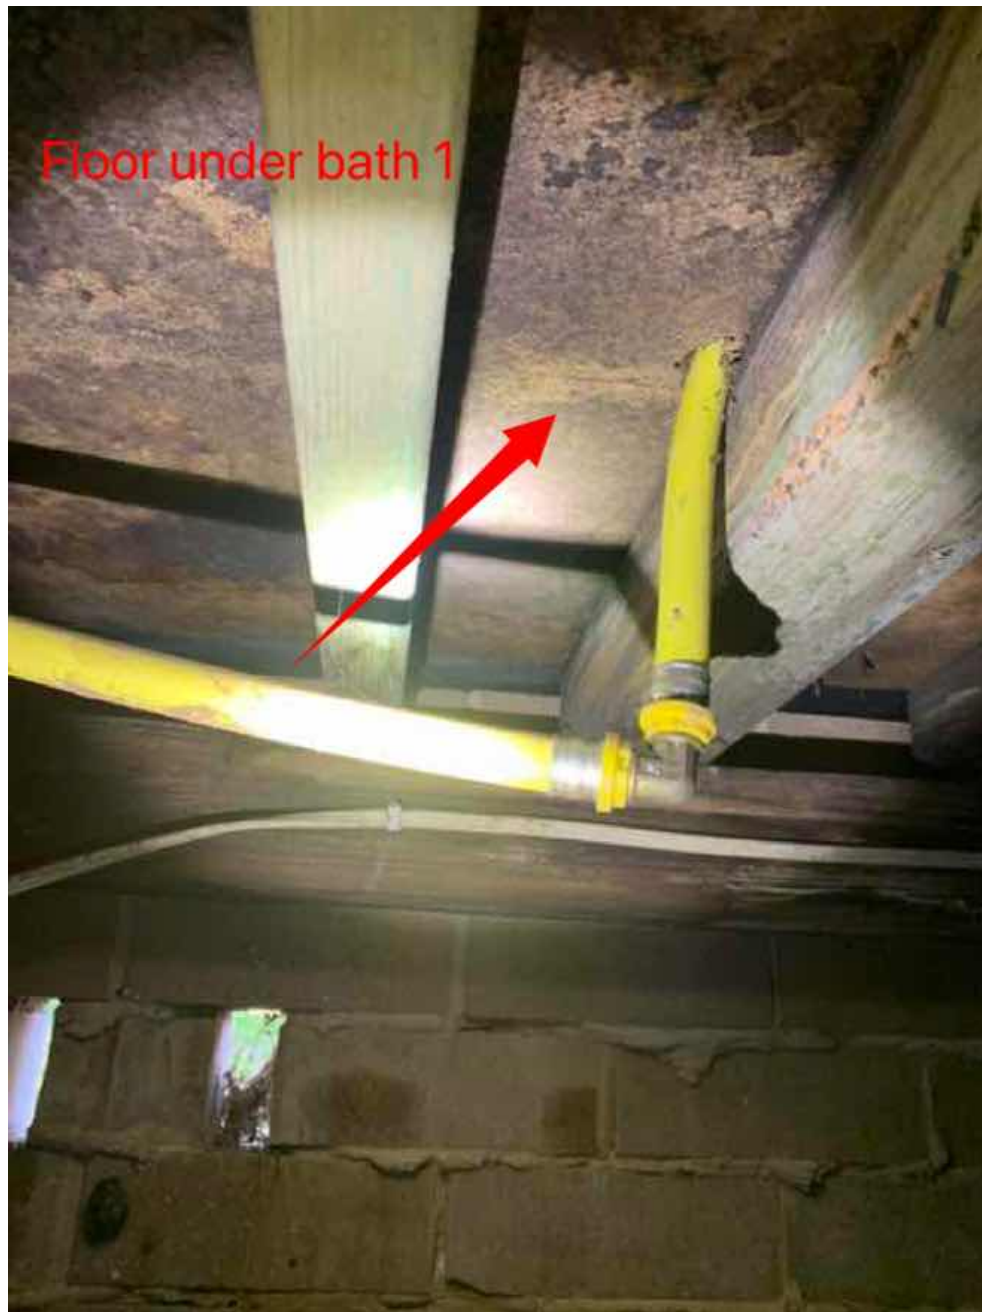
Timber fungal decay evident in to the joists. Recommendations: This is due to high humidity within the subfloor from poor ventilation and water entering the subfloor. These Timbers do not require replacement if the ventilation is addressed immediately. A qualified carpenter and bricklayer should be engaged for advice and recommendations.

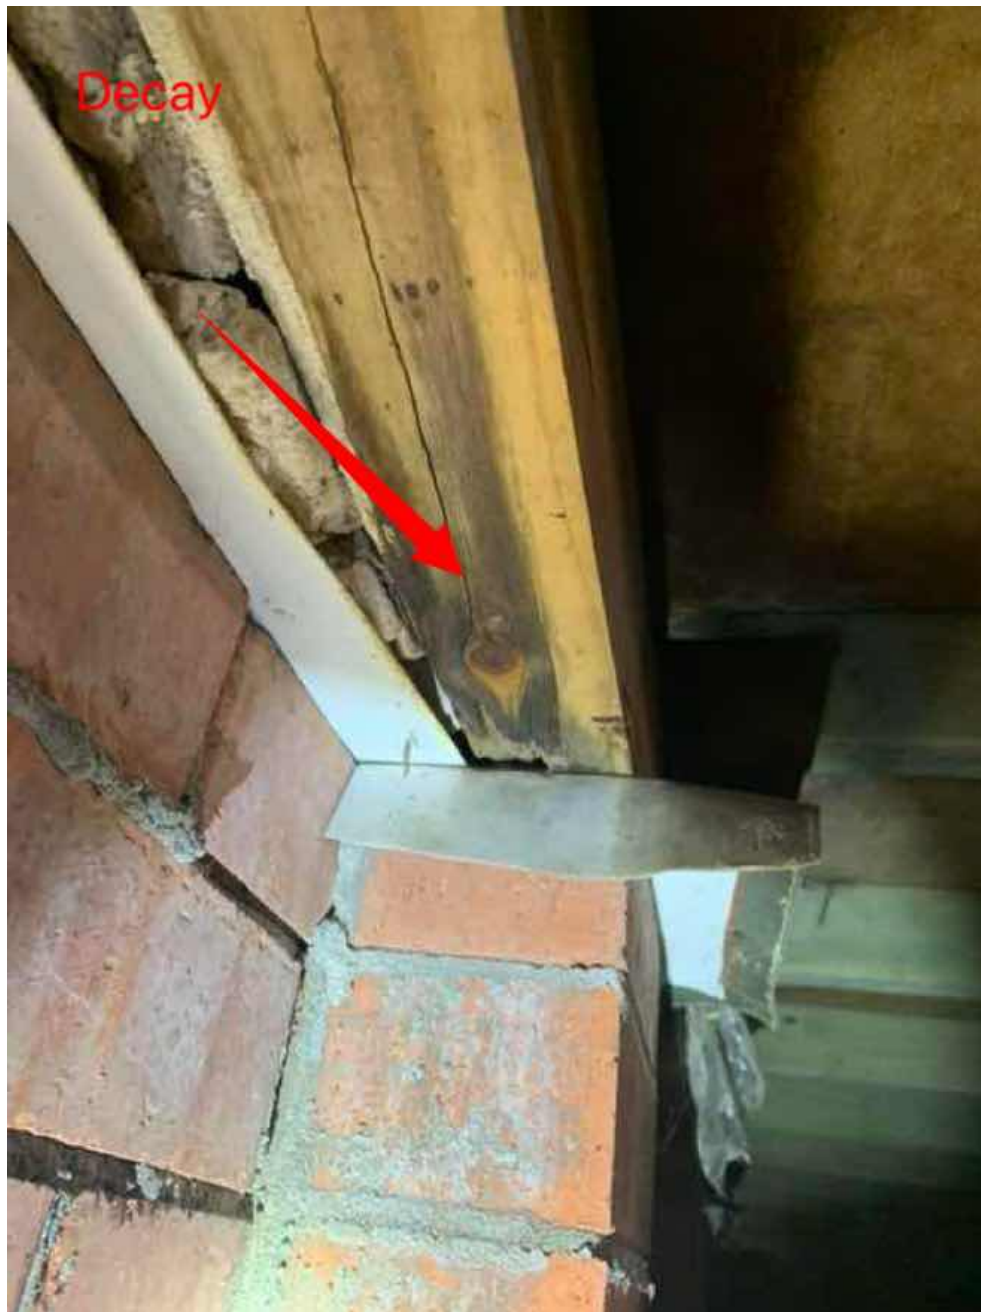
Dampness in sub floor soil. Damp sub floor soil should be avoided as it can cause fungal decay, mould and possibly footings problems. Note: we're ventilation is adequate and the ground level is still excessively wet or subject to frequent flooding the use of additional ventilation and sealing the ground within the subfloor with an impervious membrane (builders plastic) as specified in the National Construction Code 3.4.1.2 (e) may be an option. Recommend a qualified drainage plumber should be engaged for further advice and recommendations.

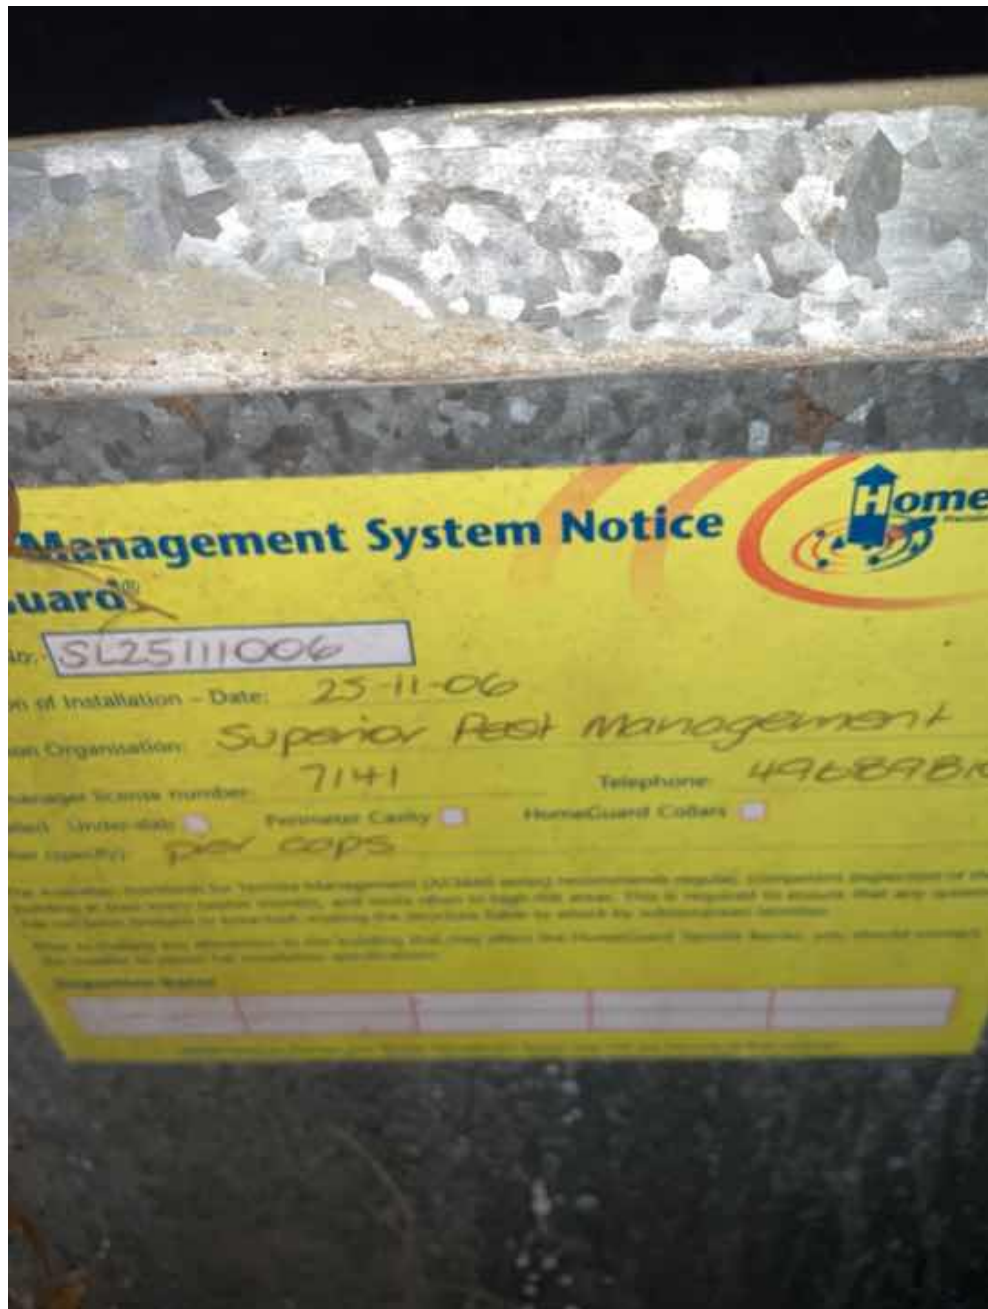
Yes, a durable notice was found in the meter-box during the inspection.
