# Inspection Report

**UNCOVER**  
BUILDING AND PEST INSPECTIONS

**1 Sample St , Sample, Nsw, 2281**

### Handover Inspection

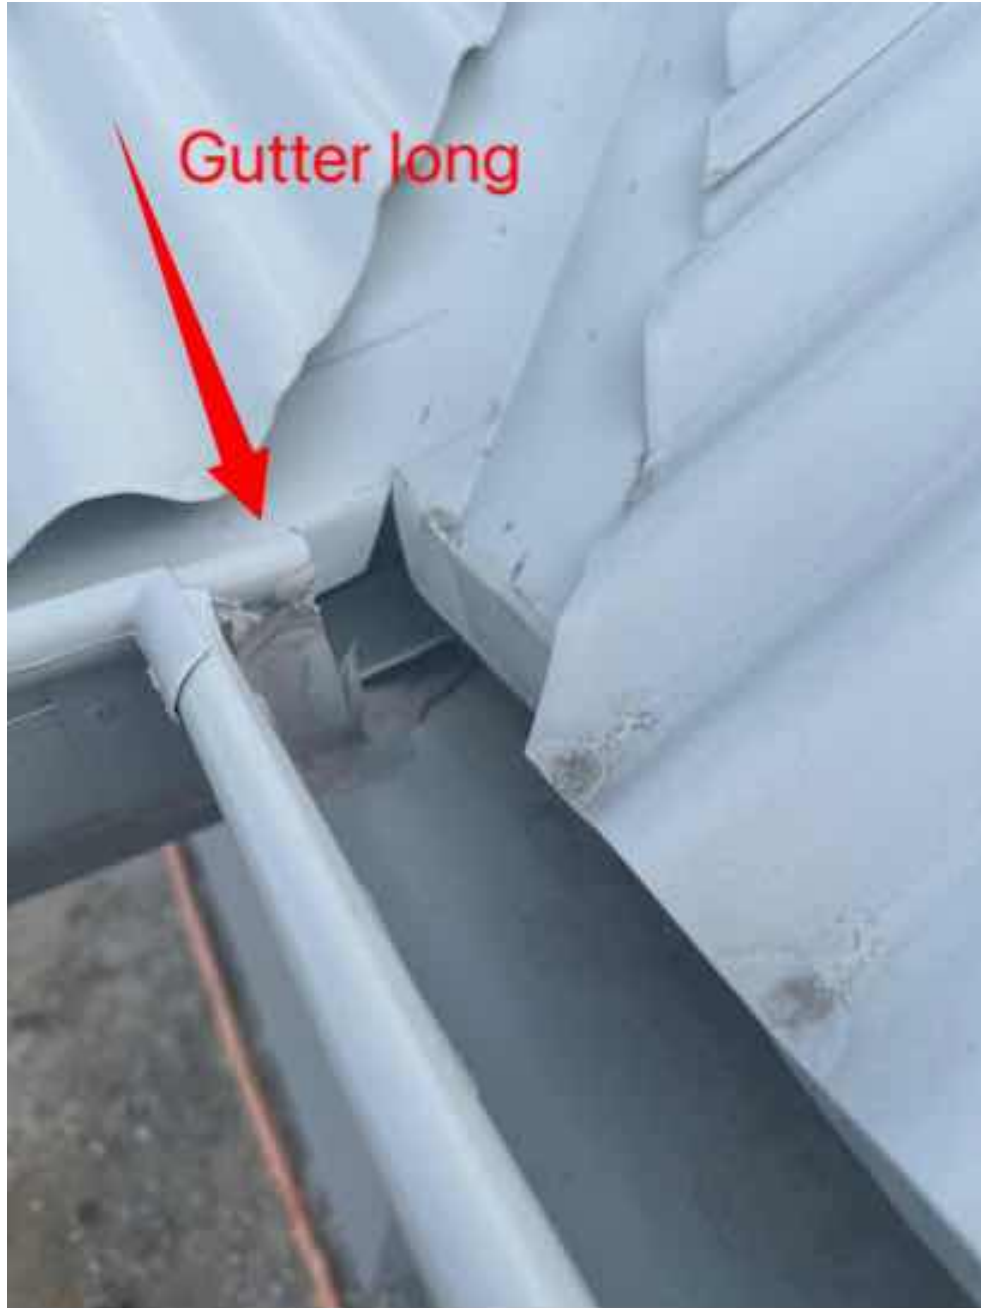
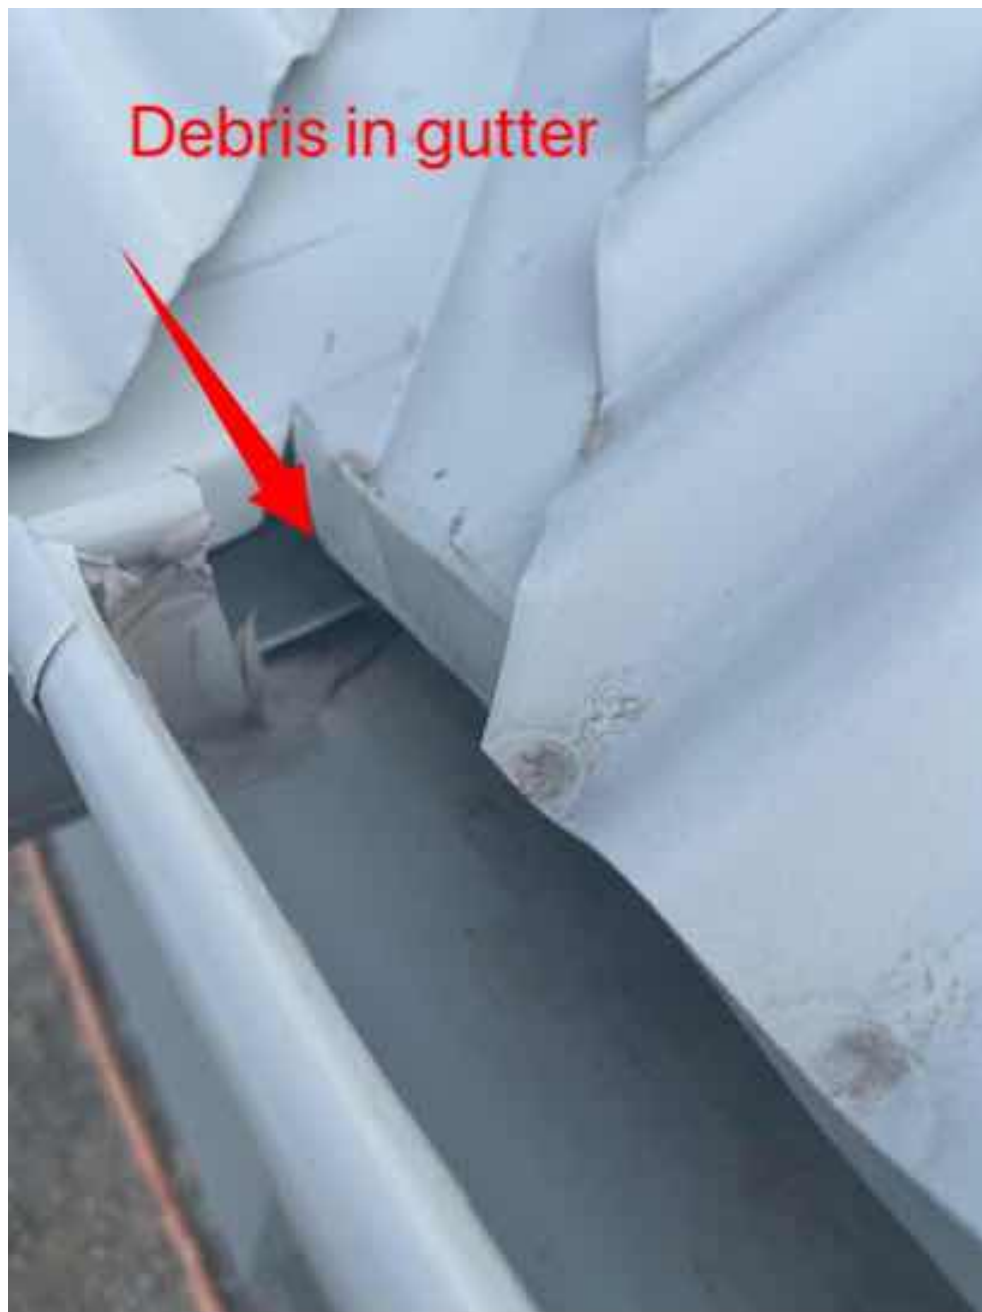
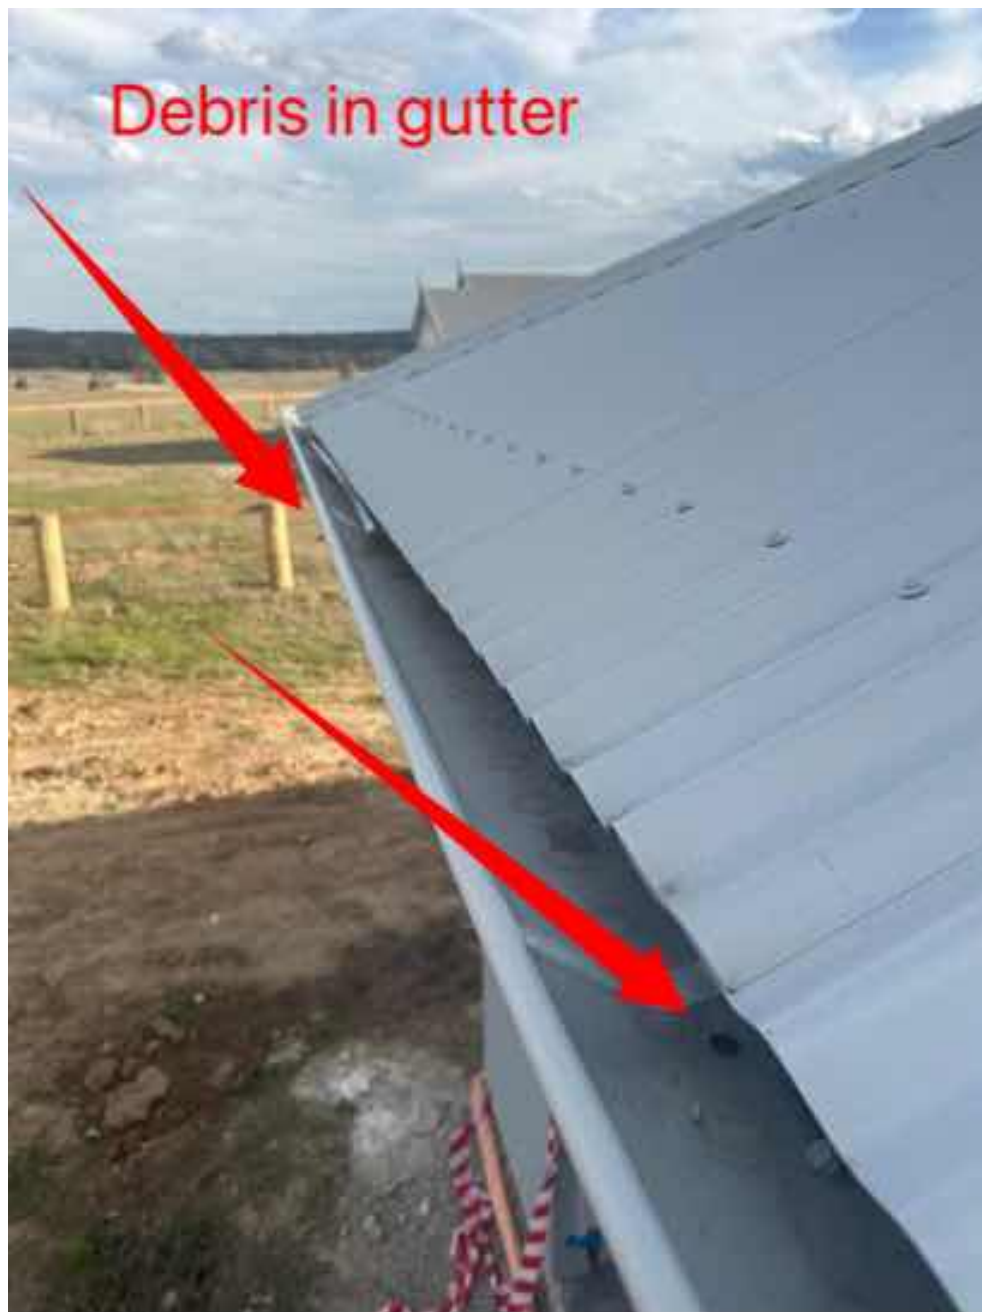
Building debris in gutter. Requires cleaning.

The gutter is long in the corner. This will restrict water flow and make hard to clean. Amendment required

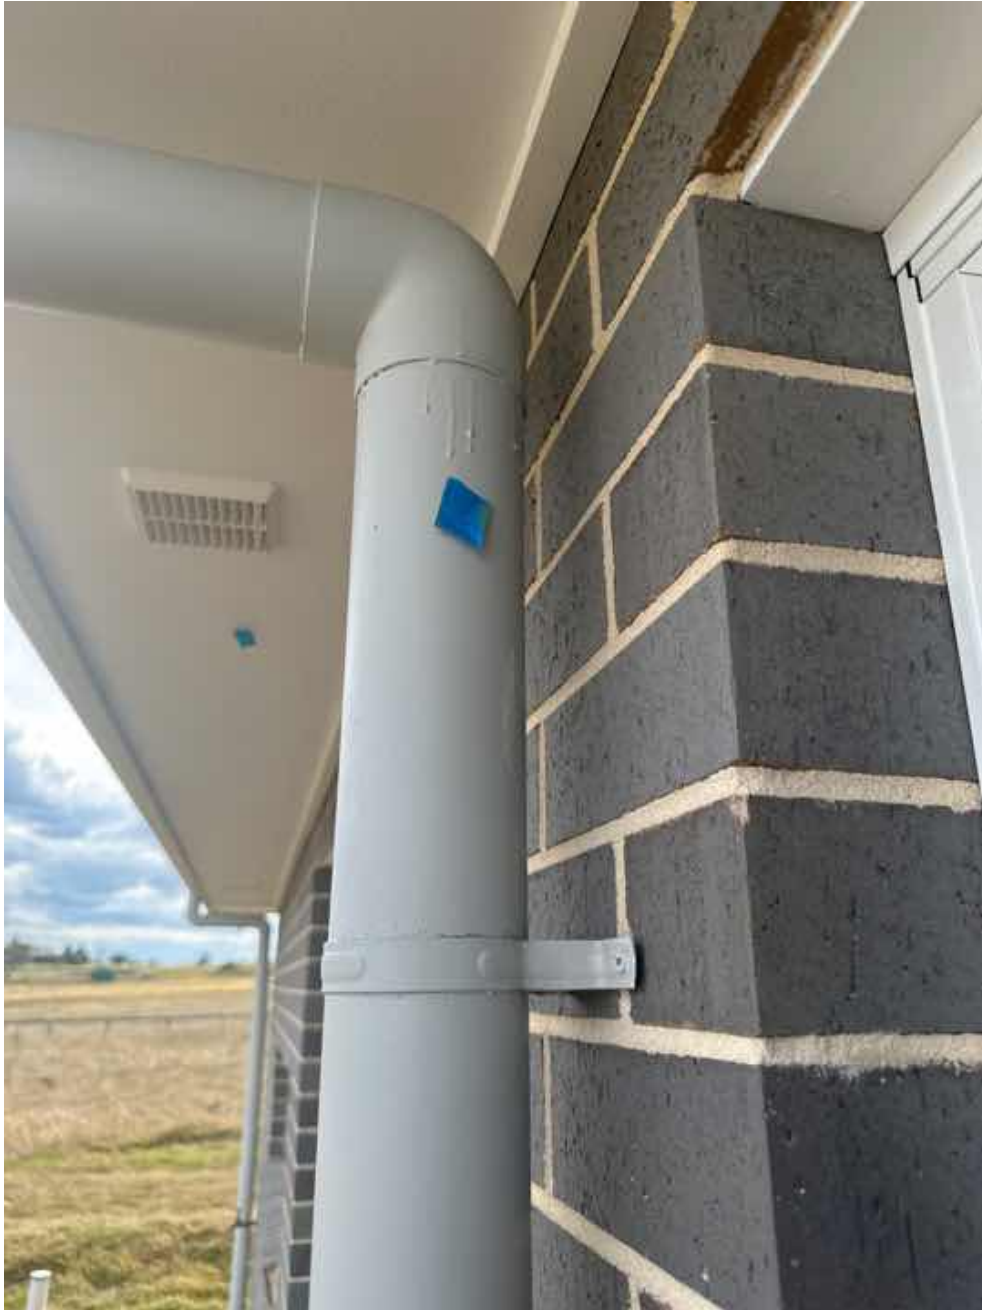
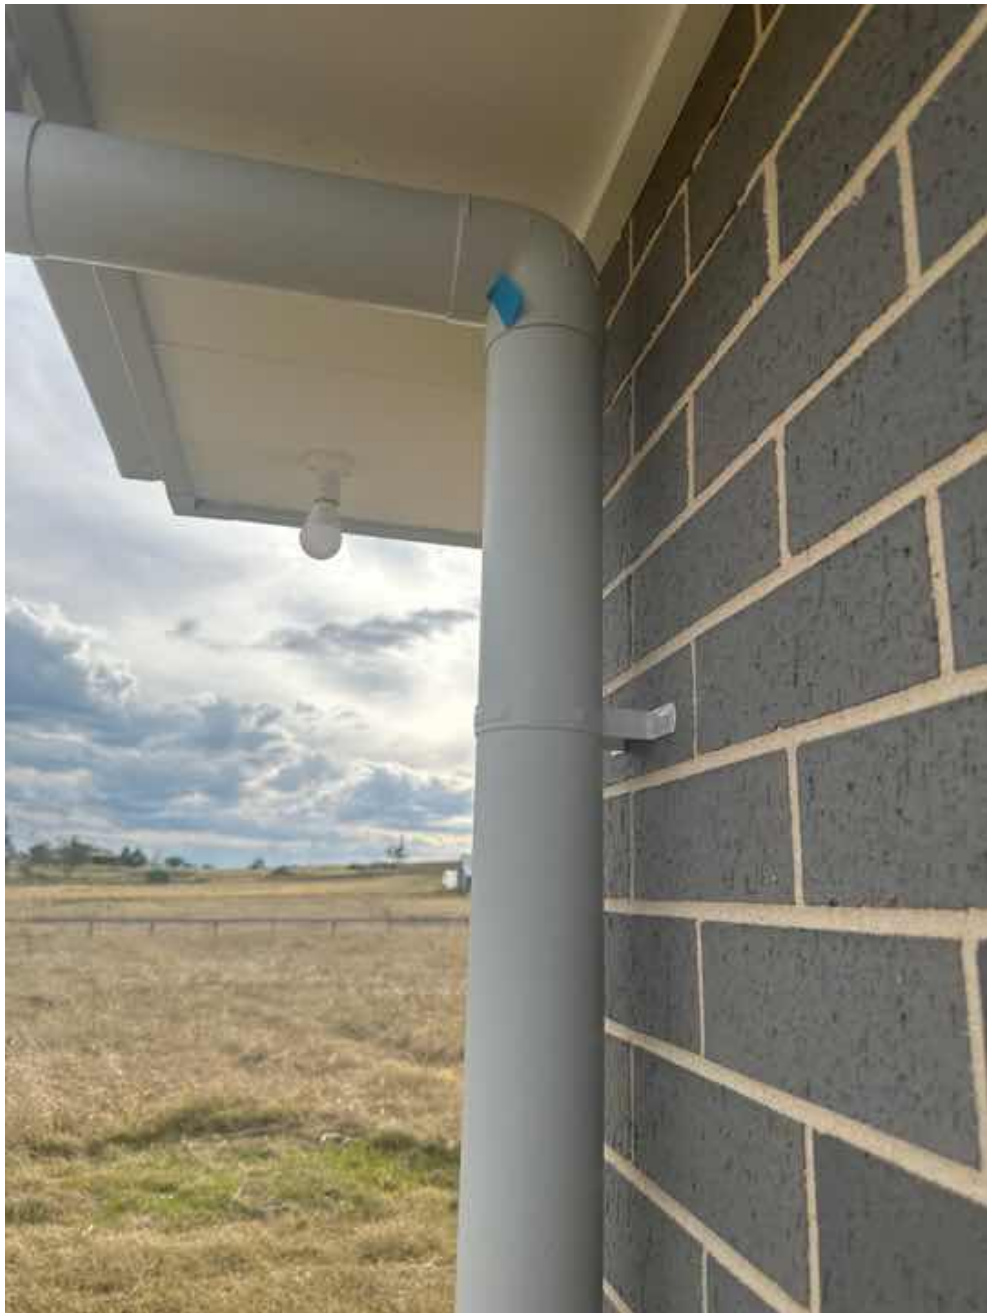
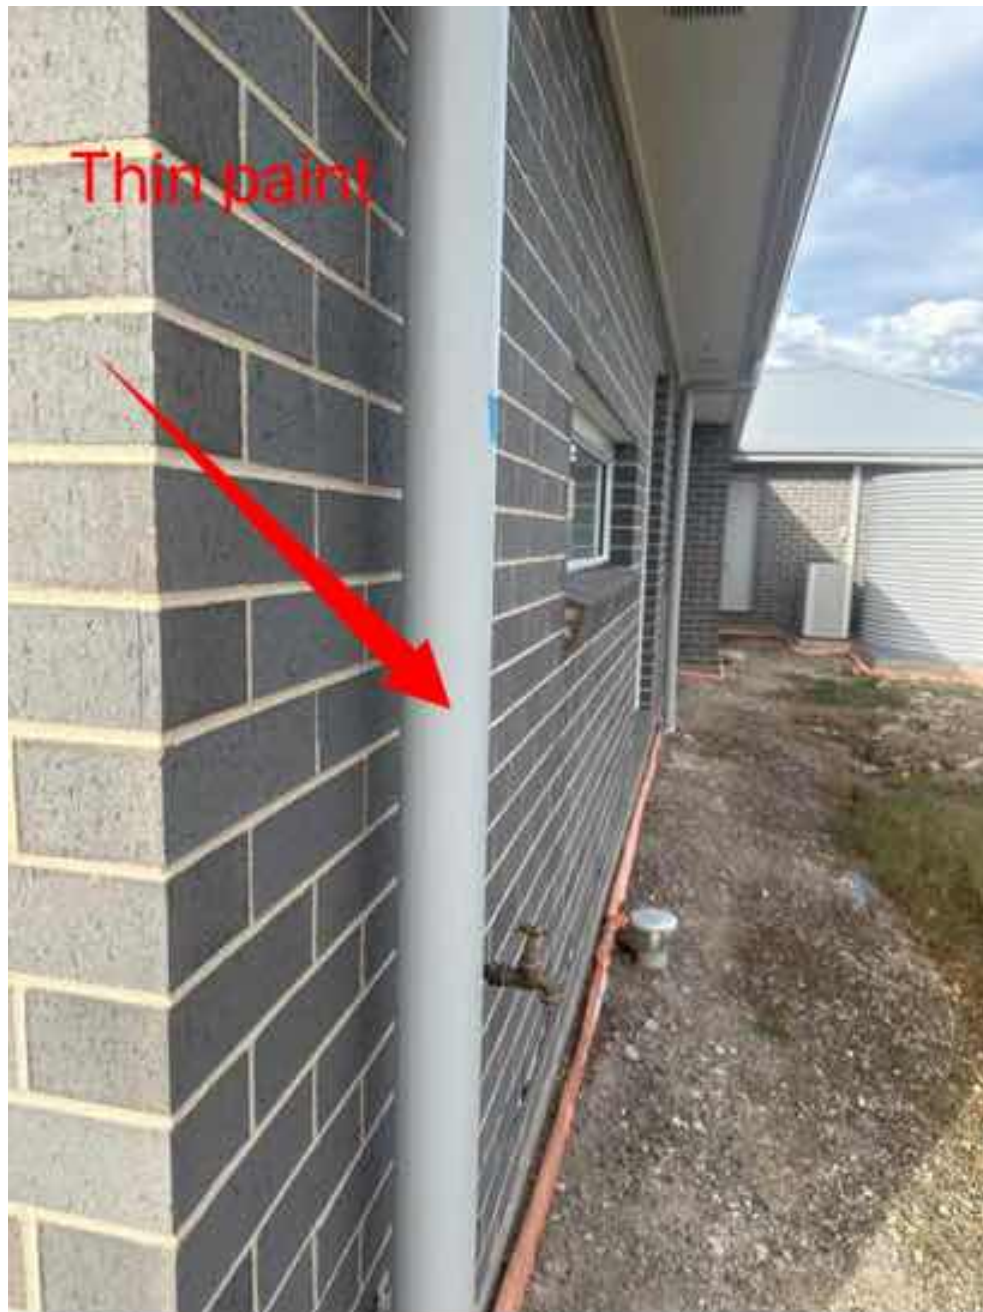
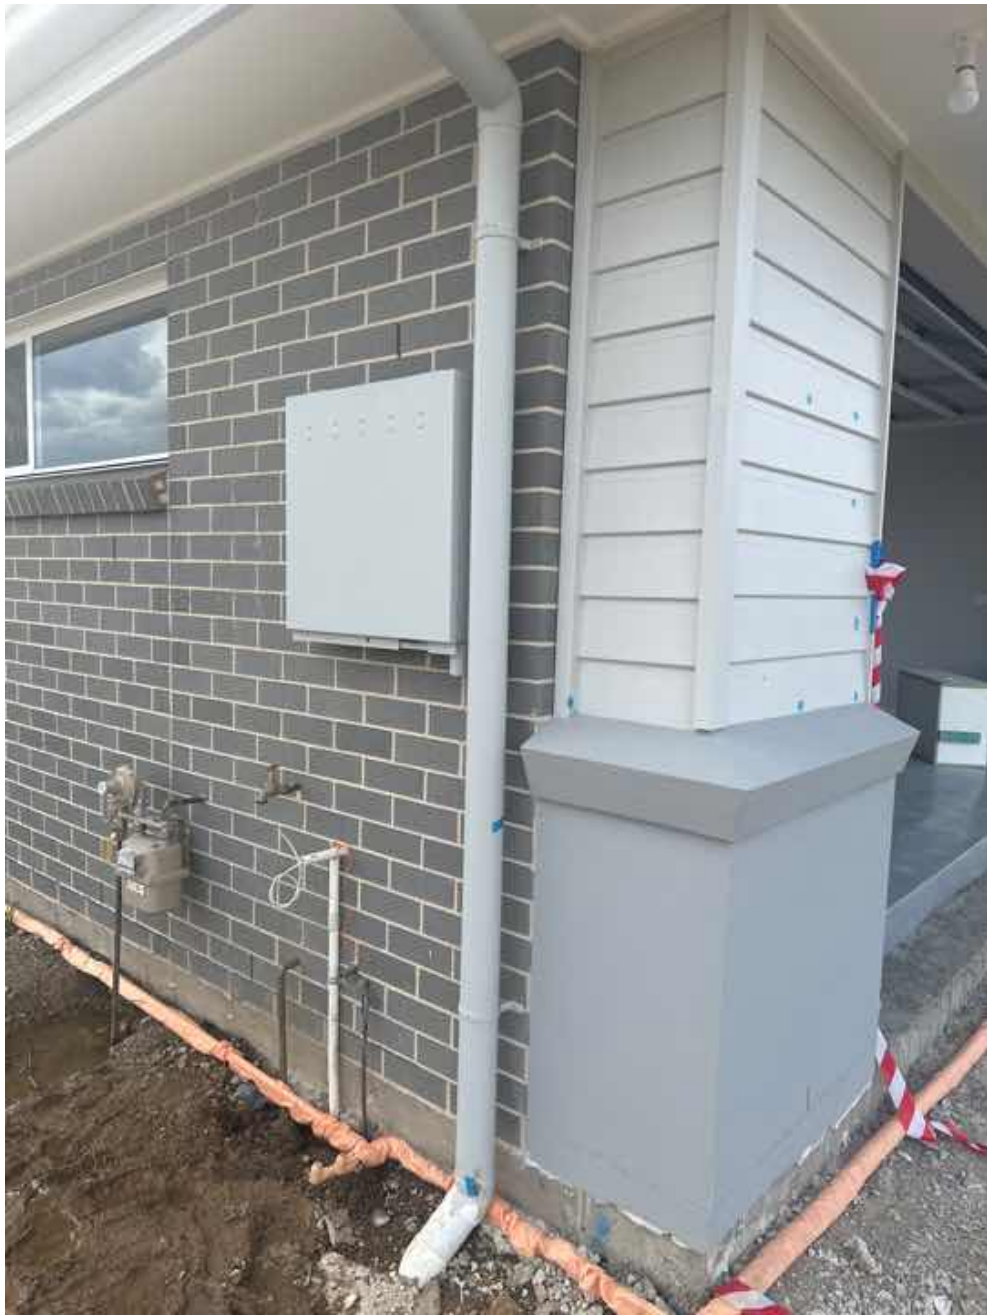
### **Down Pipe Findings**

Touch up downpipes, runs thin paint. Additional painting required.

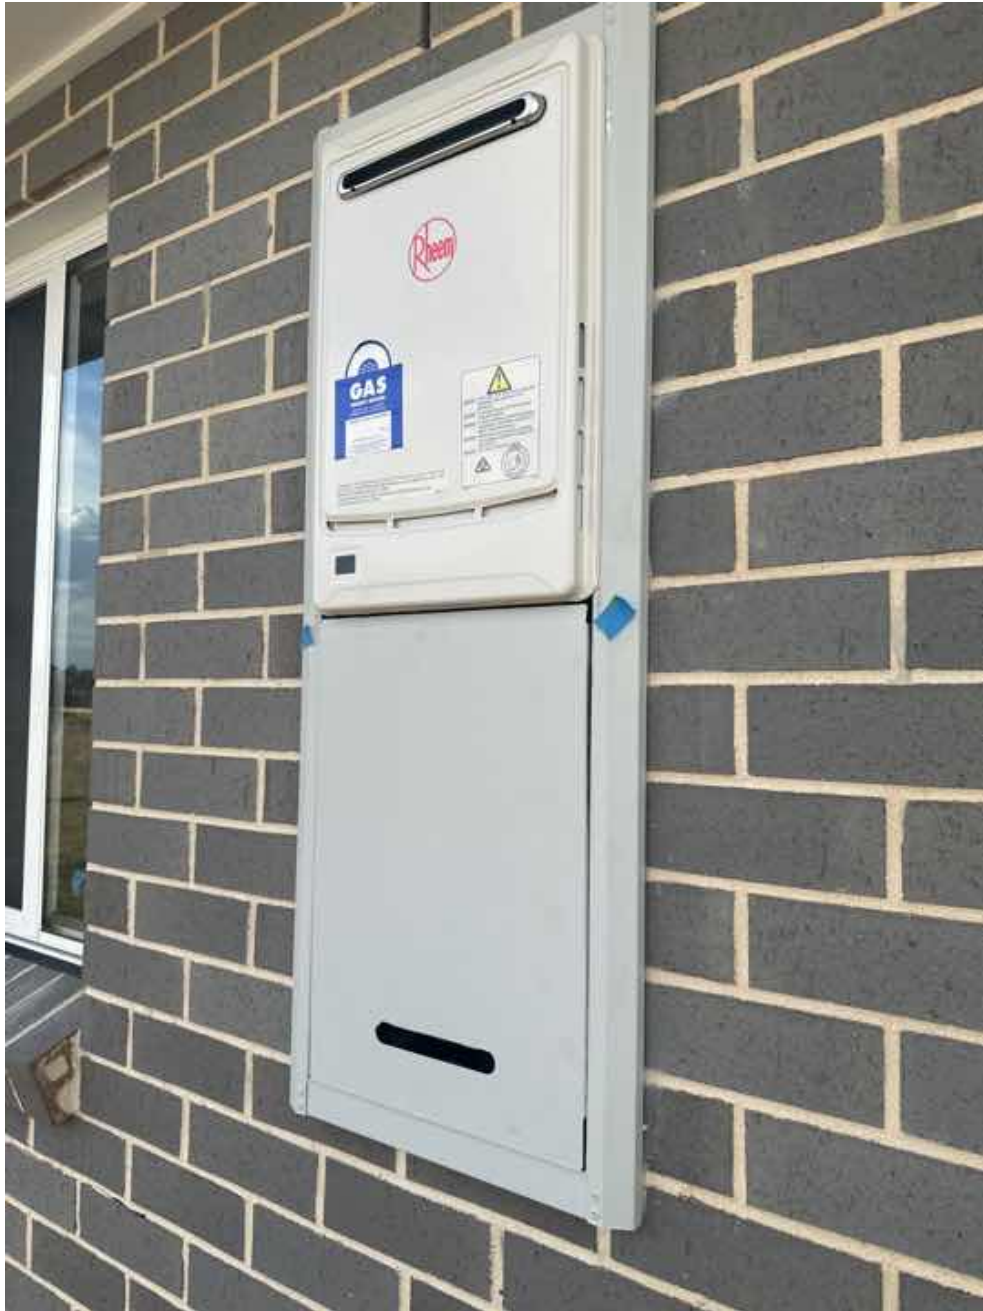
#### Hot Water Unit Findings

Box Painted. Requires touch ups.

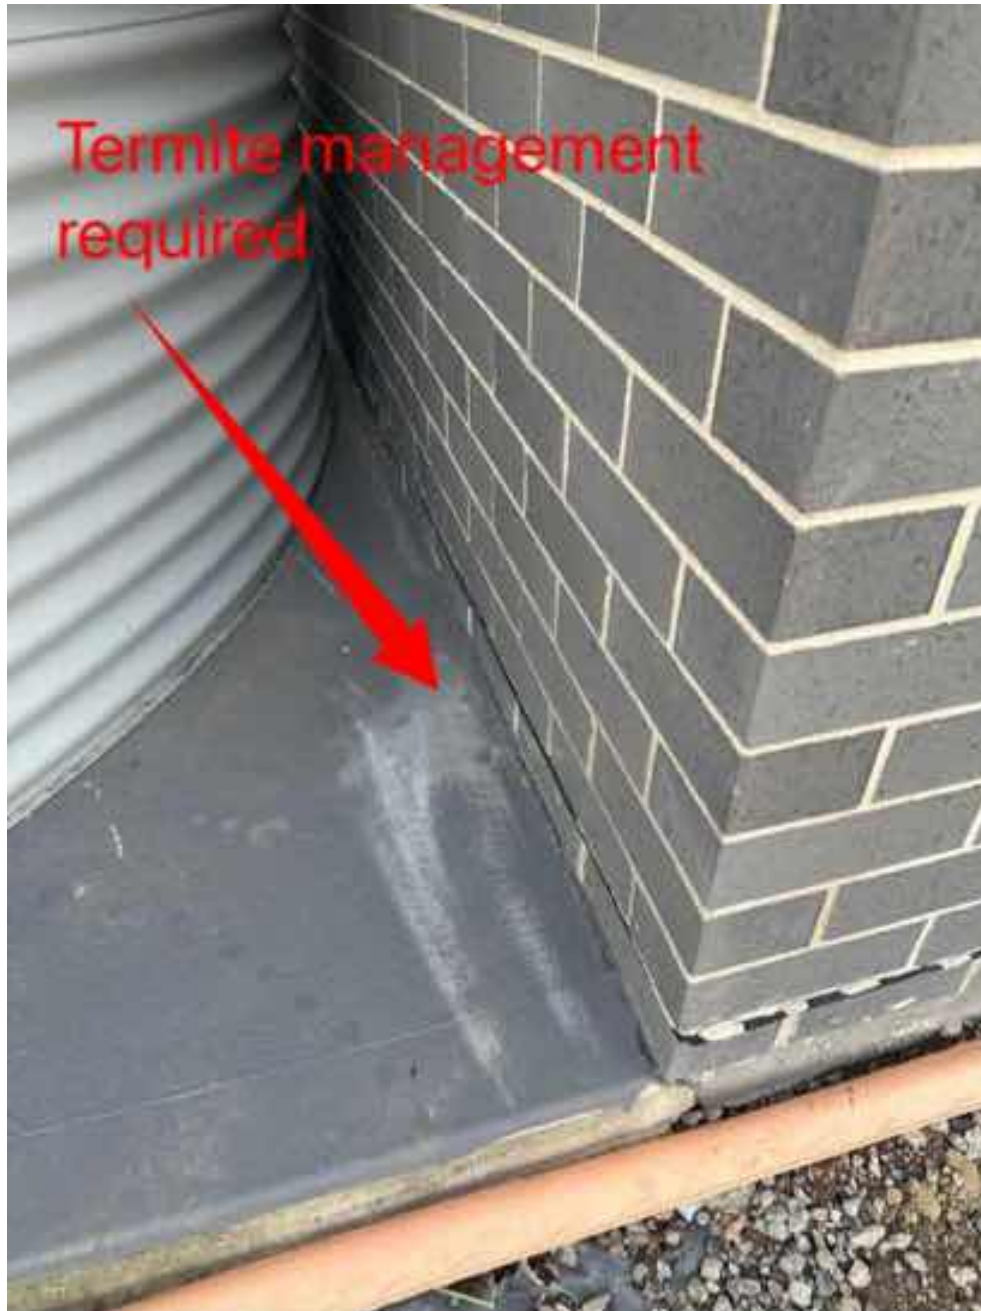
#### Water Tank Findings

The water tank slab does not appear to have been poured in with the house slab. This slab appears to have been installed up against the house slab. Termite management system needs to be installed in this joint. There is a reticulation system around the perimeter but this does not stop termite attack through this slab joint. DO NOT rely on the reticulation treatment of the exterior to protect this slab joint. The same as pipes that penetrate the slab have to be addressed with termite protection collars to stop termite entry in the centre of the slab.

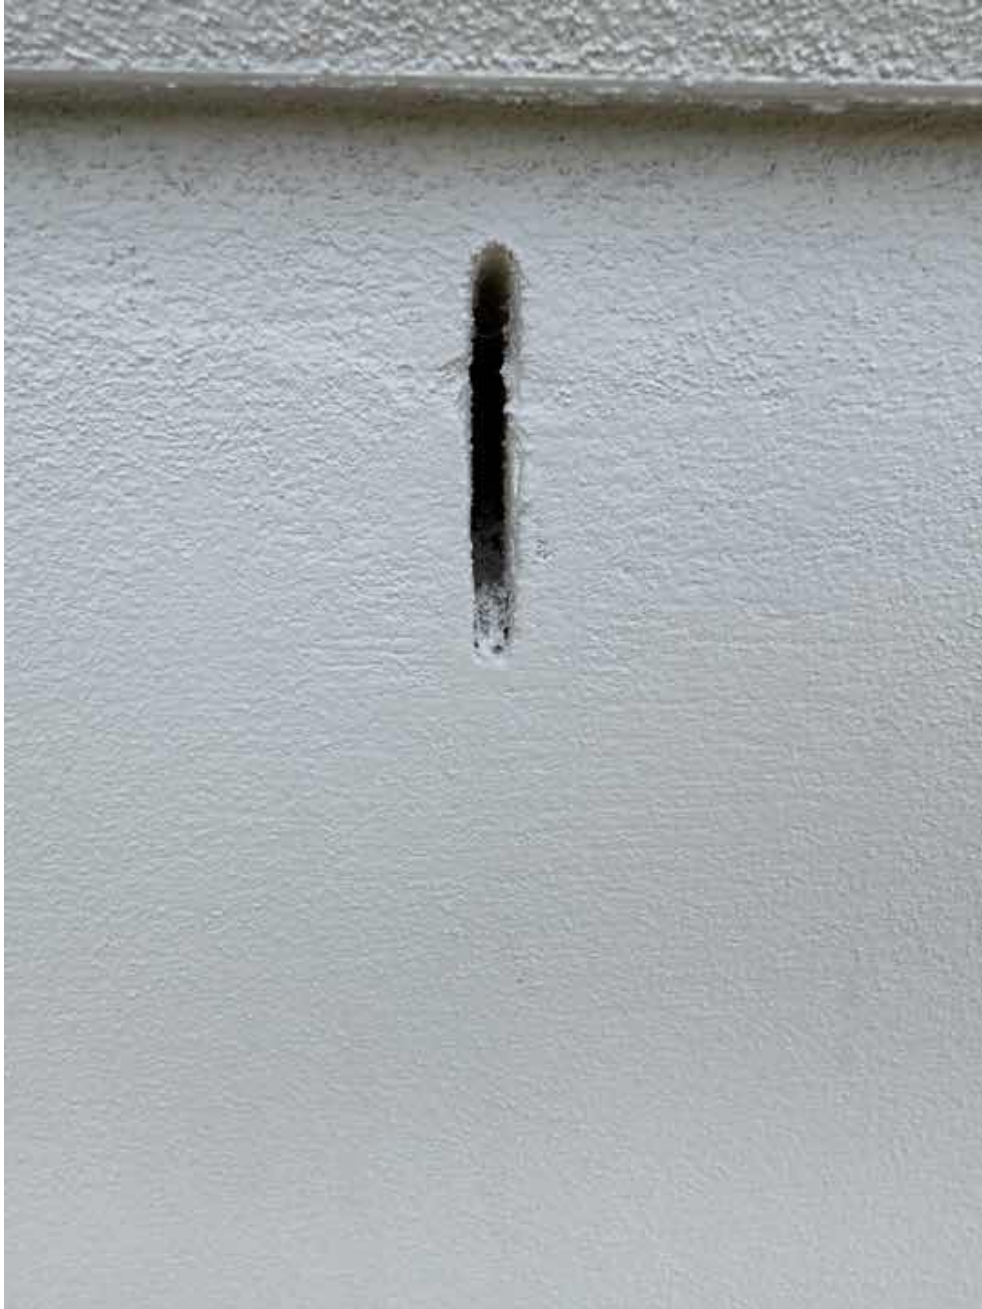
#### **Weephole Findings**

Weep holes are blocked or partially blocked by render in areas. Requires cleaning out.

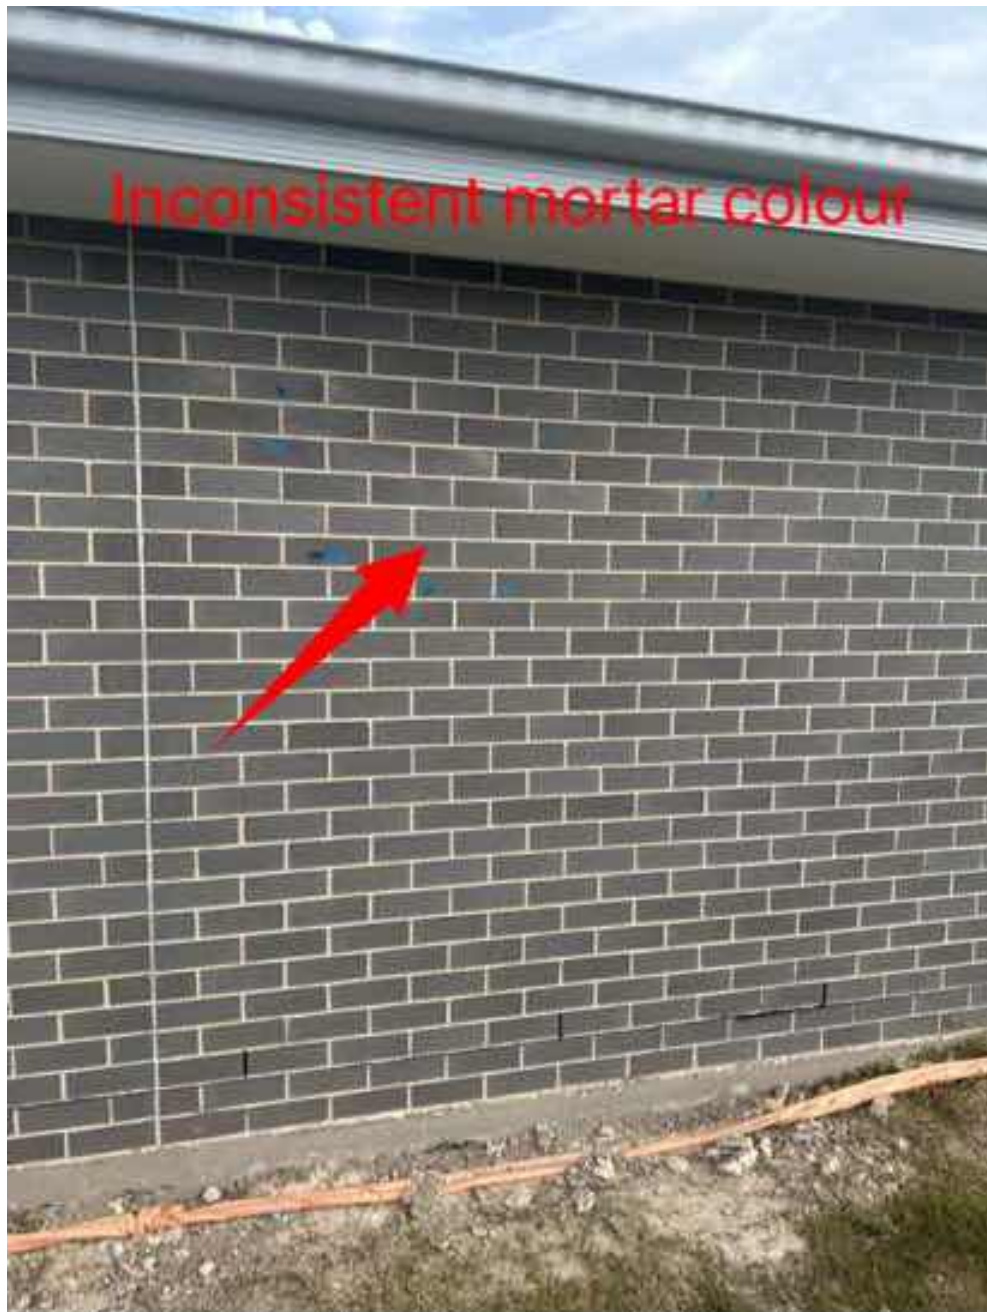
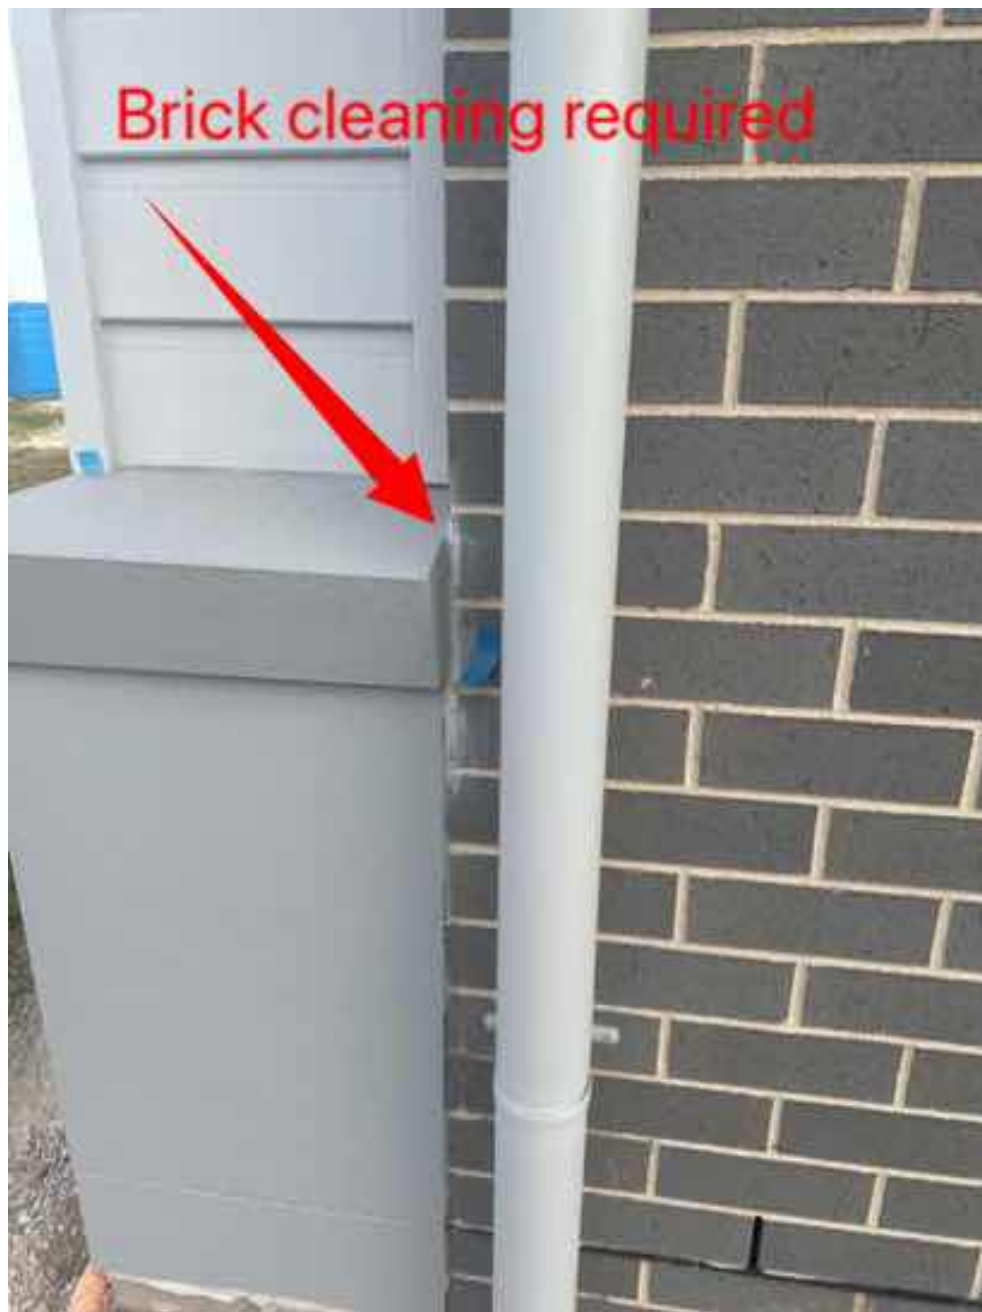
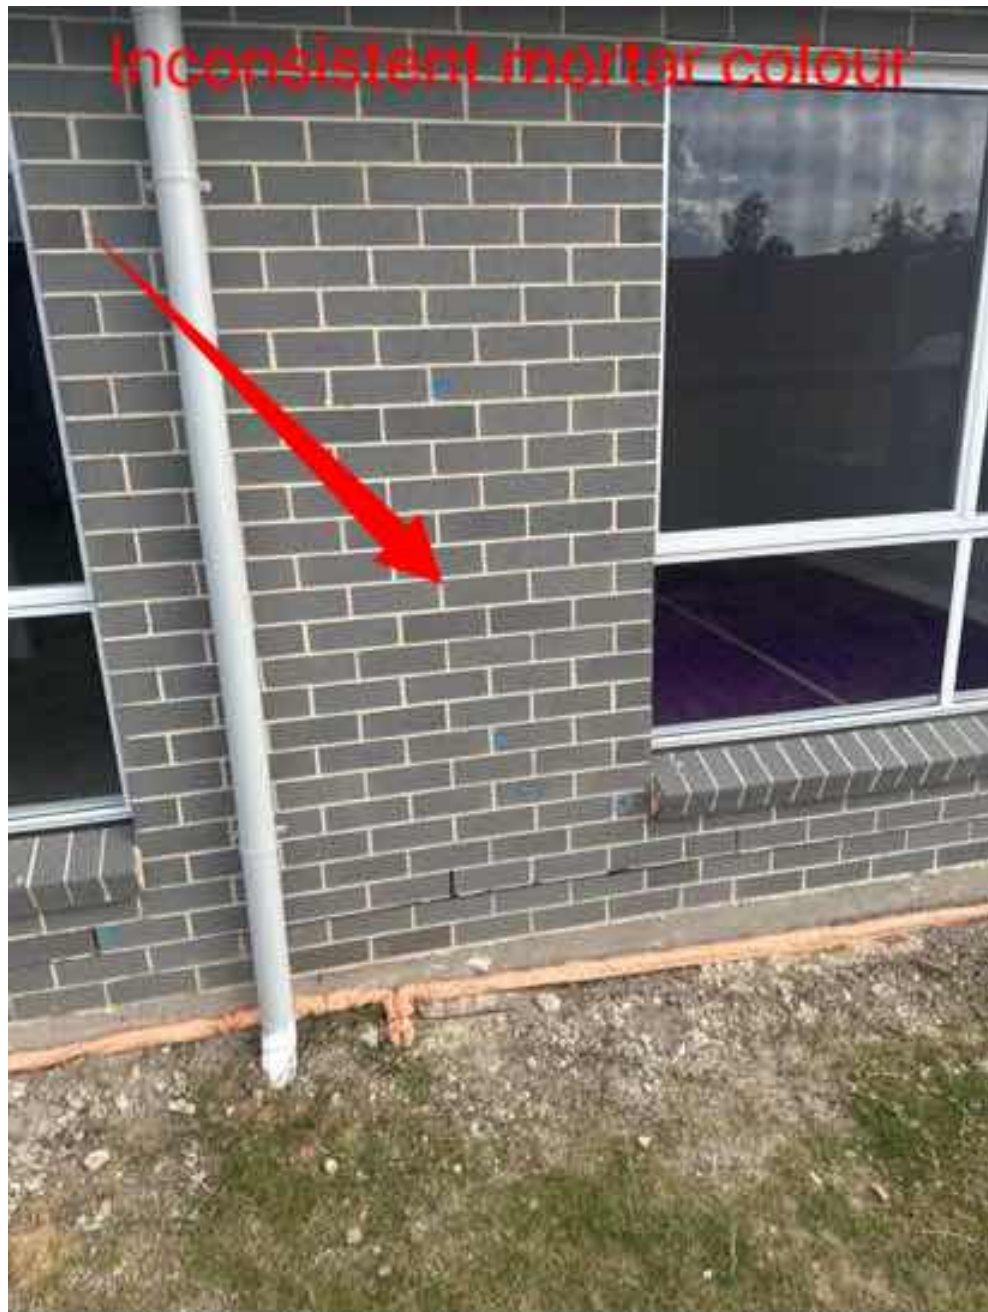
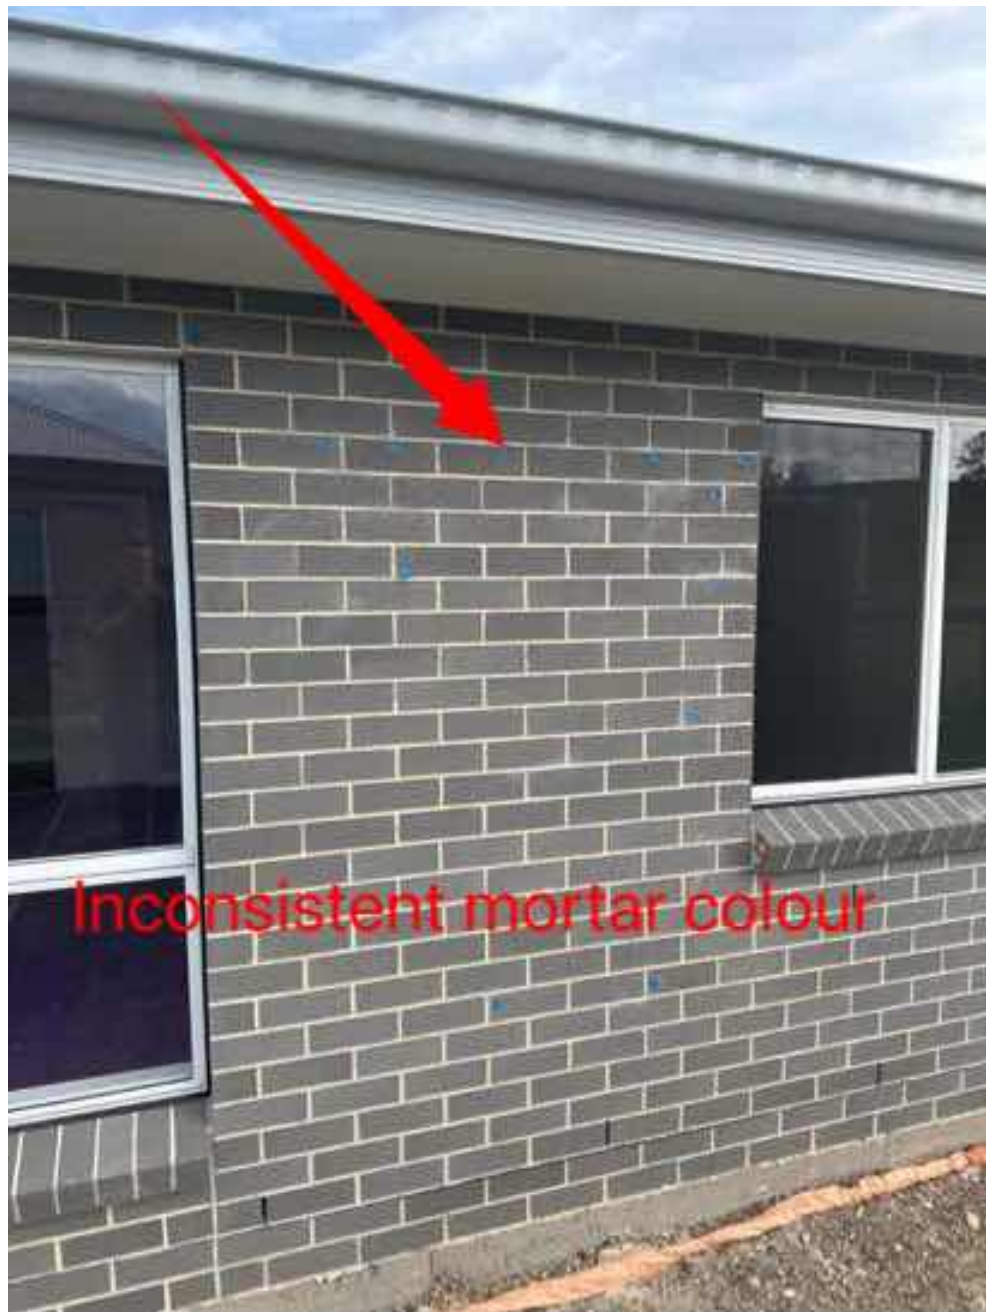
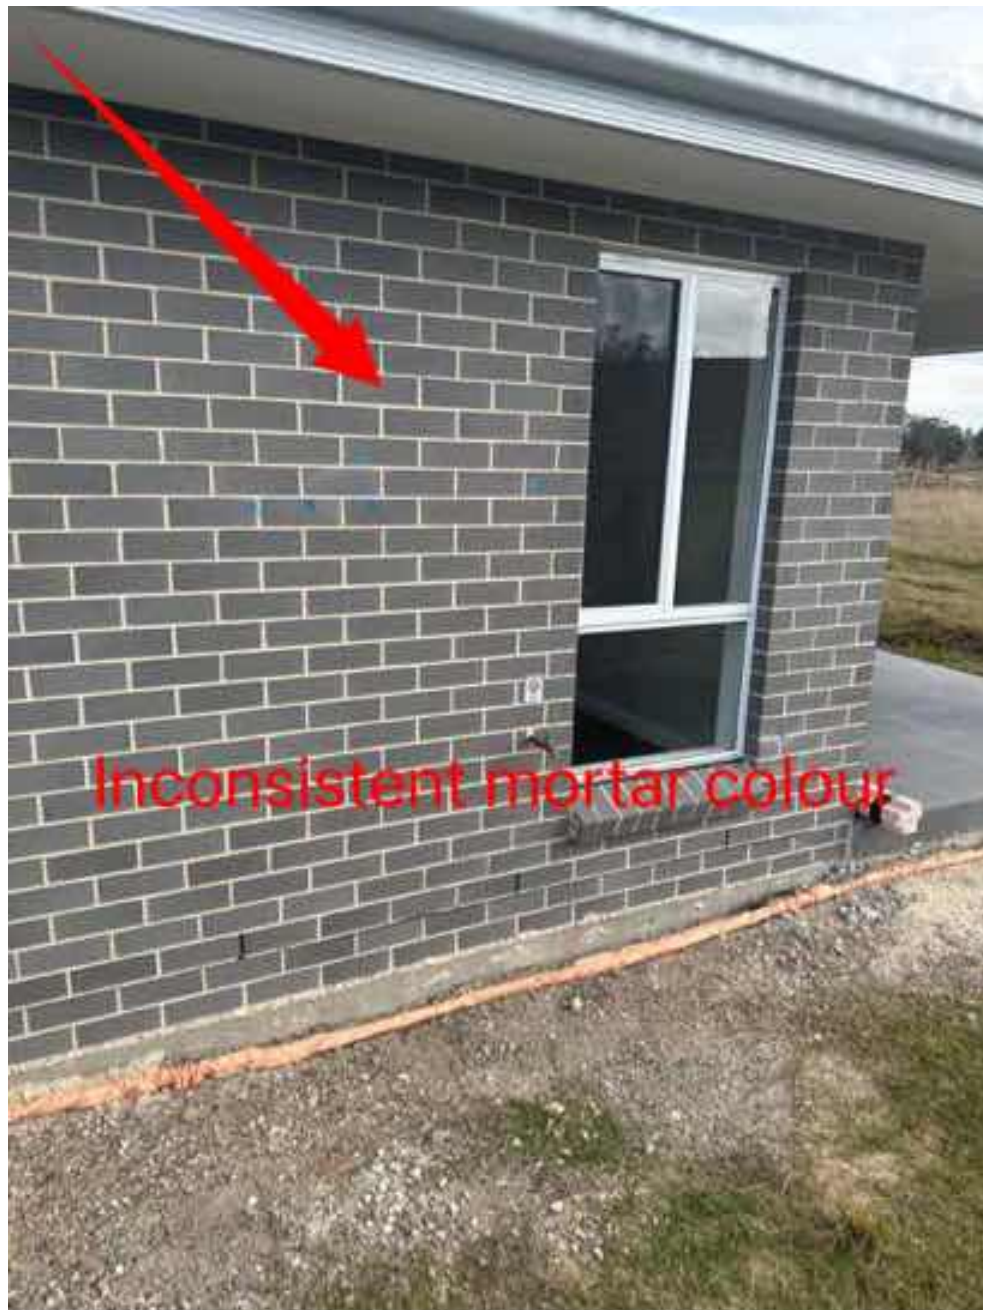
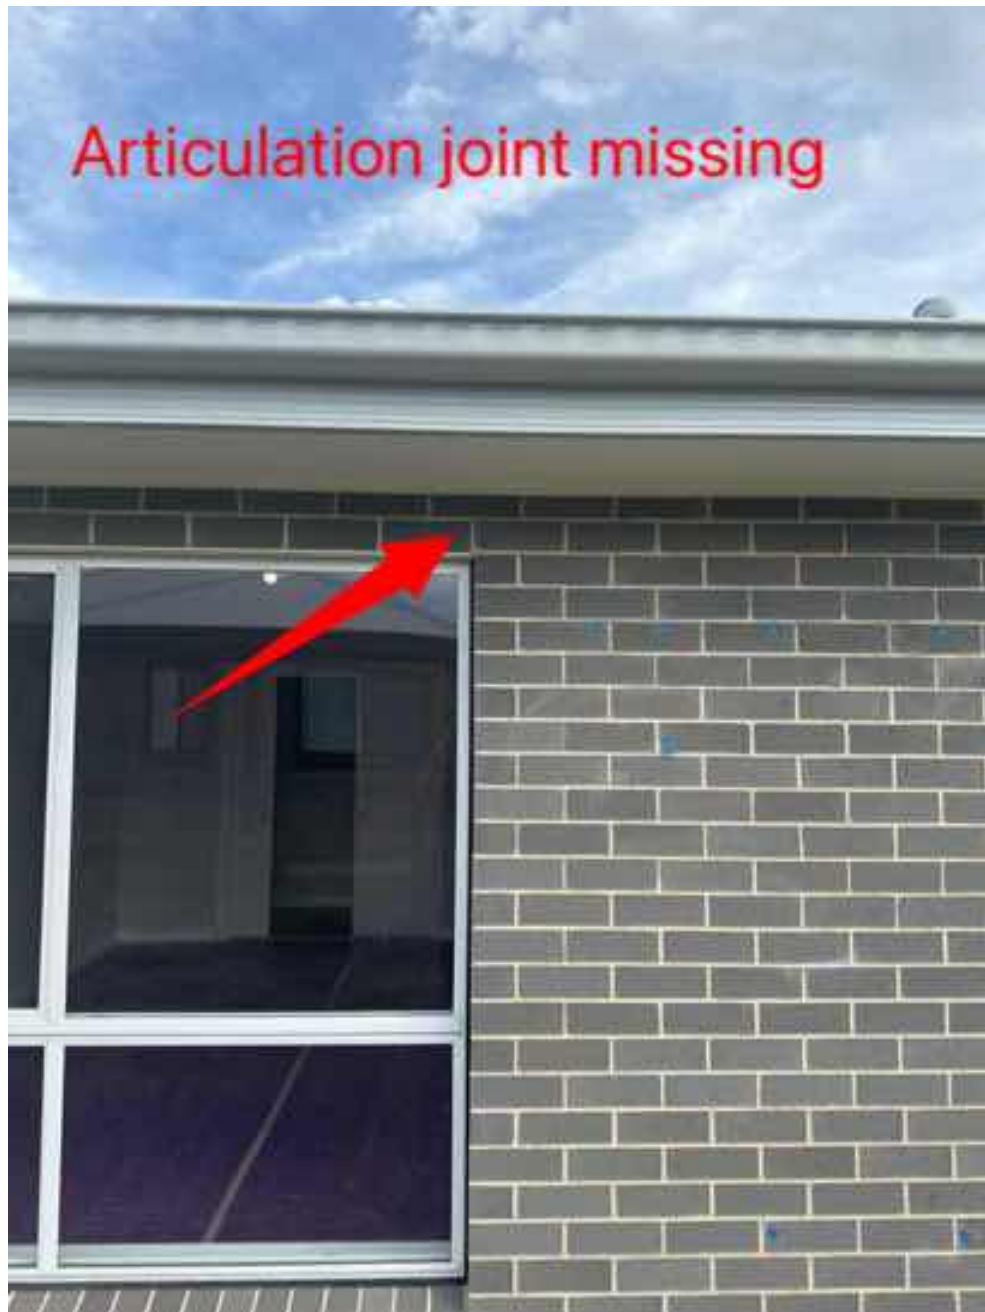
### **Brickwork Condition**

EXTERIOR	Exterior Walls	Brickwork Condition	Inconsistent mortar colour. When viewed from a normal viewing position, which is 1.5m the mortar used in the brickwork was not of a consistent colour.
EXTERIOR	Exterior Walls	Rendered Masonry Condition	Paint touch-ups required to rendered surfaces.
EXTERIOR	Exterior Windows	Overall Condition	Damage to window frame/s.
EXTERIOR	Exterior Windows	Overall Condition	The foot cut of the architraves in some locations has been cut square unlike other locations with an approx 20 degree cut. Rectification required.
EXTERIOR	Exterior Windows	Overall Condition	There are scratches to aluminium frames, noticeable from a normal viewing position which is 1.5m. Amendment required.
GARAGE	Garaging	Overall Condition	A builders clean is required.
GARAGE	Garaging	Internal Door Findings	Paint touch ups required.
GARAGE	Garaging	Internal Door Findings	Weather seals not installed. In Accordance with the National Construction Code 2019 Amendment 1 Energy Efficiency clause 3.12.3.3, seals must be fitted to all external doors and internal doors between the house and the garage, where the internal garagedoor opens into a conditioned area. A draft protection device is to be fitted to the bottom of doors and seals to the remaining edges.
