# Inspection Report

**UNCOVER**  
BUILDING AND PEST INSPECTIONS

**1 Sample St , Sample, Nsw, 2281**

### Handover Inspection

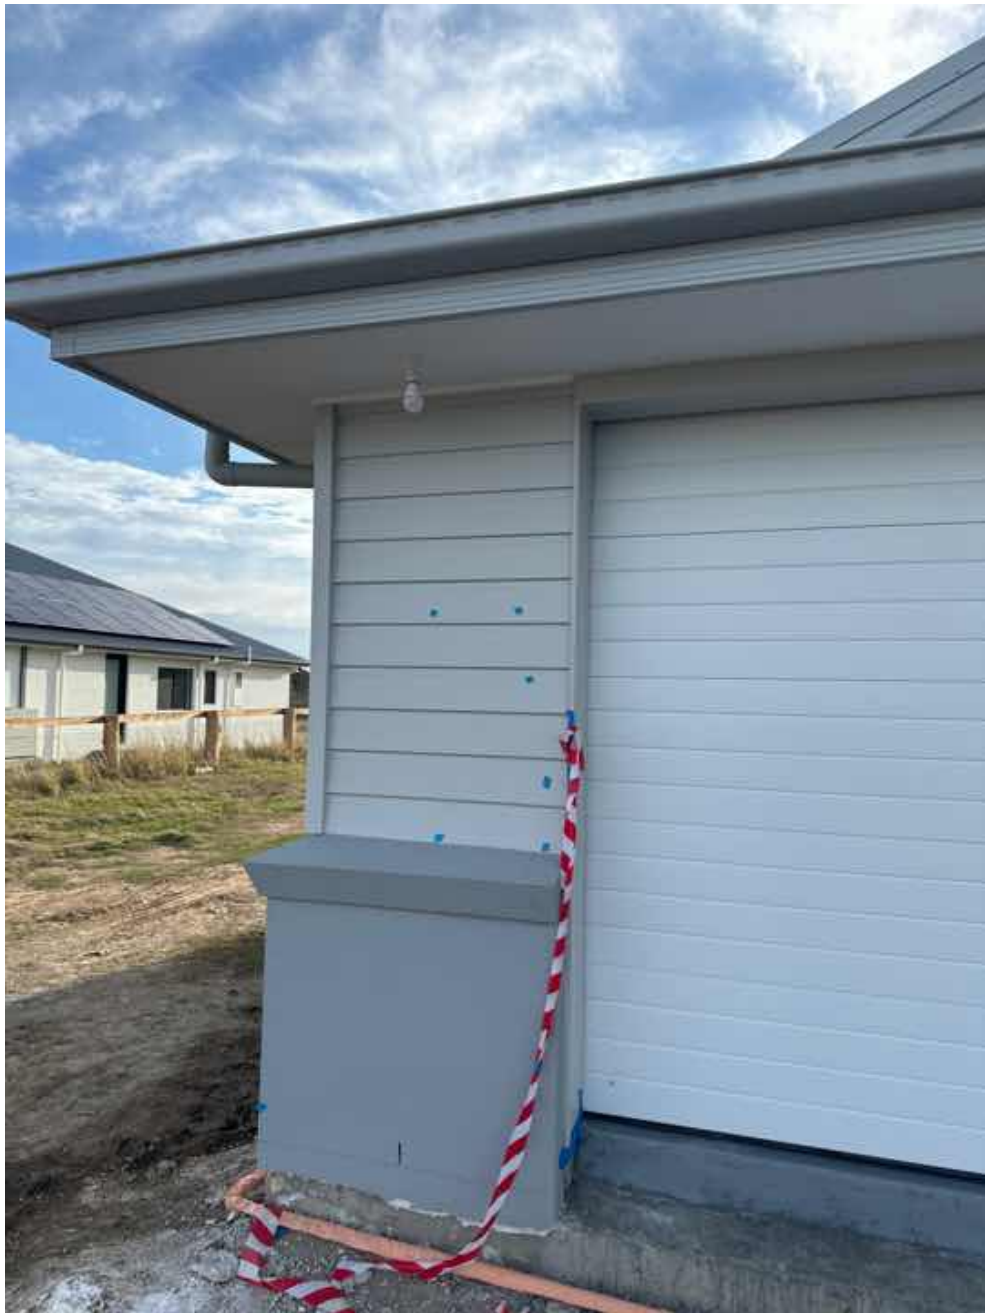
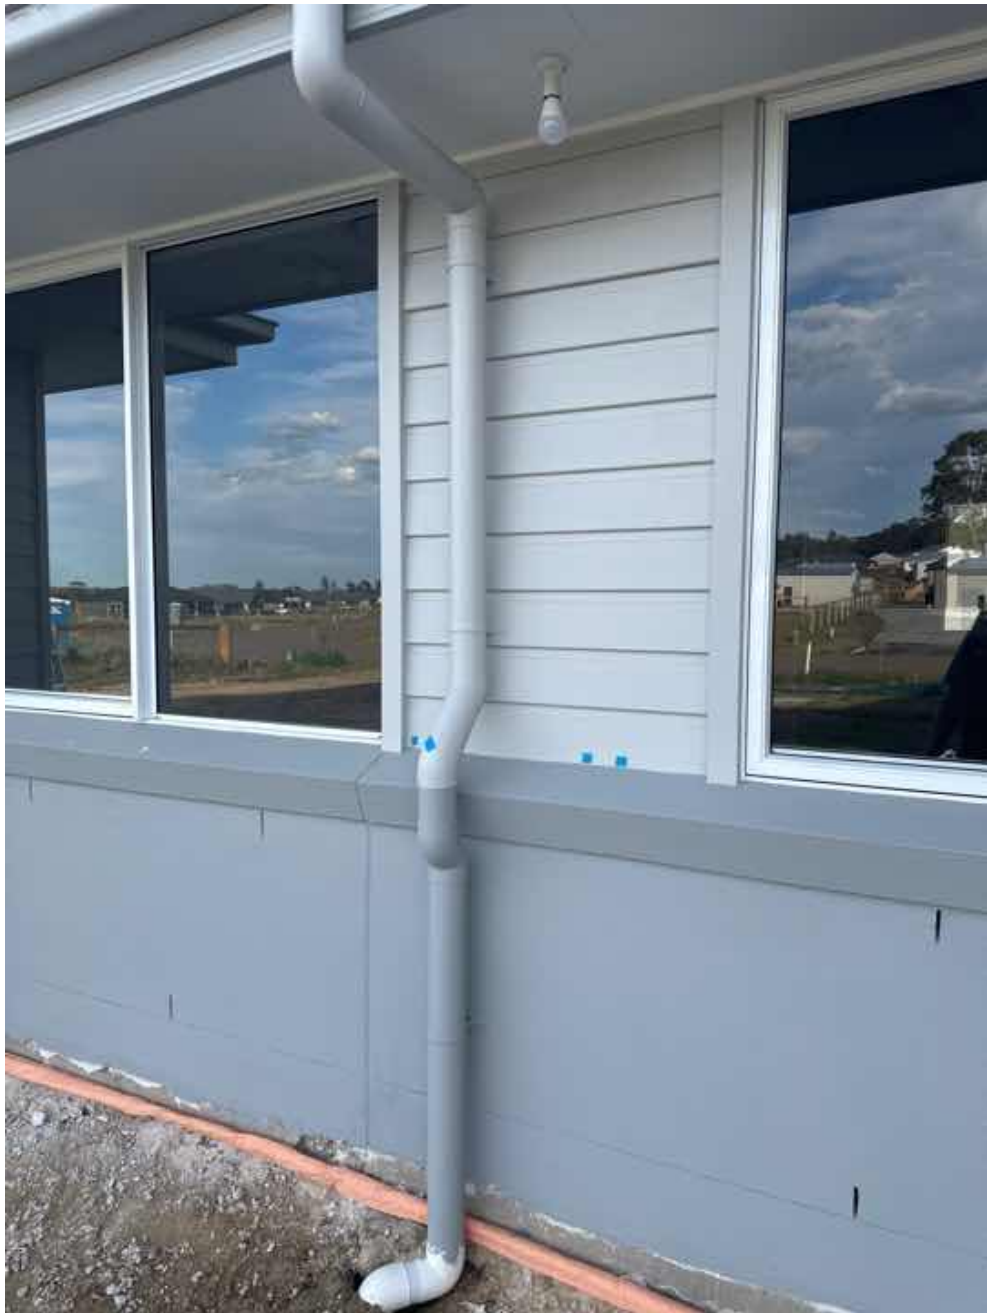
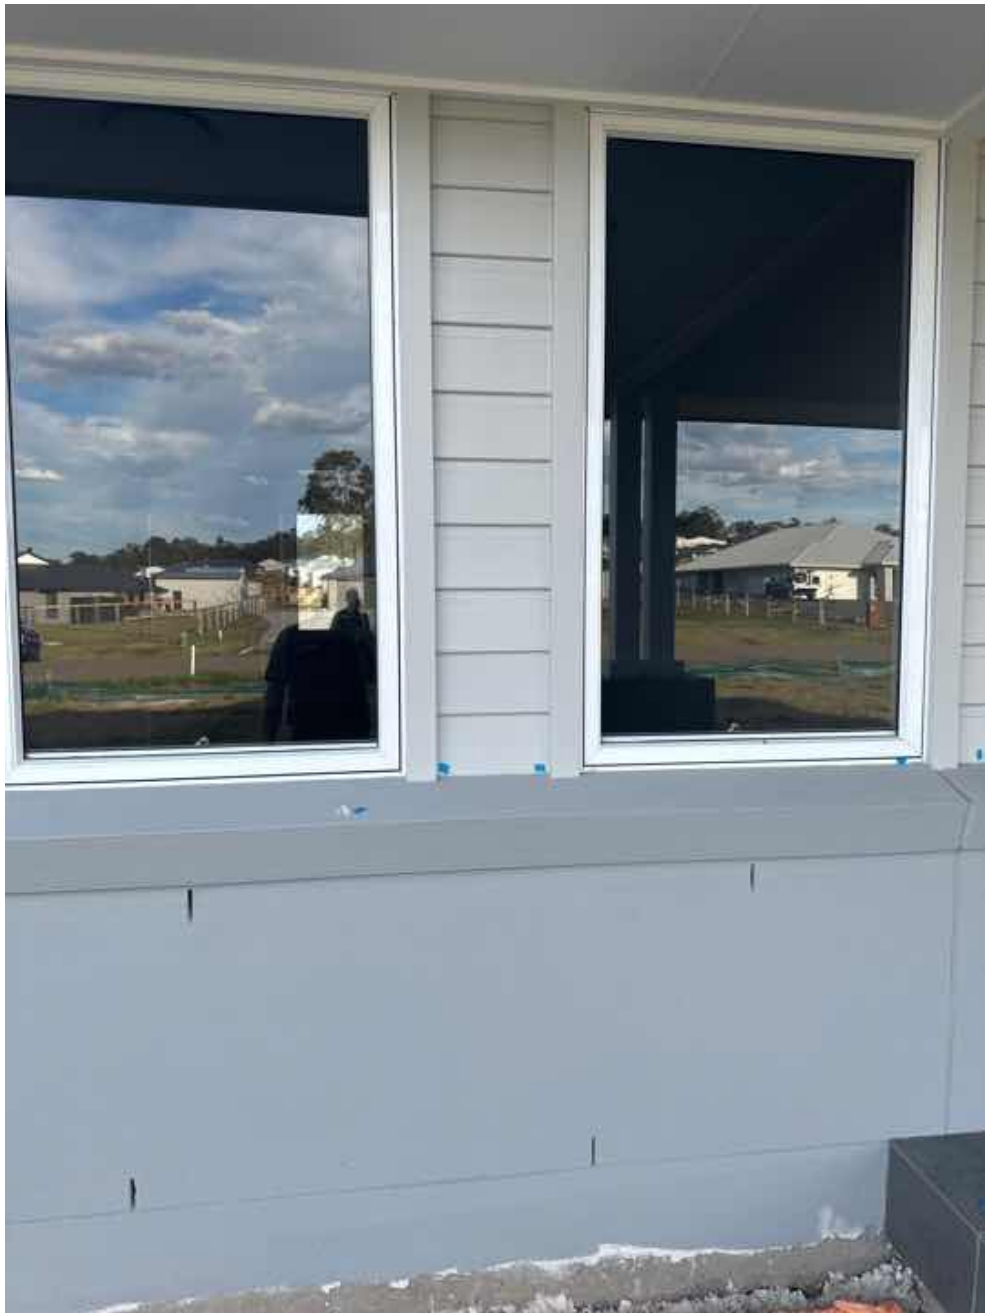
## Weatherboard Condition

Paint touch-ups required.

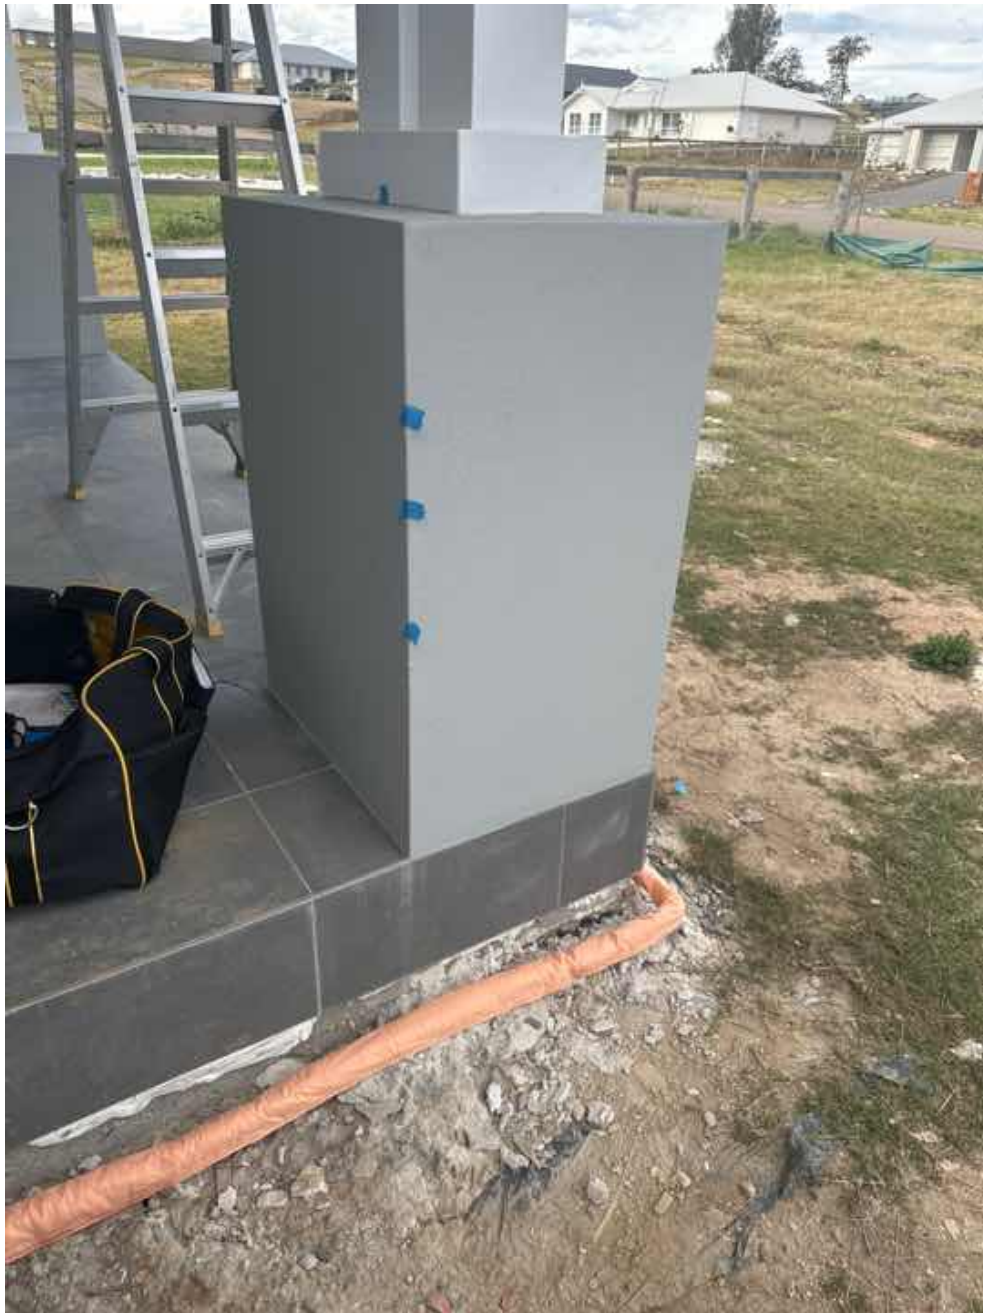
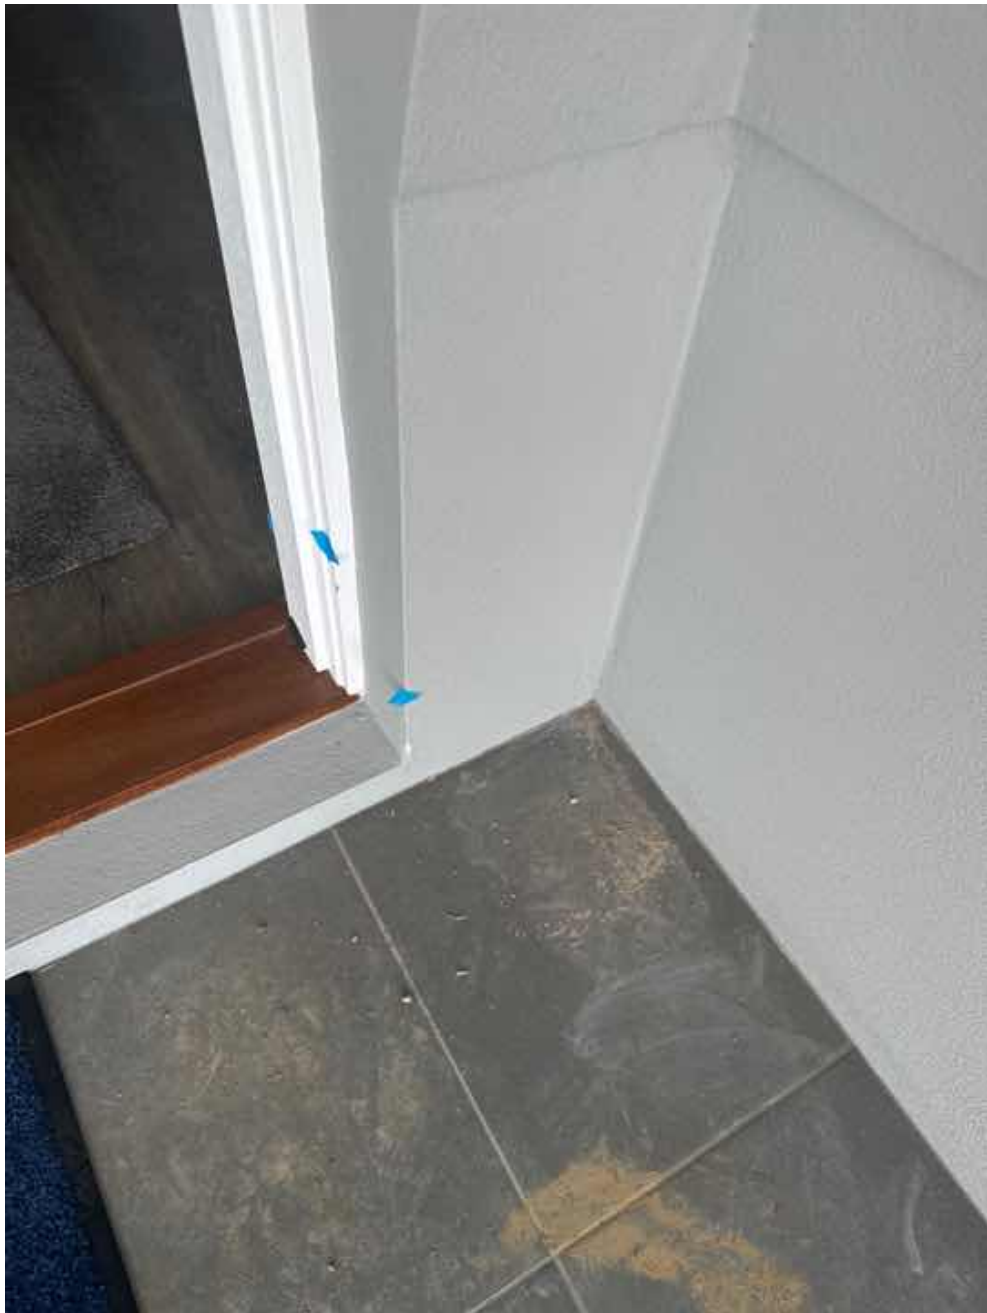
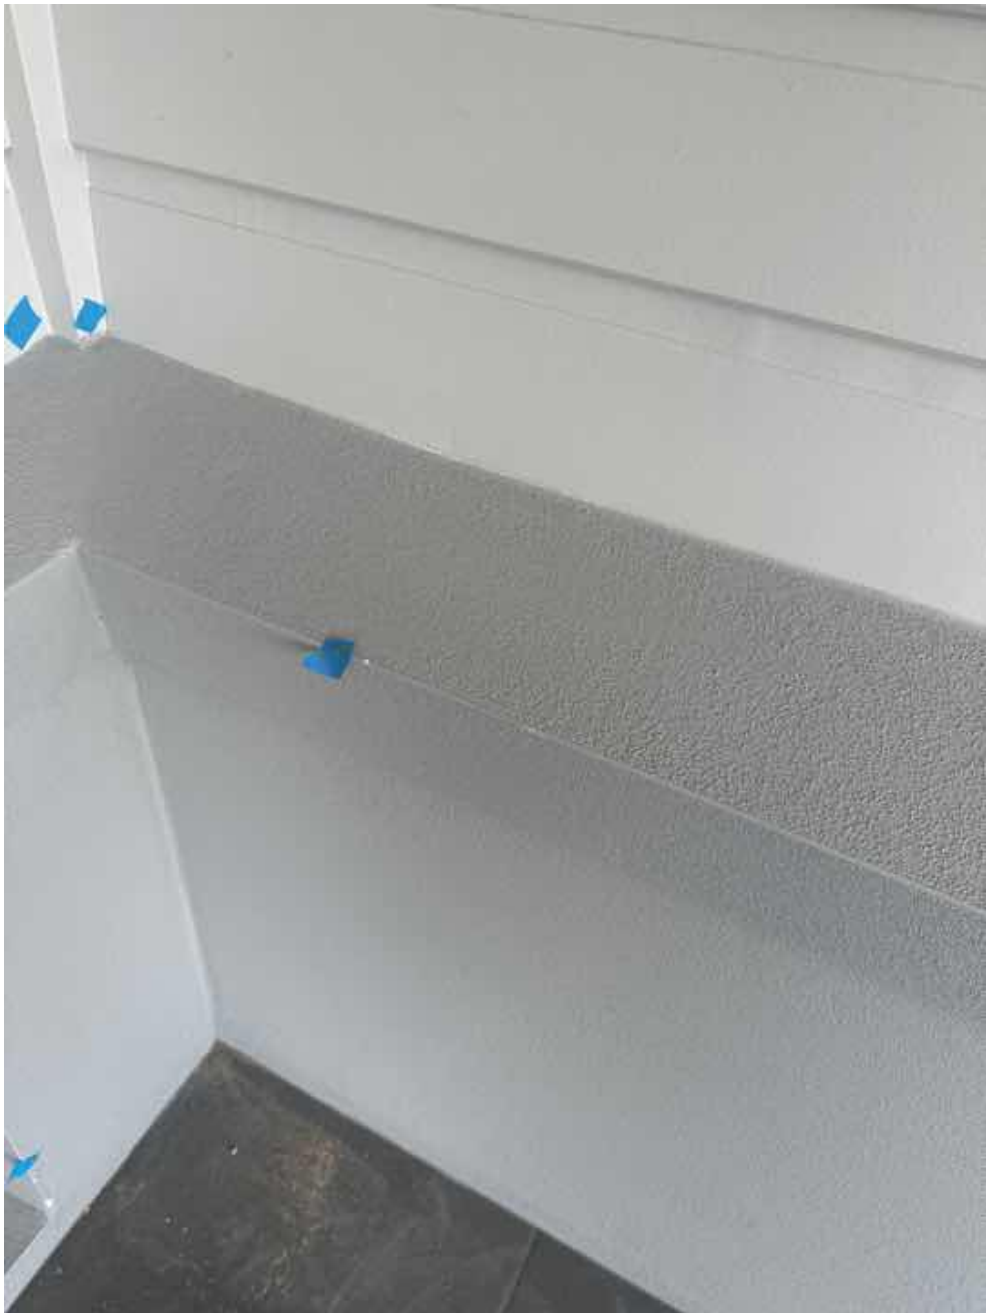
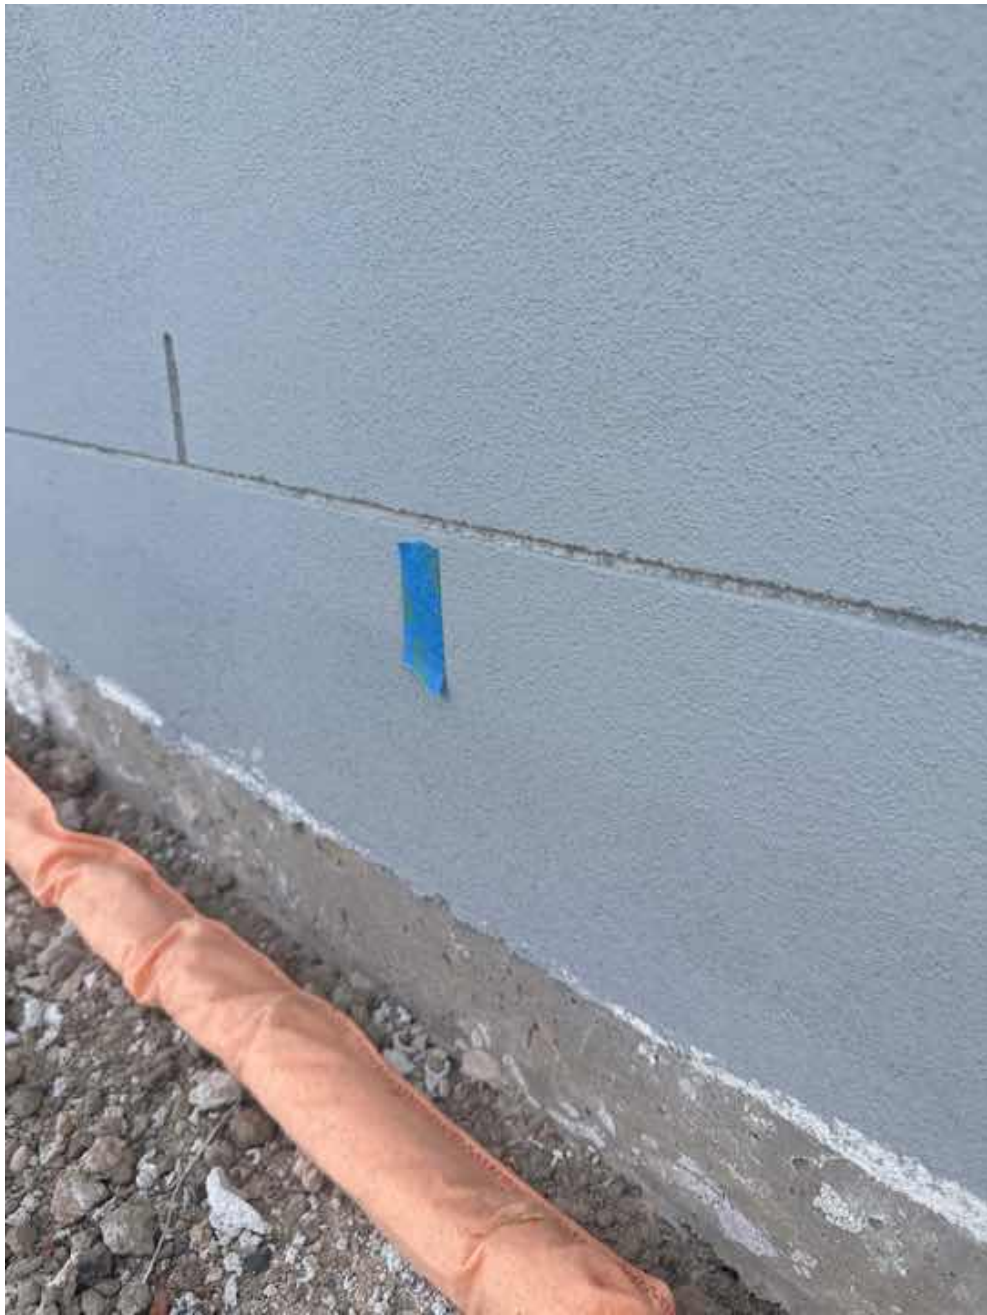
Paint touch-ups required to rendered surfaces.

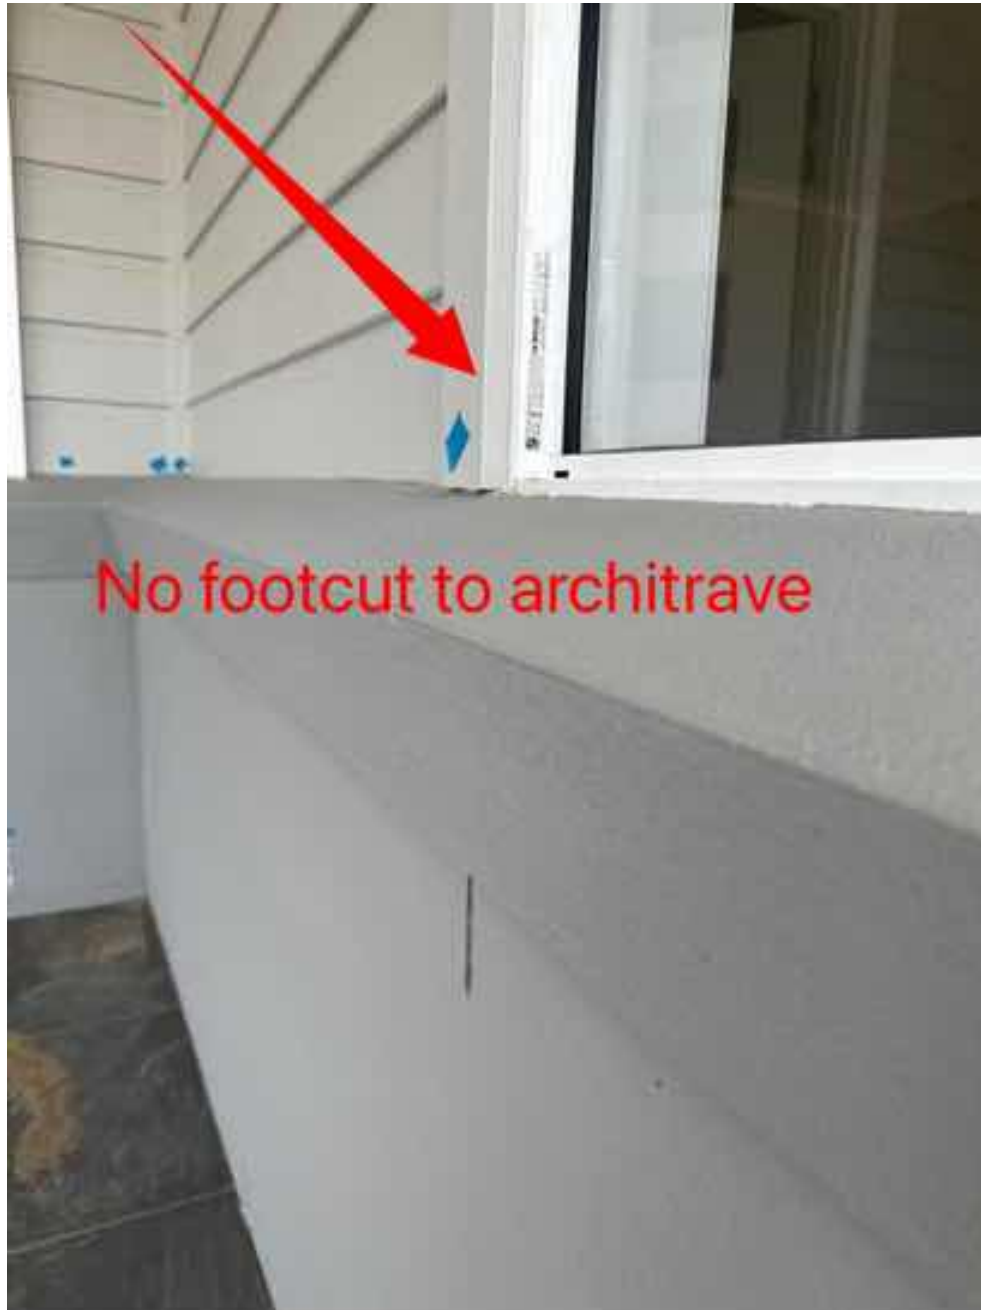
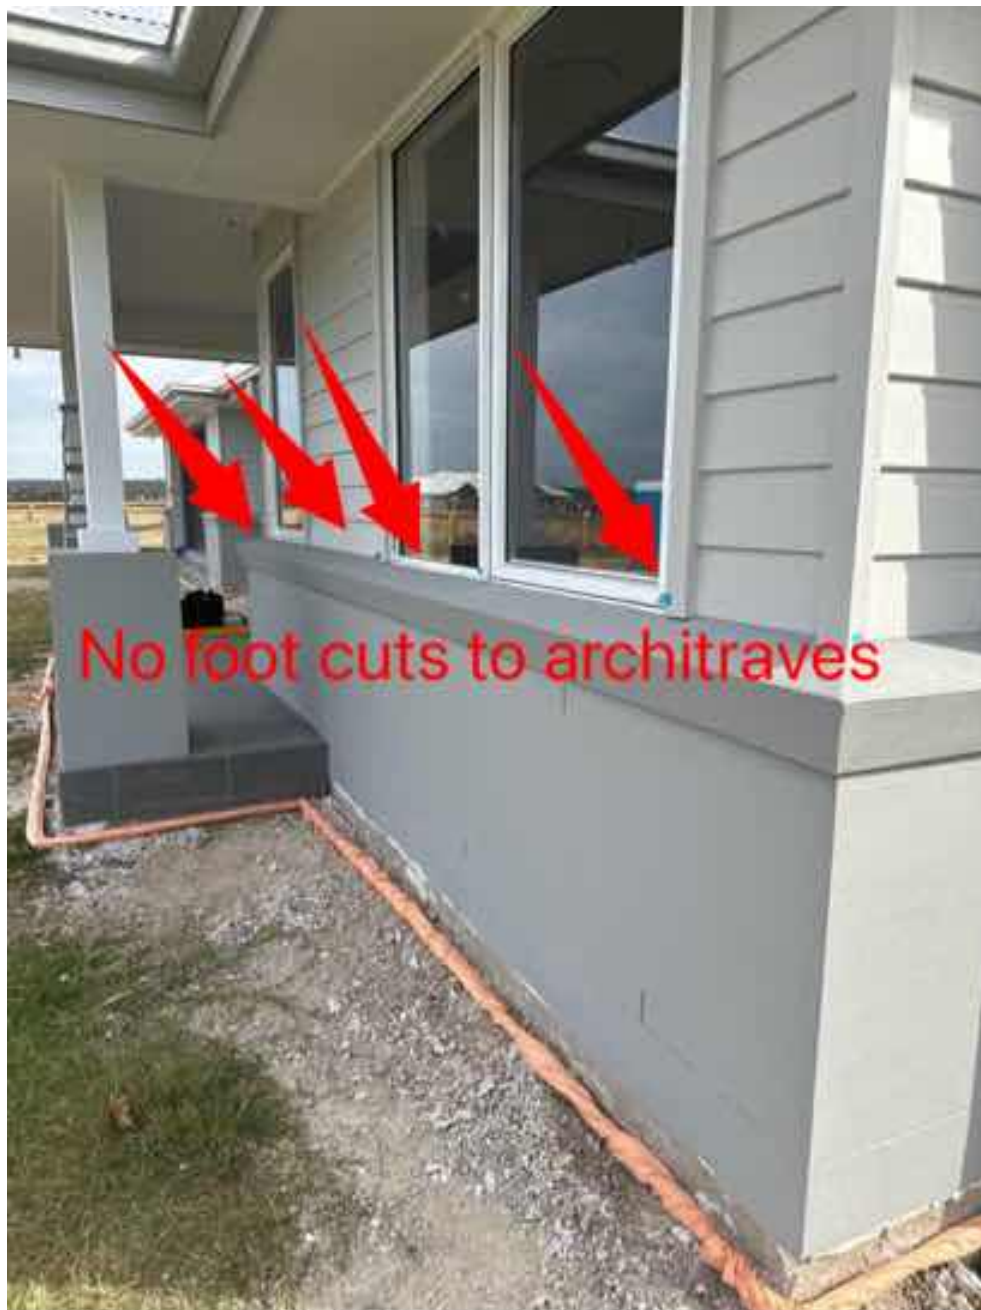
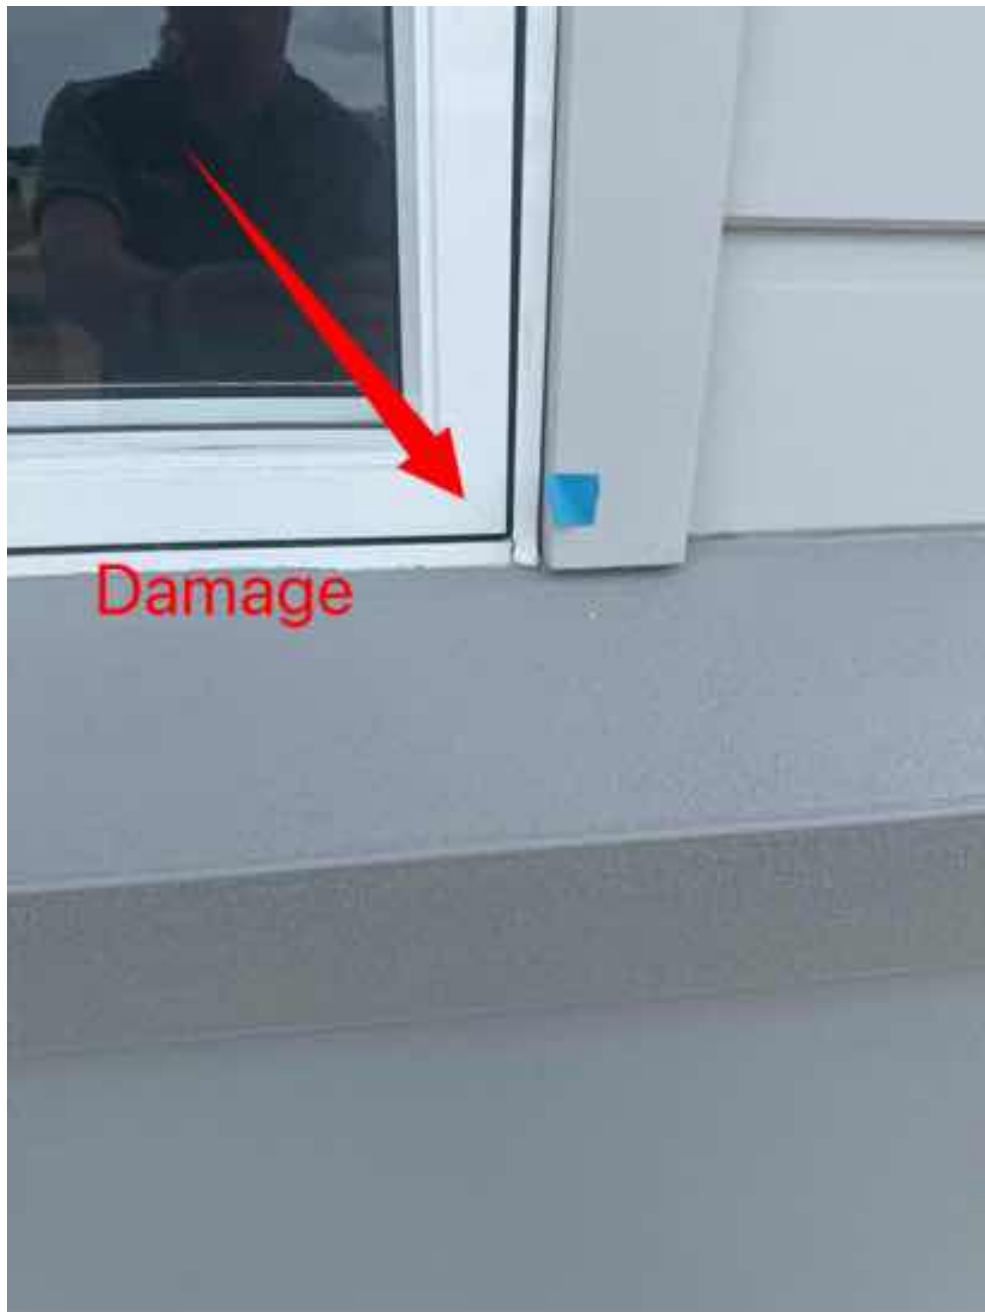
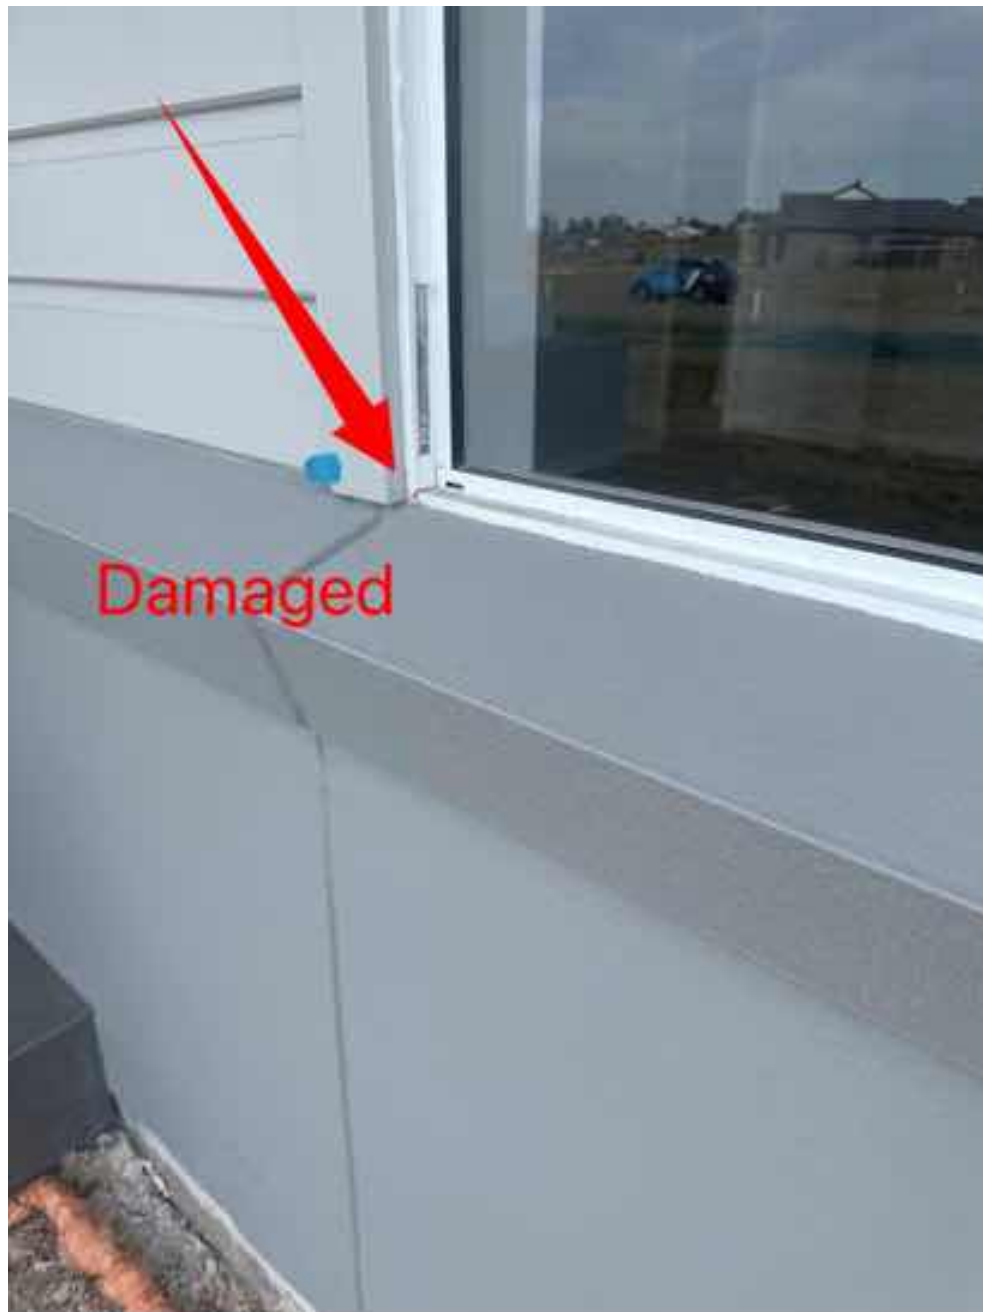
## Exterior Windows

The foot cut of the architraves in some locations has been cut square unlike other locations with an approx 20 degree cut. Rectification required.

There are scratches to aluminium frames, noticeable from a normal viewing position which is 1.5m. Amendment required.

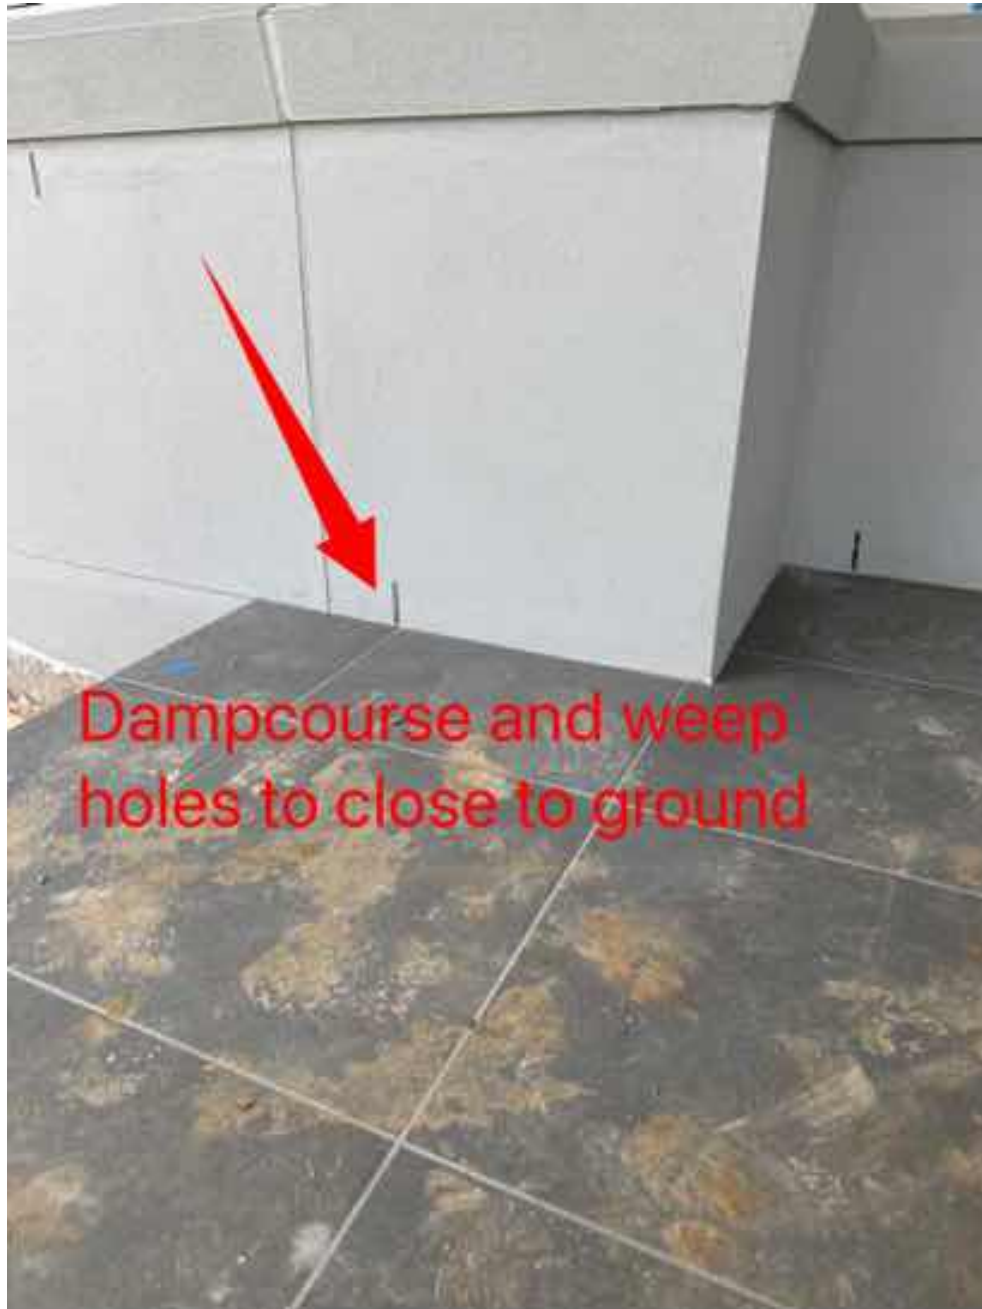
### Damp Proof Course

Damp course to close to ground or paved surface. The National Construction Code section 3.3.5.8 stipulates that damp proof courses need to be 150mm above ground level or 75mm above concreted or paved surfaces that slope away from the building or 50mm above concreted or paved surfaces that are protected by weather (carport or verandah)

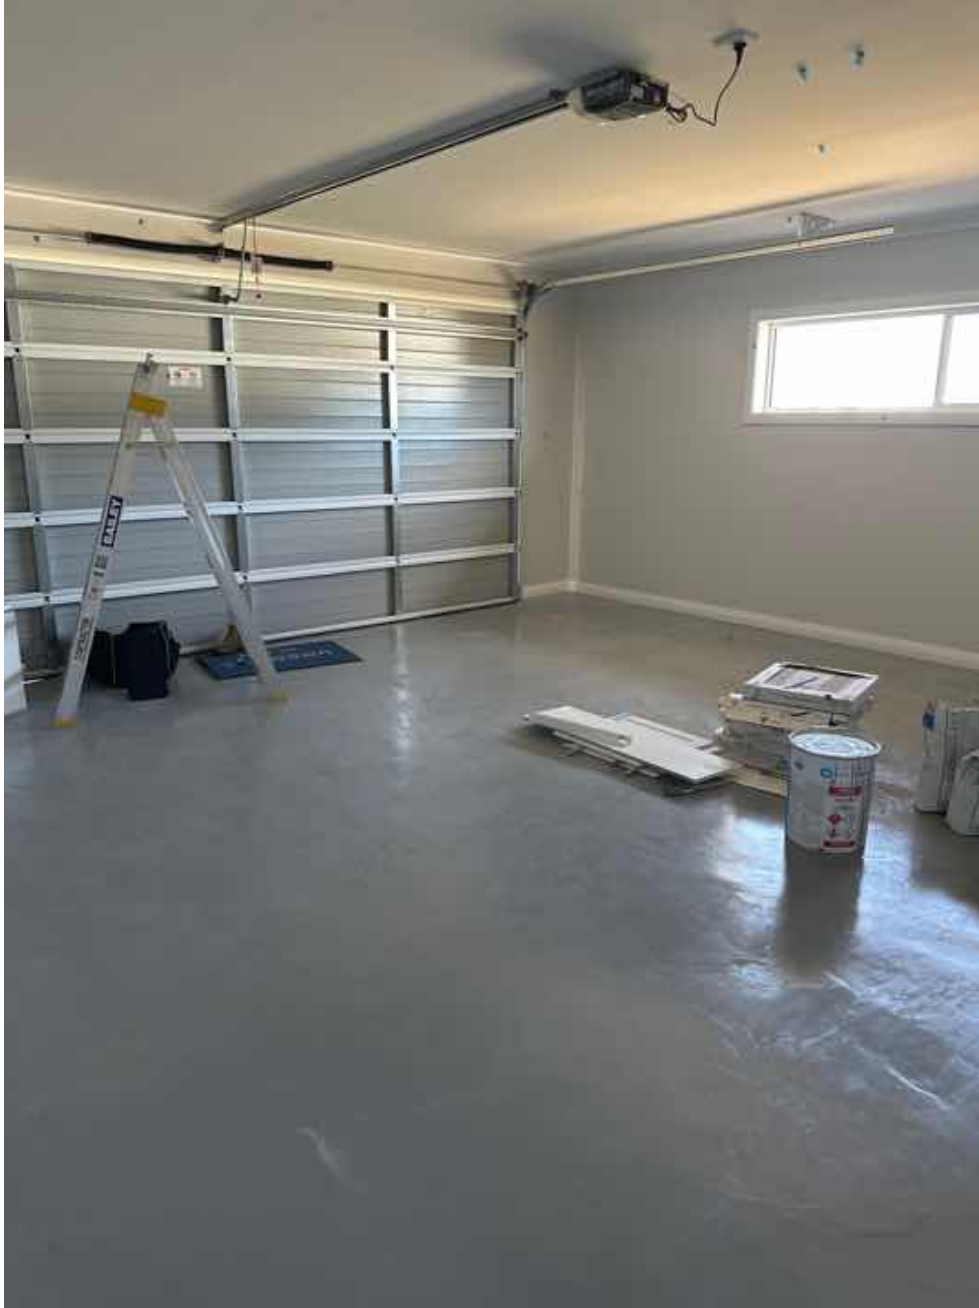
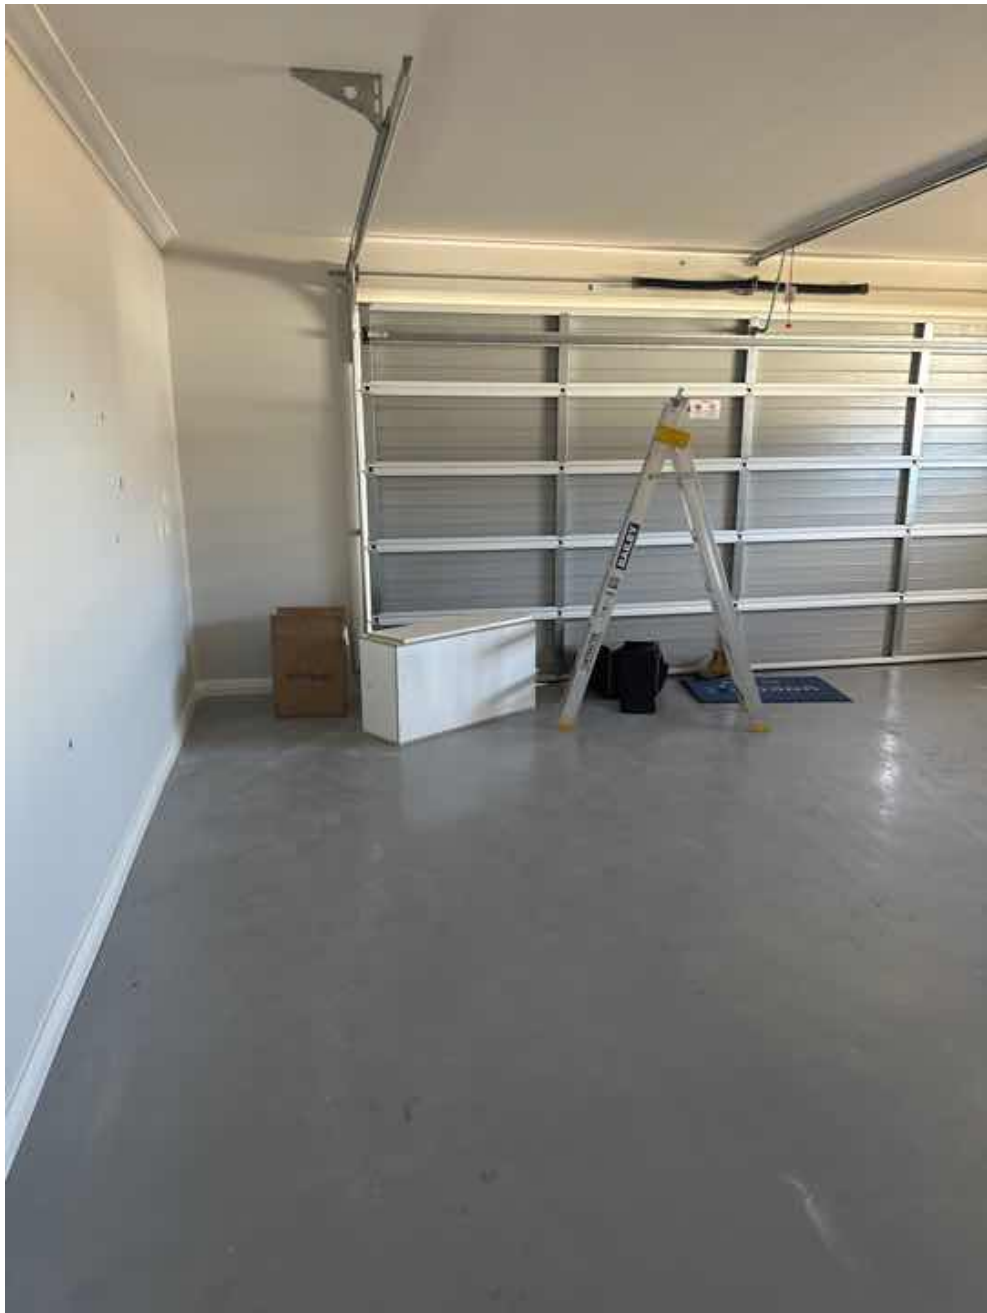
#### Overall Condition

Rectification work required  
A builders clean is required.

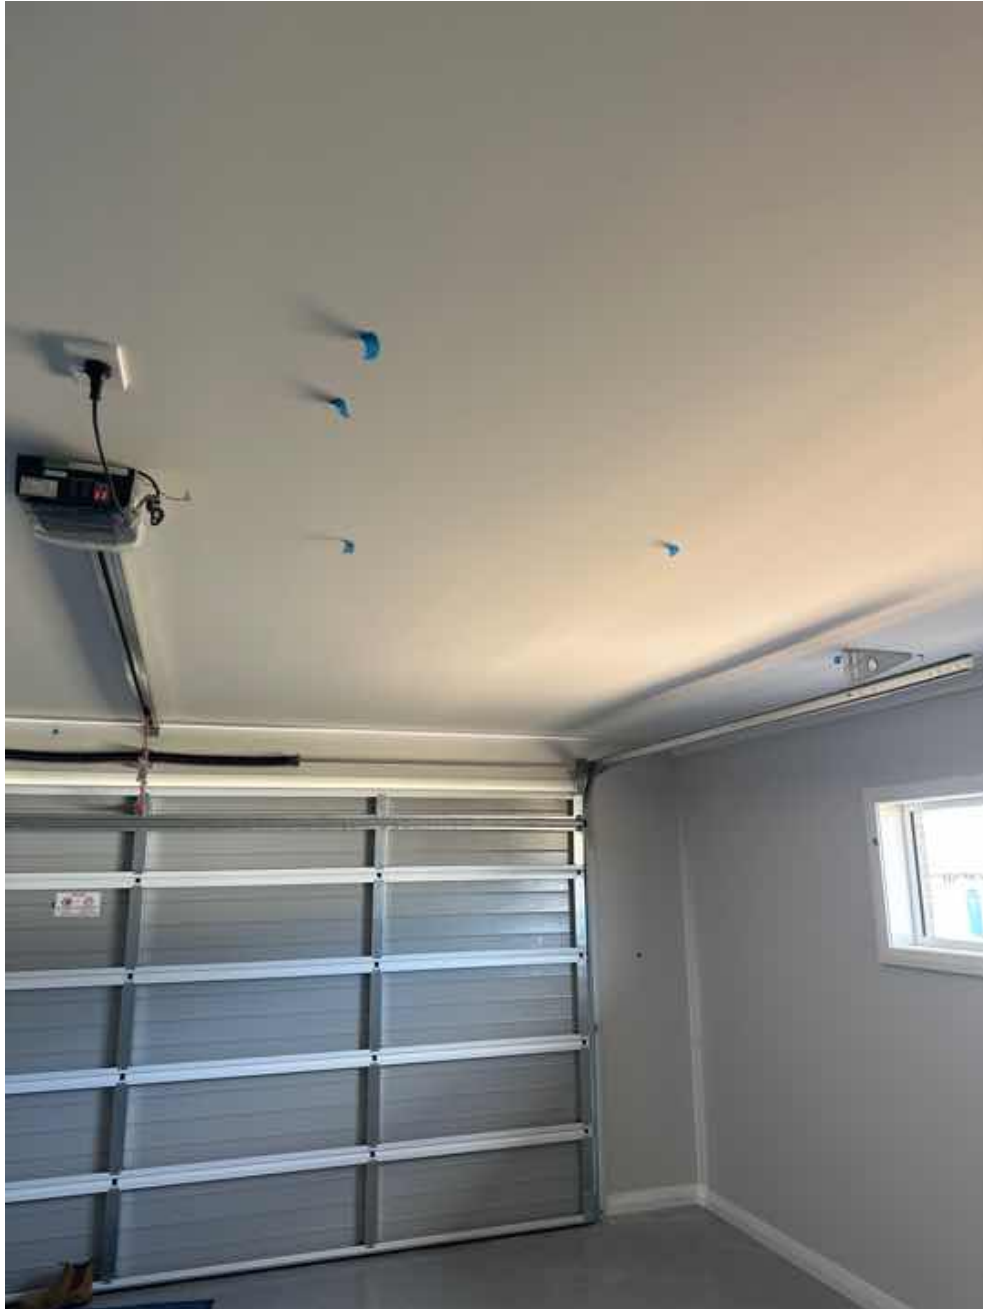
## Ceiling Findings

Paint touch ups required as indicated by markers
