# Inspection Report

**UNCOVER**  
BUILDING AND PEST INSPECTIONS

**1 Sample St , Sample, Nsw, 2281**

### Handover Inspection

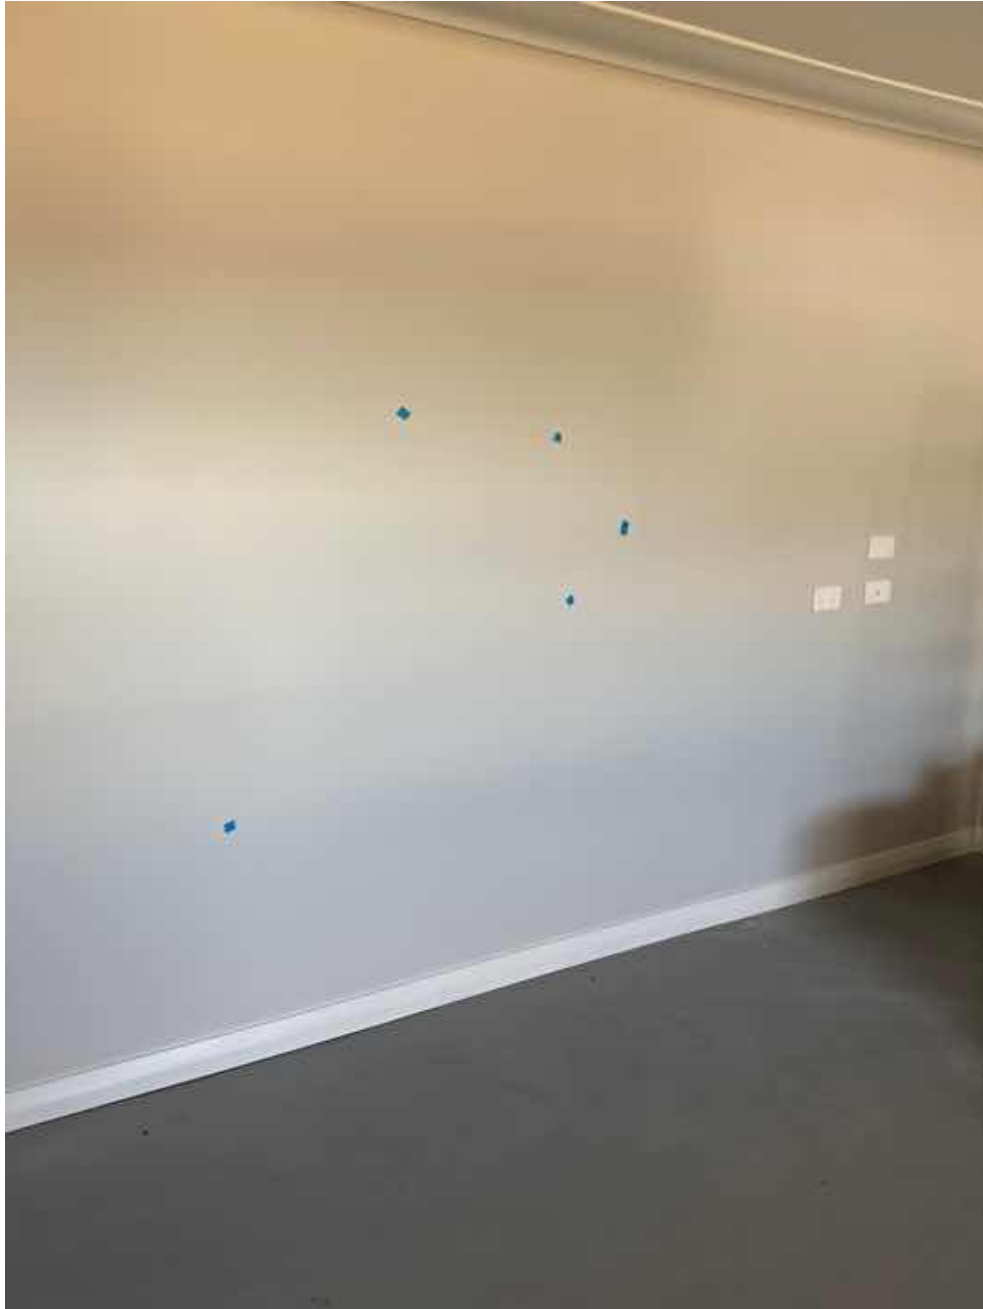
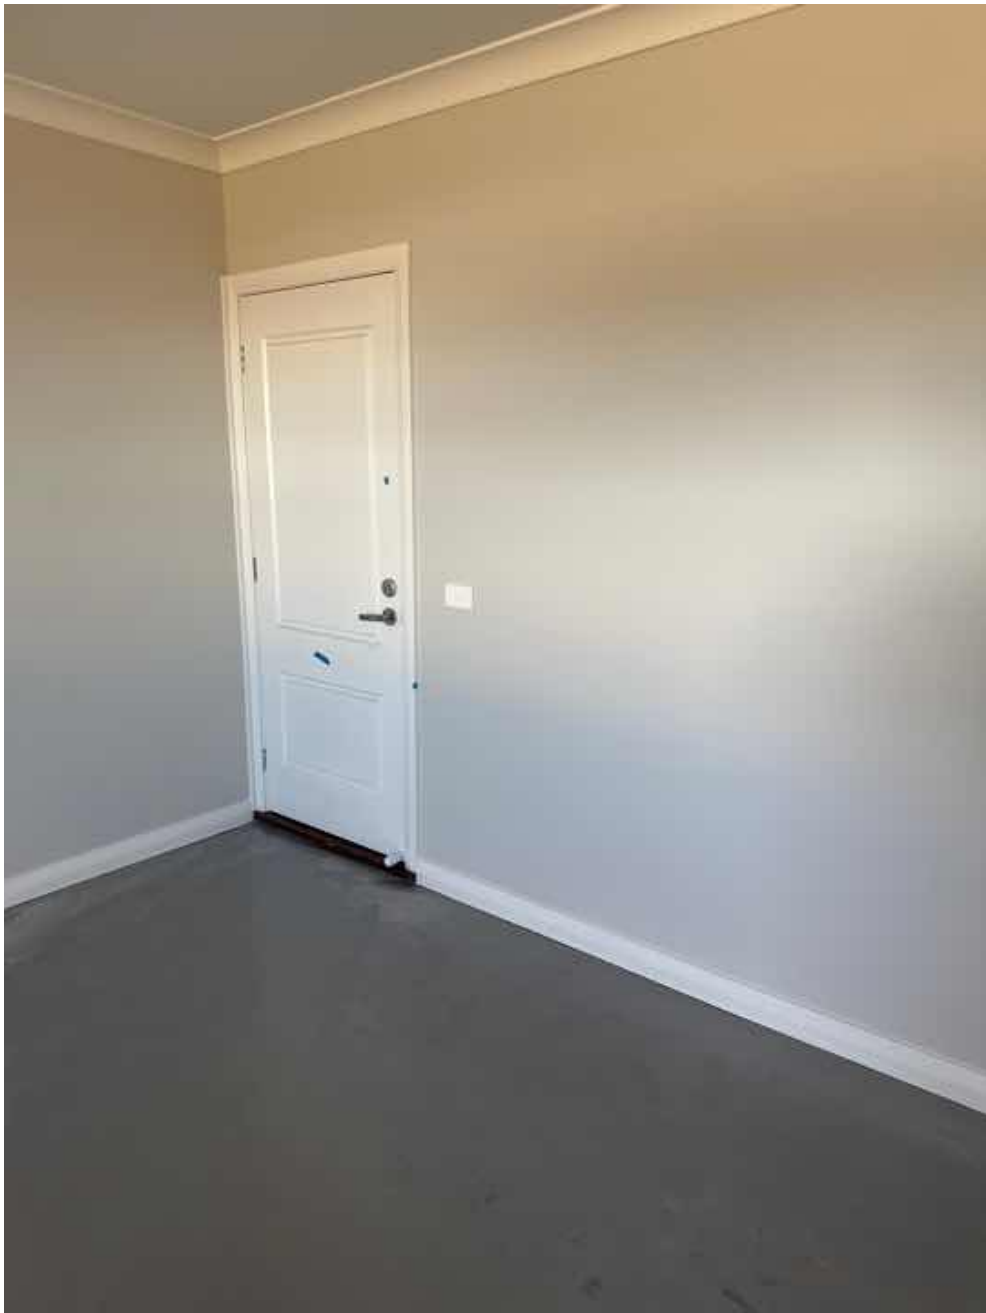
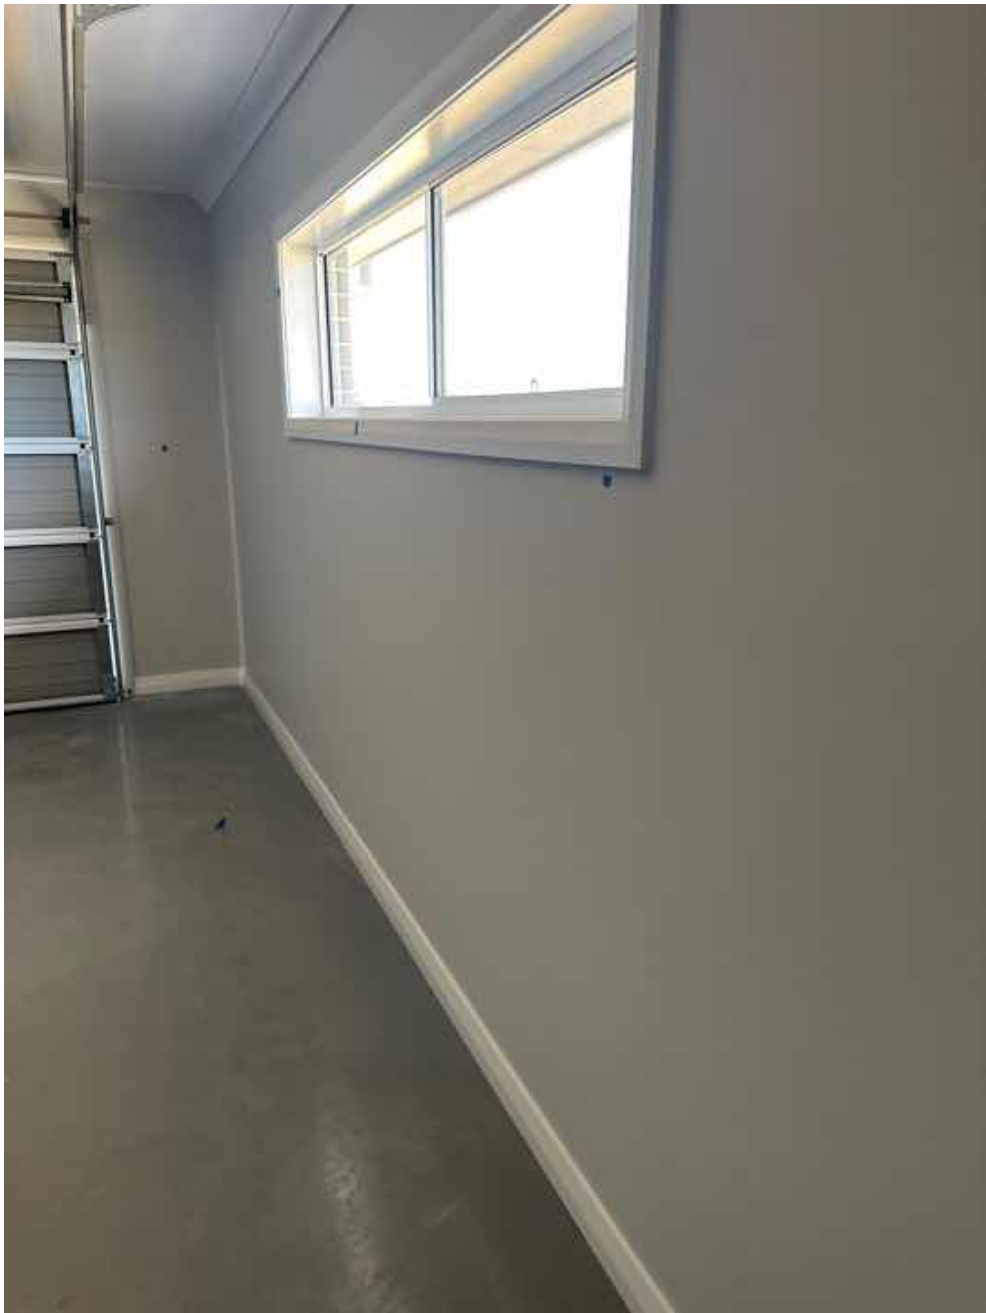
## Internal Wall Findings

Paint touch ups required

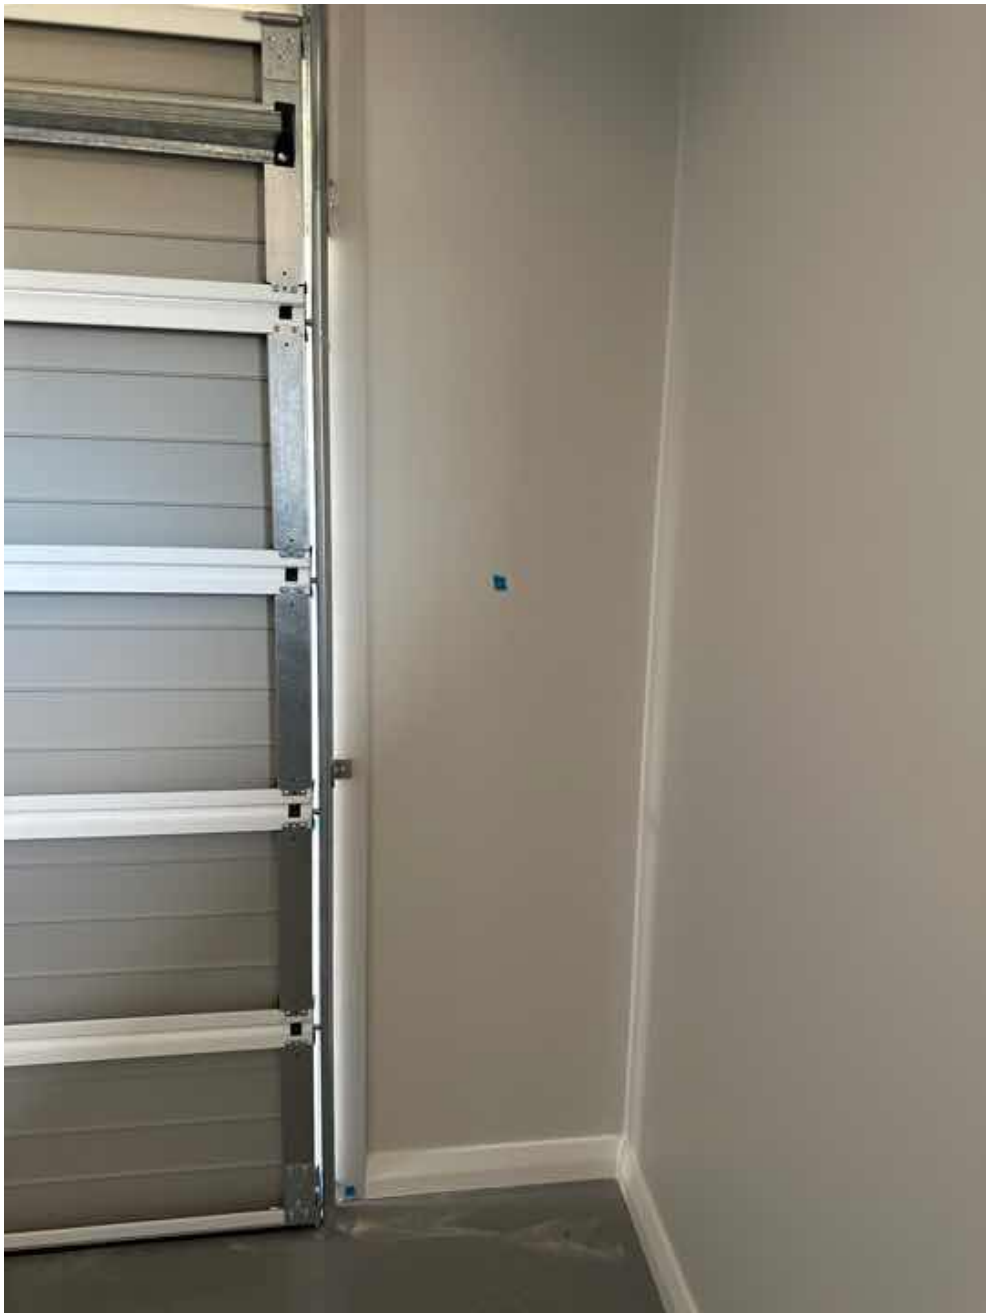
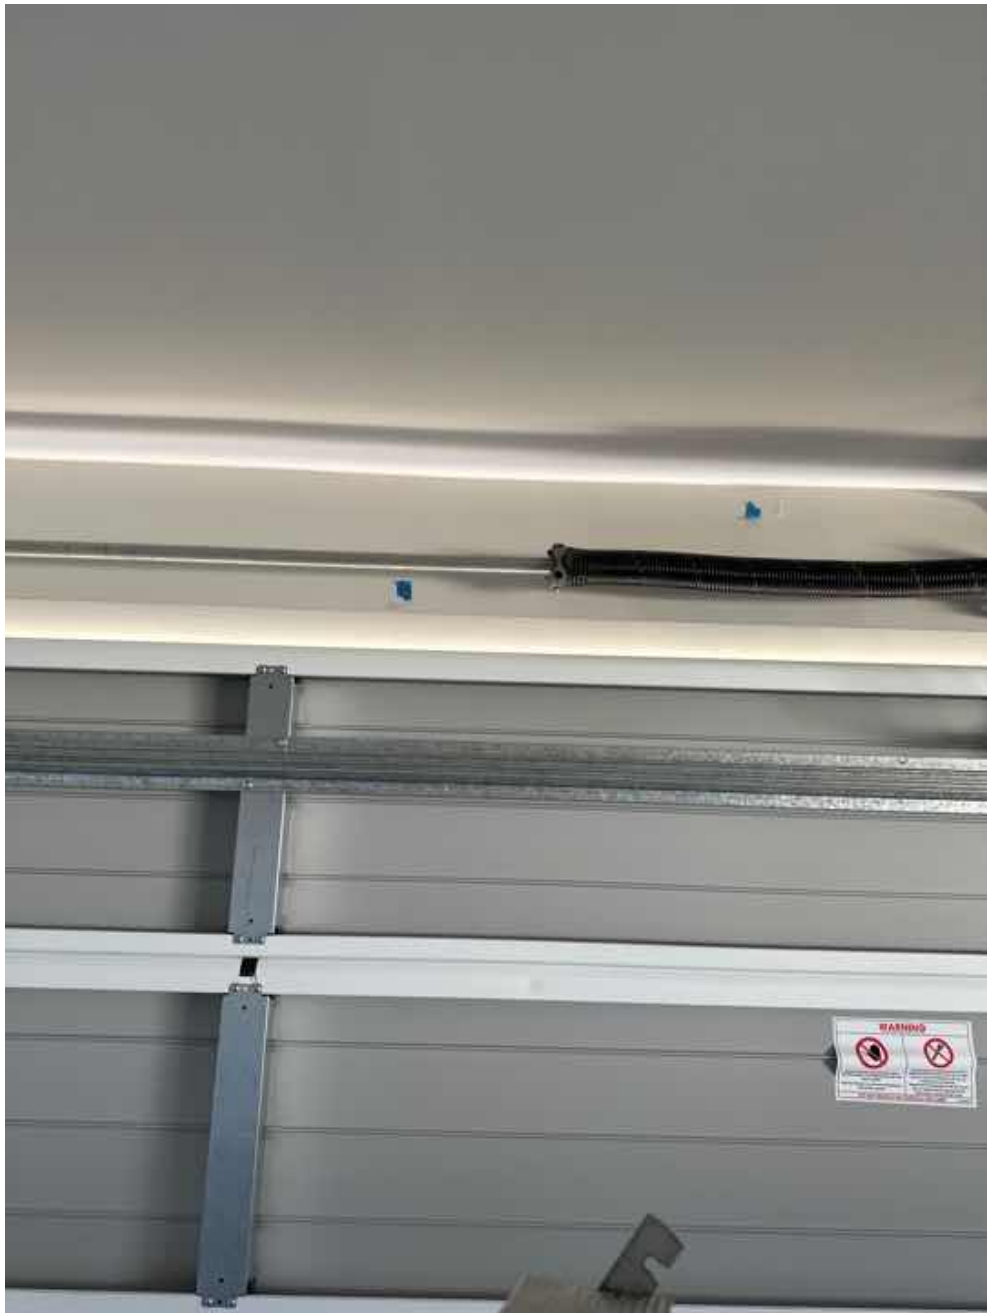
Weather seals not installed. In Accordance with the National Construction Code 2019 Amendment 1 Energy Efficiency clause 3.12.3.3, seals must be fitted to all external doors and internal doors between the house and the garage, where the internal garagedoor opens into a conditioned area. A draft protection device is to be fitted to the bottom of doors and seals to the remaining edges.

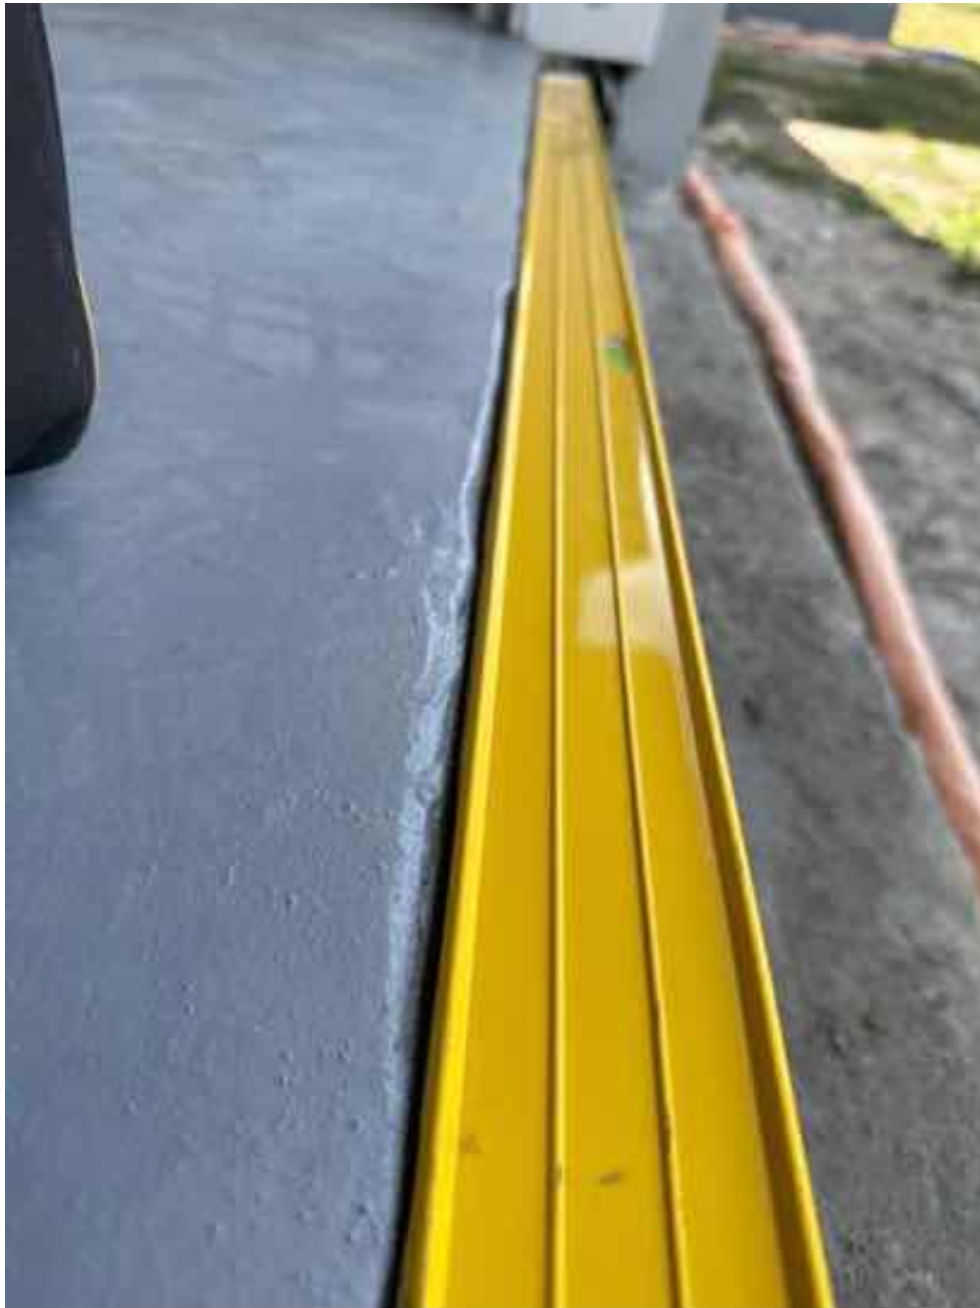
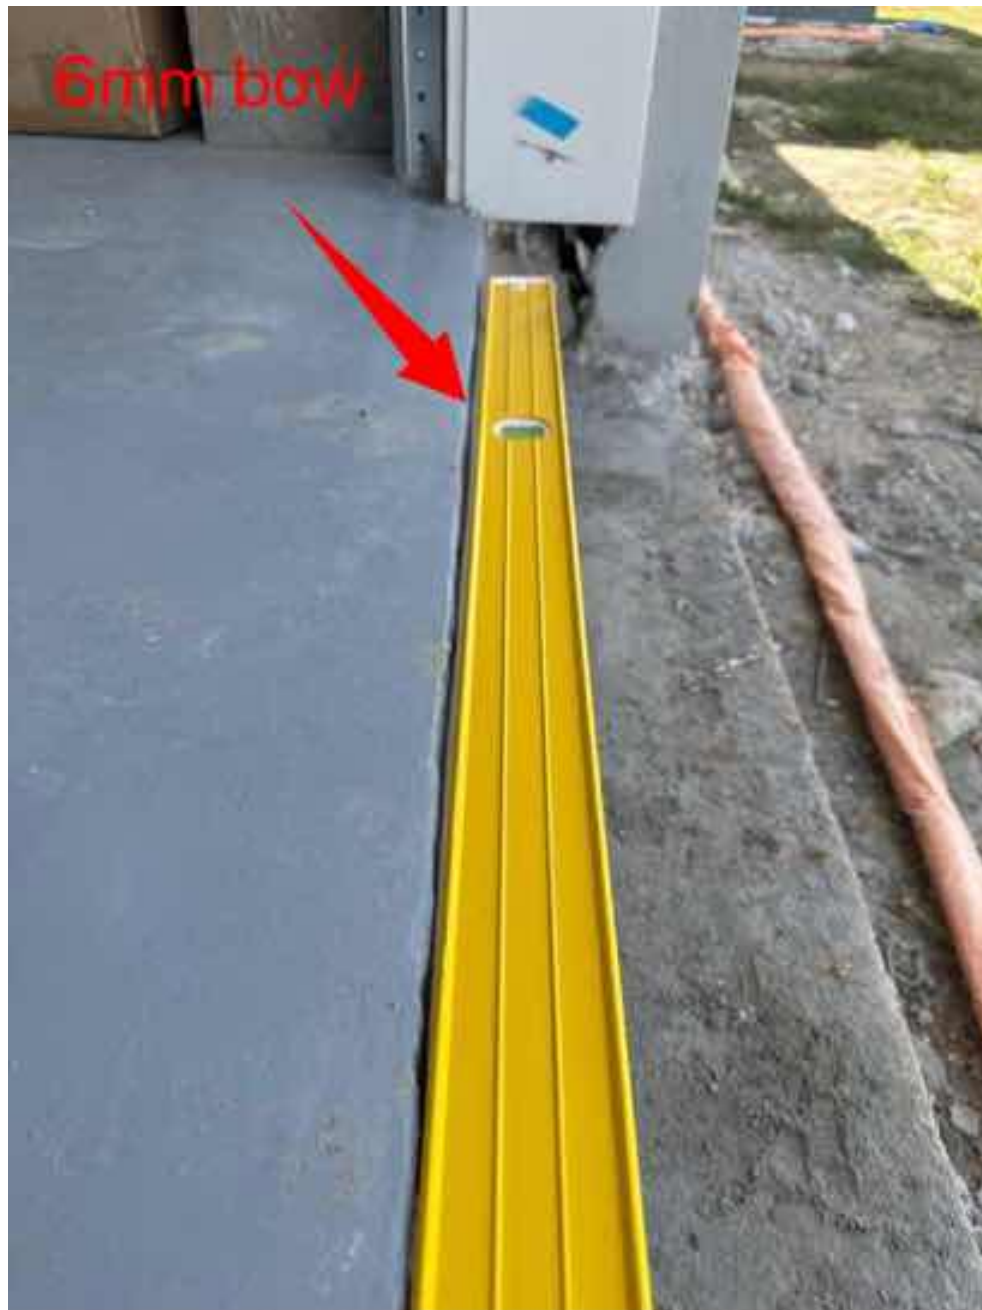
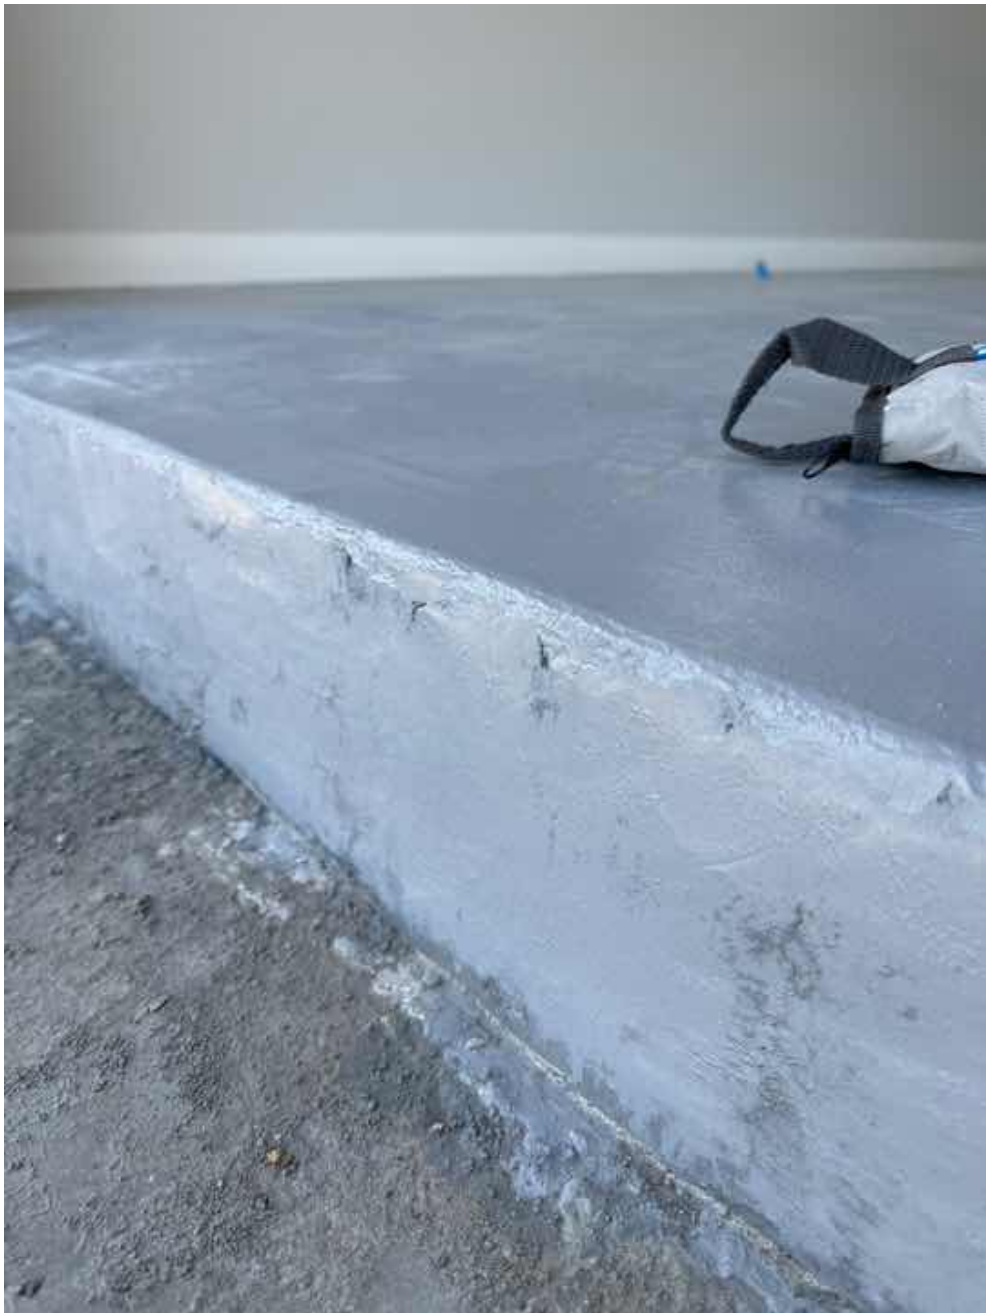
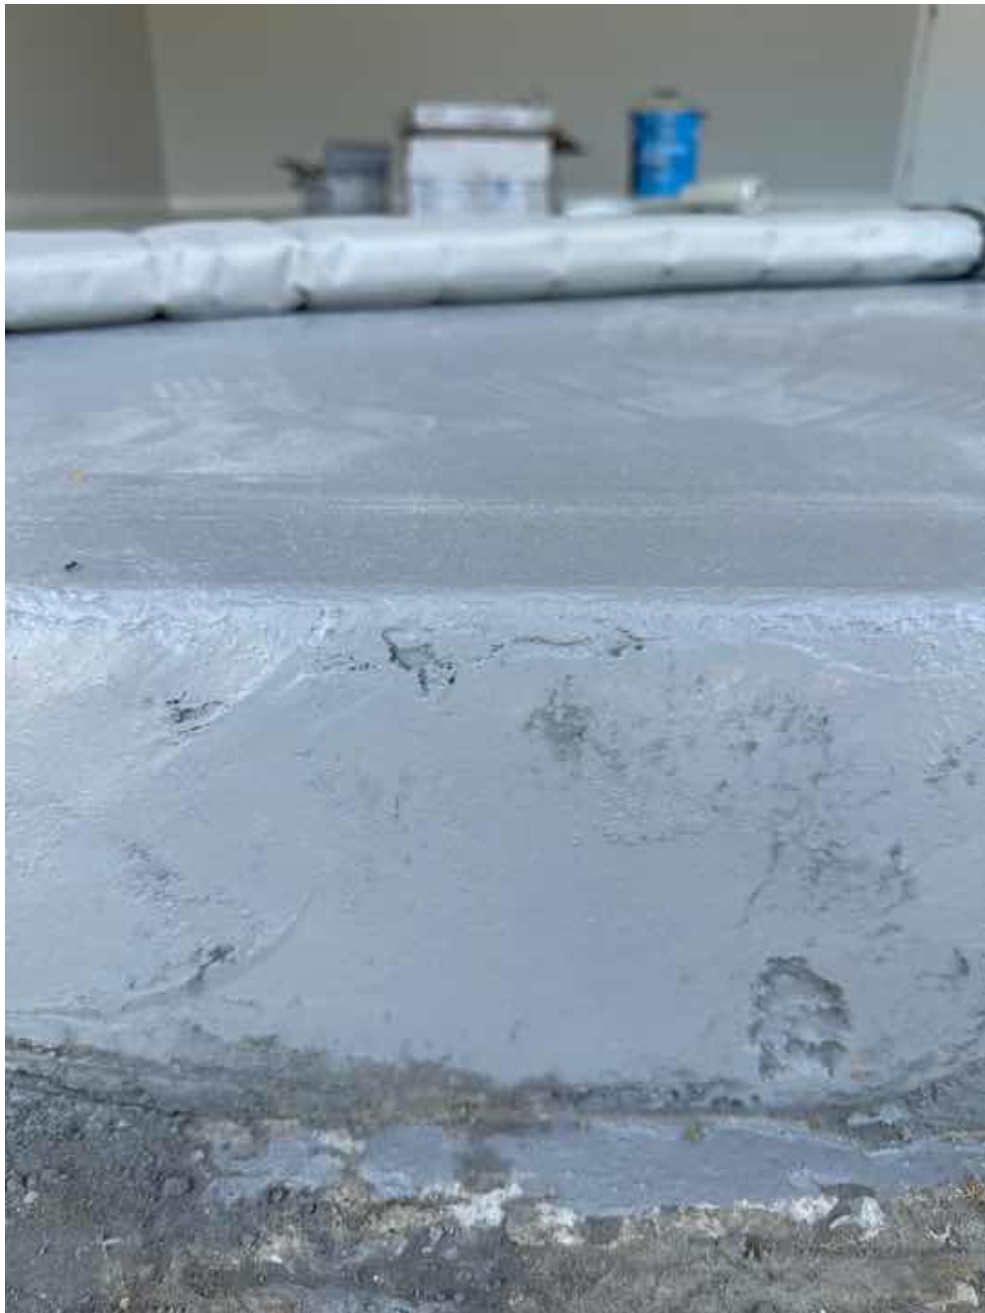
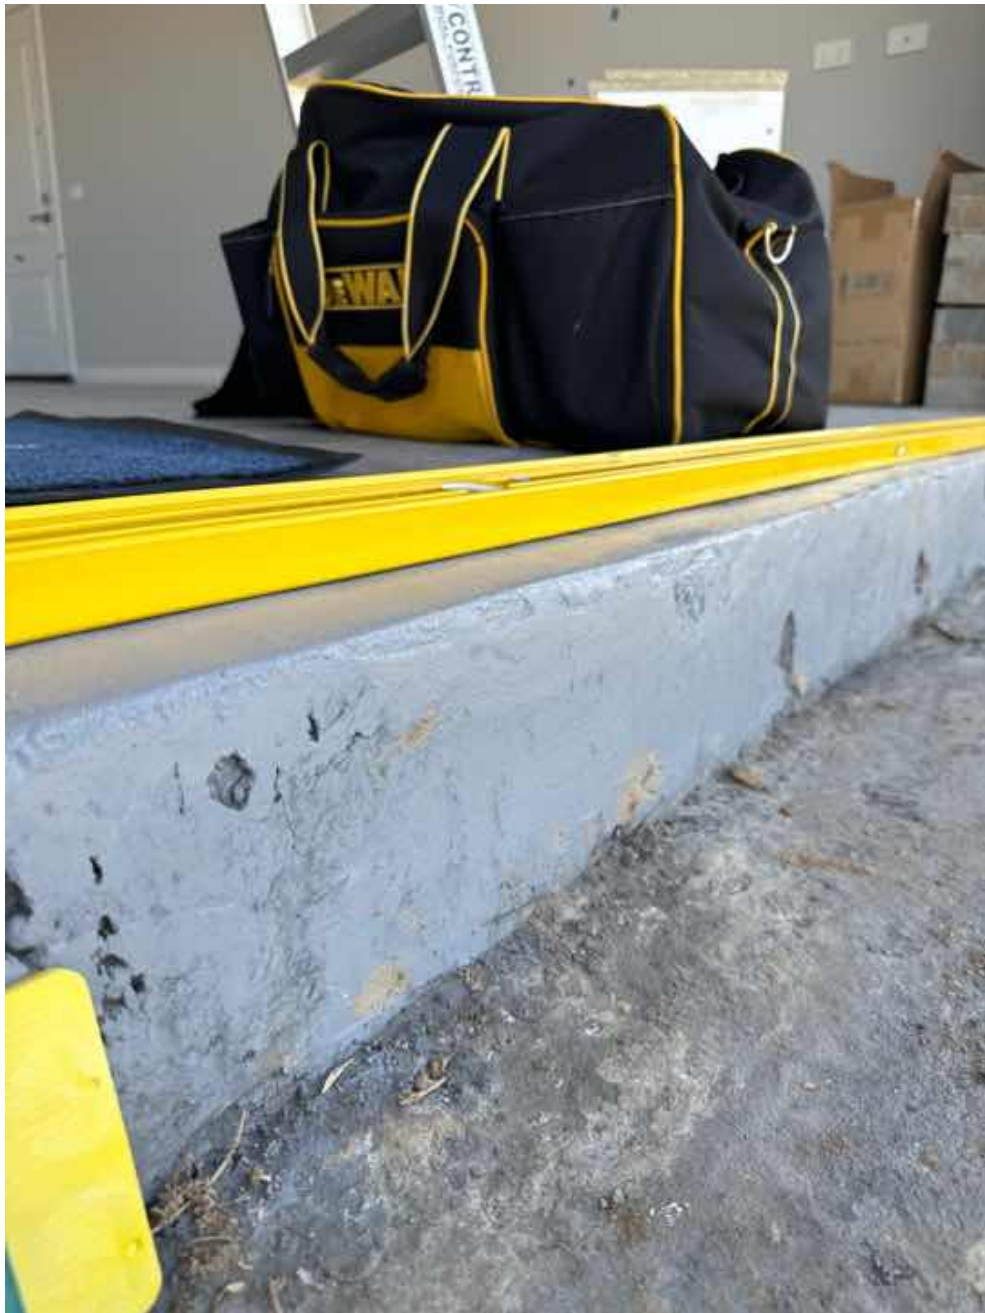
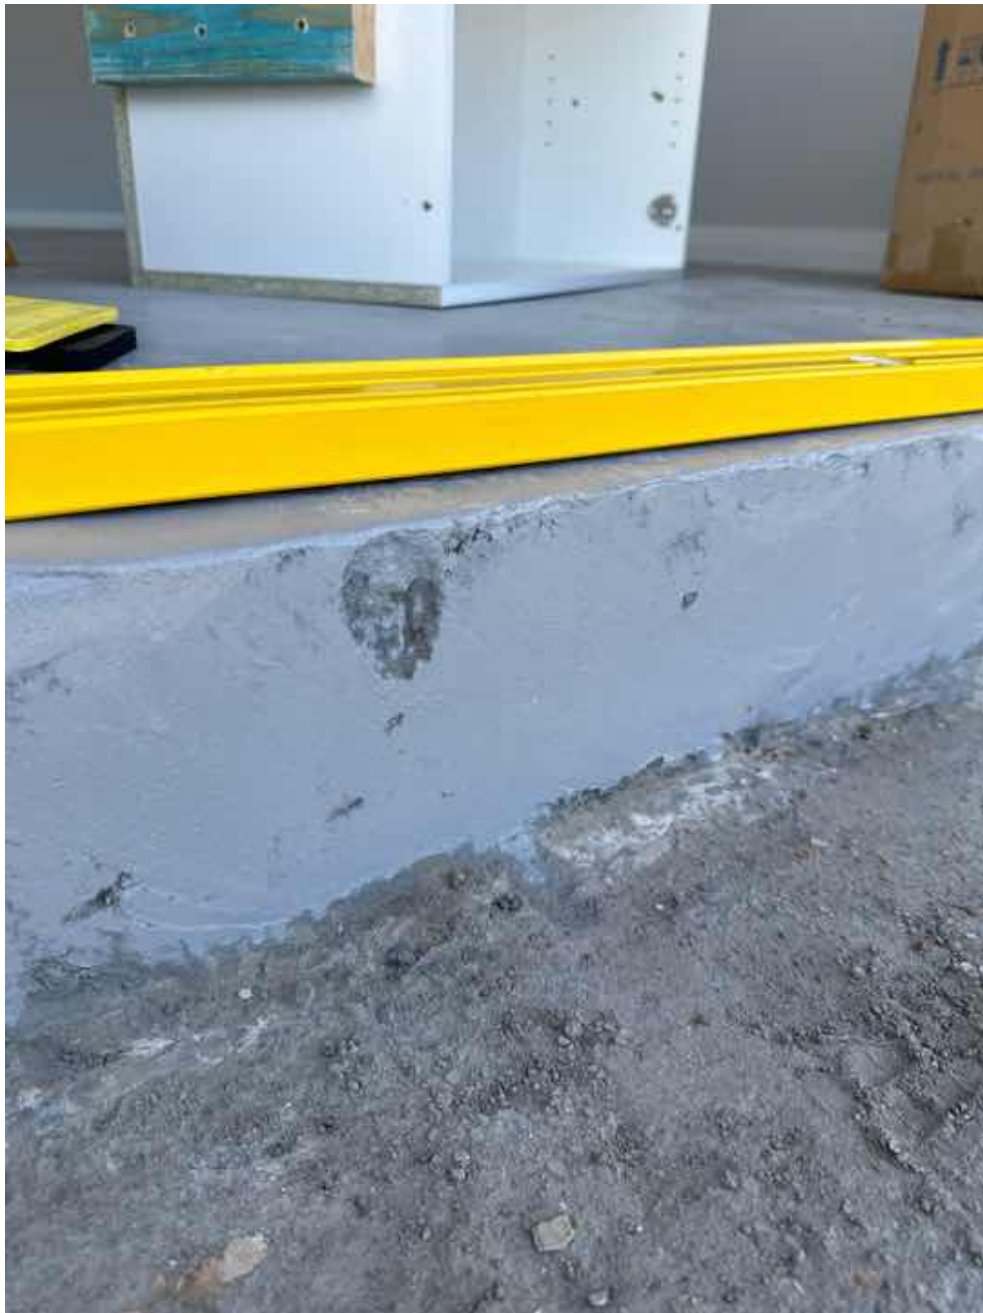
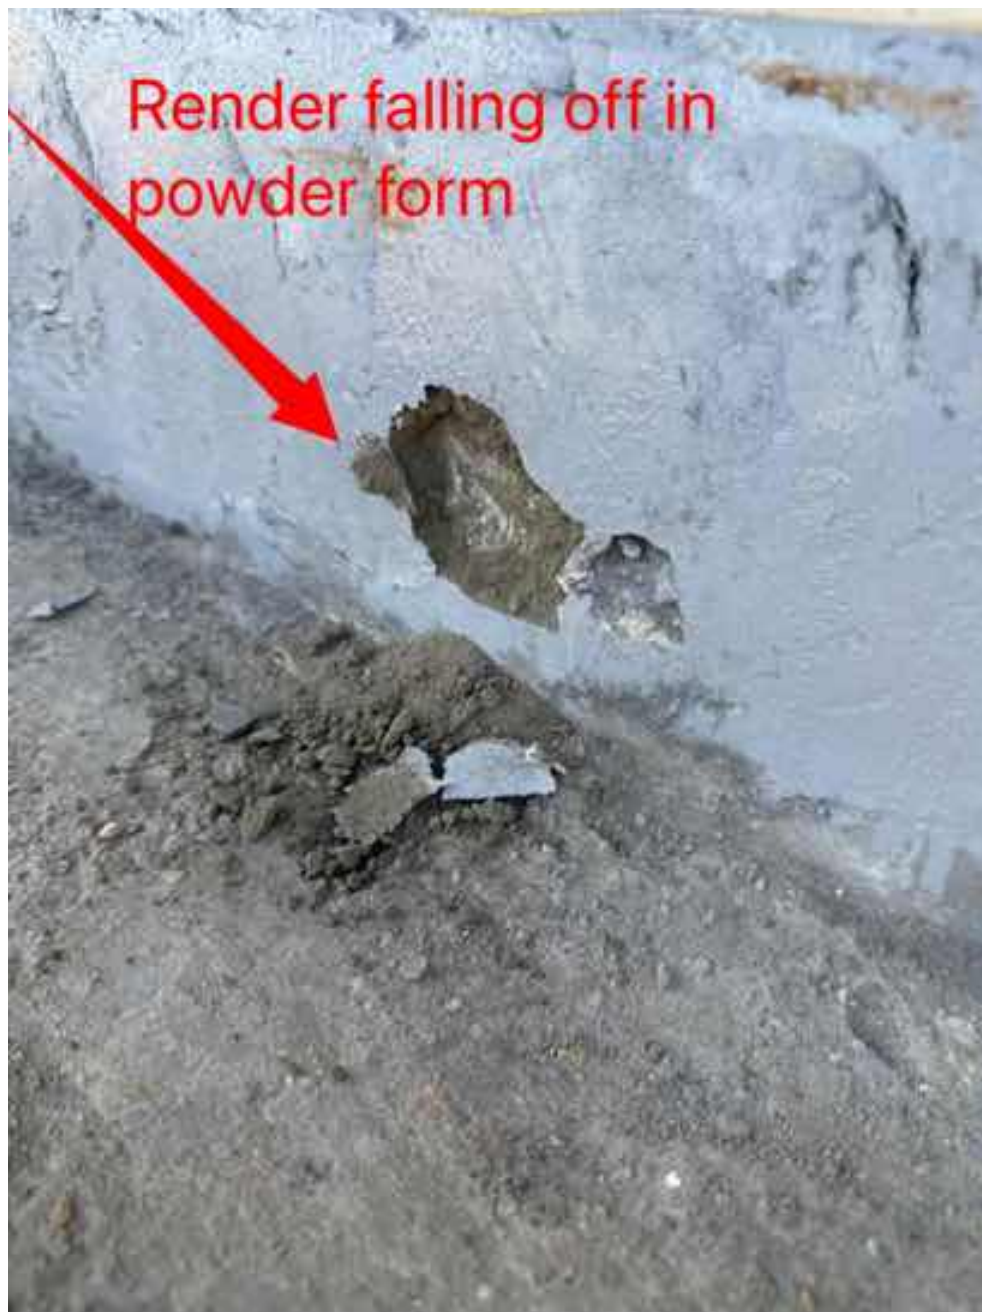
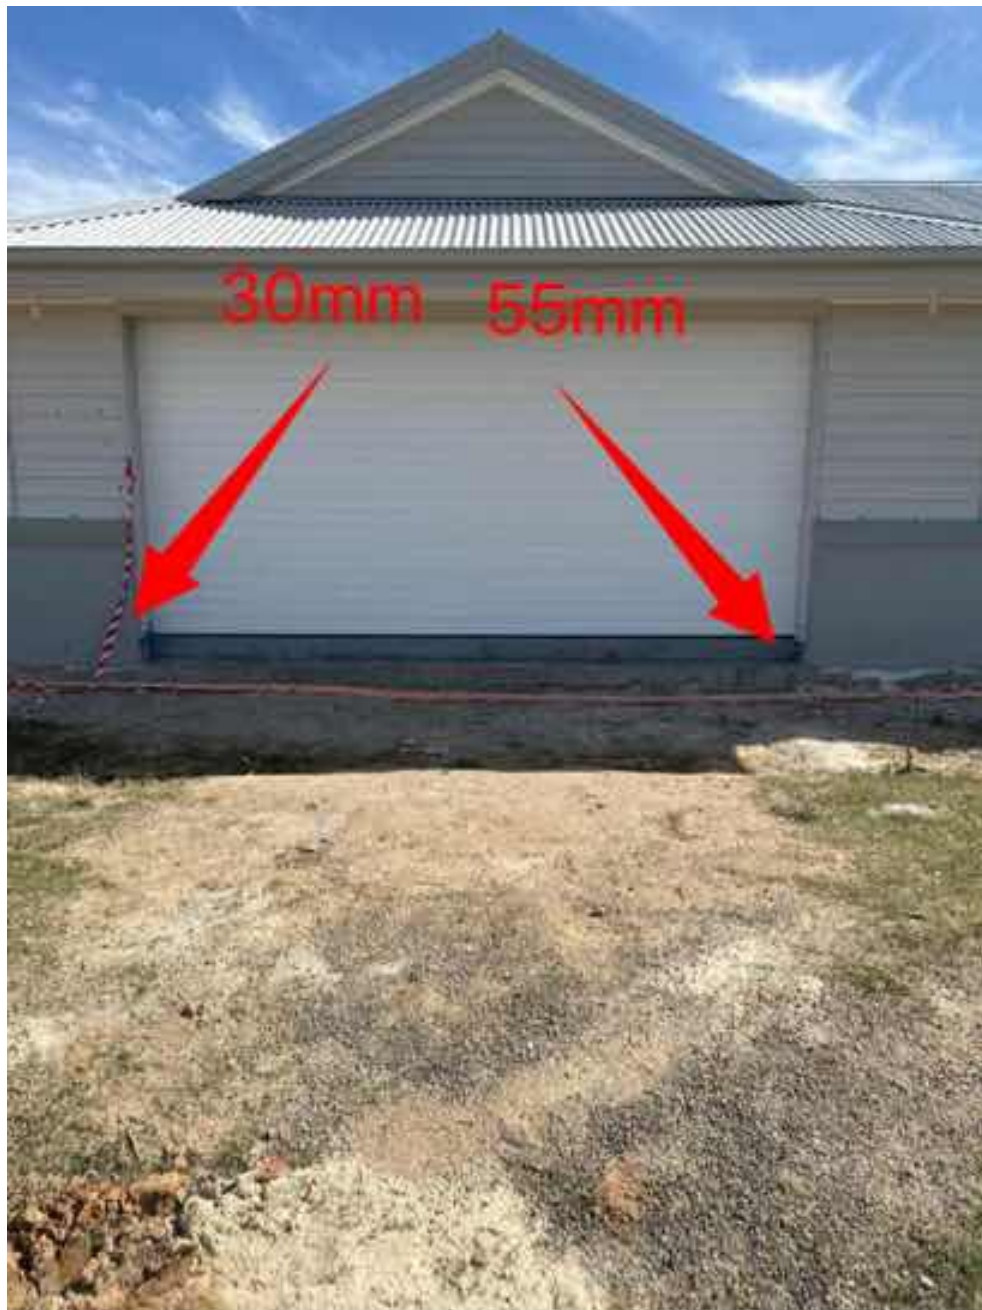
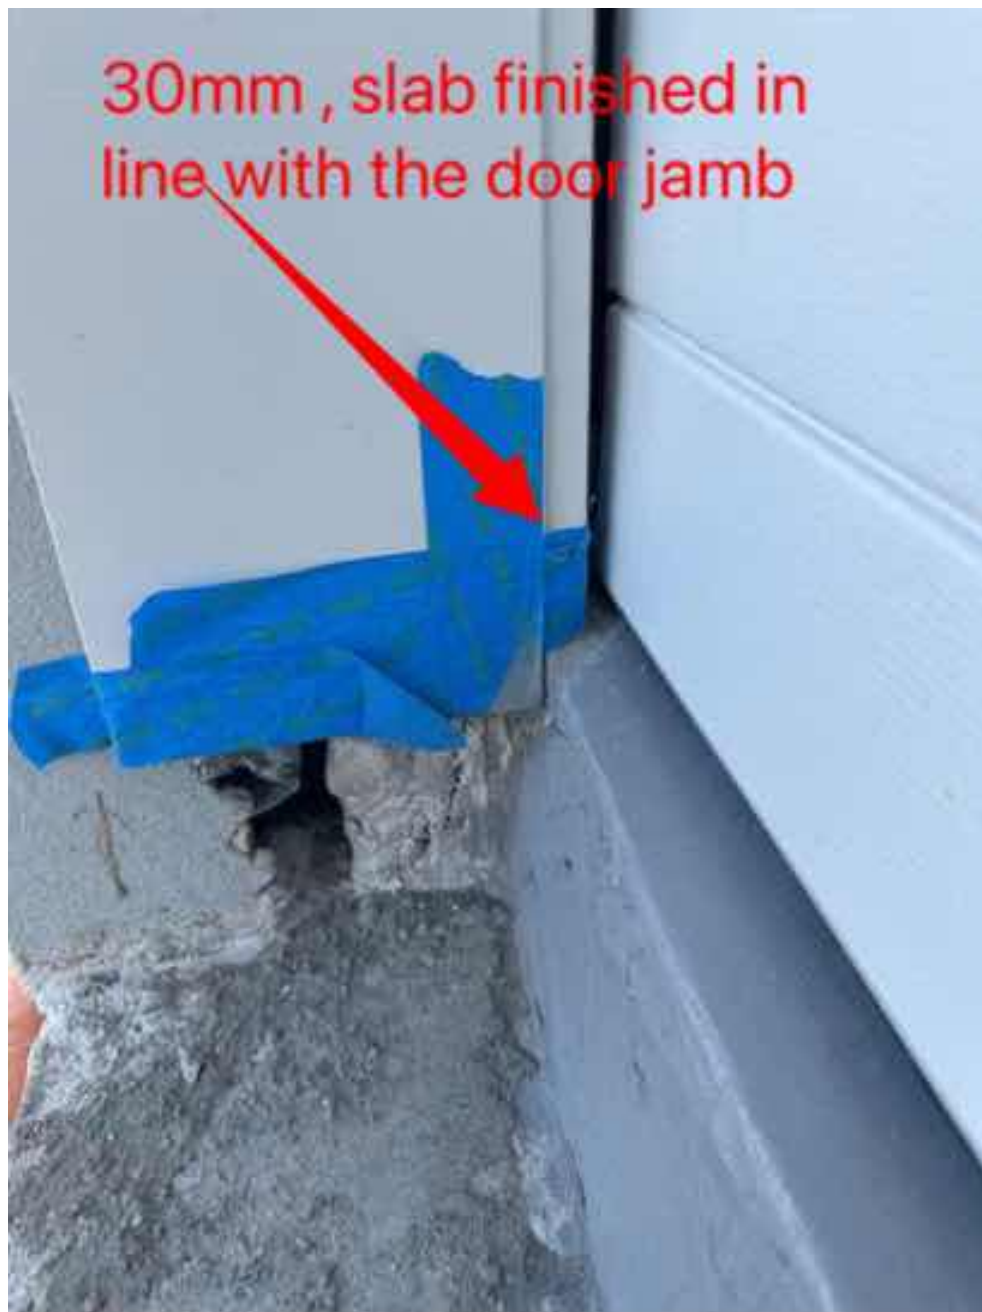
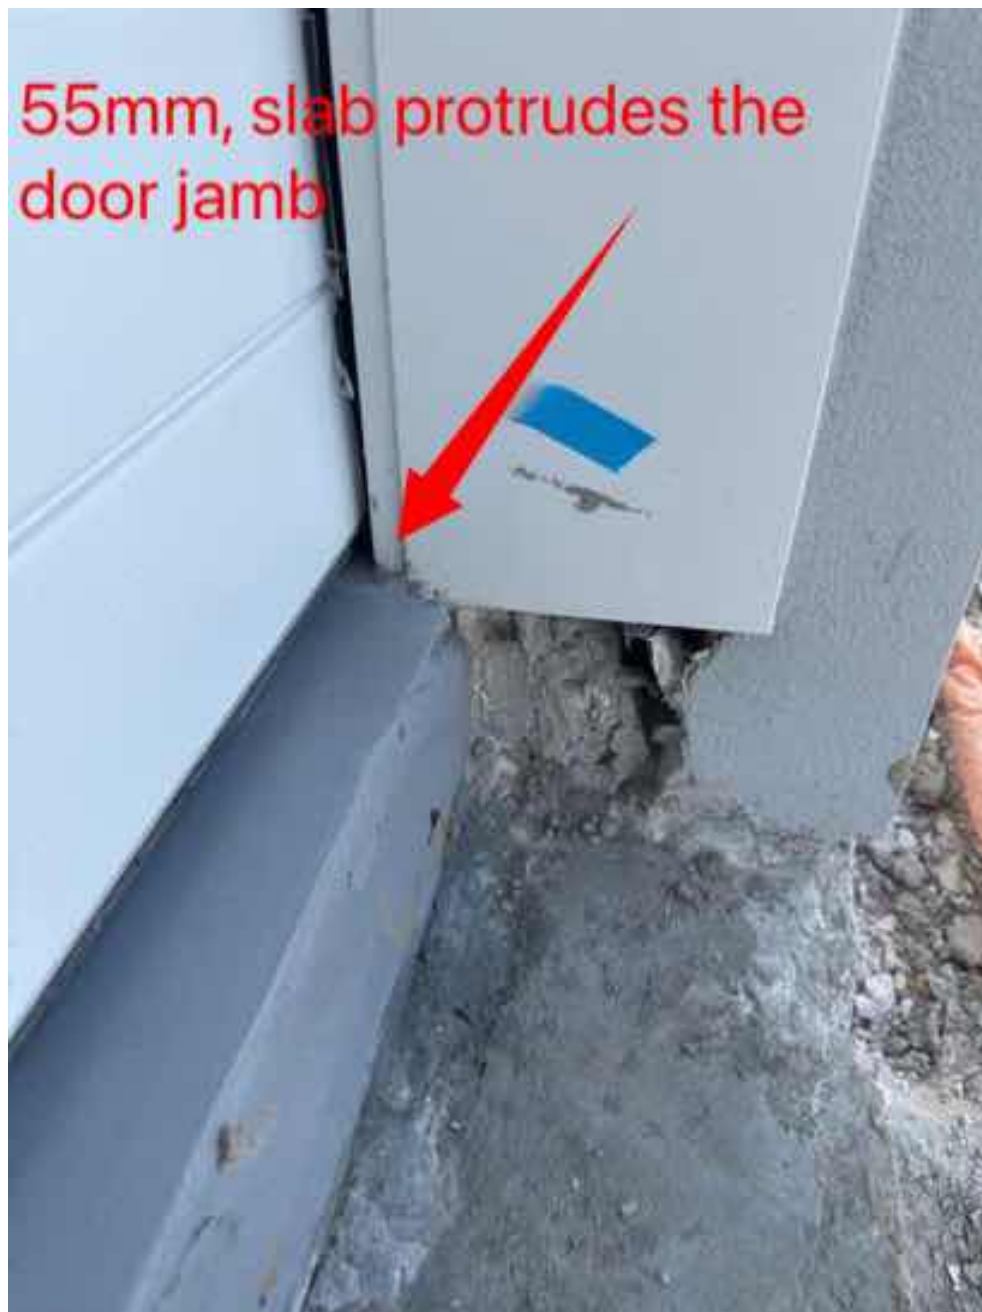
## Floor Findings

Clean required

Surface damaged throughout the concrete floor, dirt and debris sealed over. We suggest you ask the builder have the top surface ground and re sealed to make an appropriate level of exposed concrete surface finish. The front edge of the concrete slab it not straight and bowed in several locations along its length. The front edge of the slab has a bow of approx 6mm over a 2m length.

The front edge of the garage slab has been rendered with a cement based product. This product is not adhered to the face of the slab and is falling off in powder form. Recommend removing entire product and re rendering with an appropriate product.

The garage front edge of the concrete slab is not parallel with the garage door or door jamb. The concrete slab protruded forward of the garage door by approx 30mm on the left hand side and 55mm on the right hand side. Amendment required
