# Inspection Report

**UNCOVER**  
BUILDING AND PEST INSPECTIONS

**1 Sample St , Sample, Nsw, 2281**

### Handover Inspection

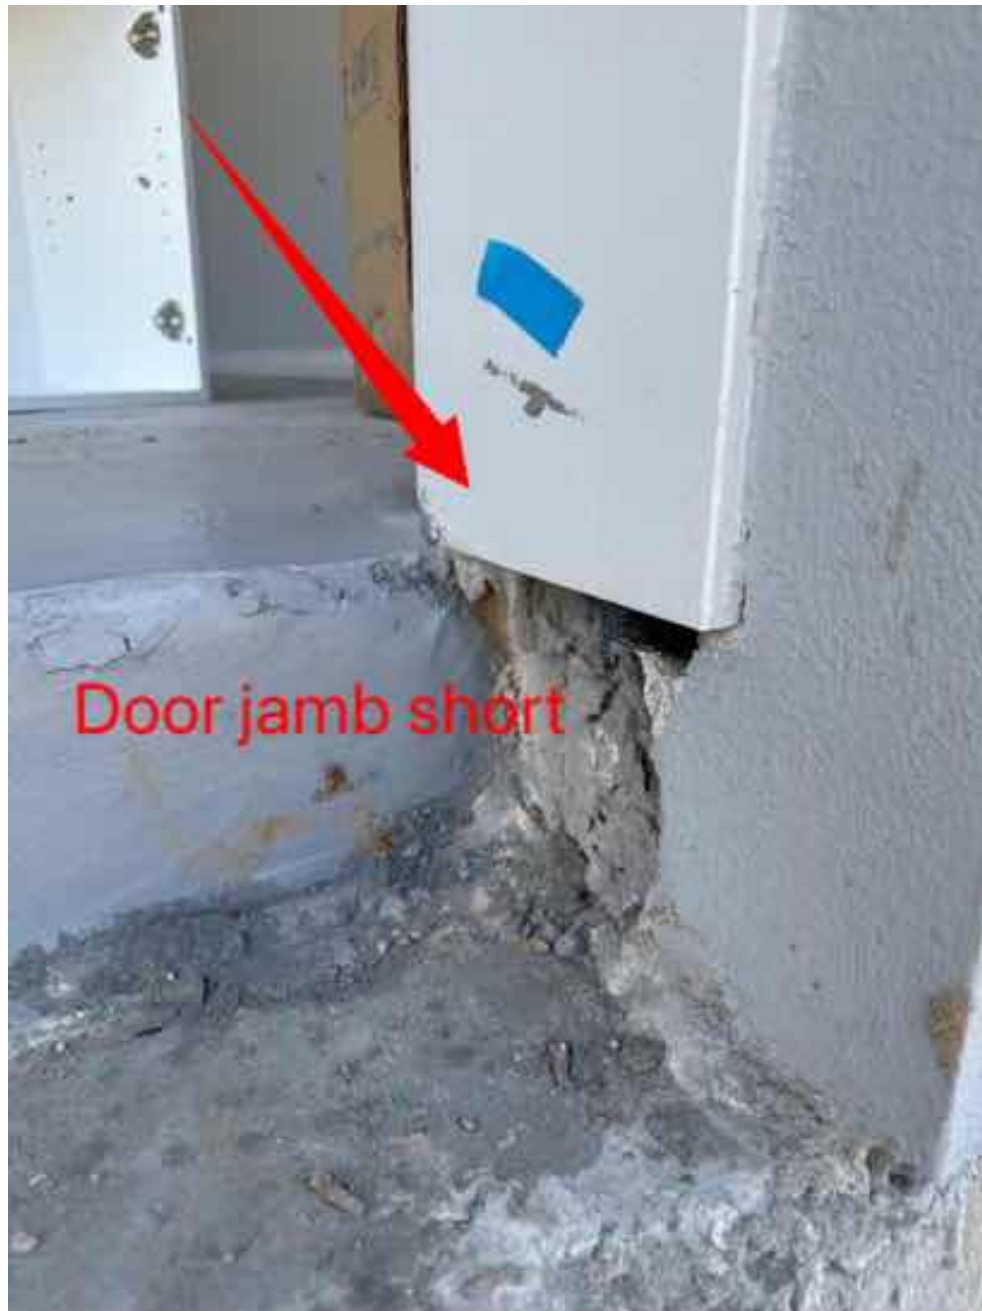
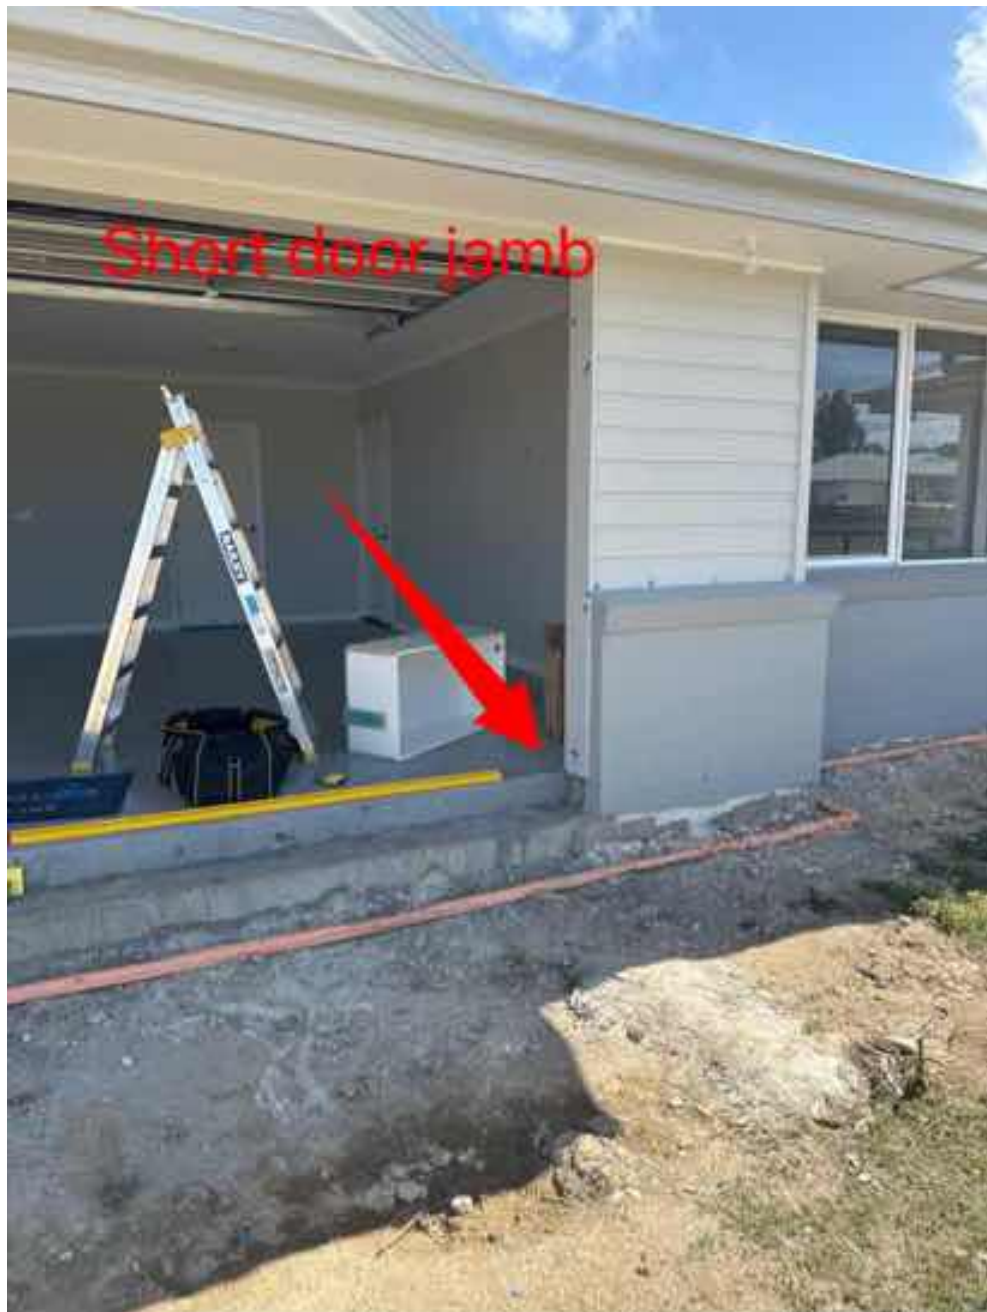
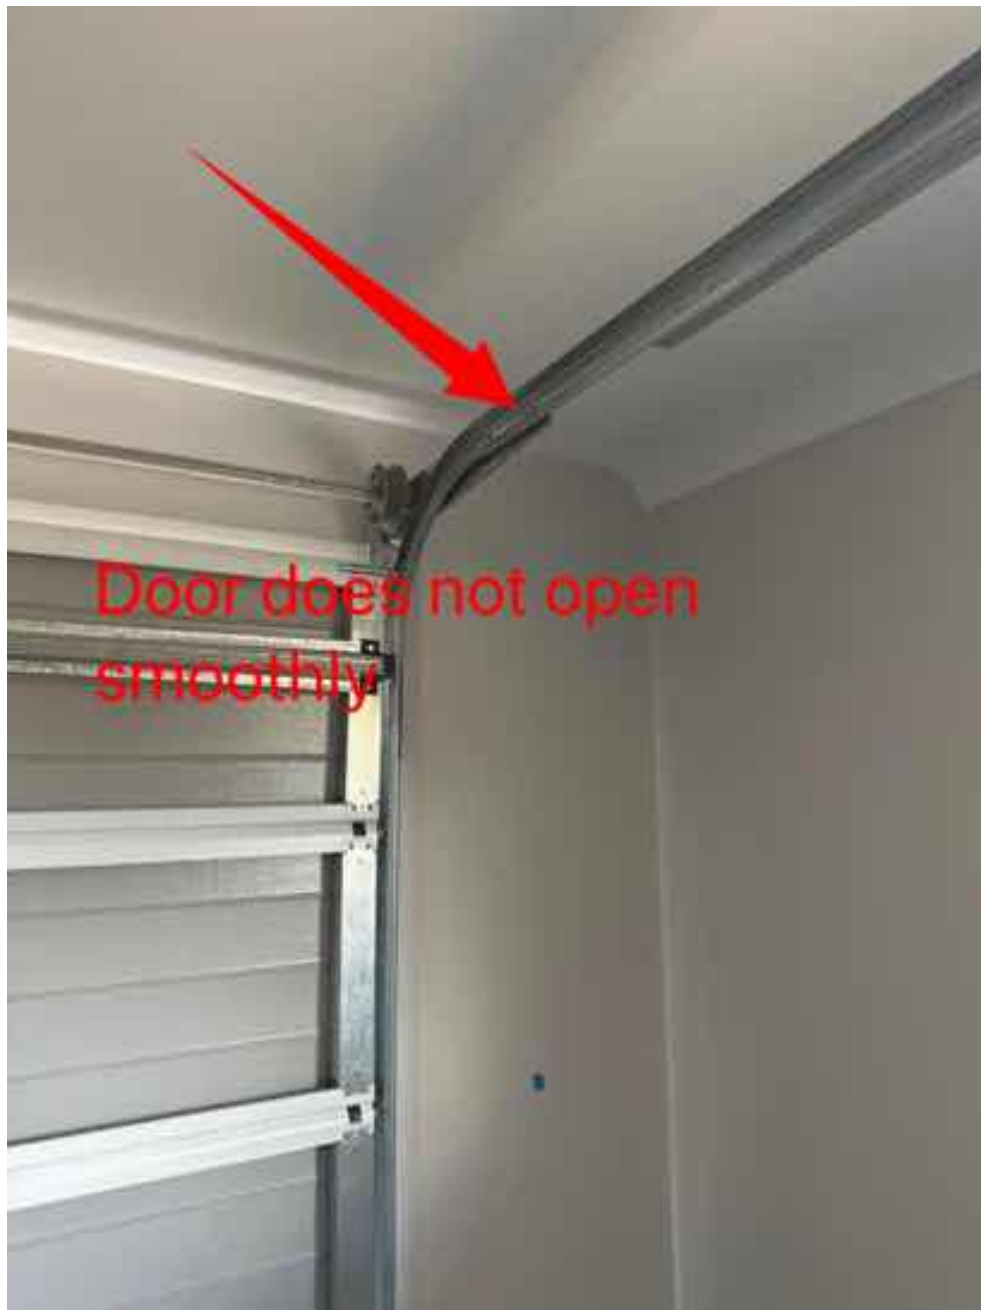
## Garage Door

The garage door jamb are not the same length on either side of the garage door. Believing that you will have the driveway slab set 15mm-20mm below the lip of the concrete slab to create a good waterproof joint, the door jamb on the right hand side is short in length. Amendment required

The garage door, does not operate smoothly with the automatic opener. The rollers jump and bind. Adjustment required.

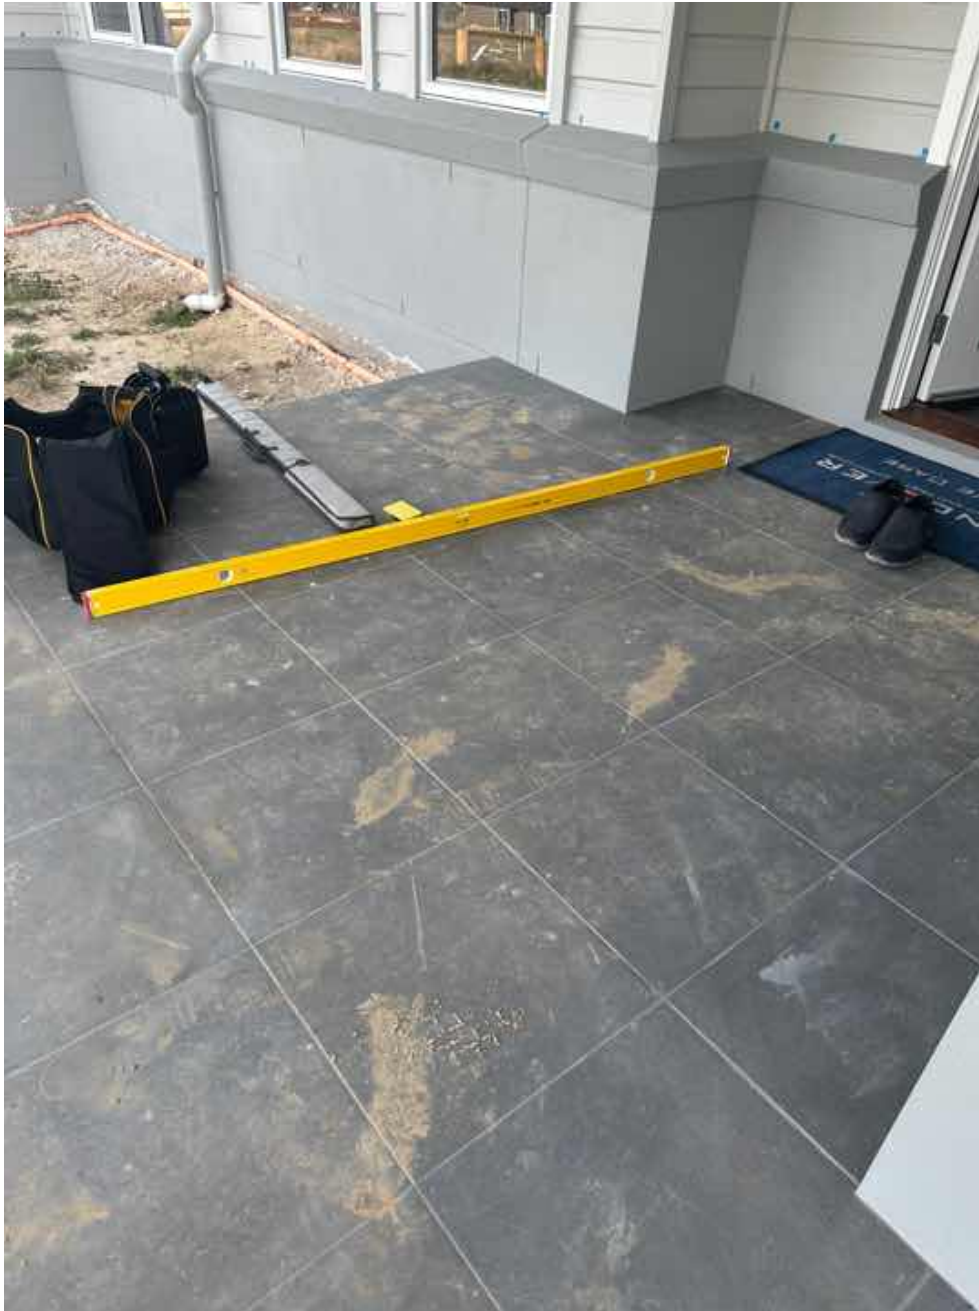
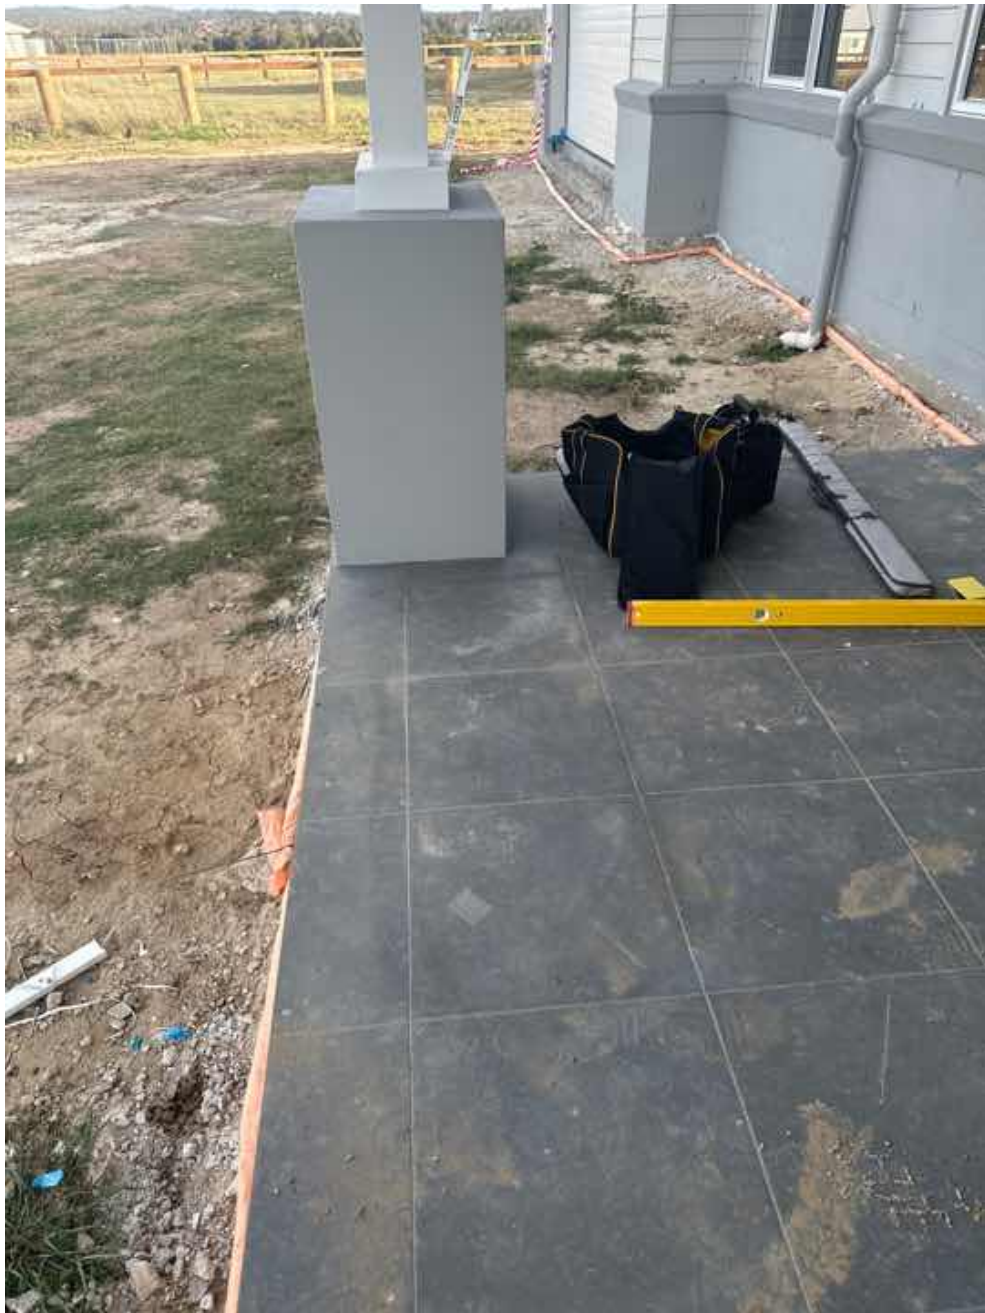
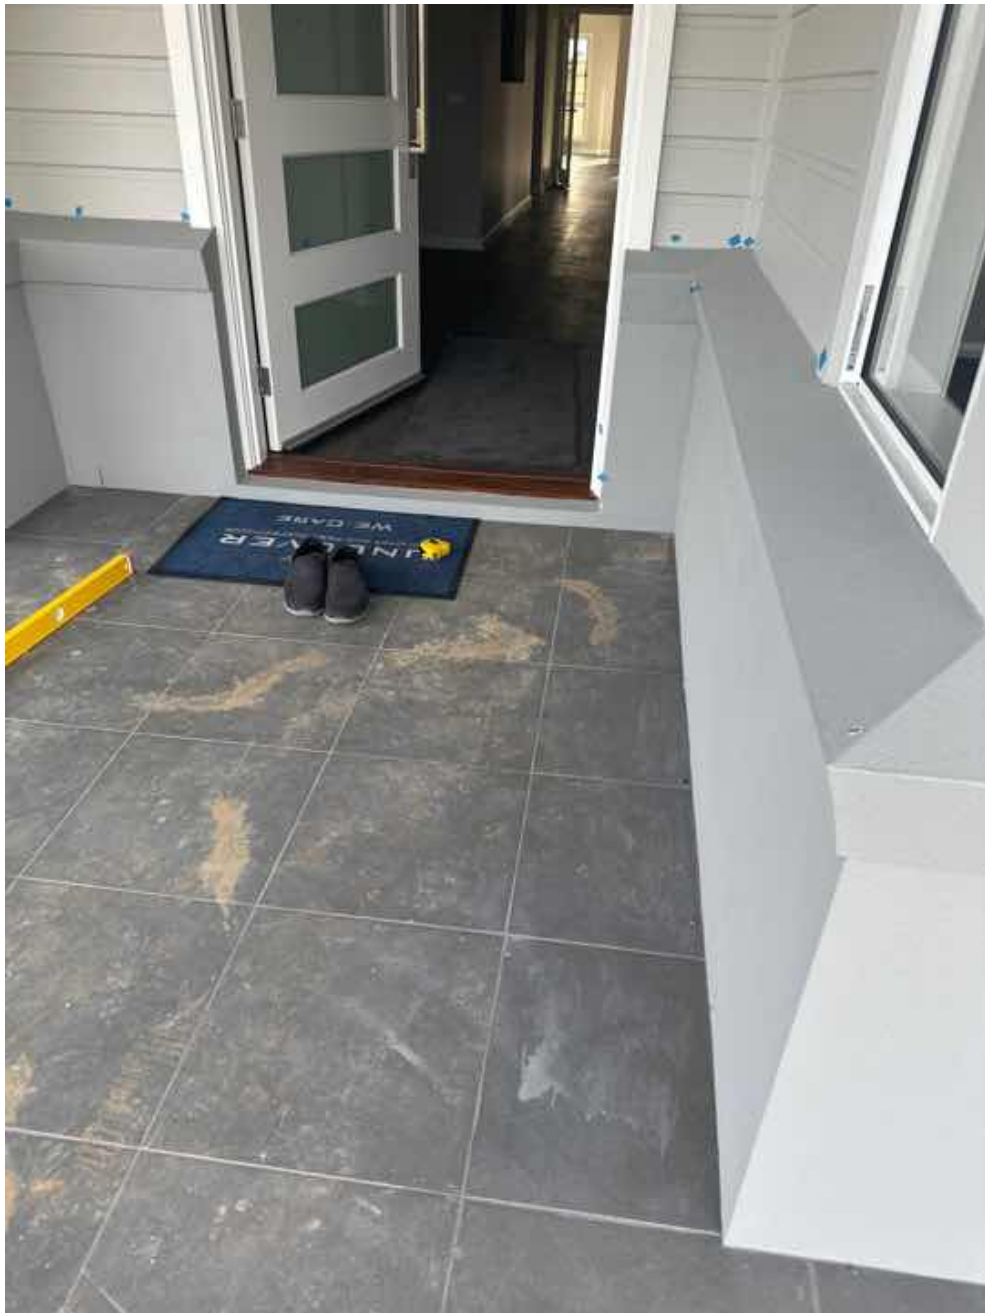
### Front Balcony Findings

Floor cleaning required to front entry area.

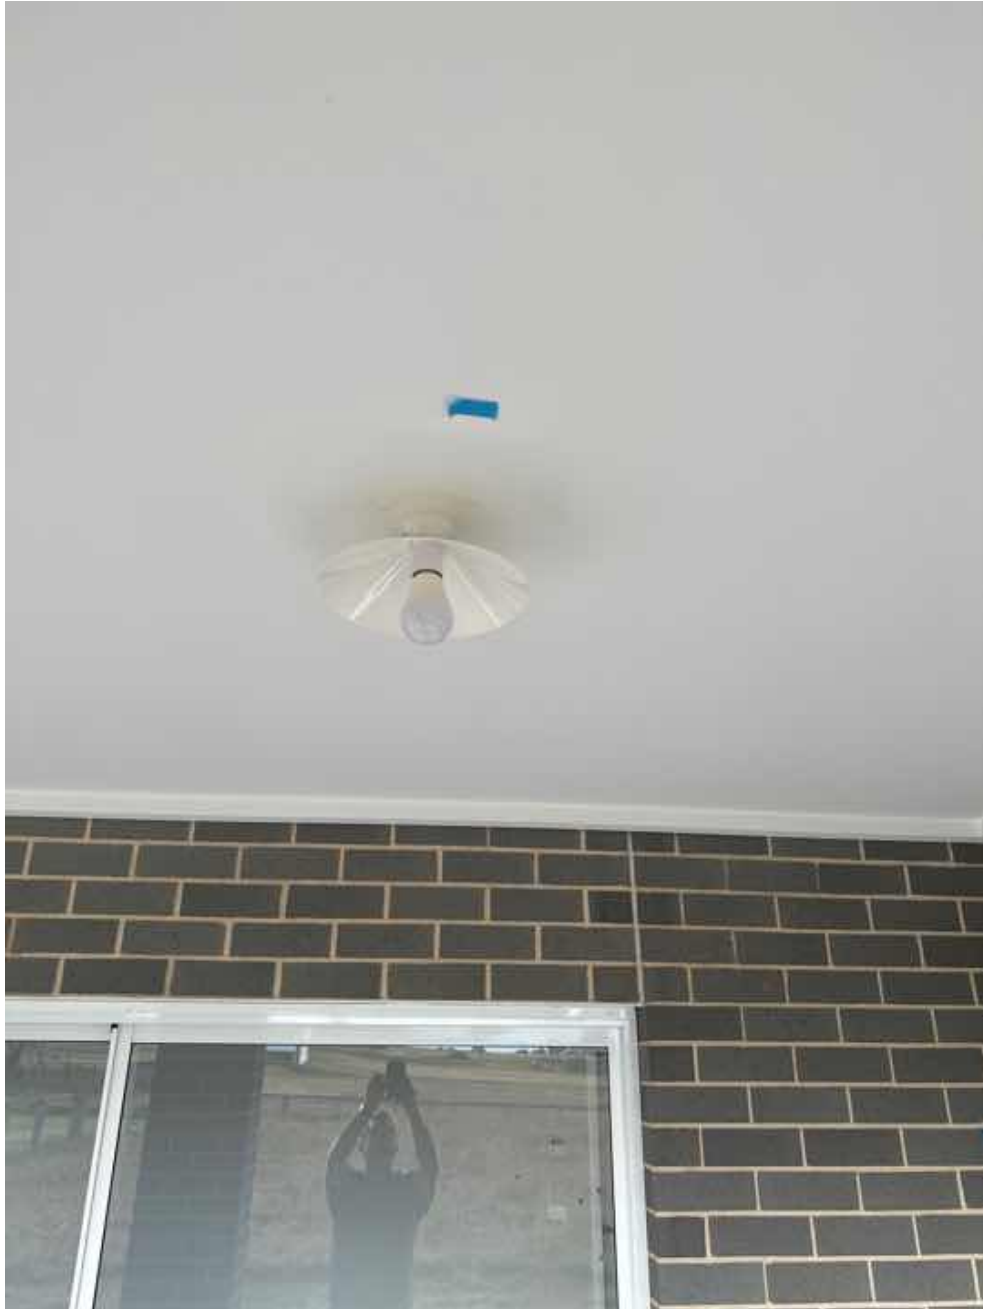
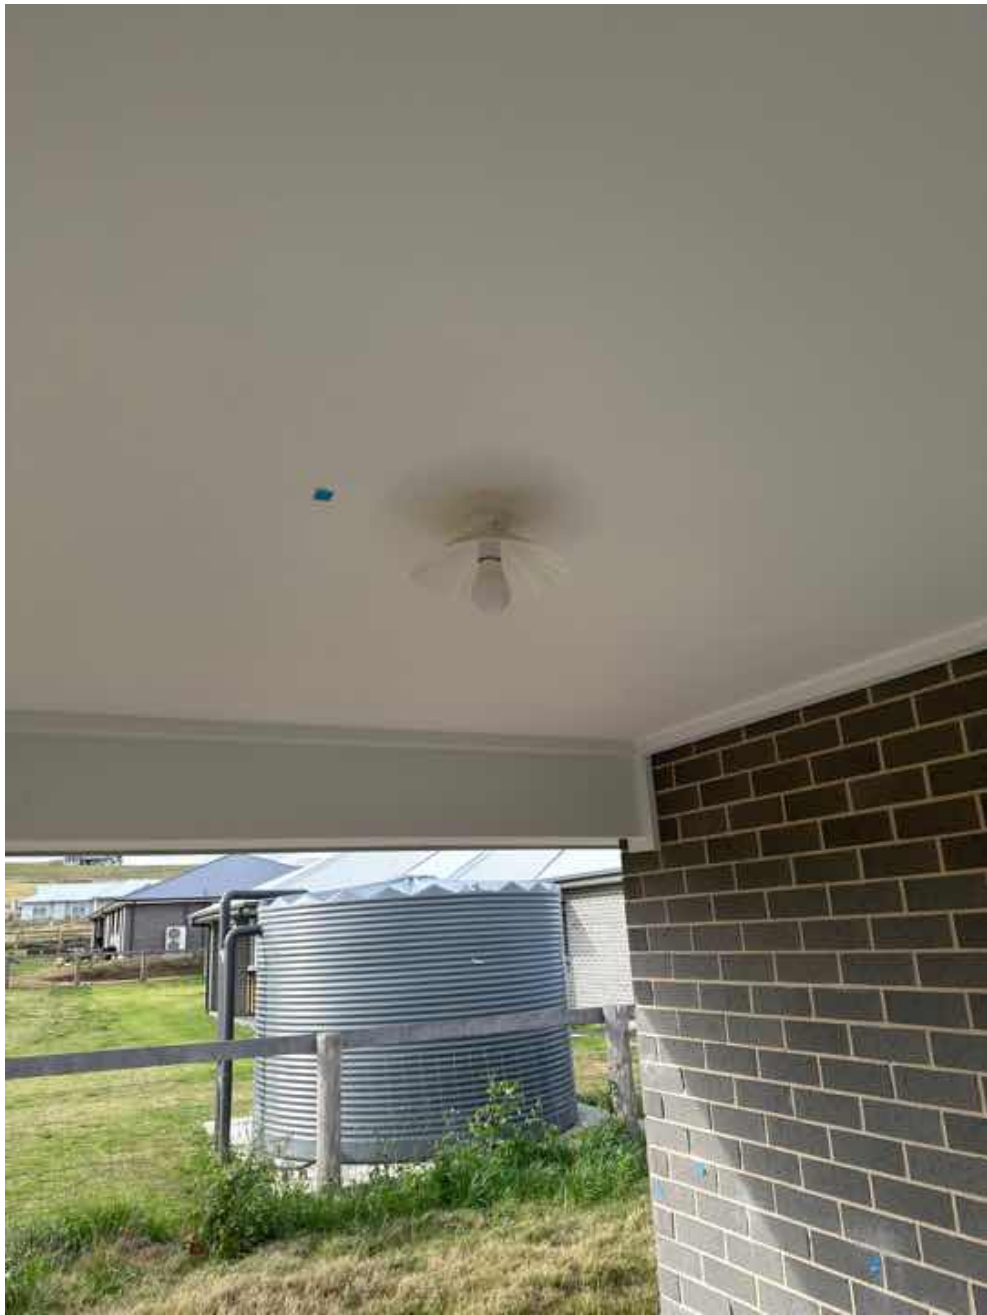
## Ceiling

Paint touch ups required.

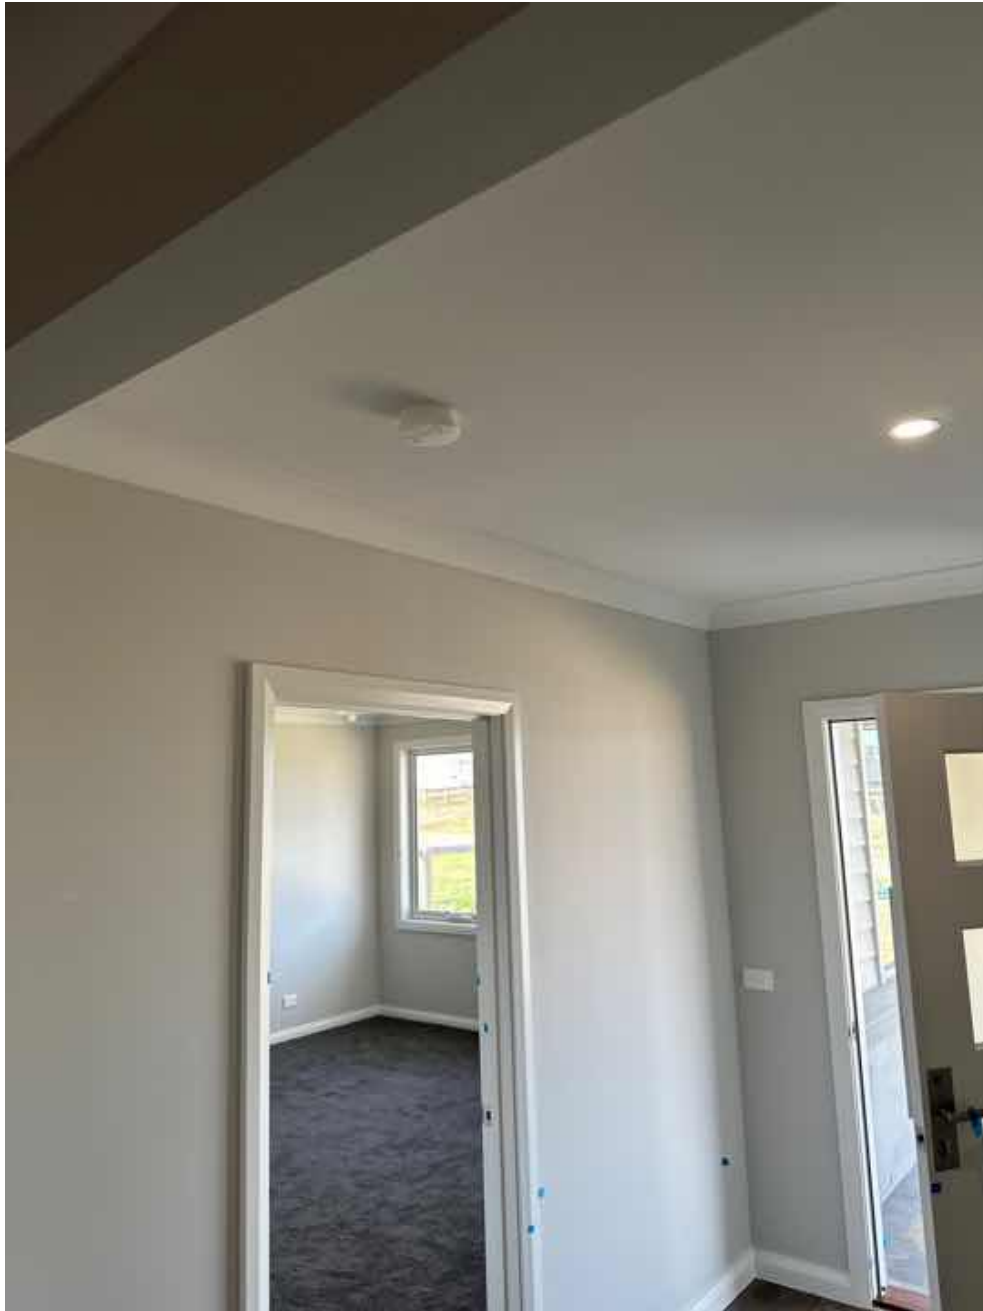
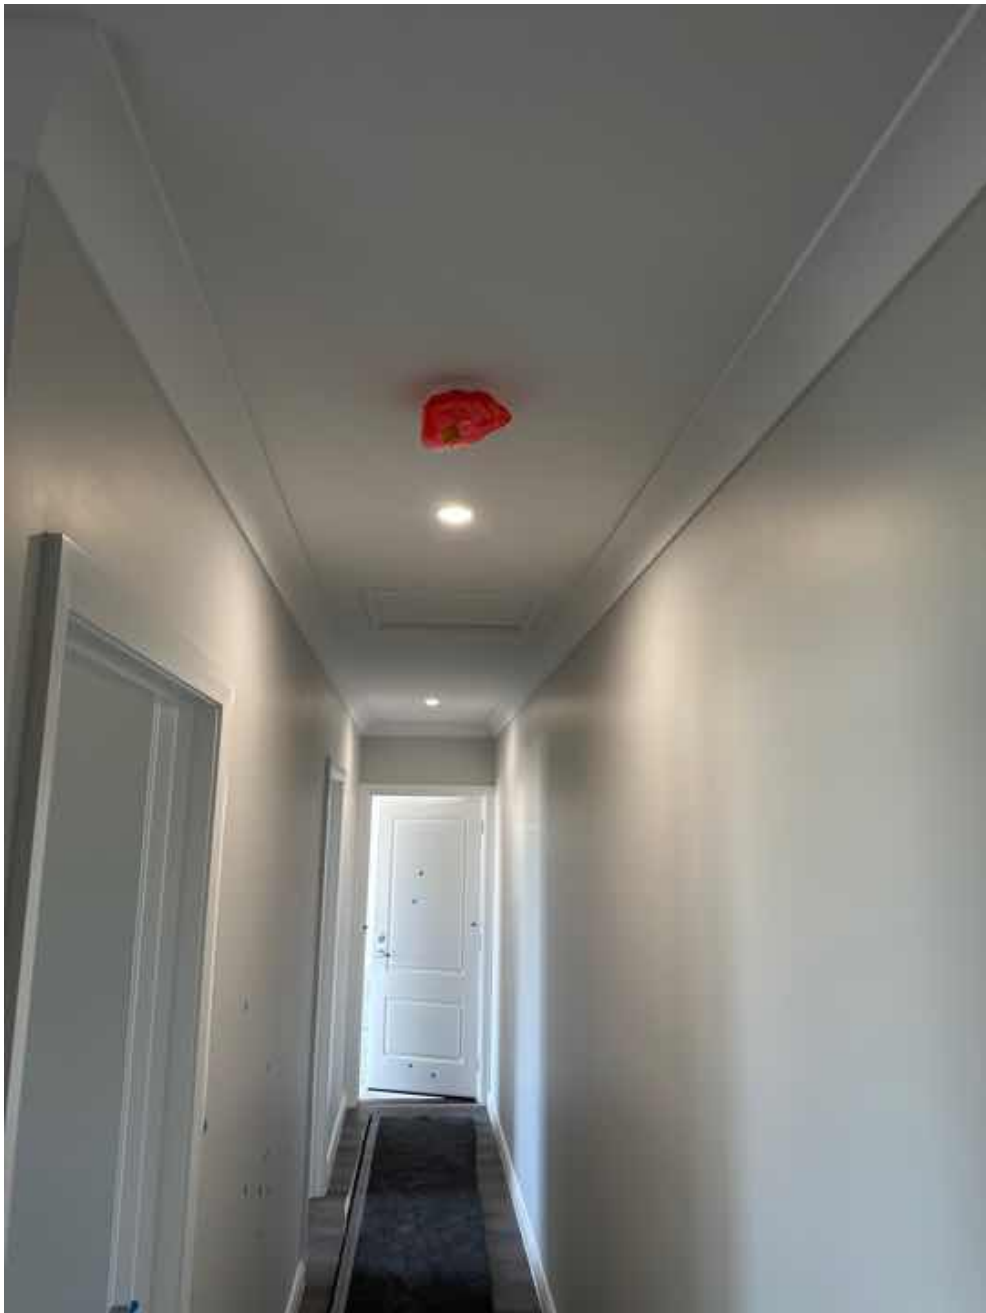
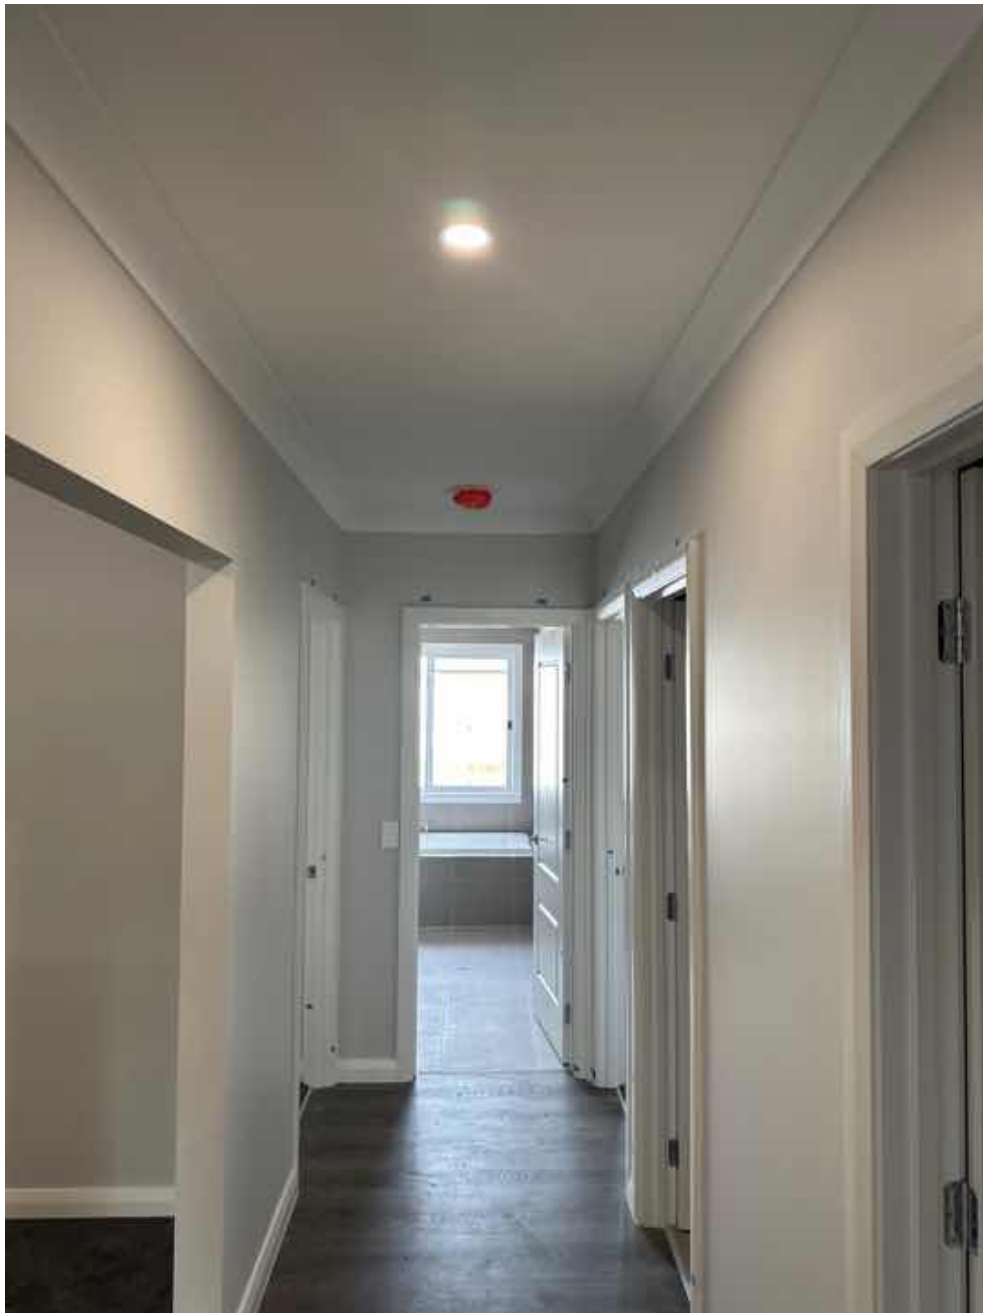
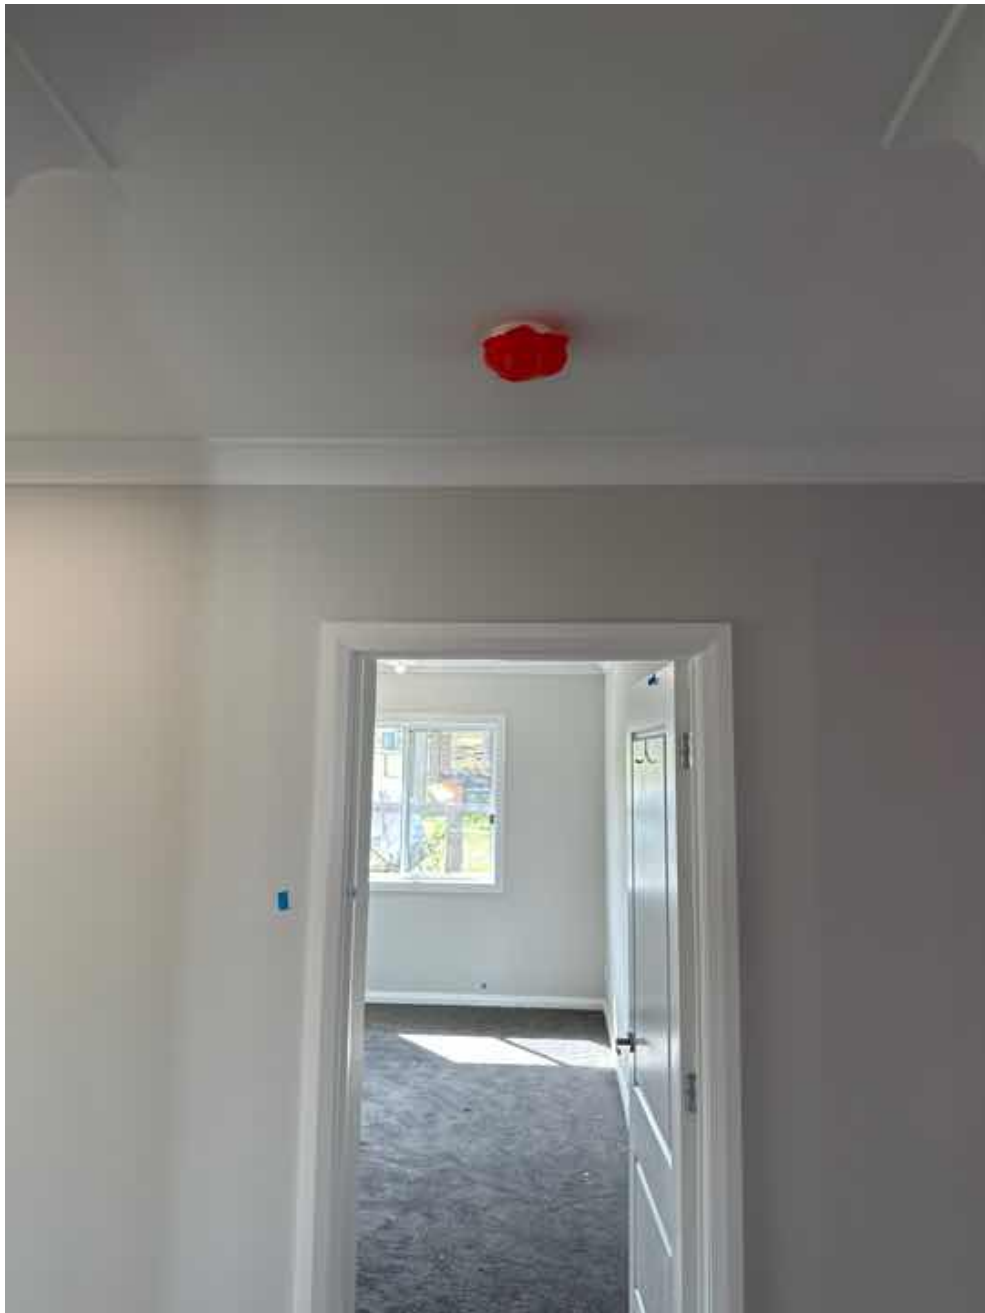
### Smoke Alarm

Yes 4 smoke alarms were sighted but not tested.

Legislation requires smoke Alarms to be installed. The National Construction Code, clause 9.5.3 states that a smoke detector must be located in any storey containing bedrooms, every corridor or hallway associated with a bedroom, or if there is no hallway, in an area between the bedrooms and the remainder of the house, and each other story not containing bedrooms.

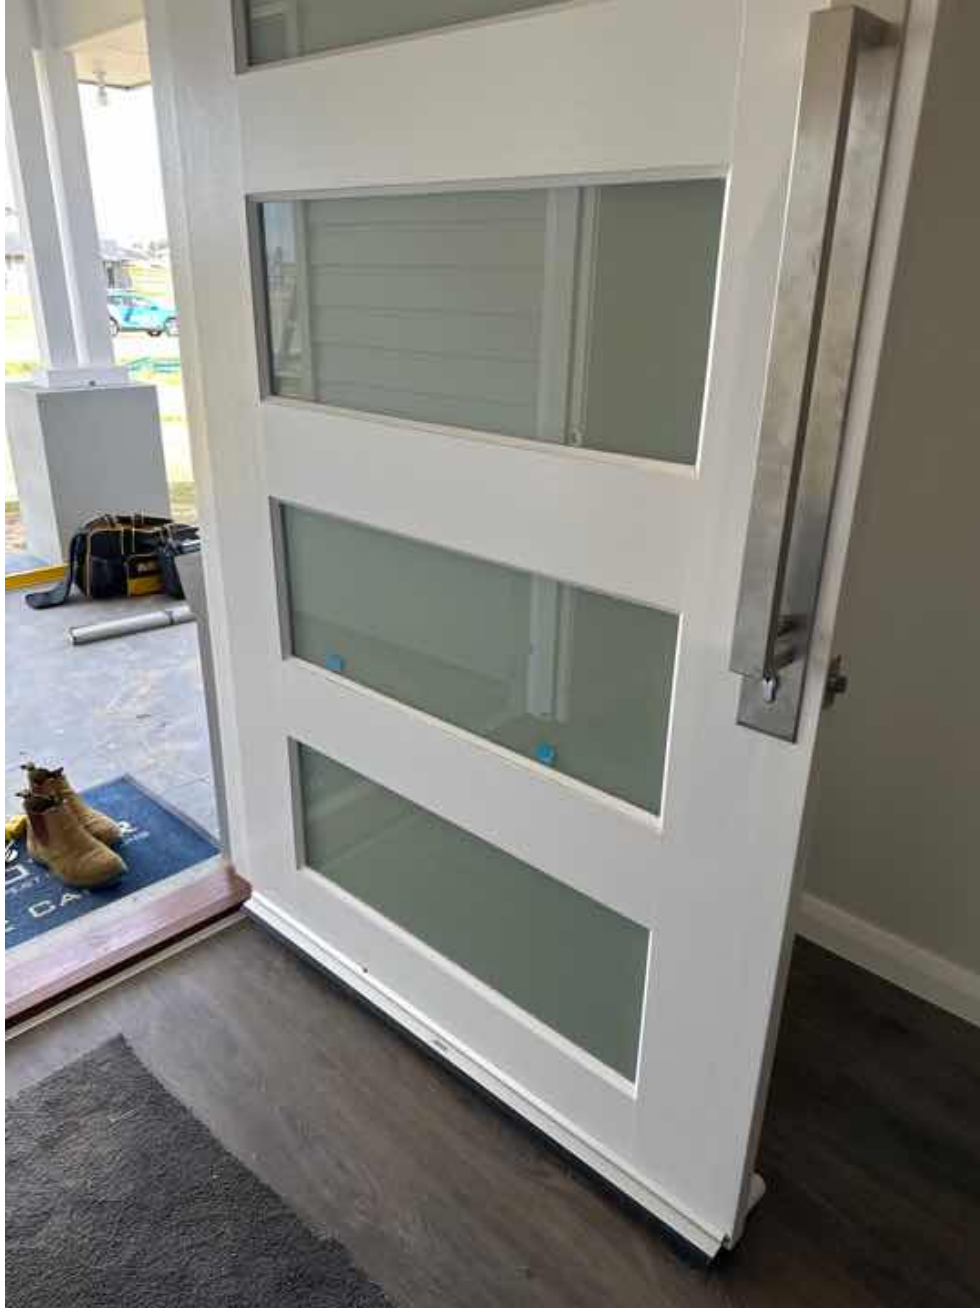
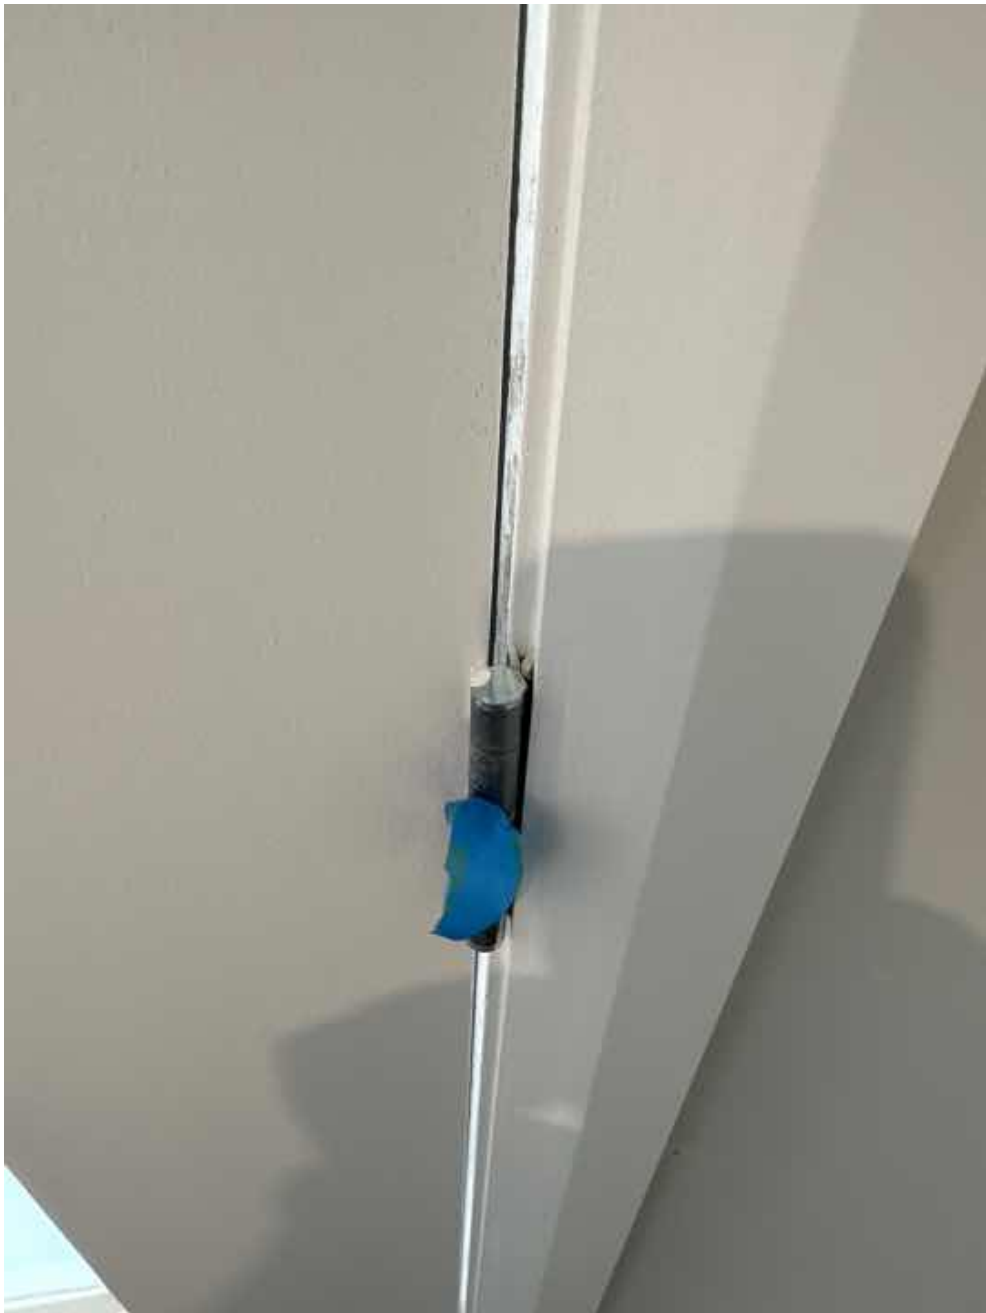
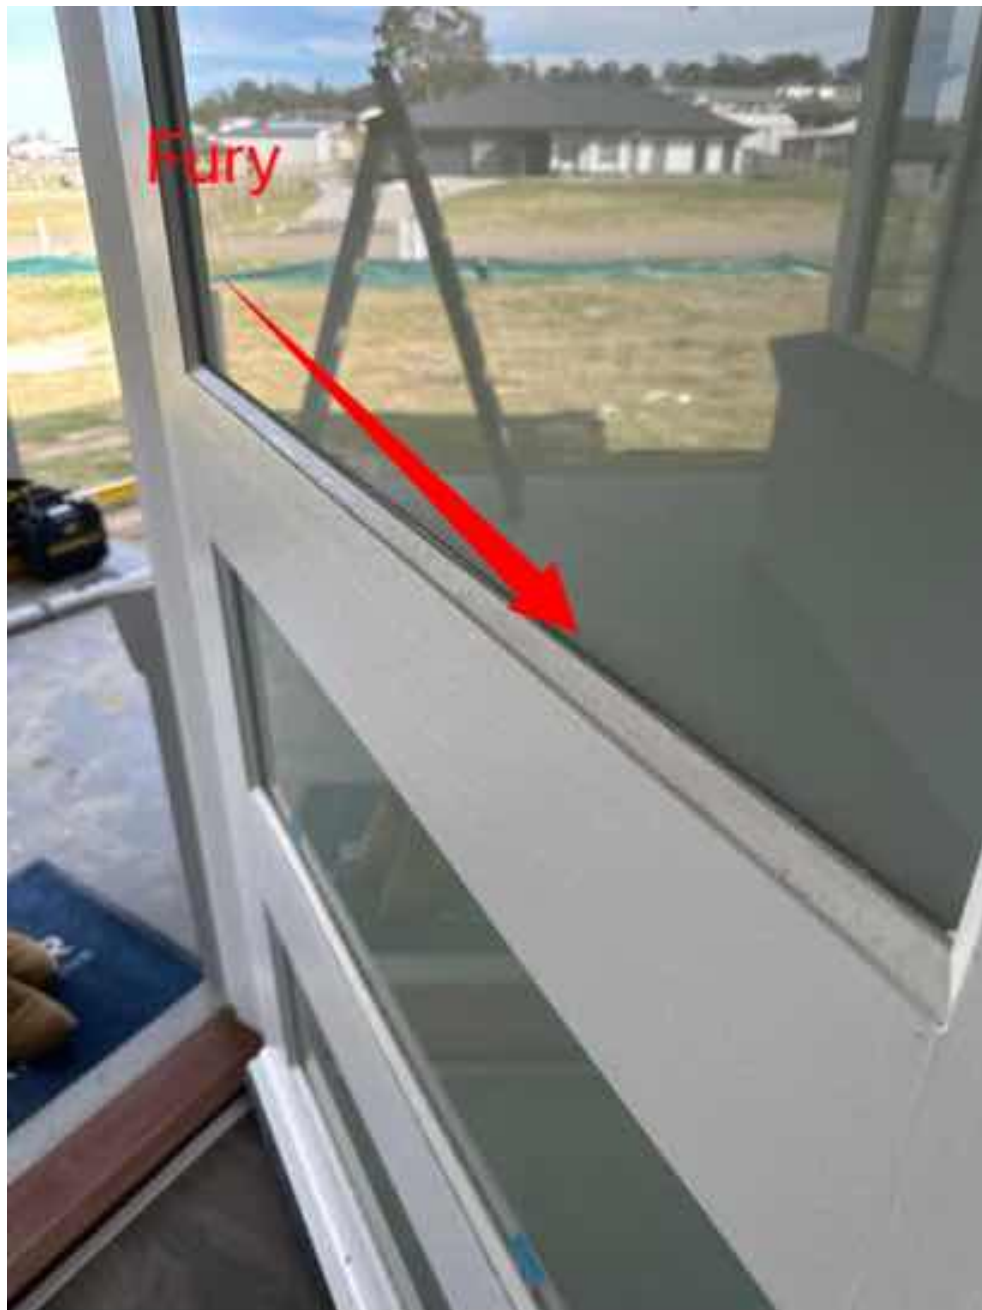
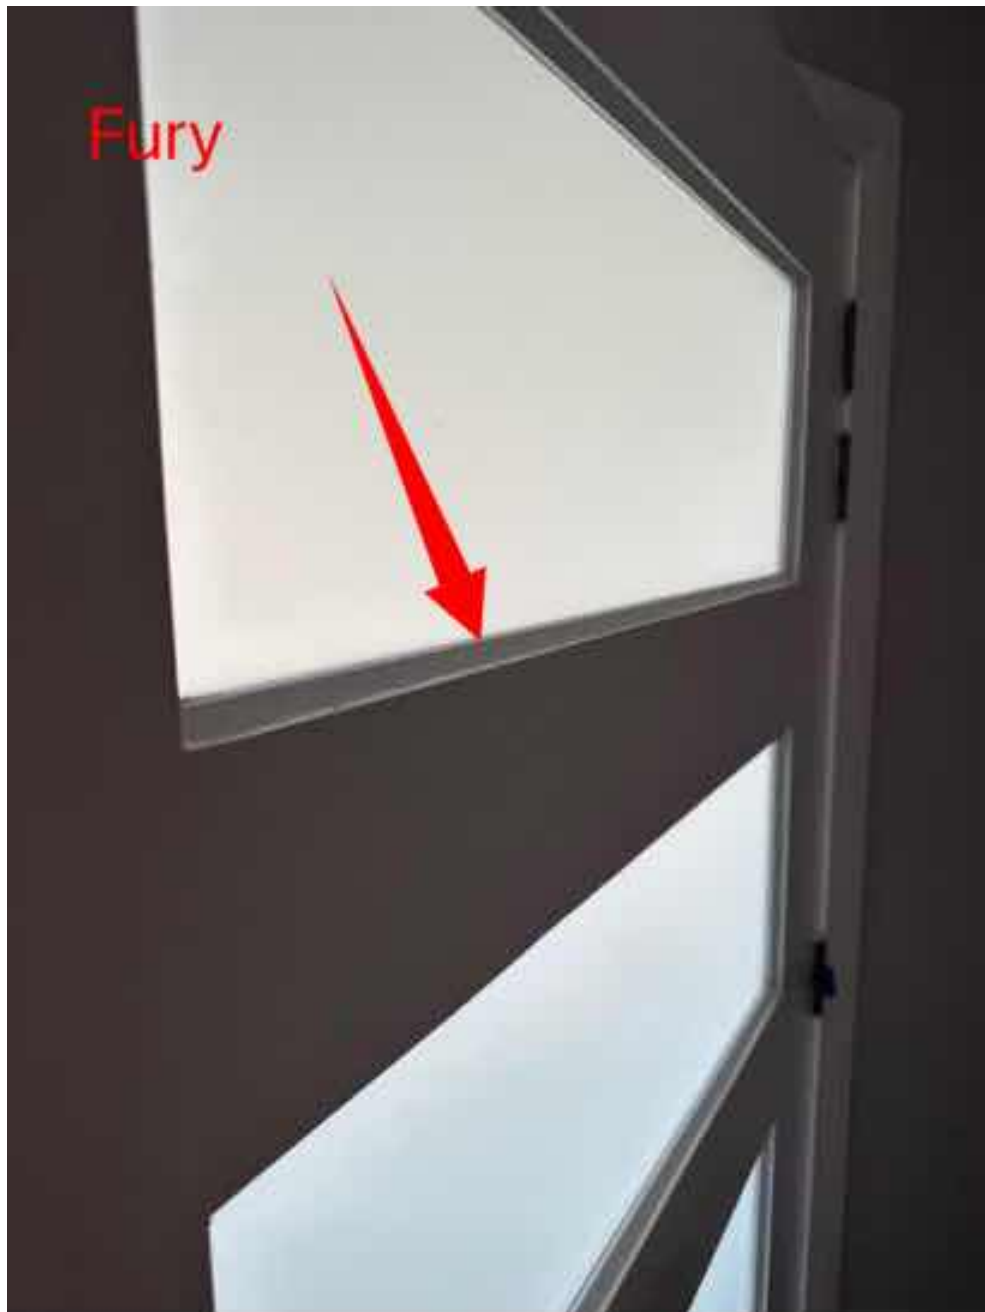
### **Front Entry Doors**

Door rattles when closed, adjustment required

The door detailed edges around the glass have not been sanded and are fuzzy. Requires a loghts sand and another coat of paint.
