# Inspection Report

**UNCOVER**  
BUILDING AND PEST INSPECTIONS

**1 Sample St , Sample, Nsw, 2281**

### Handover Inspection

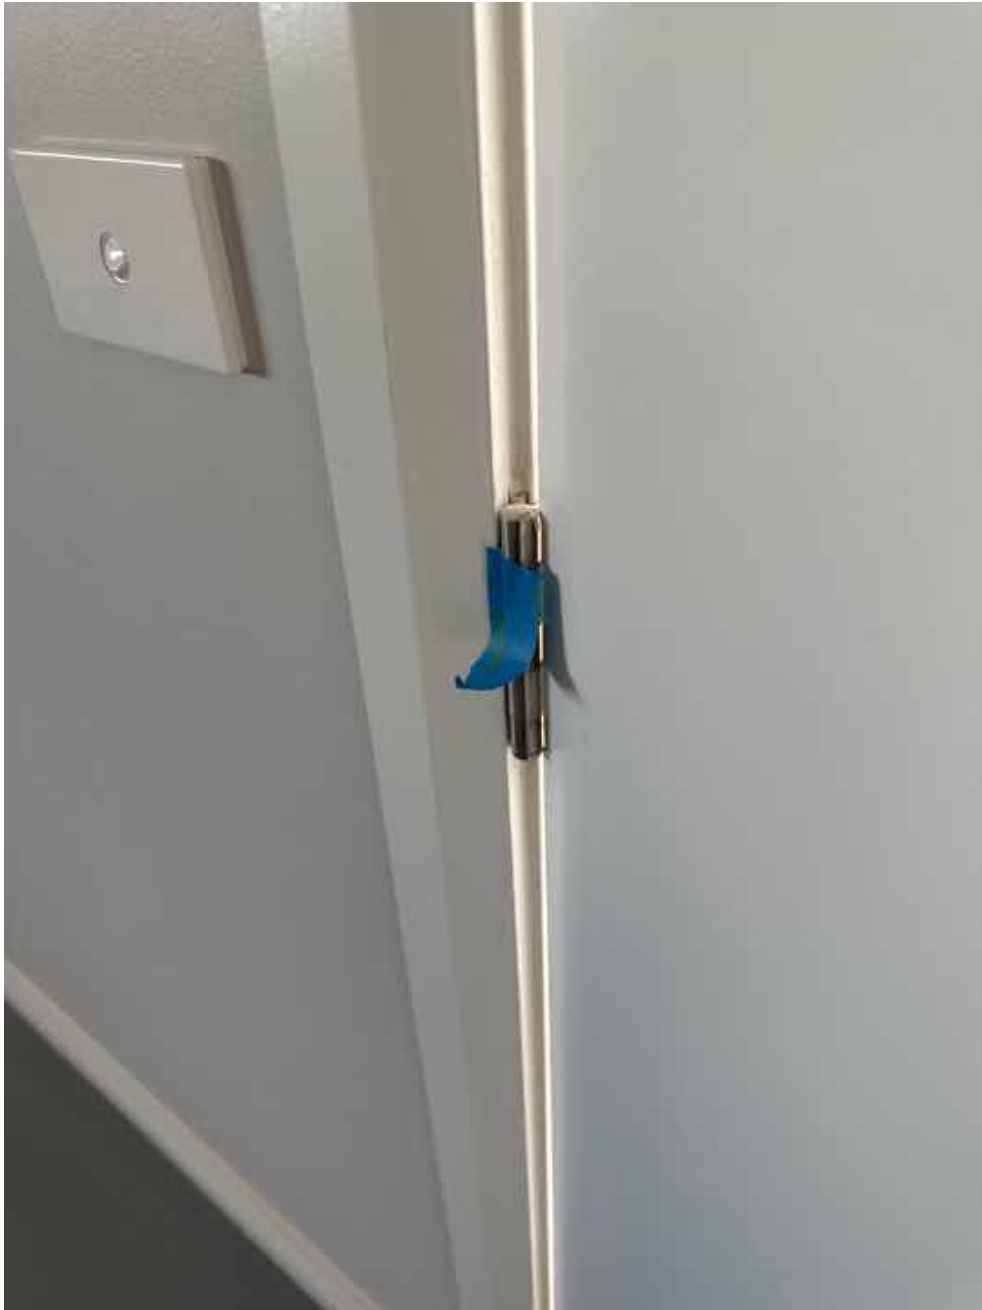
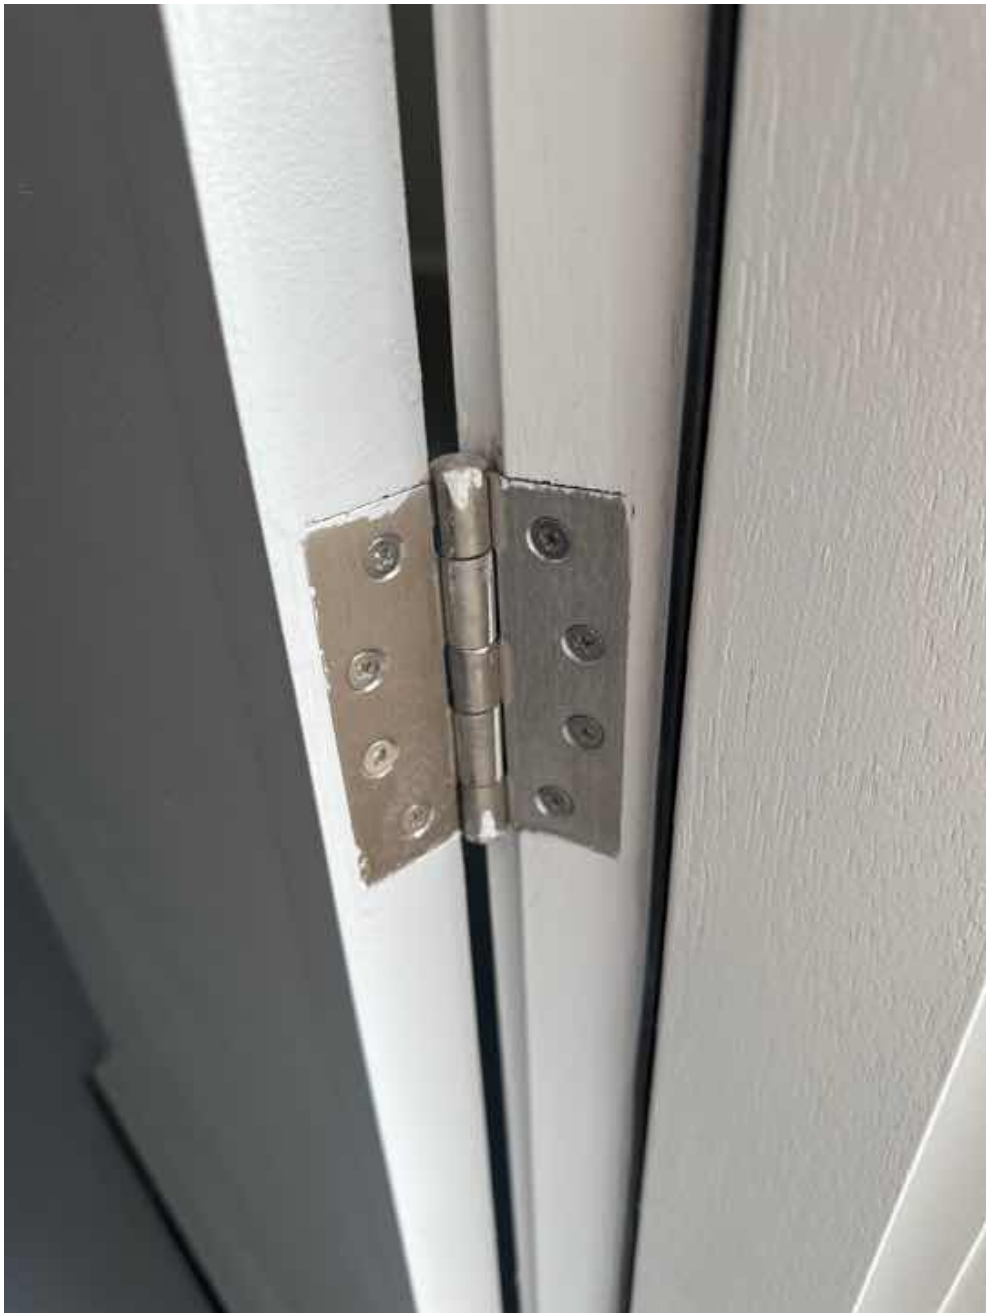
**Other Doors**

Paint on screen door handle  
Paint on screen door hinges  
Paint touch ups required.

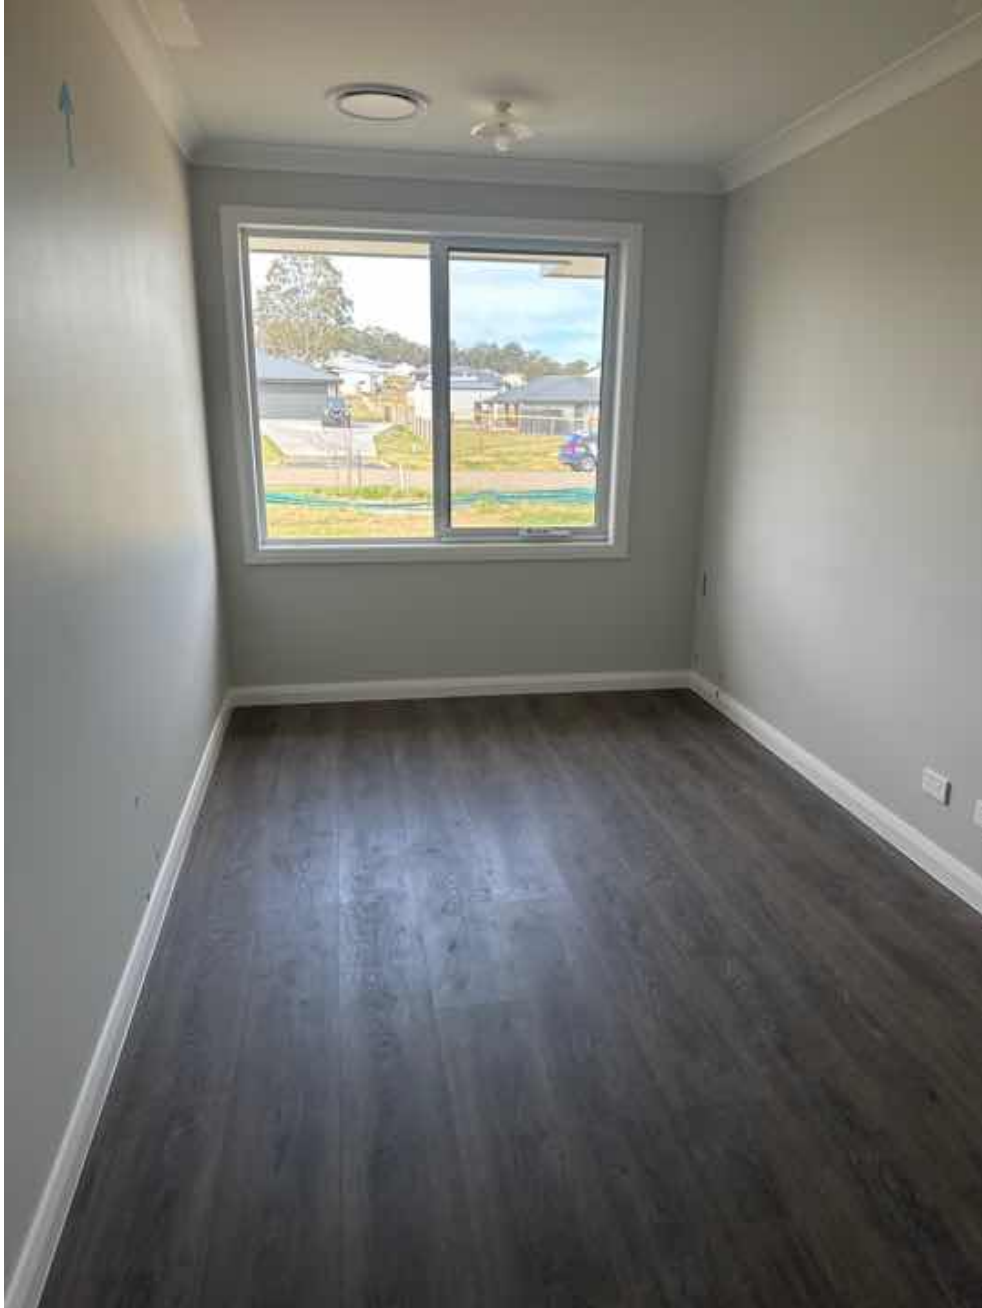
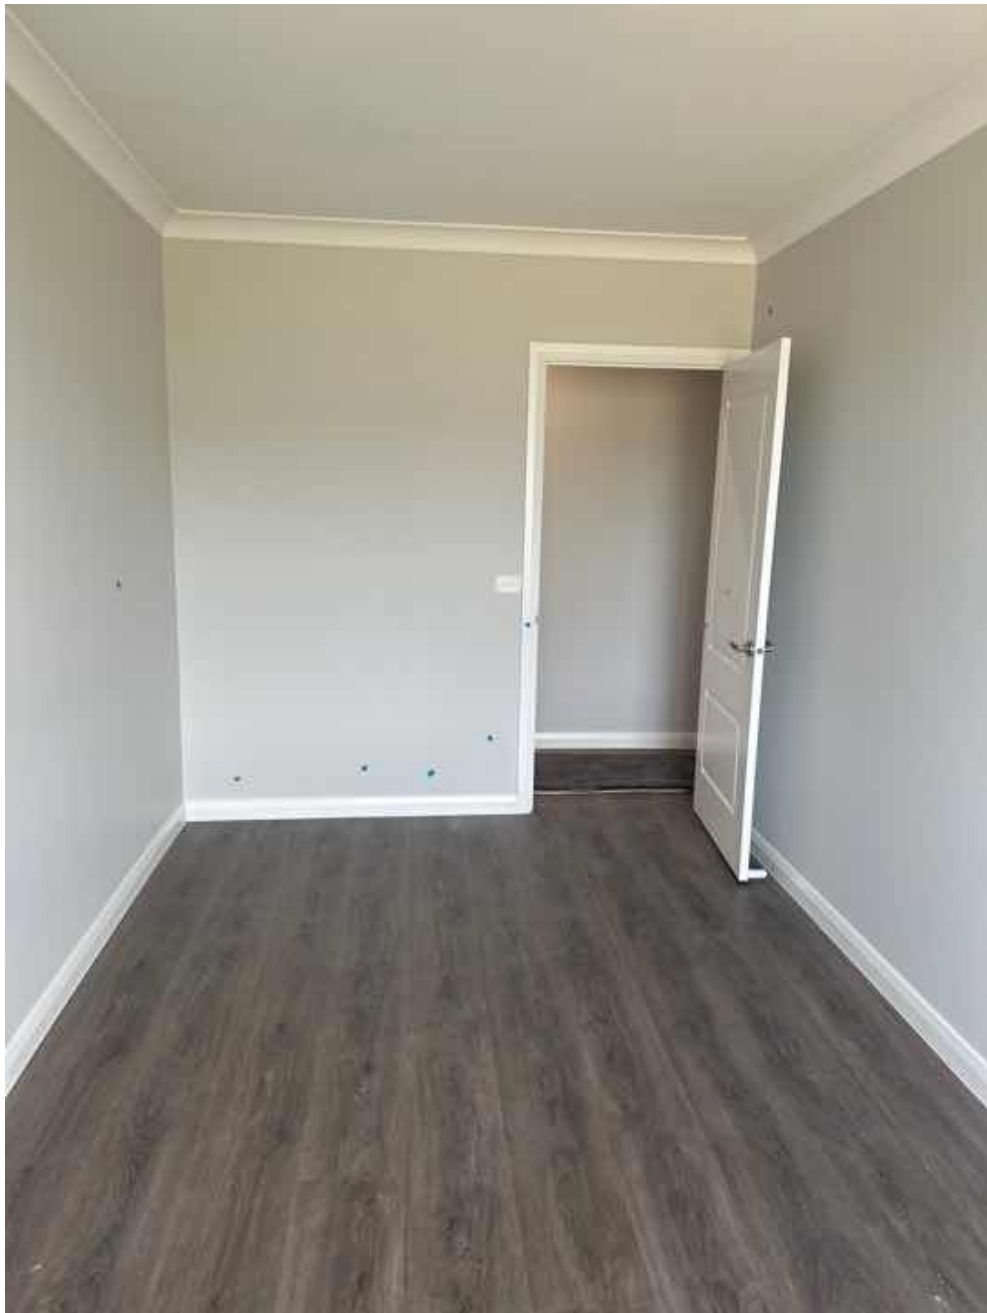
Rectification work required

A builders clean is required.

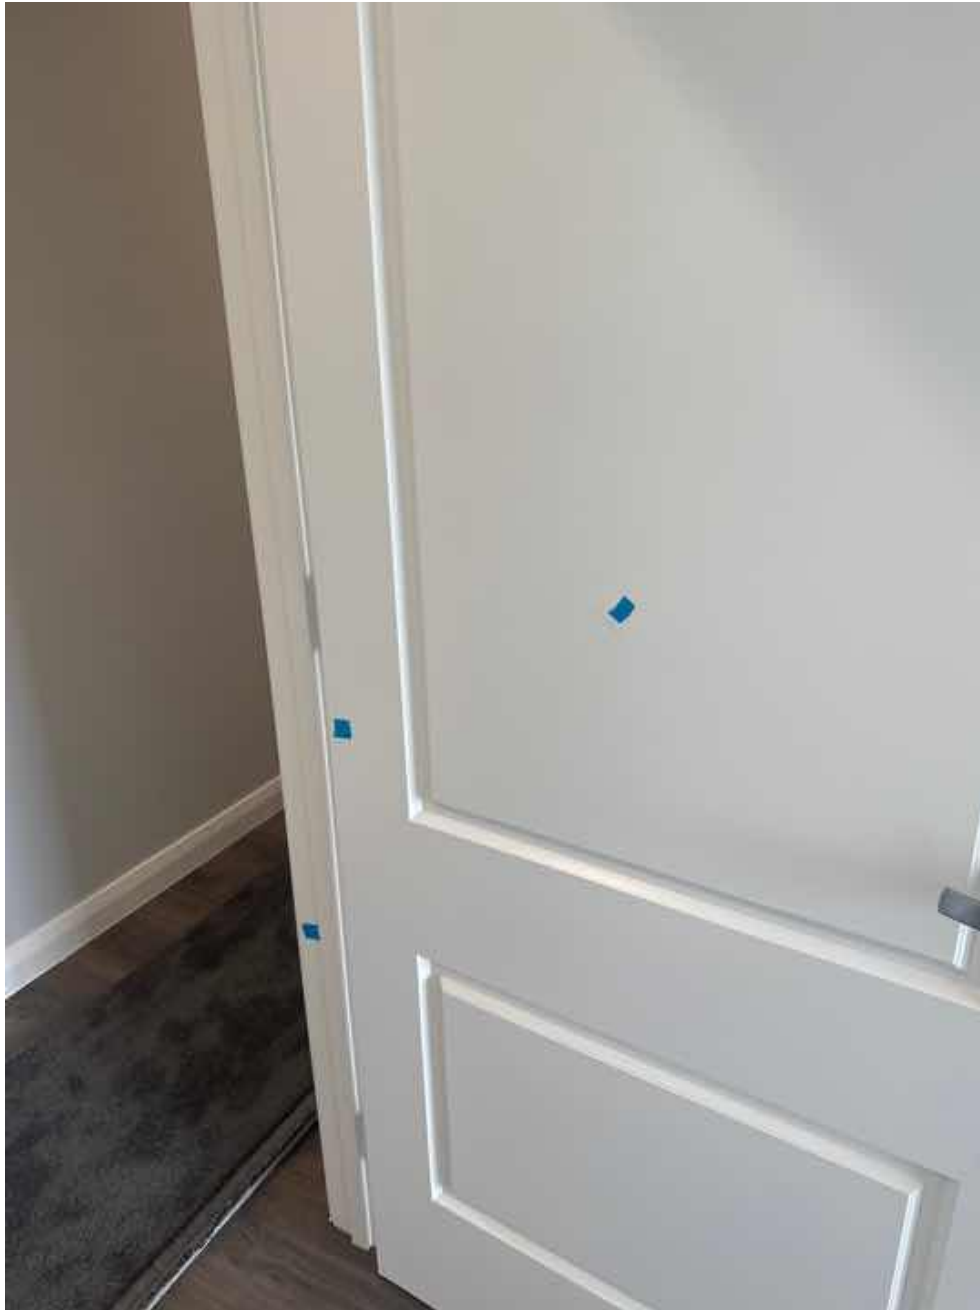
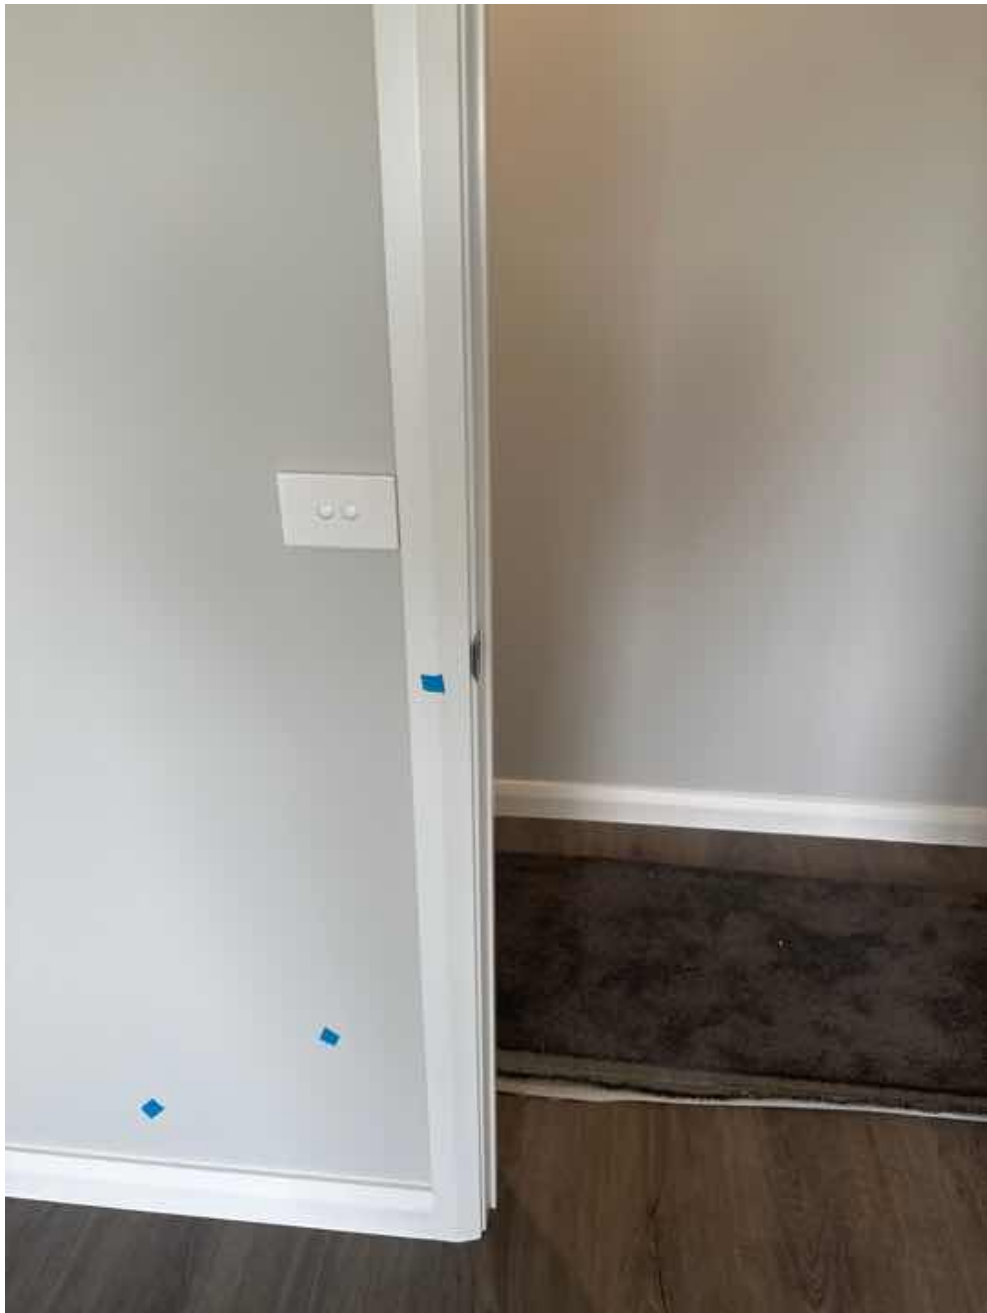
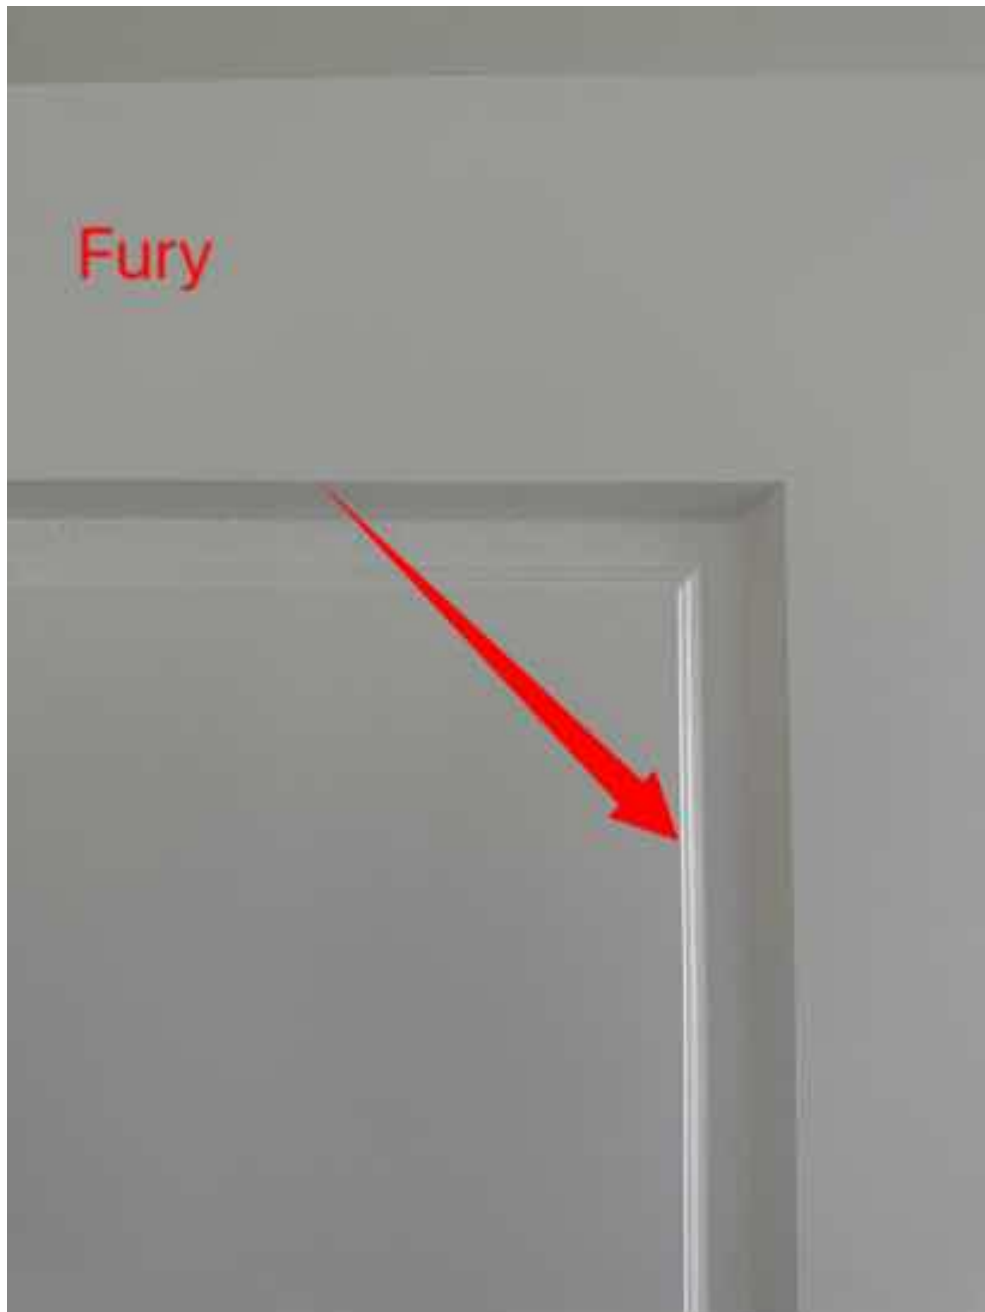
## Door

Paint touch ups required as indicated by markers

The door face router detail has not been sanded between coats. This detail is fuzzy in appearance from a normal viewing position of 1.5m and is rough to touch. Requires a light sand and re painting.

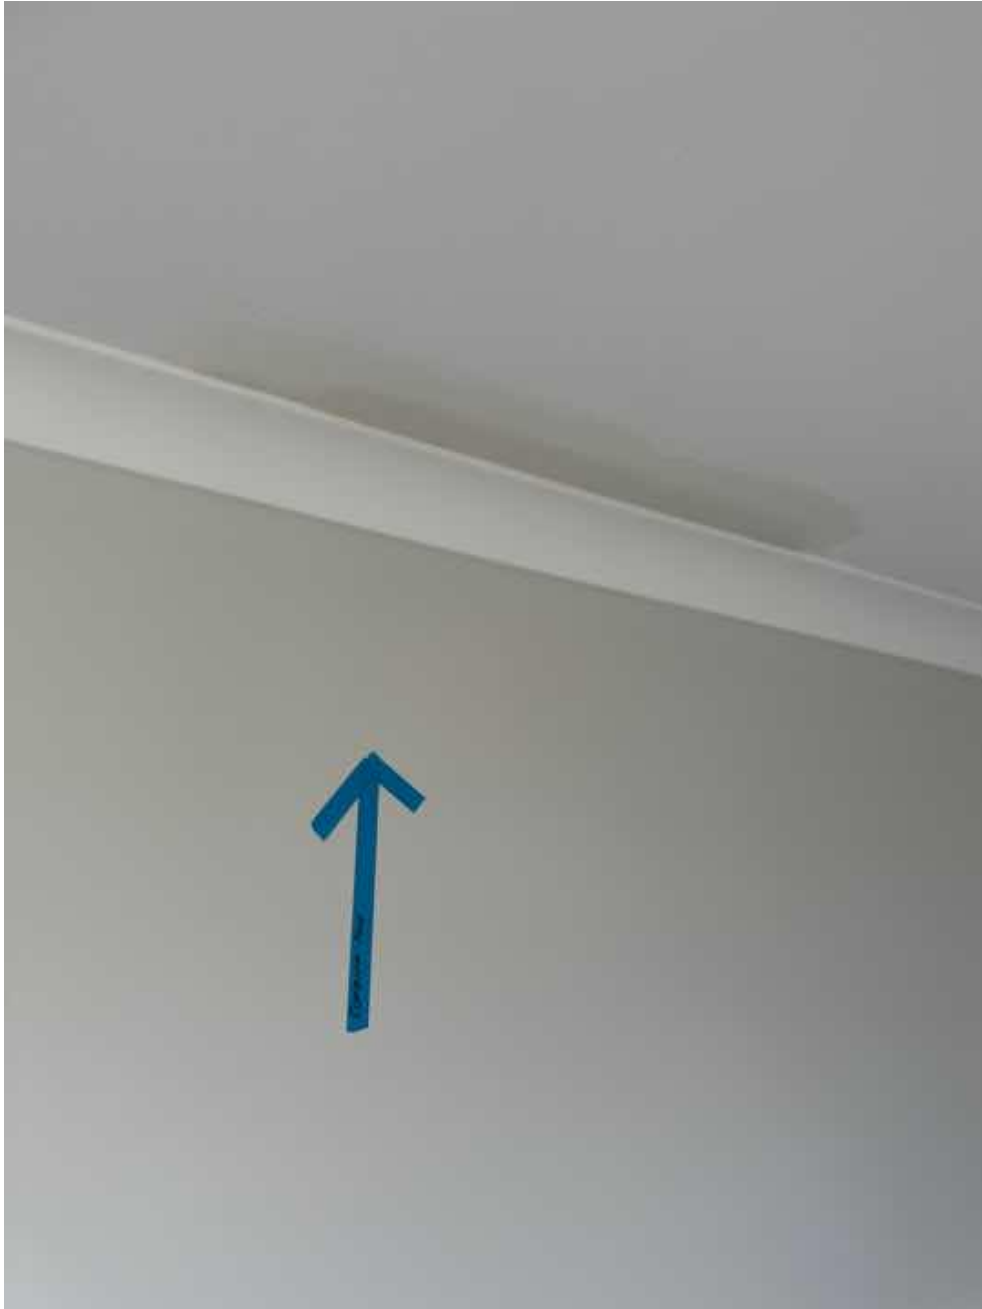
**Ceiling**

Patch and paint required.

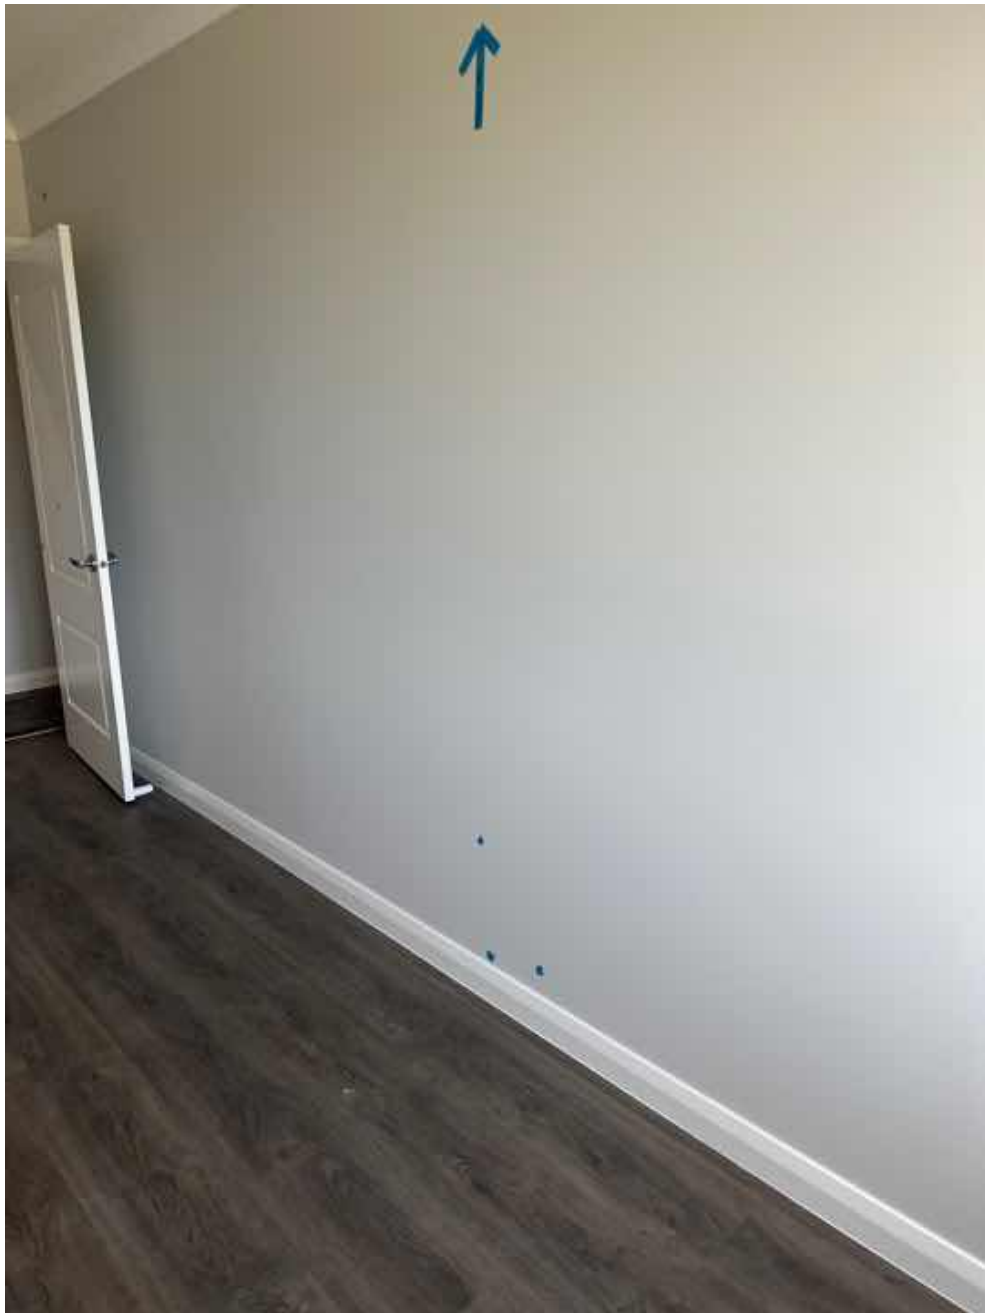
**Walls**

Paint touch ups required. Defects noticeable from normal viewing position. Additional plastering, sanding and painting required.

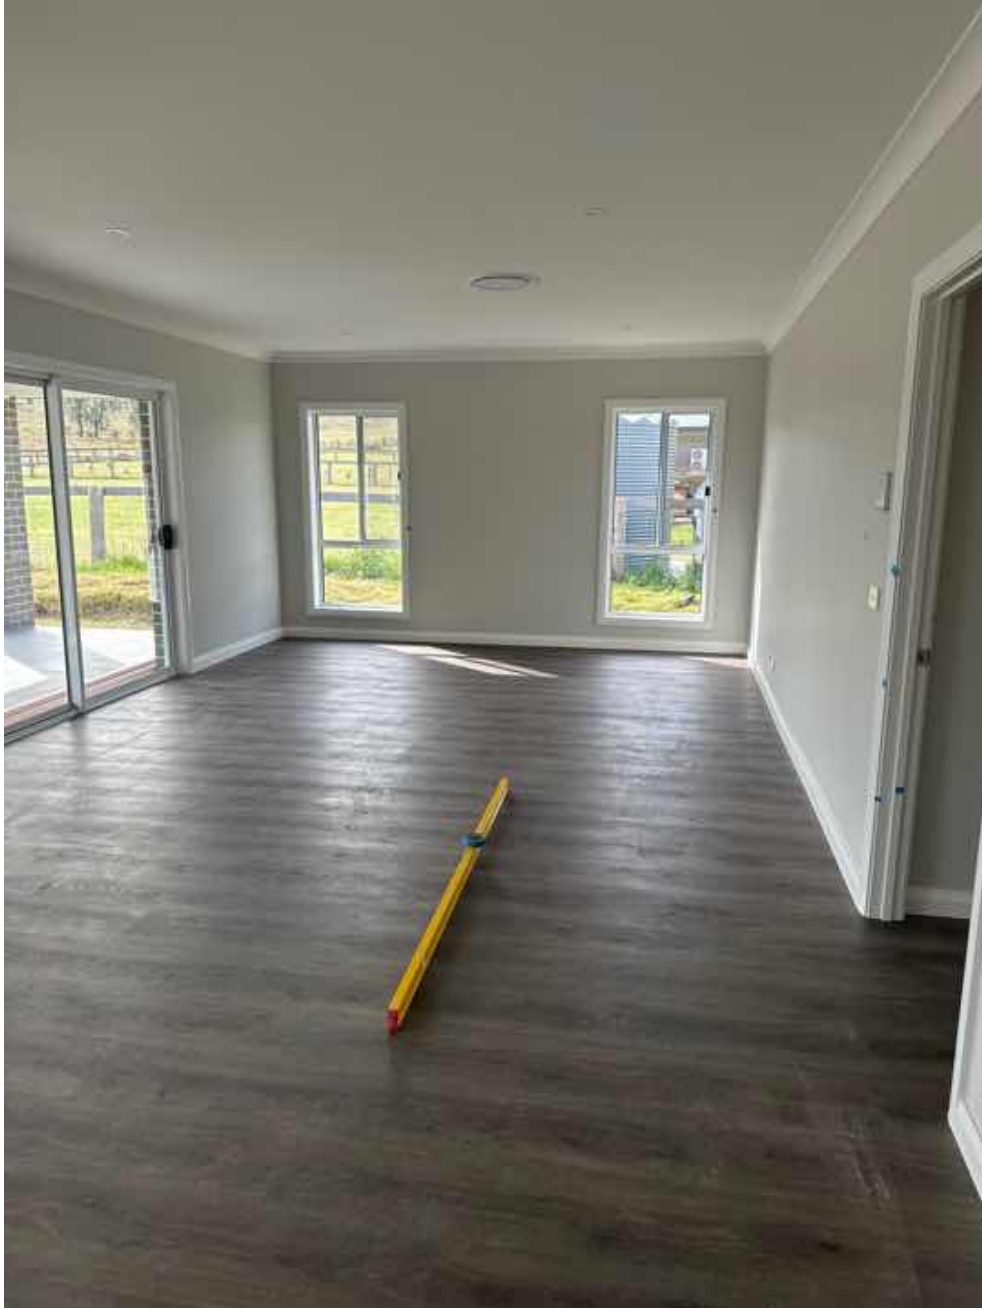
Rectification work required

A builders clean is required.

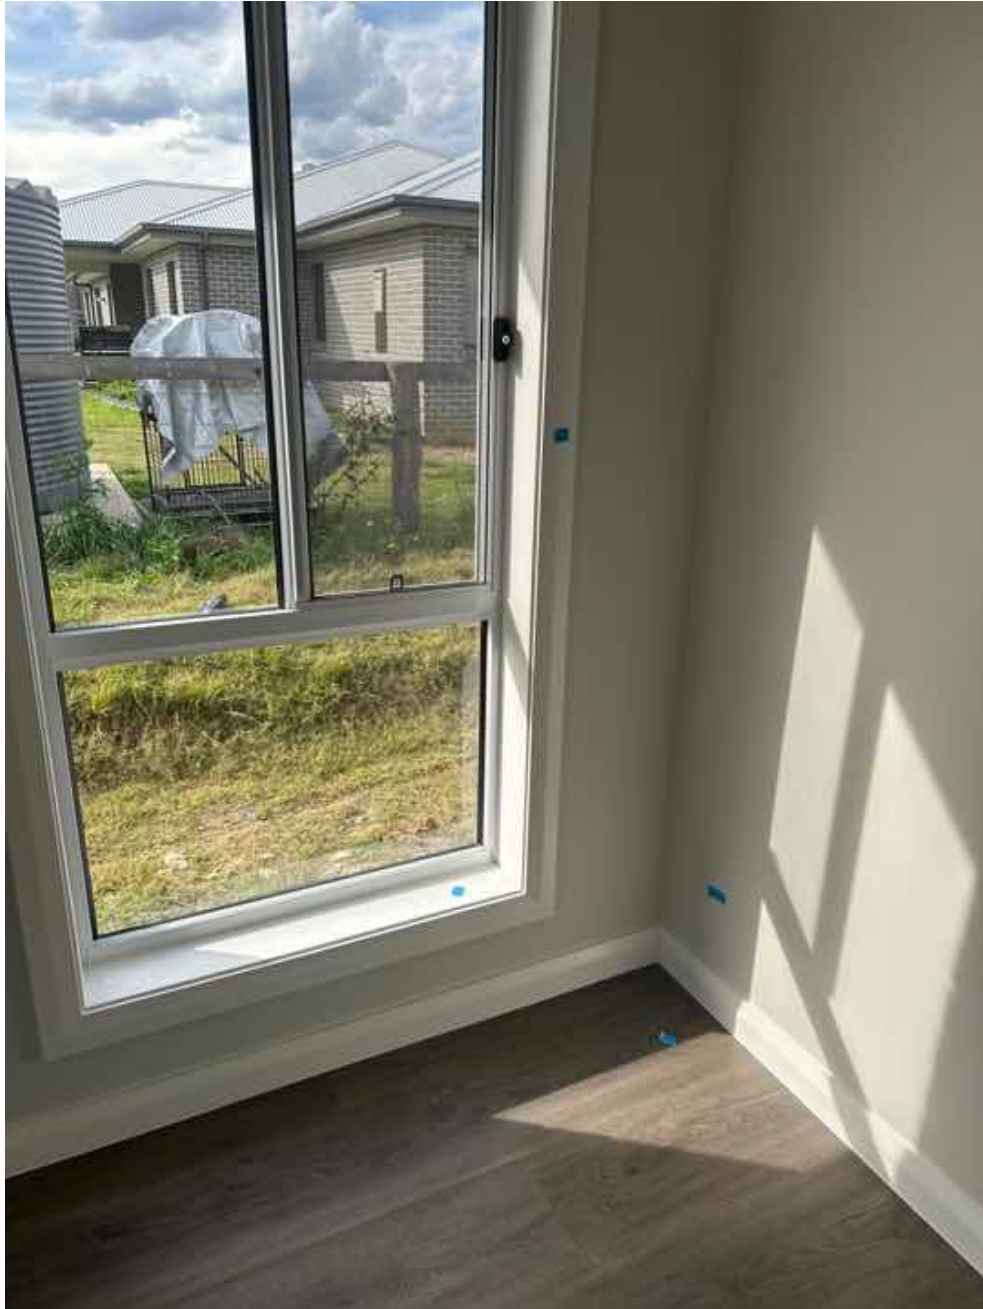
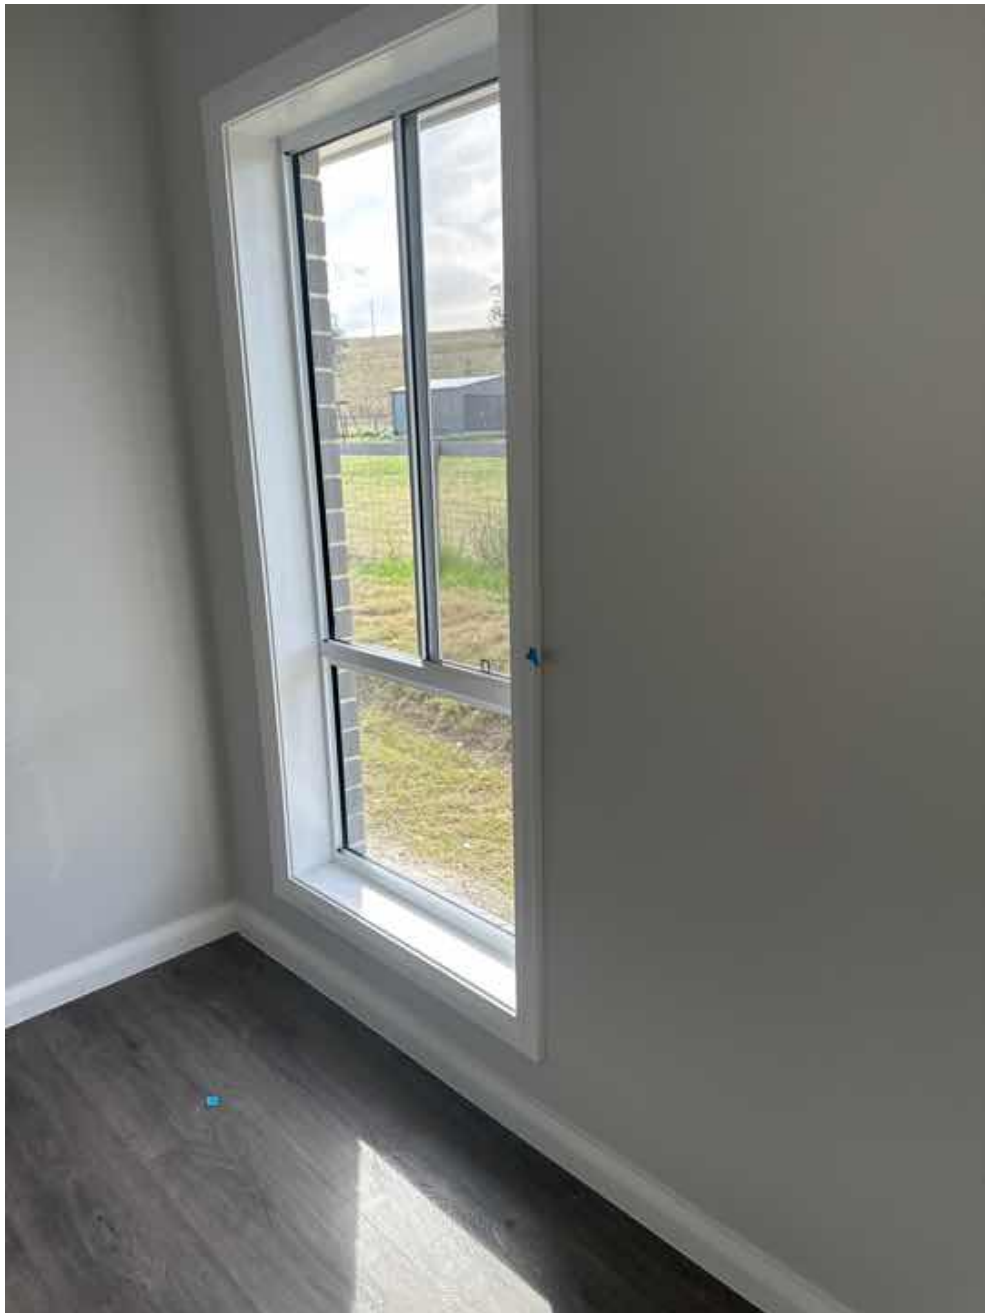
## Windows

Paint touch ups required.

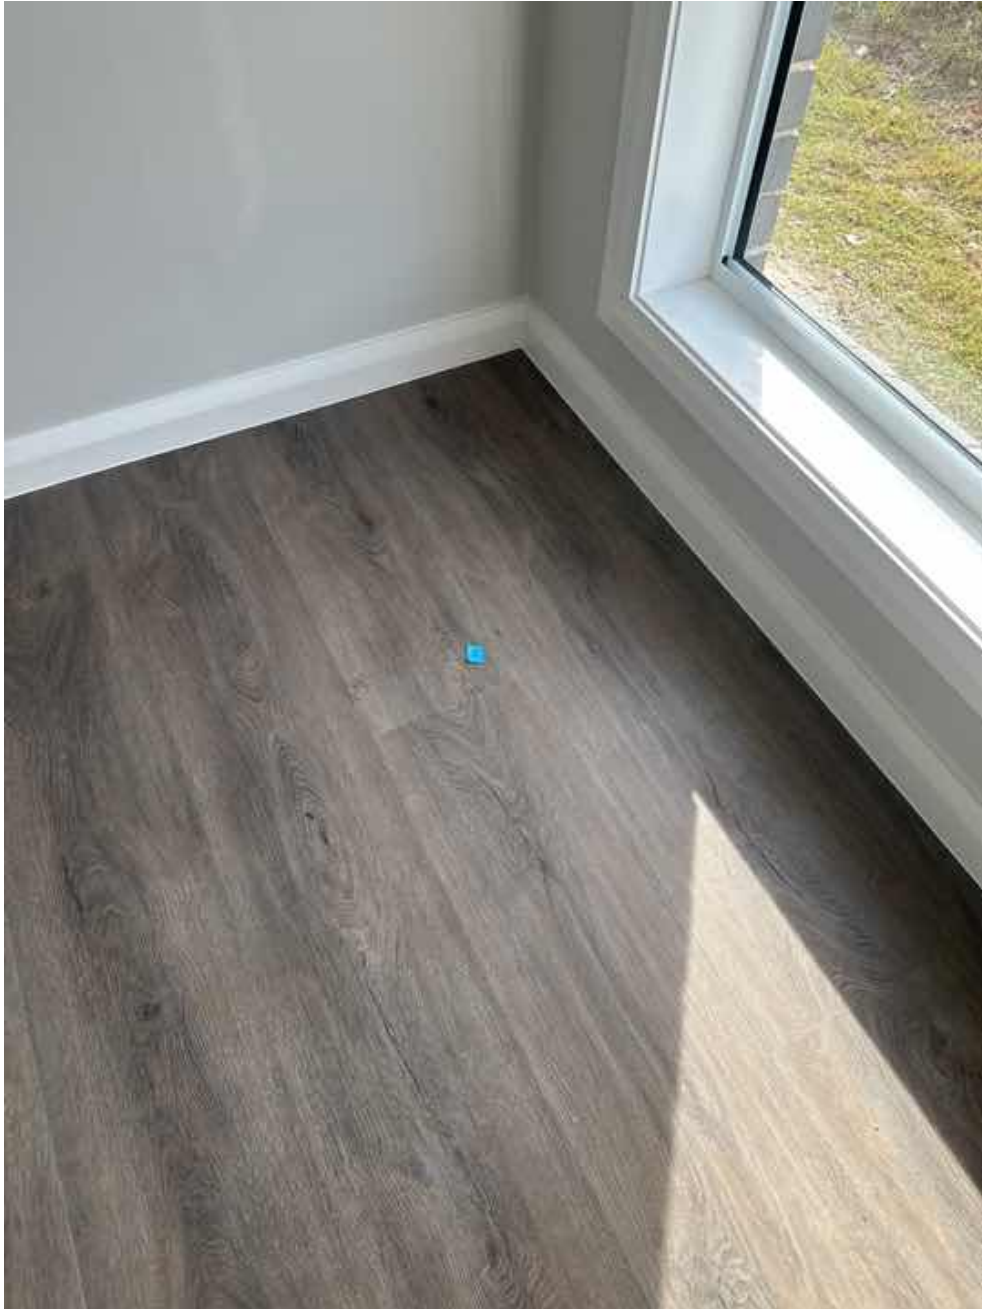
**Flooring**

Paint, glue or grout on flooring. Requires cleaning.

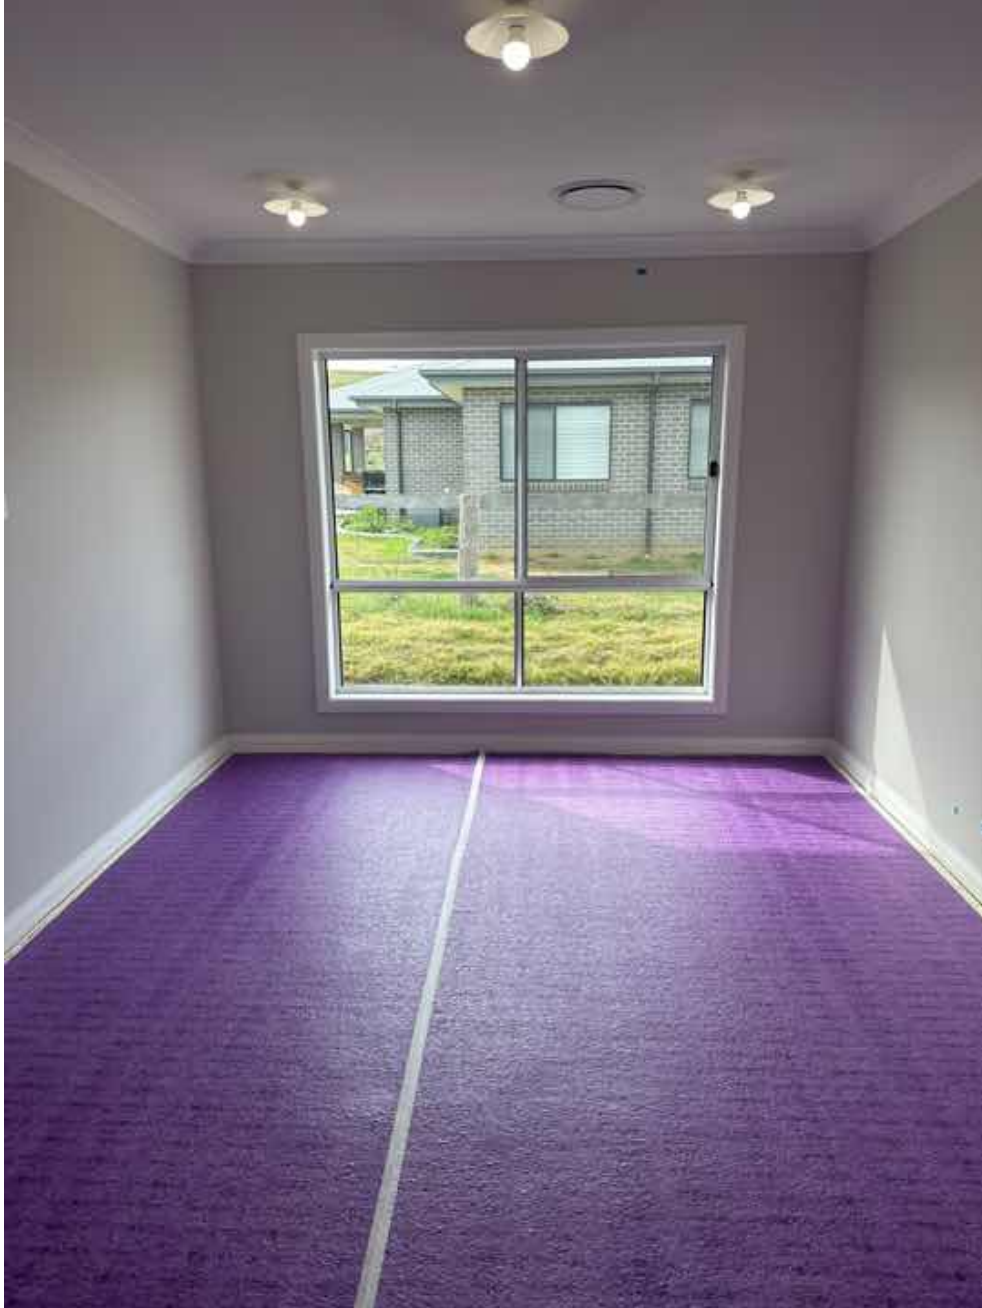
Rectification work required

A builders clean is required.

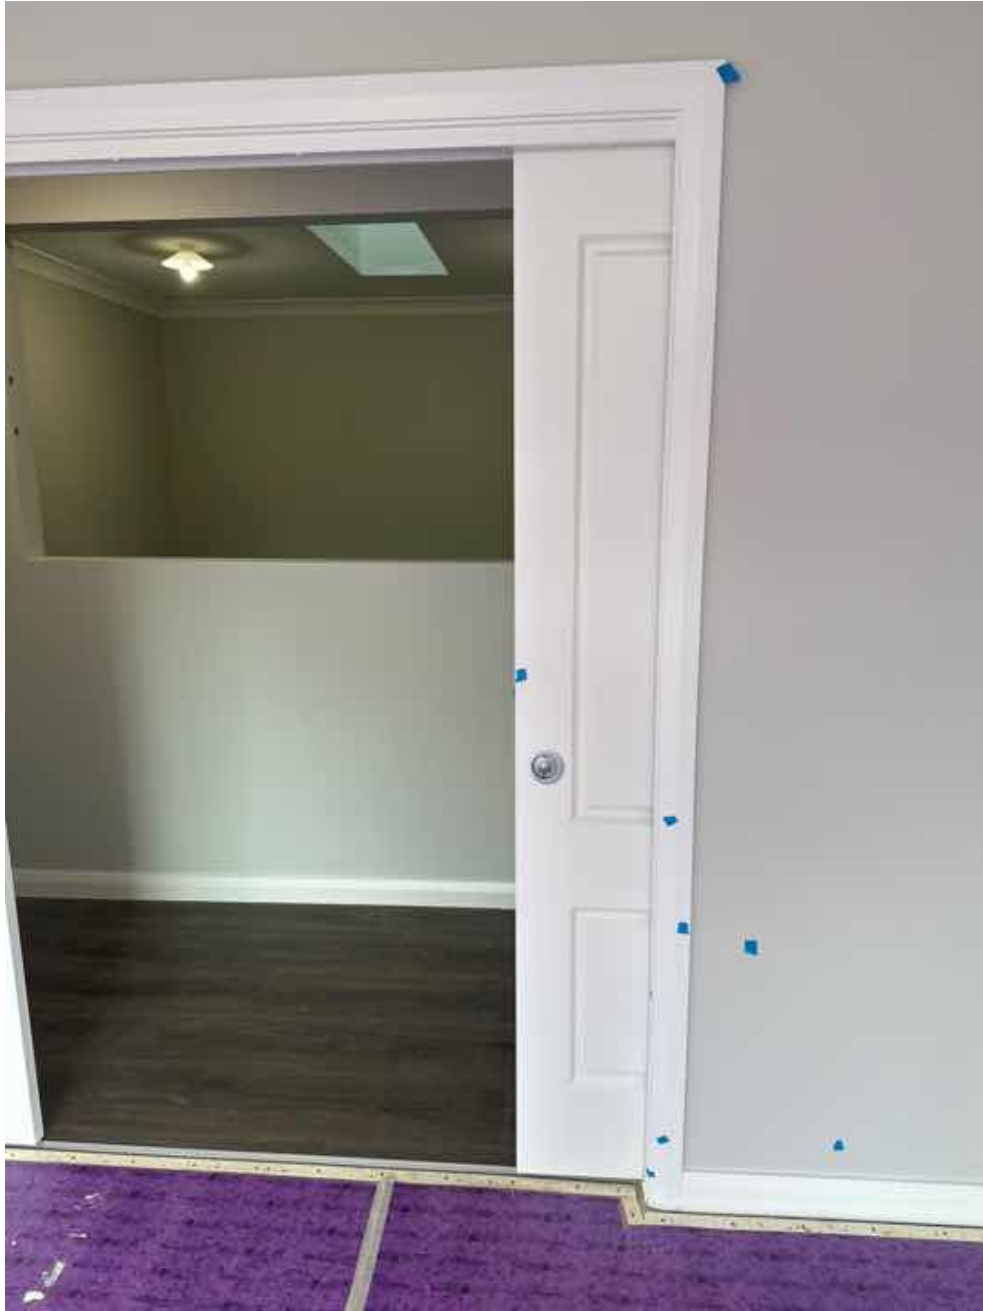
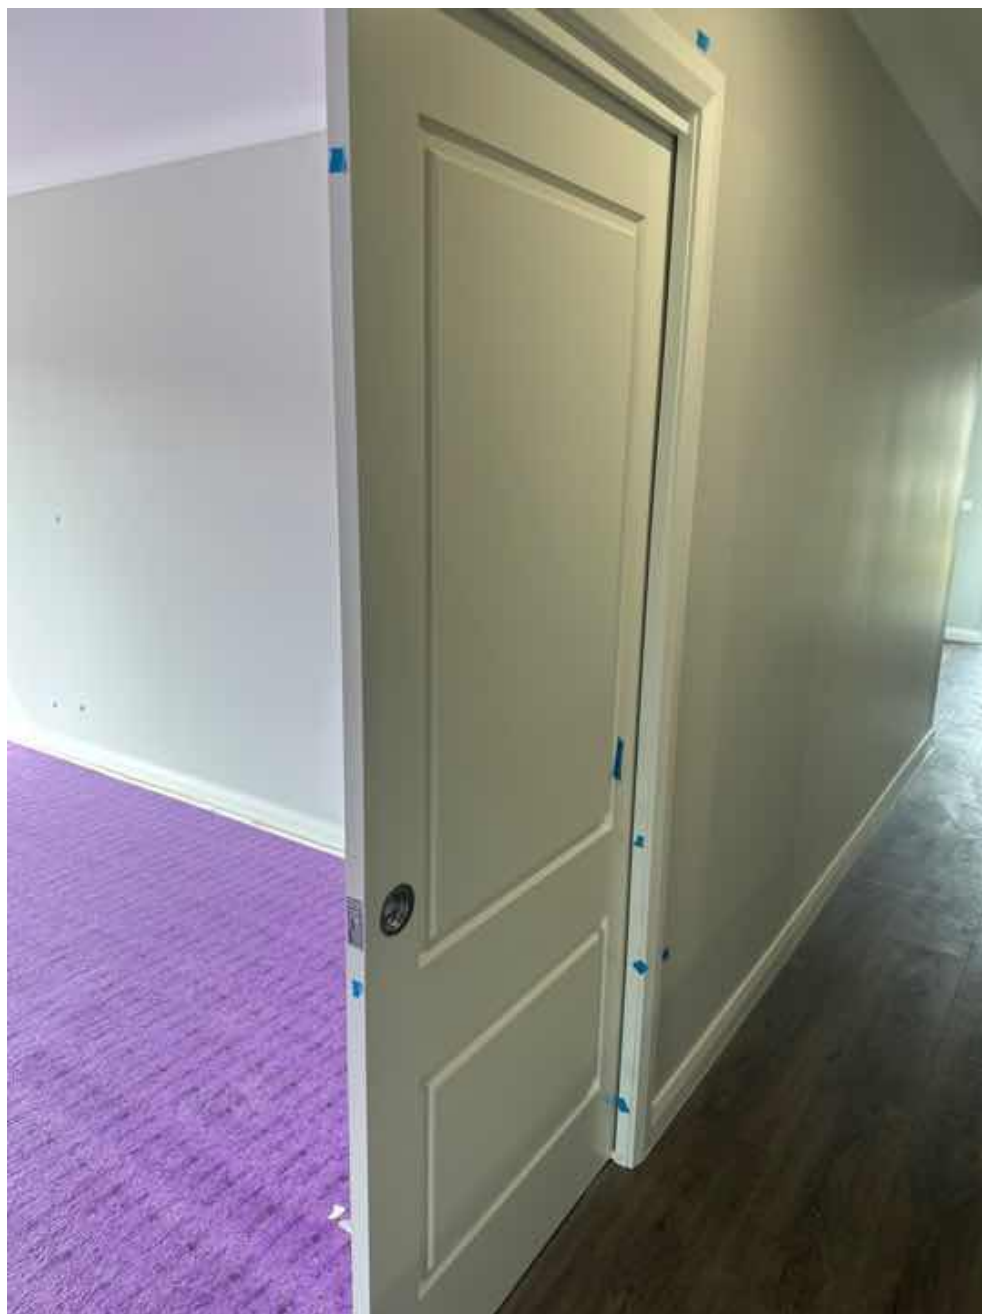
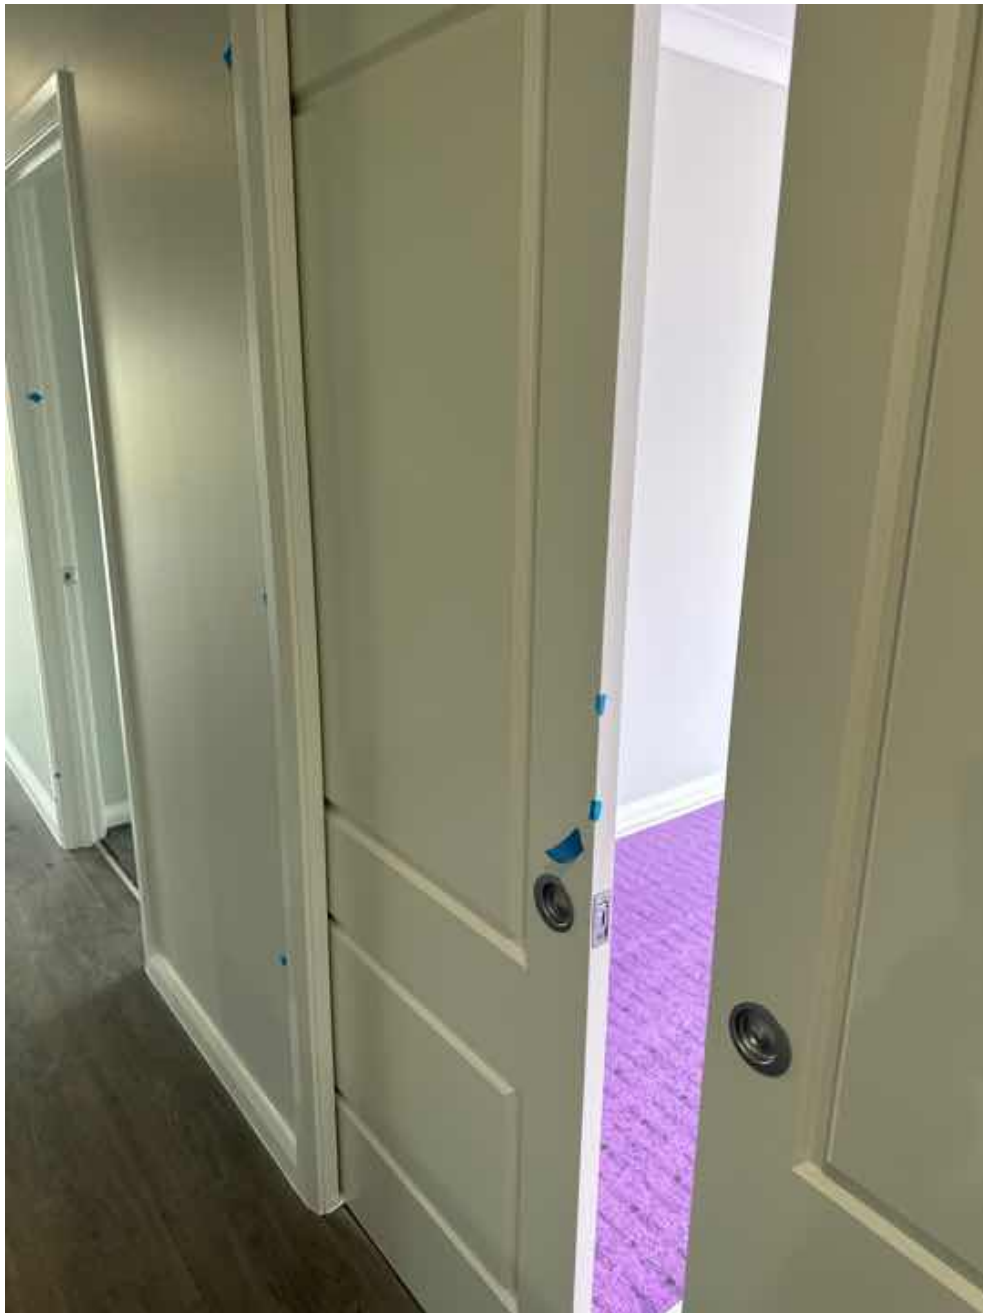
**Door**

Paint touch ups required as indicated by markers
