# Inspection Report

**UNCOVER**  
BUILDING AND PEST INSPECTIONS

**1 Sample St , Sample, Nsw, 2281**

### Handover Inspection

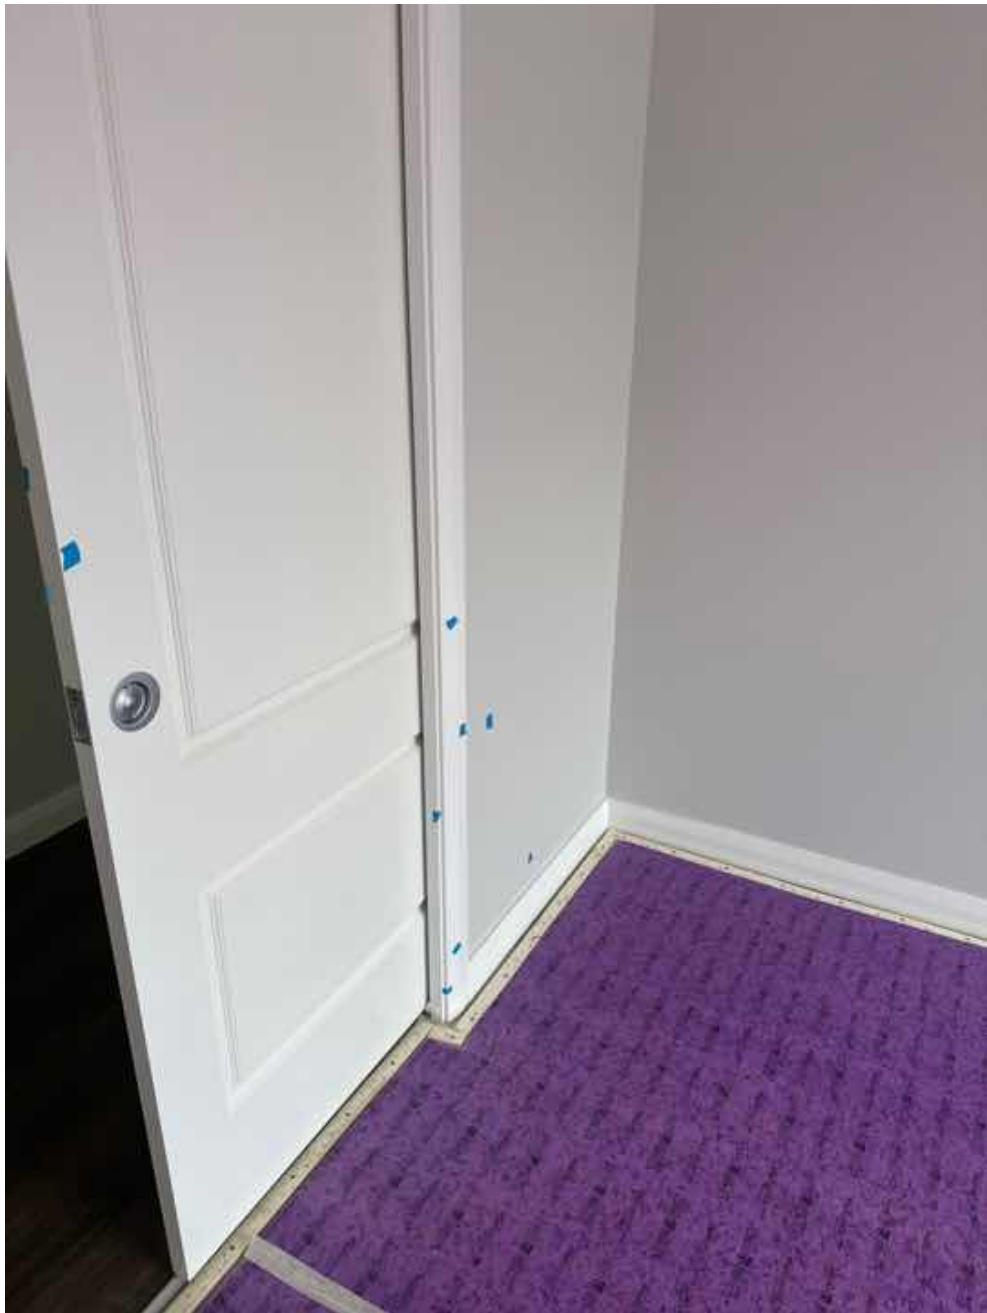
**Walls**

Paint touch ups required. Defects noticeable from normal viewing position. Additional plastering, sanding and painting required.

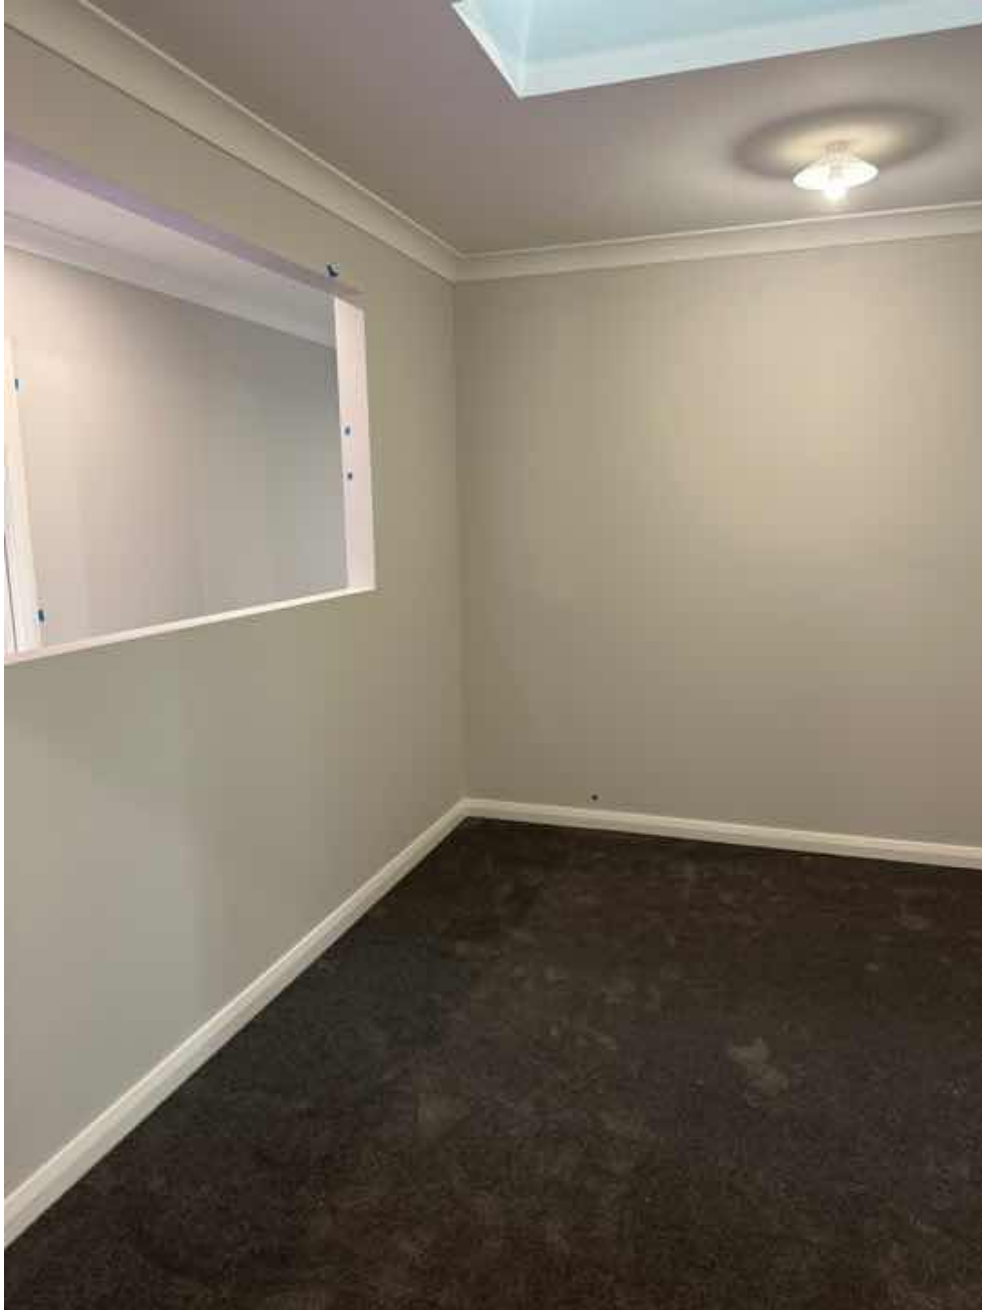
Rectification work required

A builders clean is required.

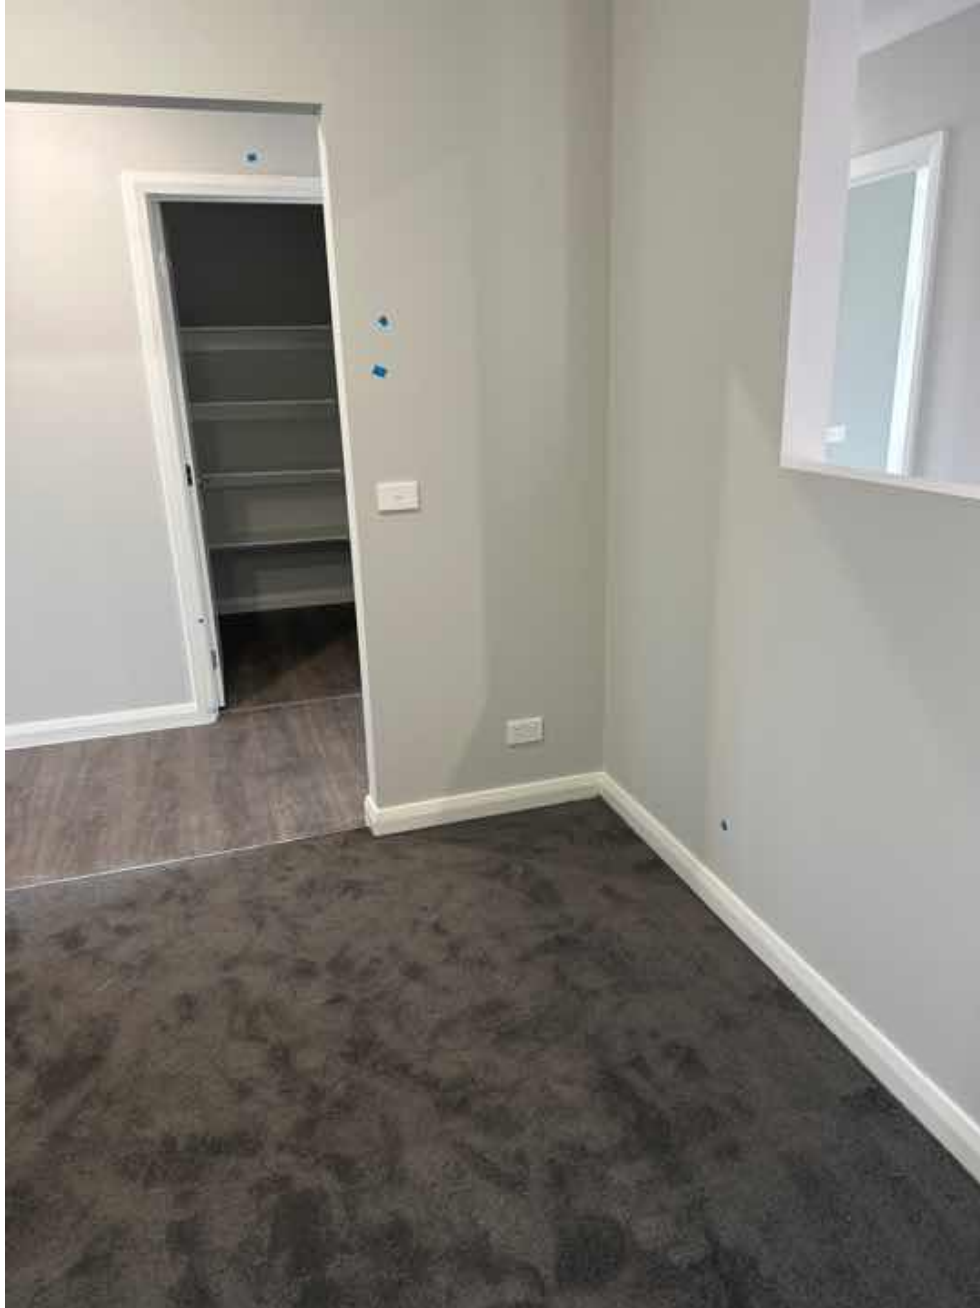
**Walls**

The remote is uninstalled for the velux window.

Paint touch ups required. Defects noticeable from normal viewing position. Additional plastering, sanding and painting required.

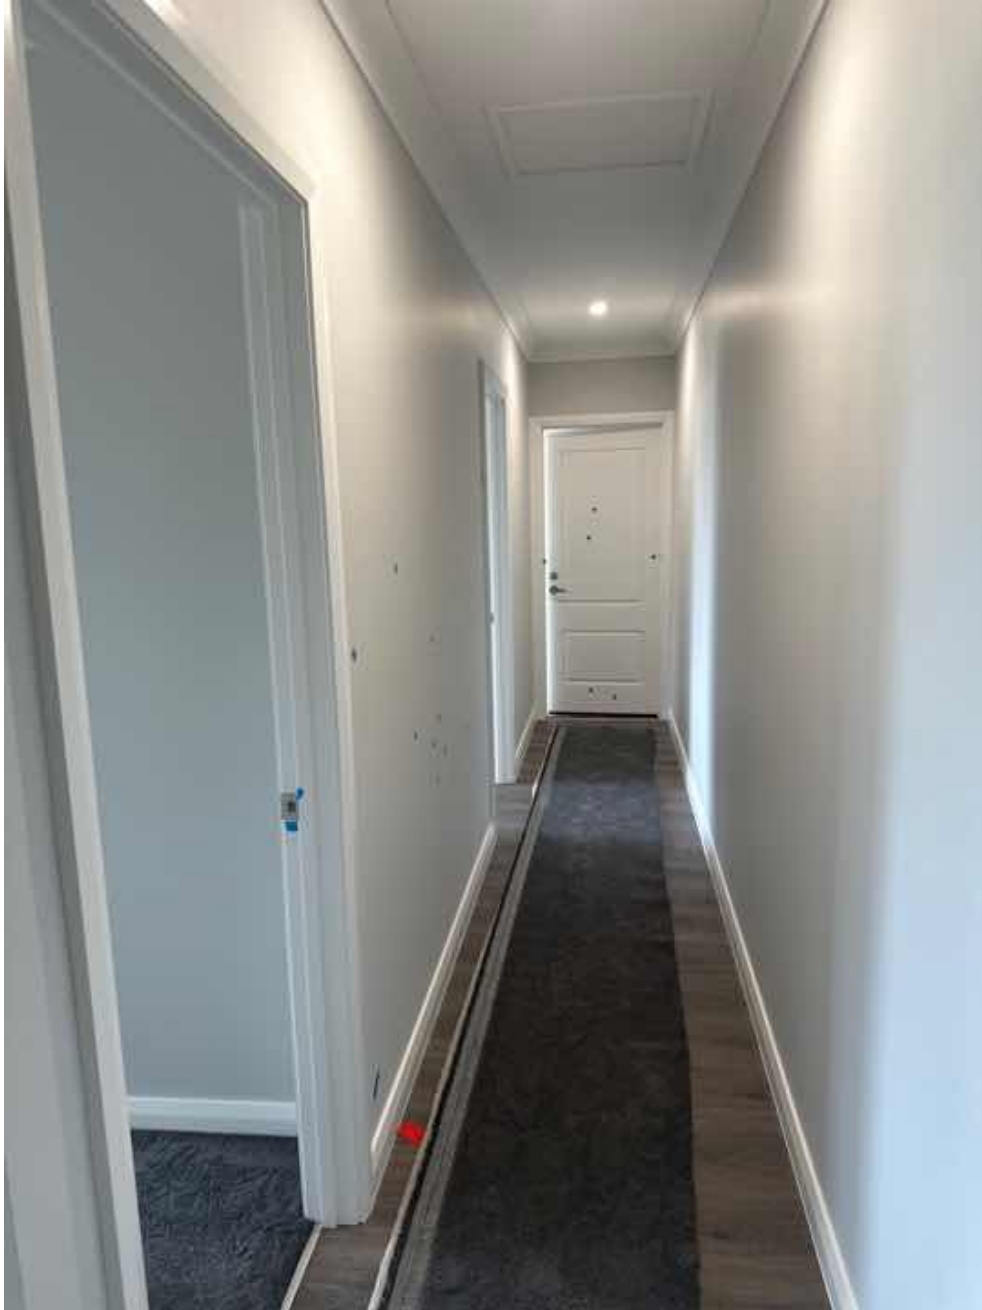
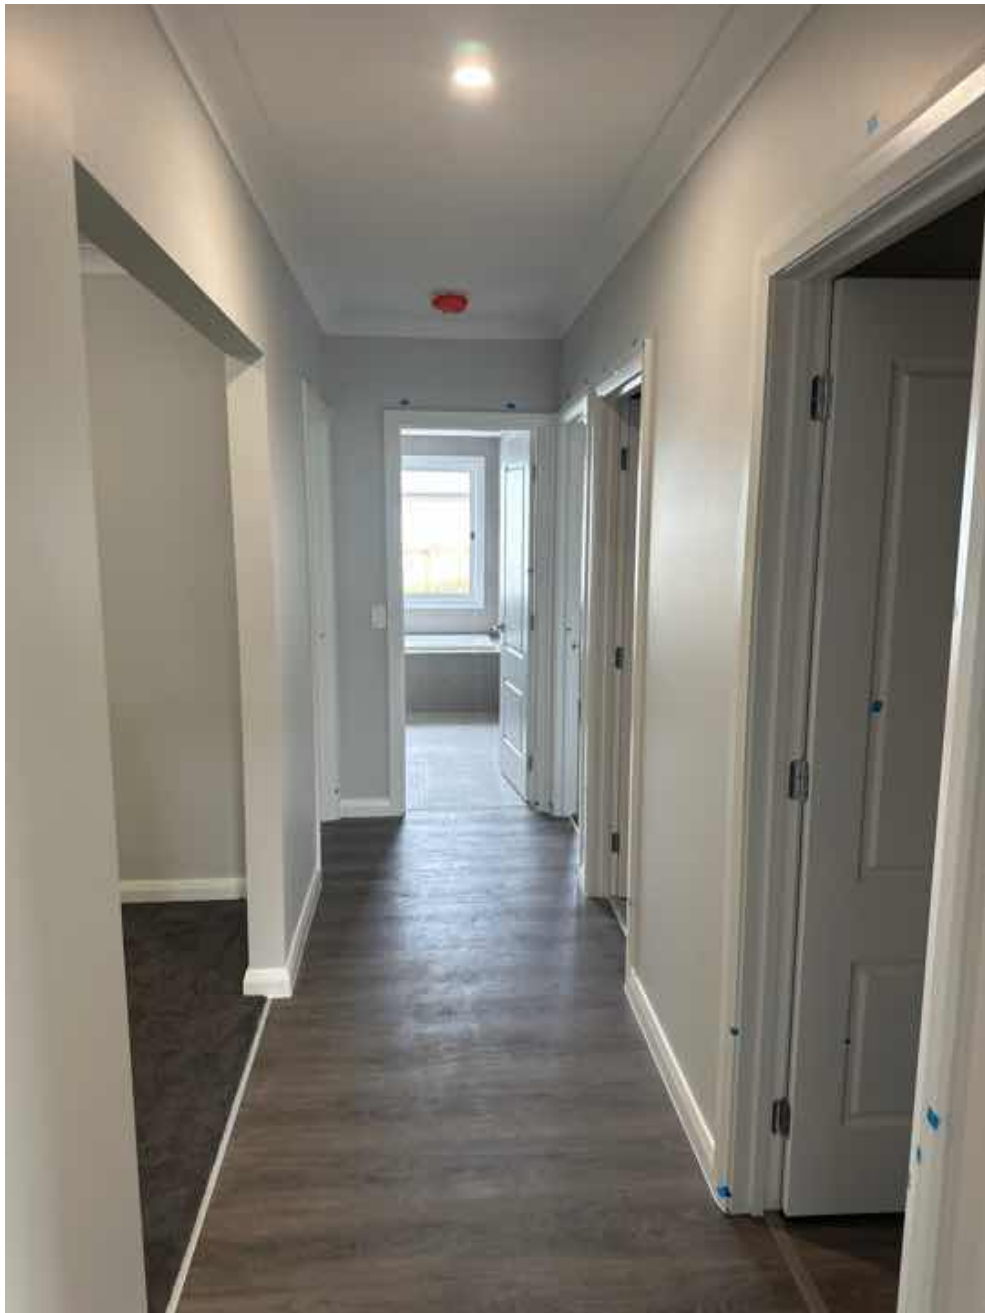
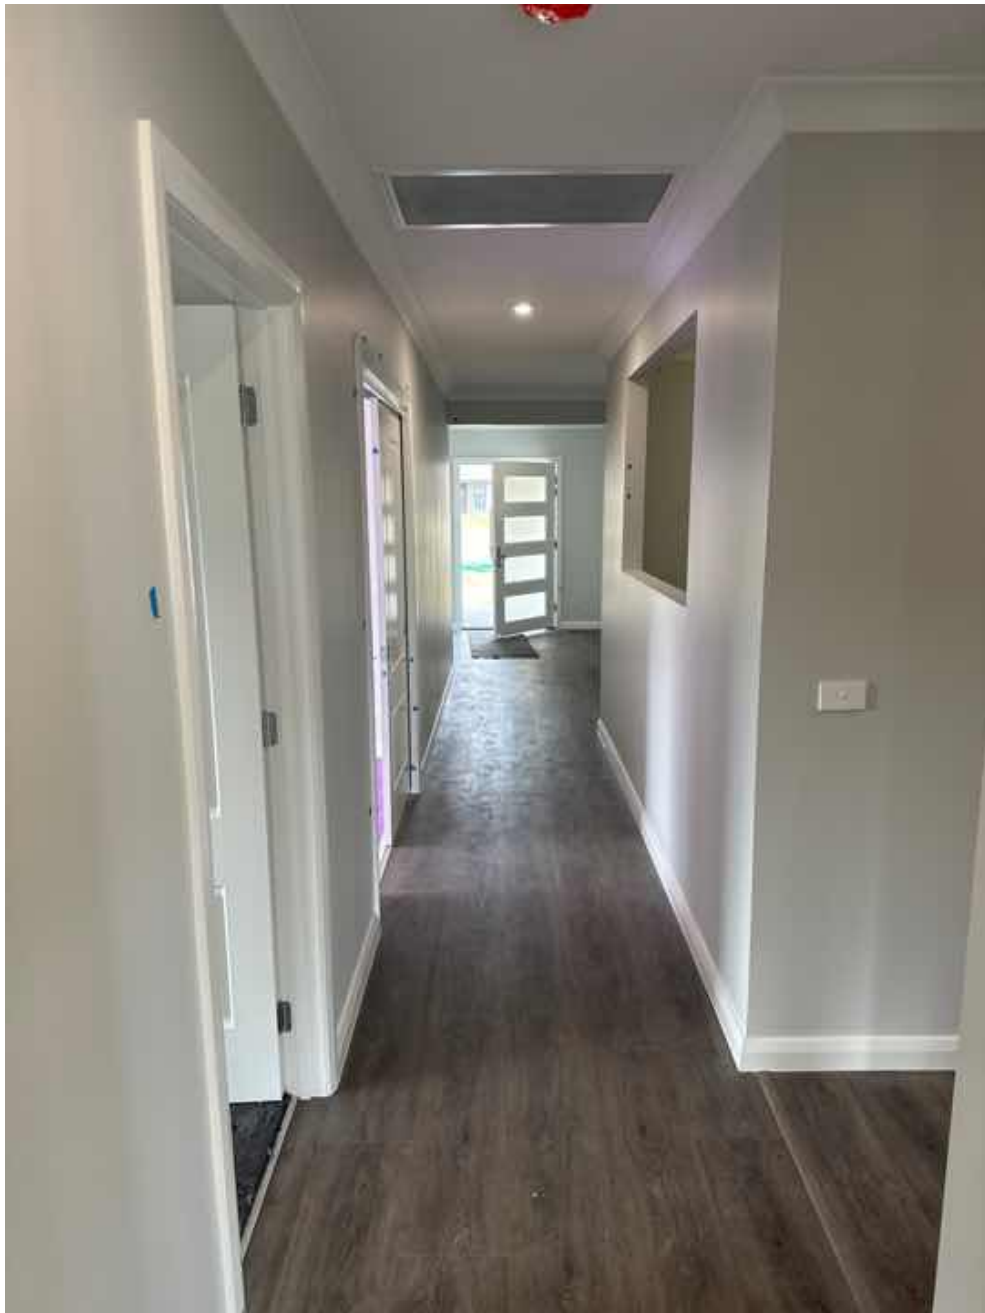
Rectification work required

A builders clean is required.

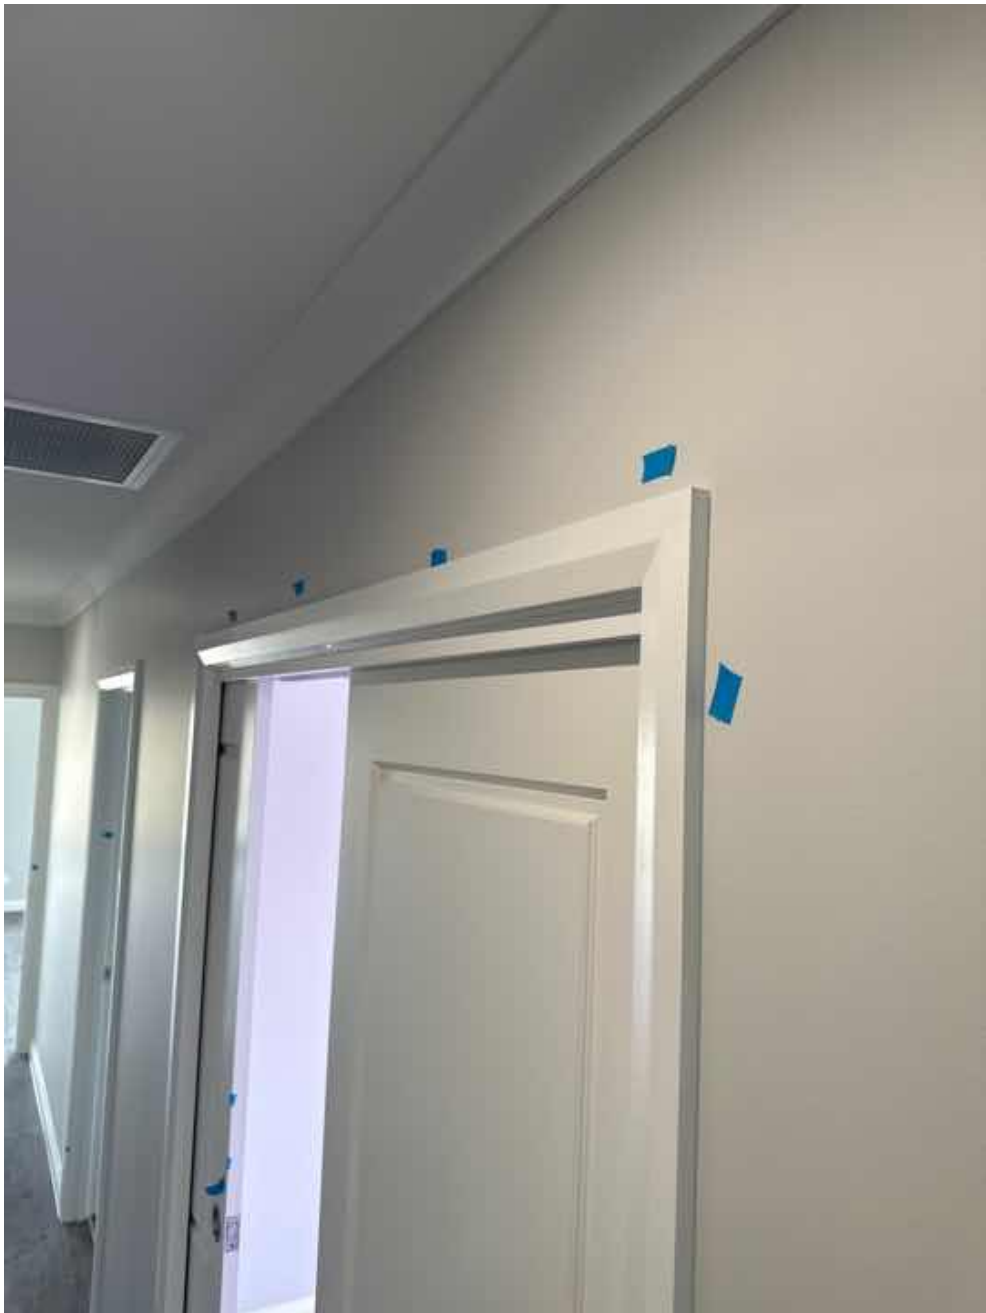
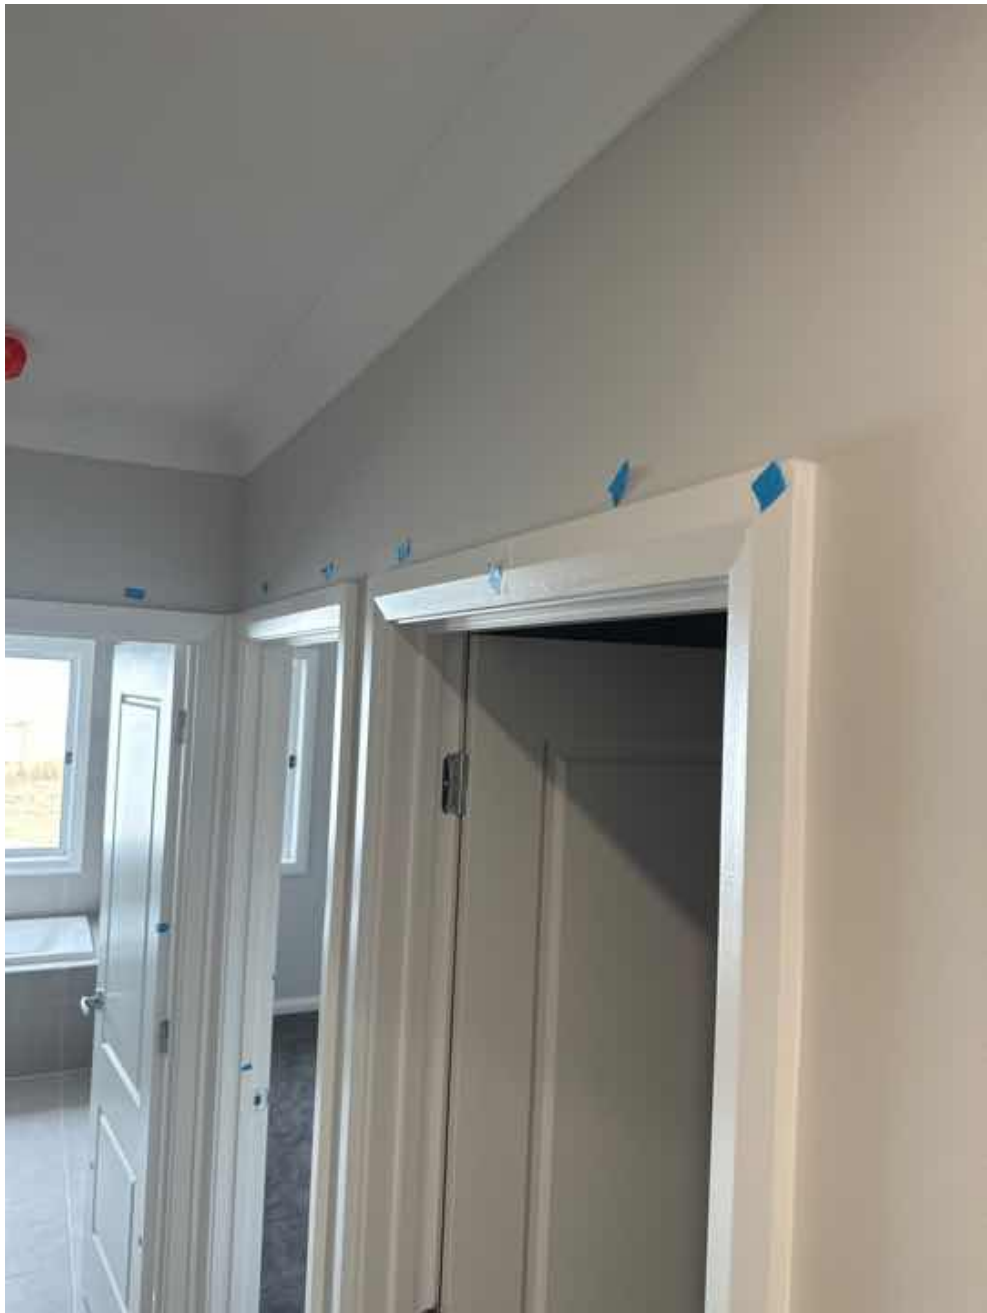
## Walls

Paint touch ups required. Defects noticeable from normal viewing position. Additional plastering, sanding and painting required.

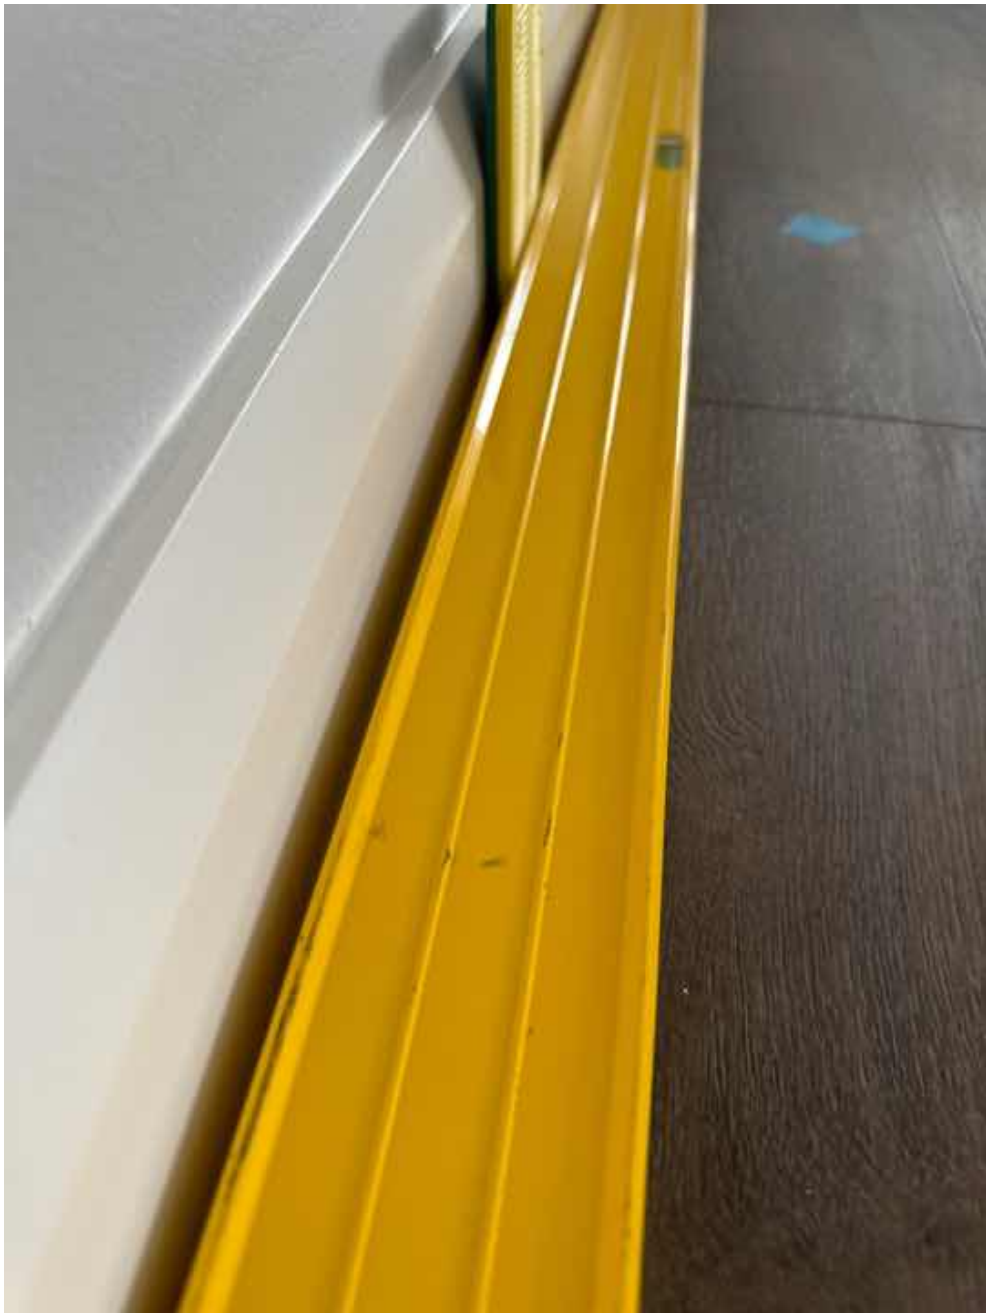
## Flooring

The skirting is bowed in the hallway approx 8mm over 1.8m. Rectification required.

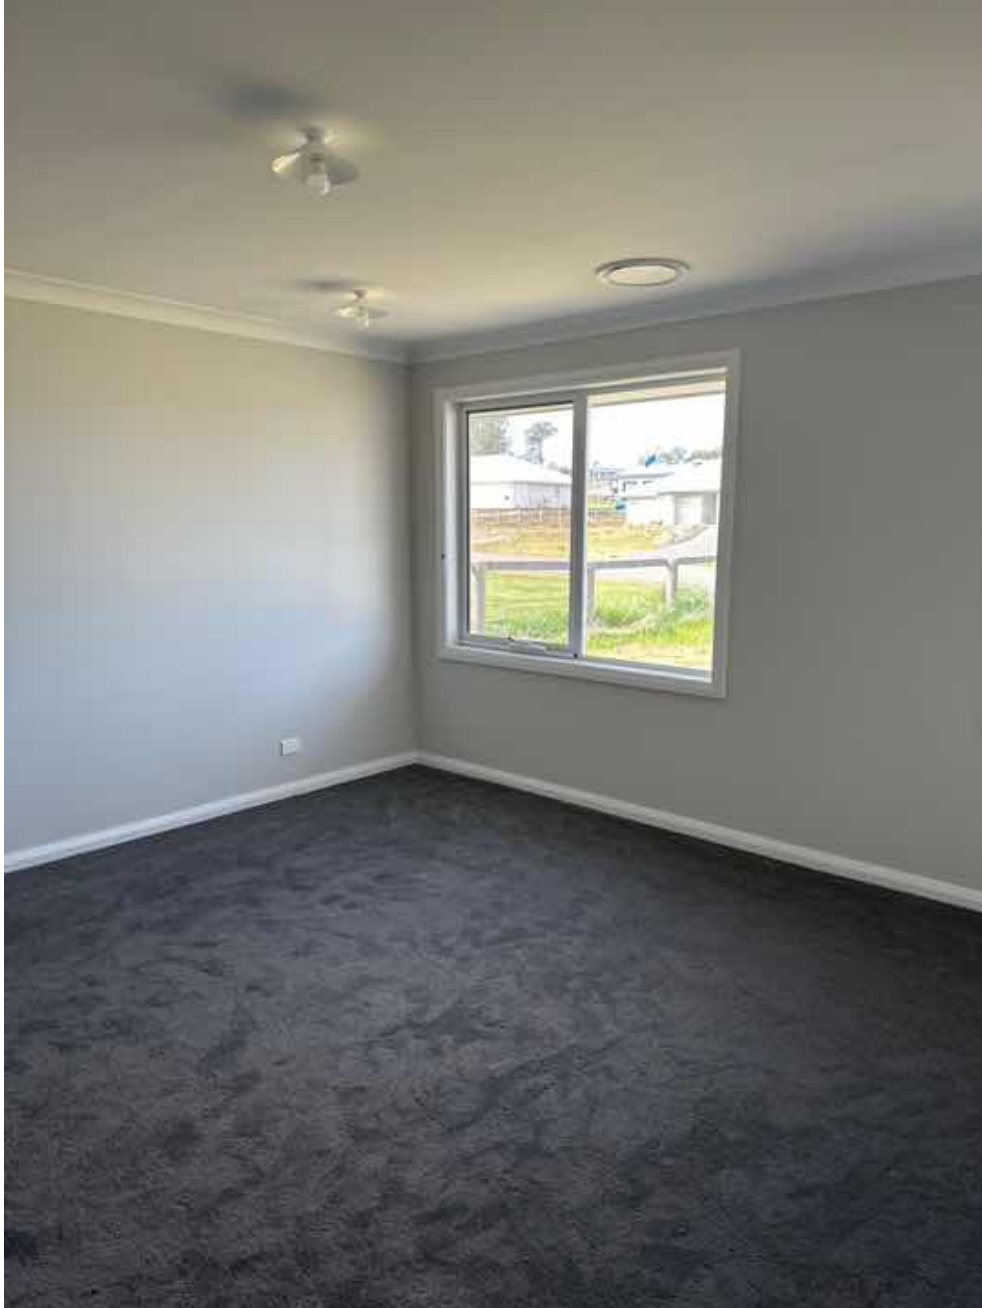
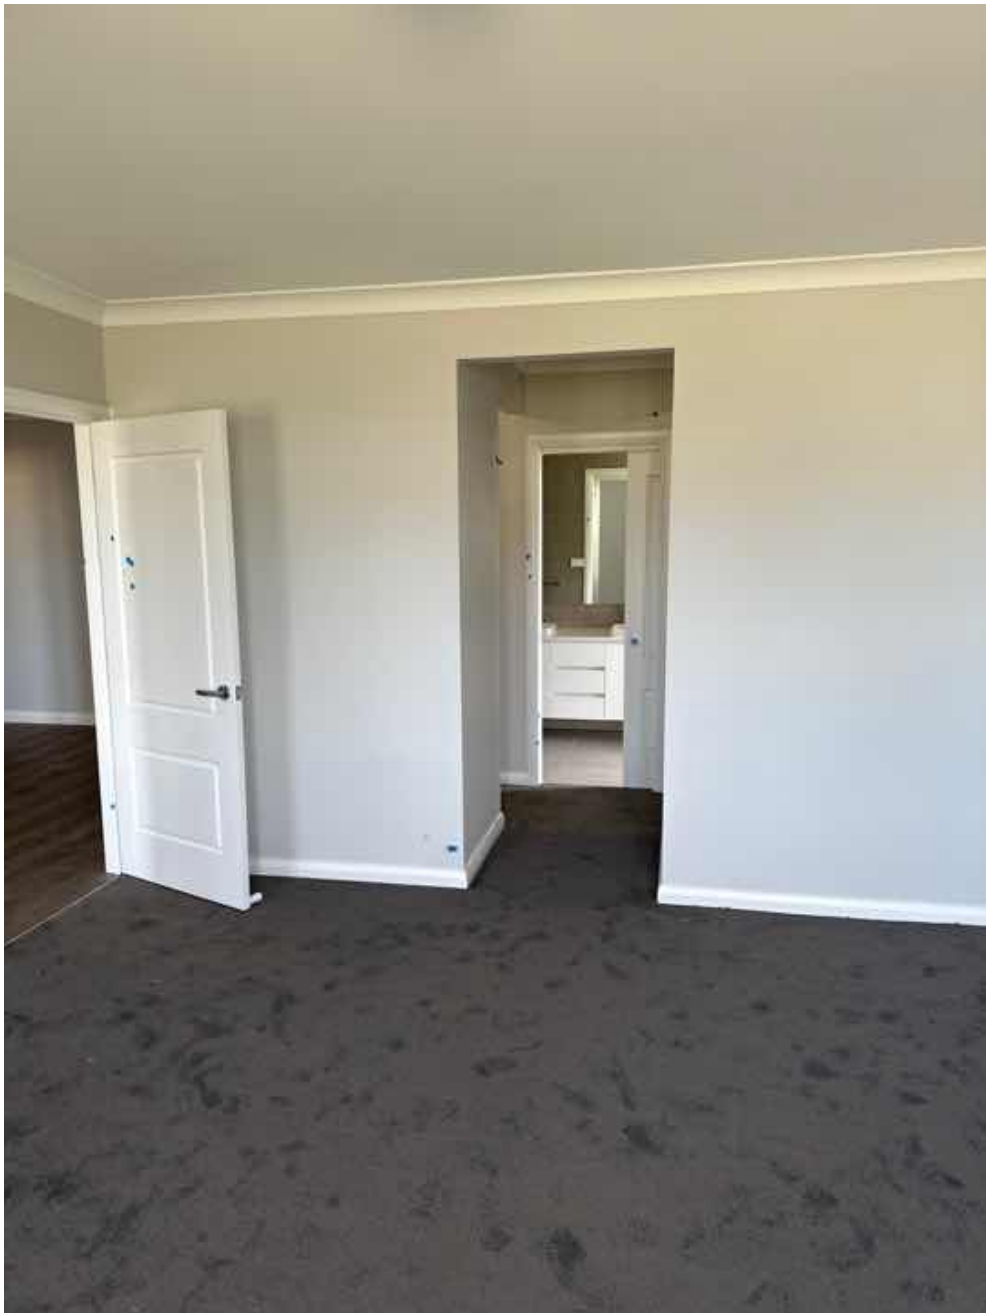
Rectification work required

A builders clean is required.

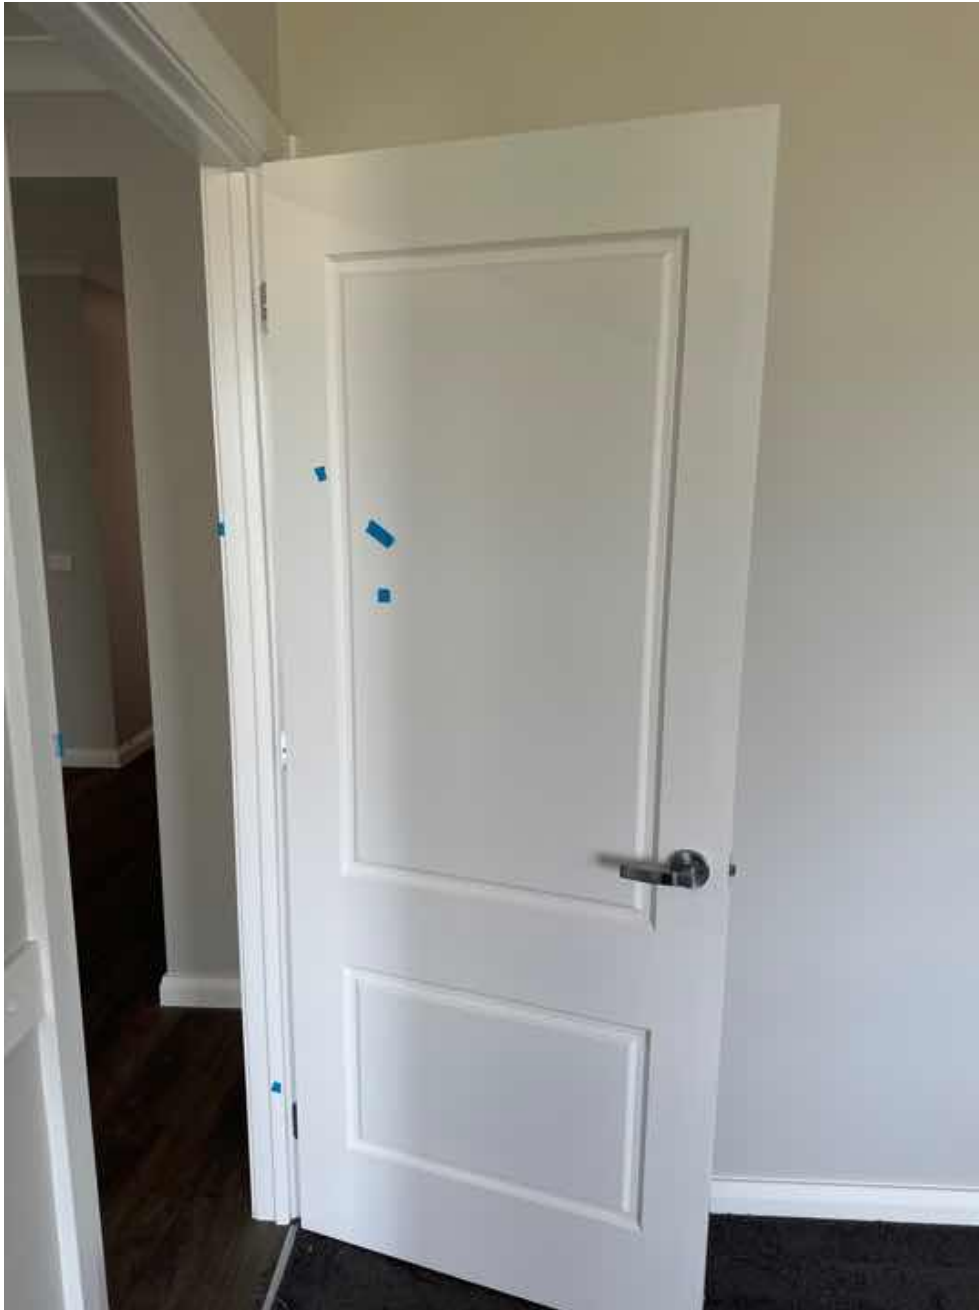
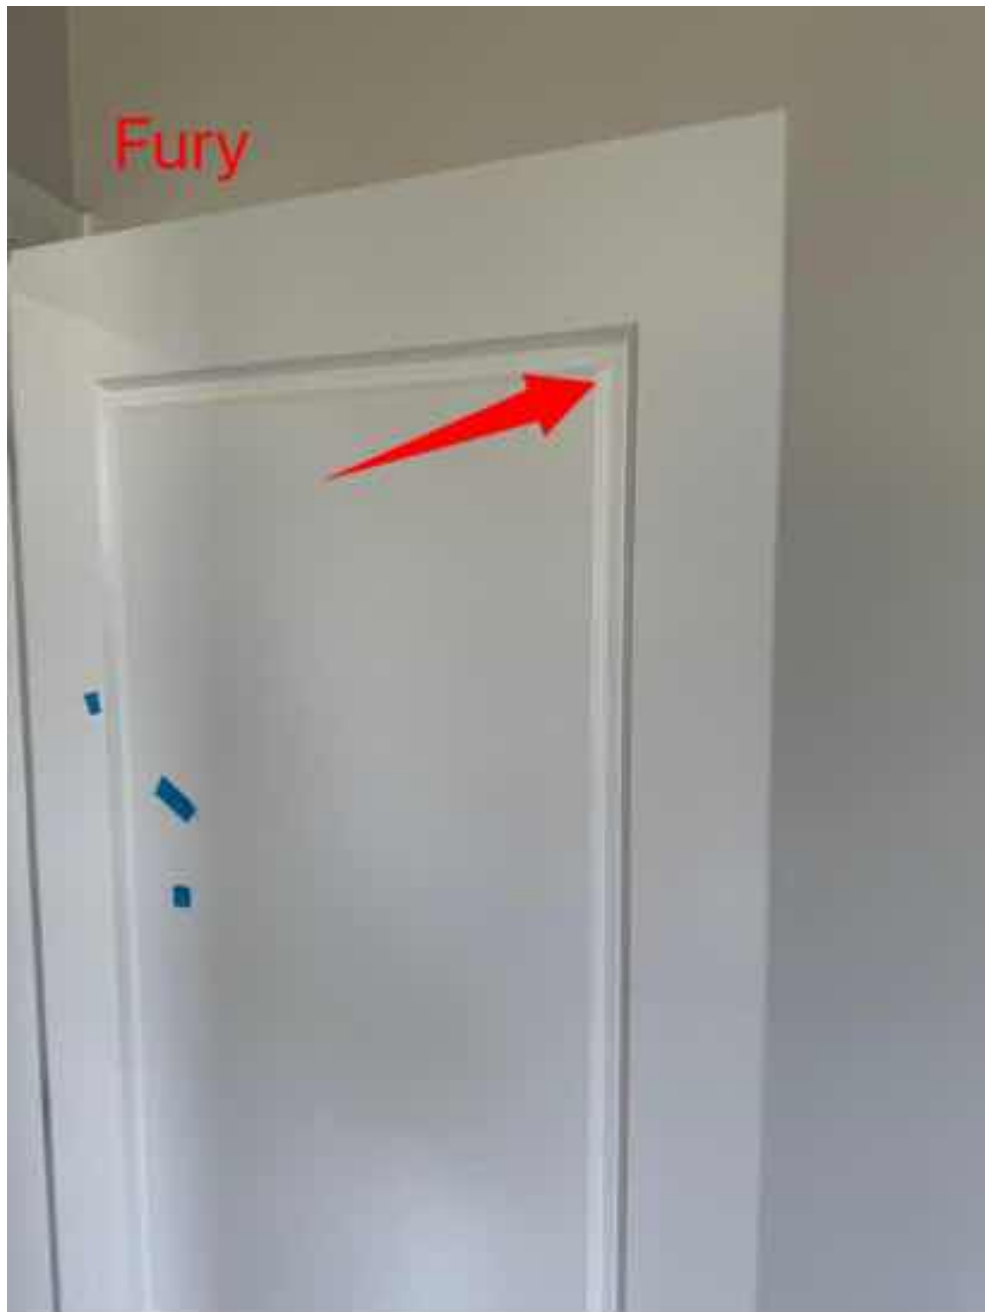
## Door

Paint touch ups required as indicated by markers

The door face router detail has not been sanded between coats. This detail is fuzzy in appearance from a normal viewing position of 1.5m and is rough to touch. Requires a light sand and re painting.
