# Inspection Report

**UNCOVER**  
BUILDING AND PEST INSPECTIONS

**1 Sample St , Sample, Nsw, 2281**

### Handover Inspection

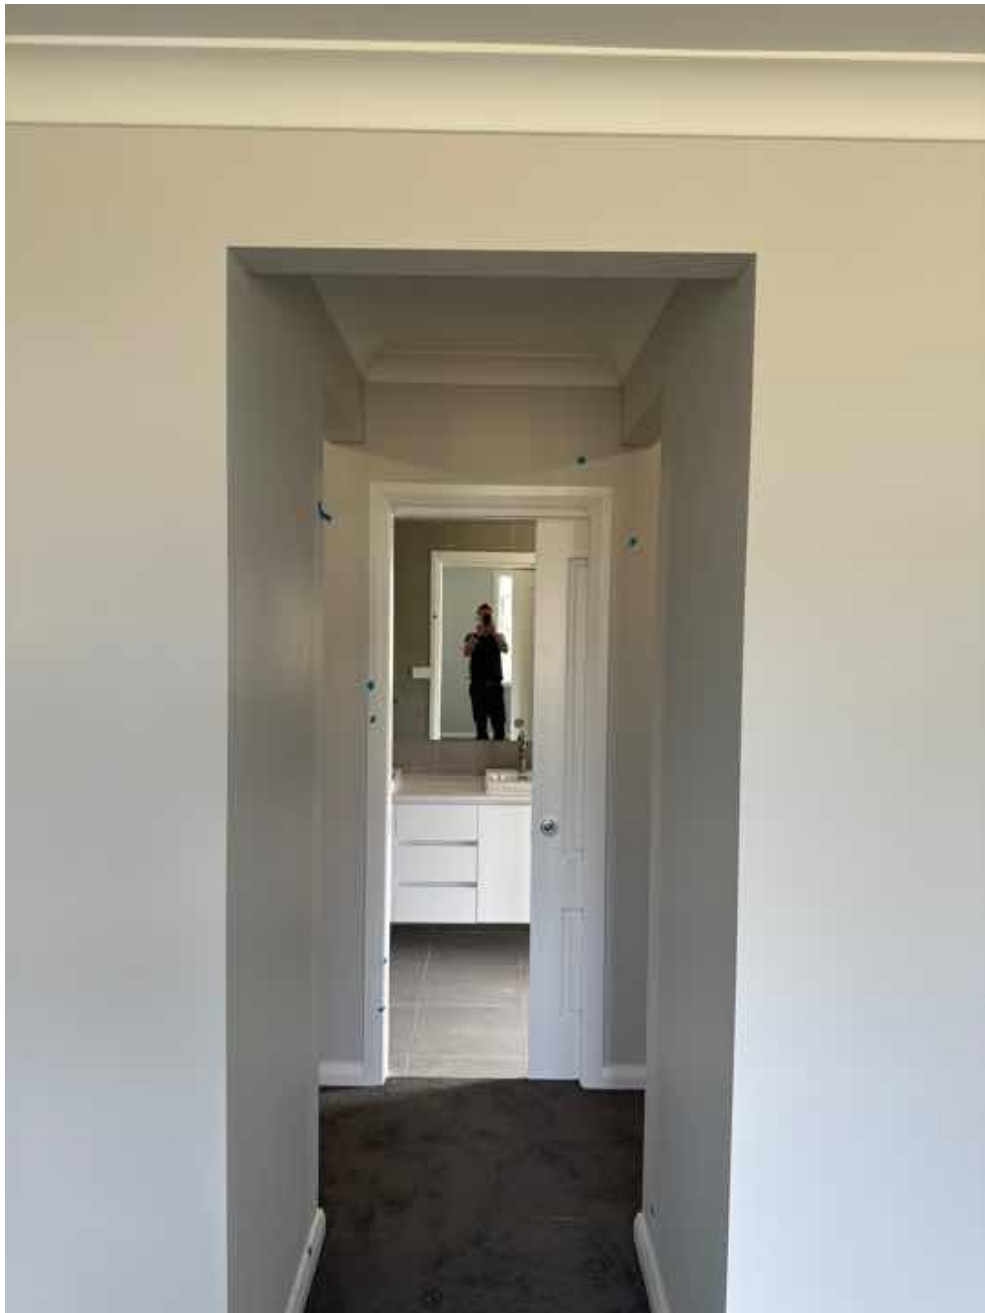
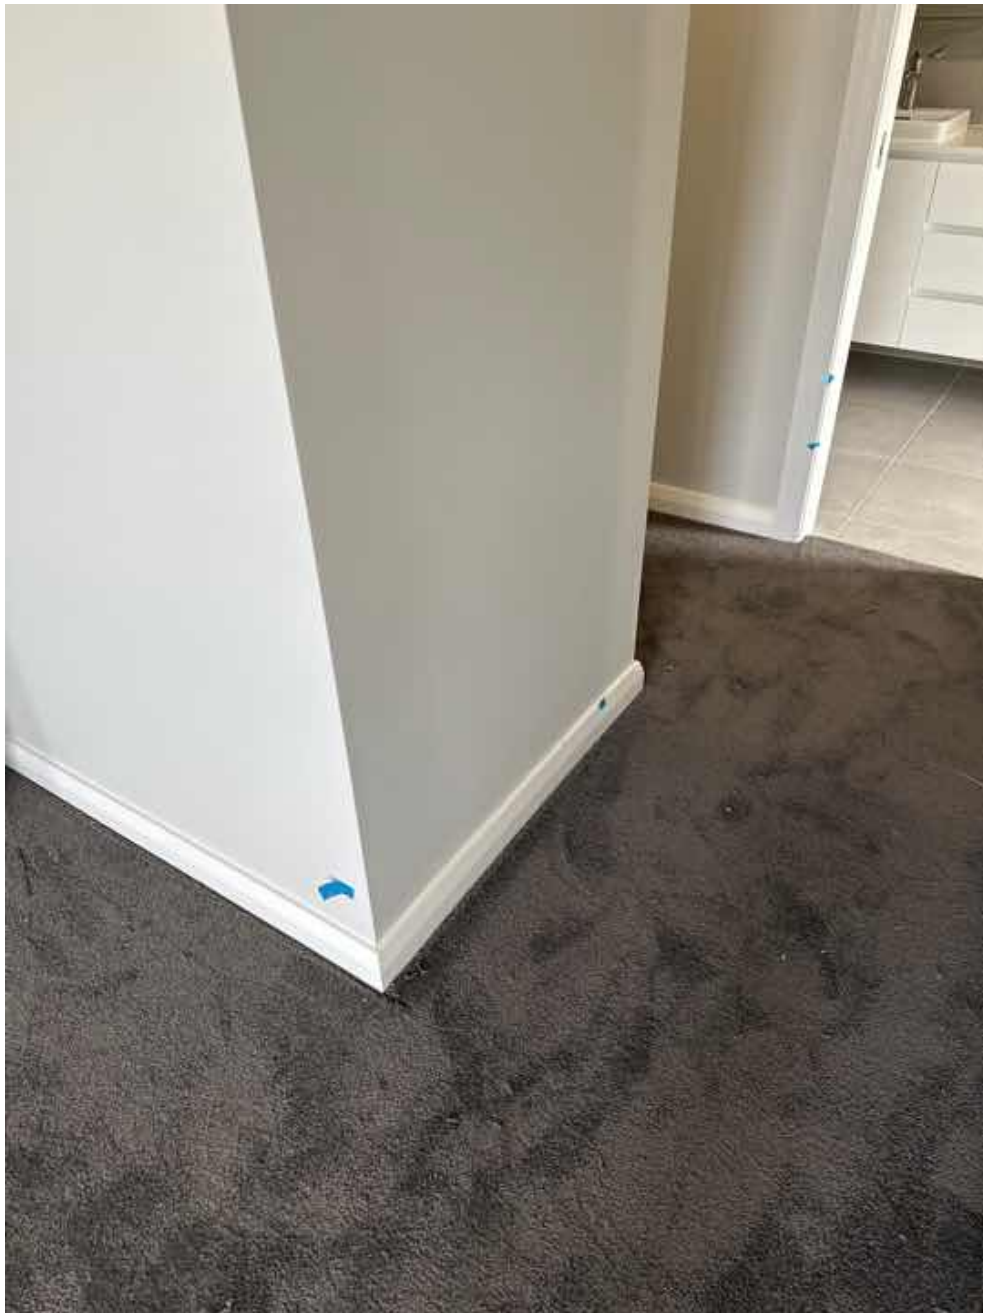
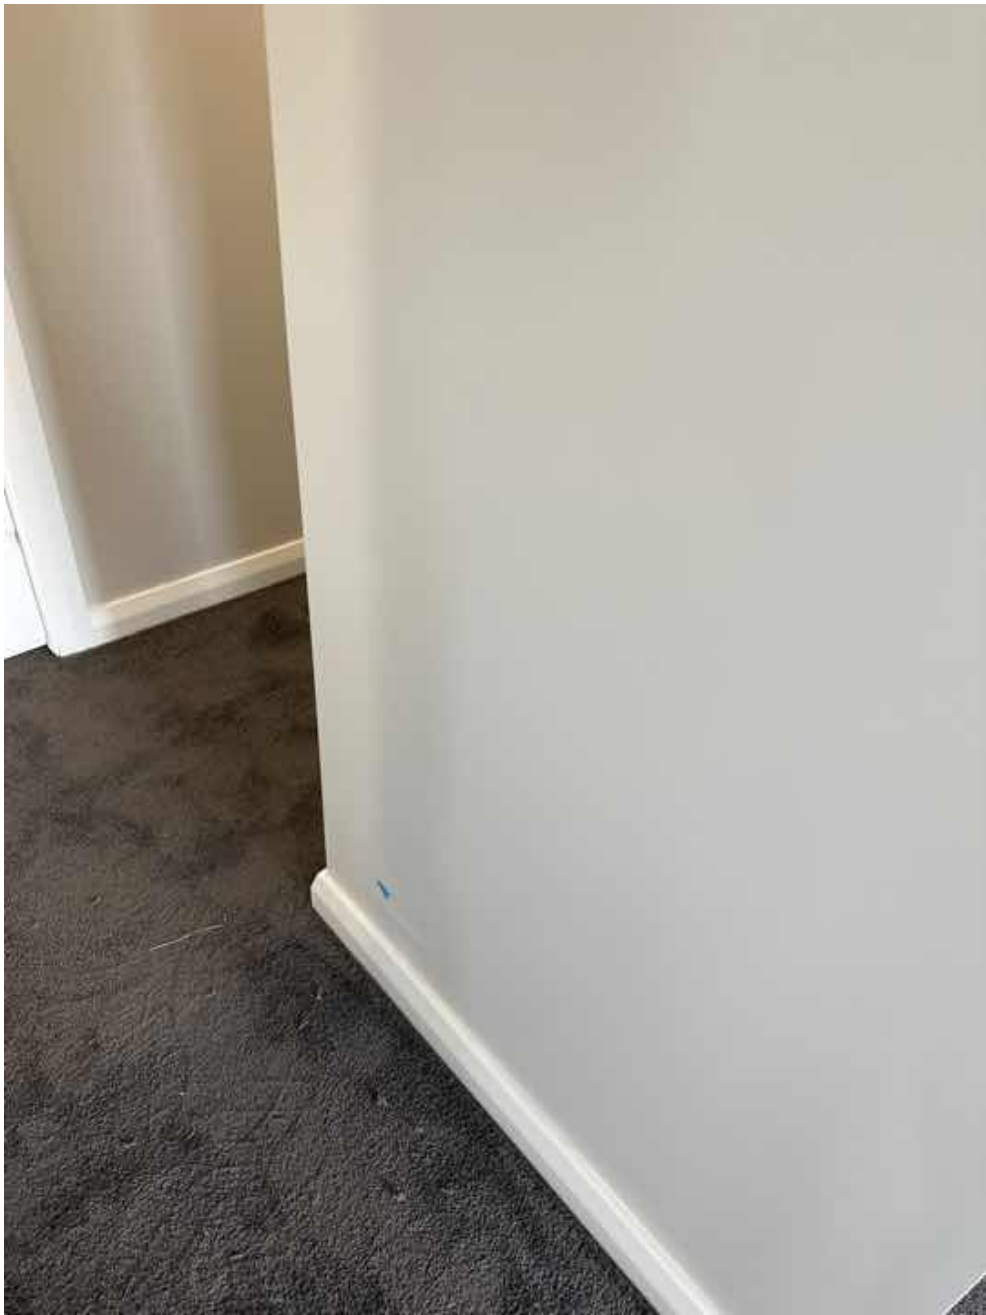
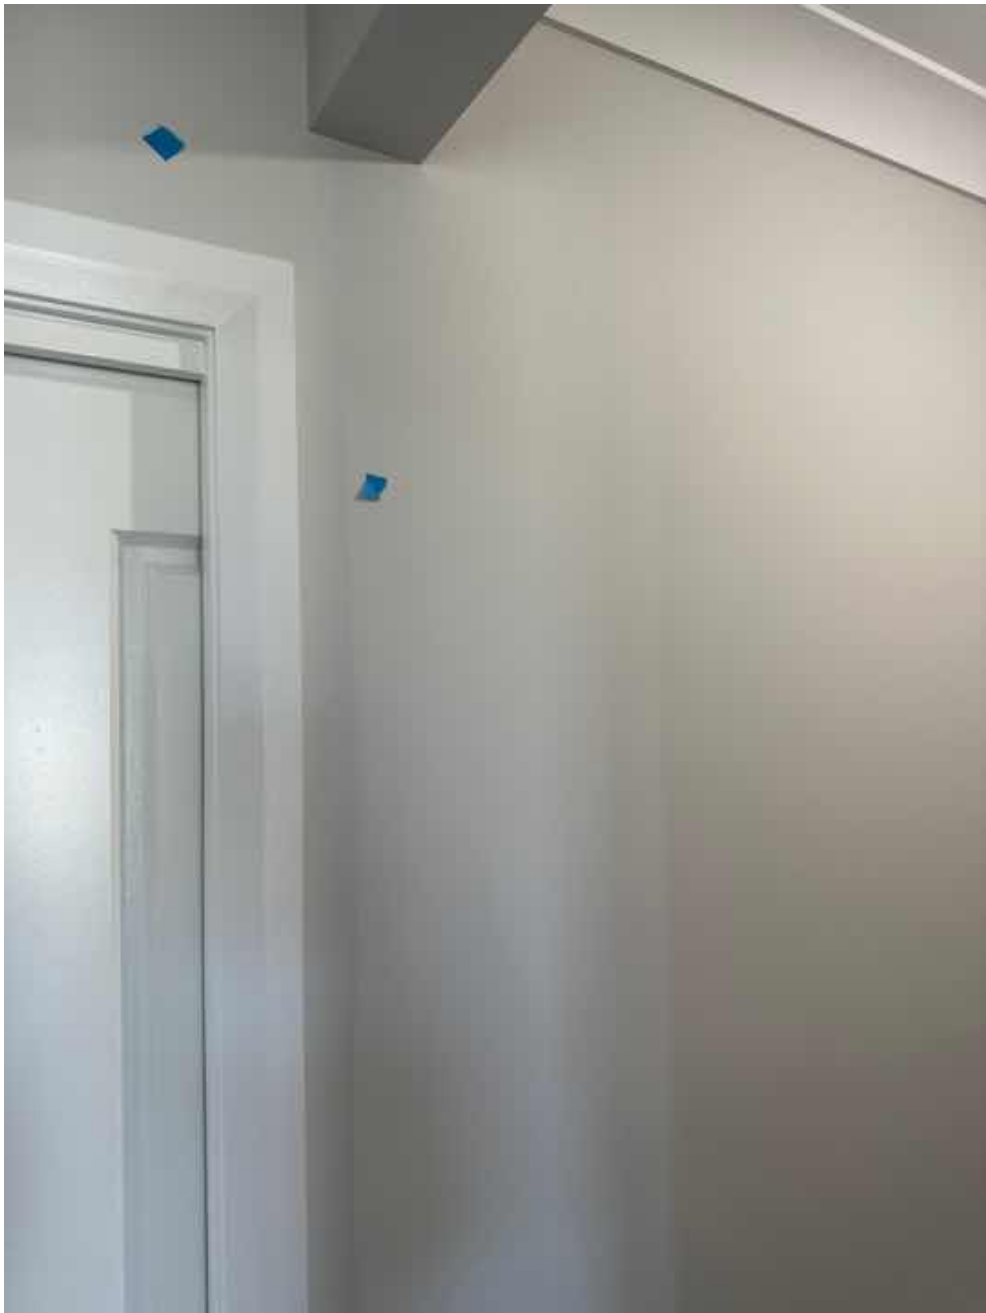
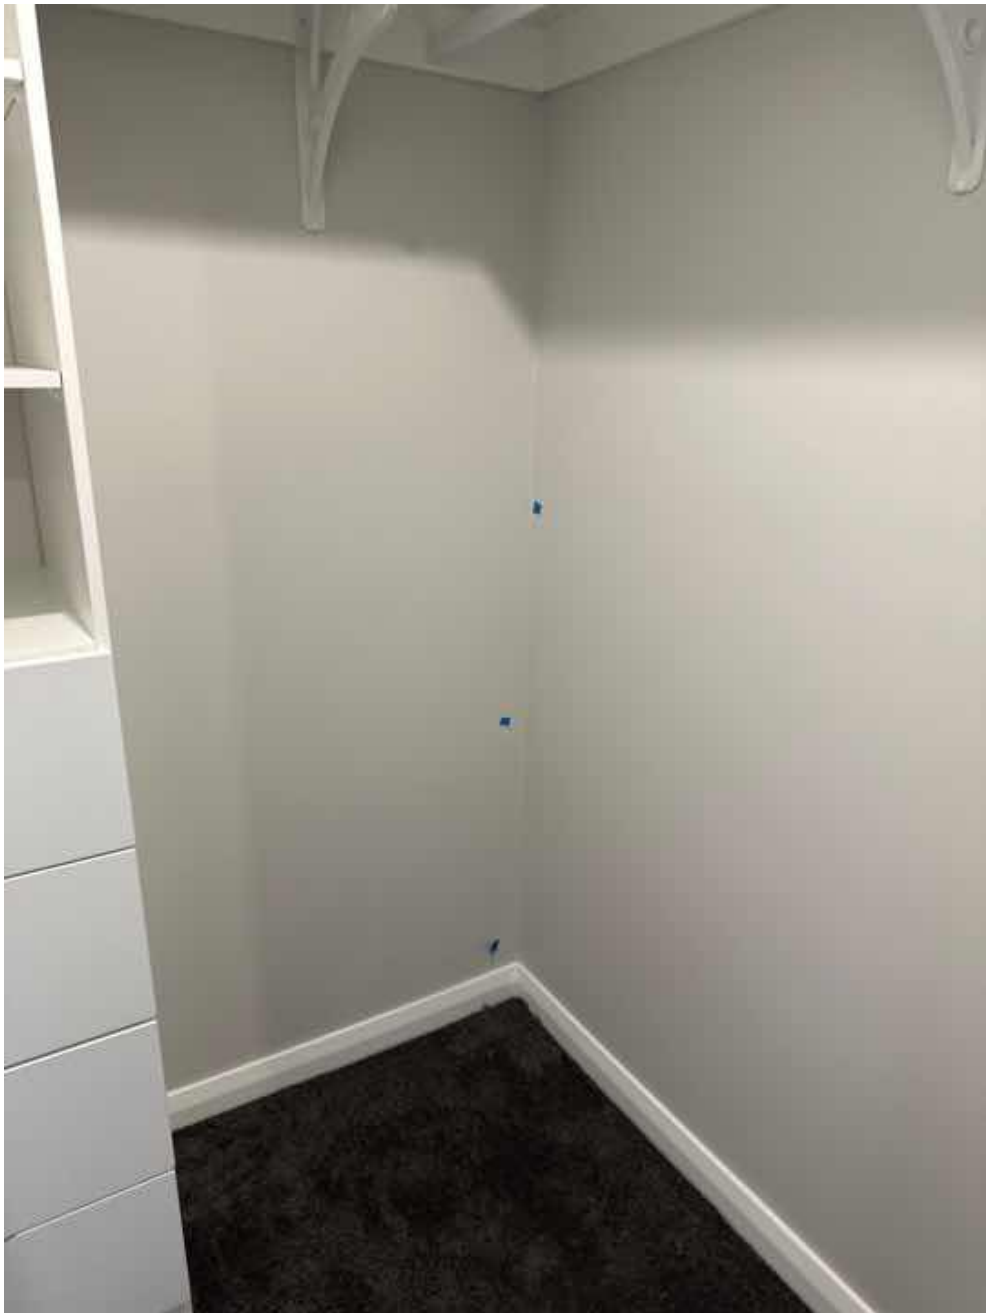
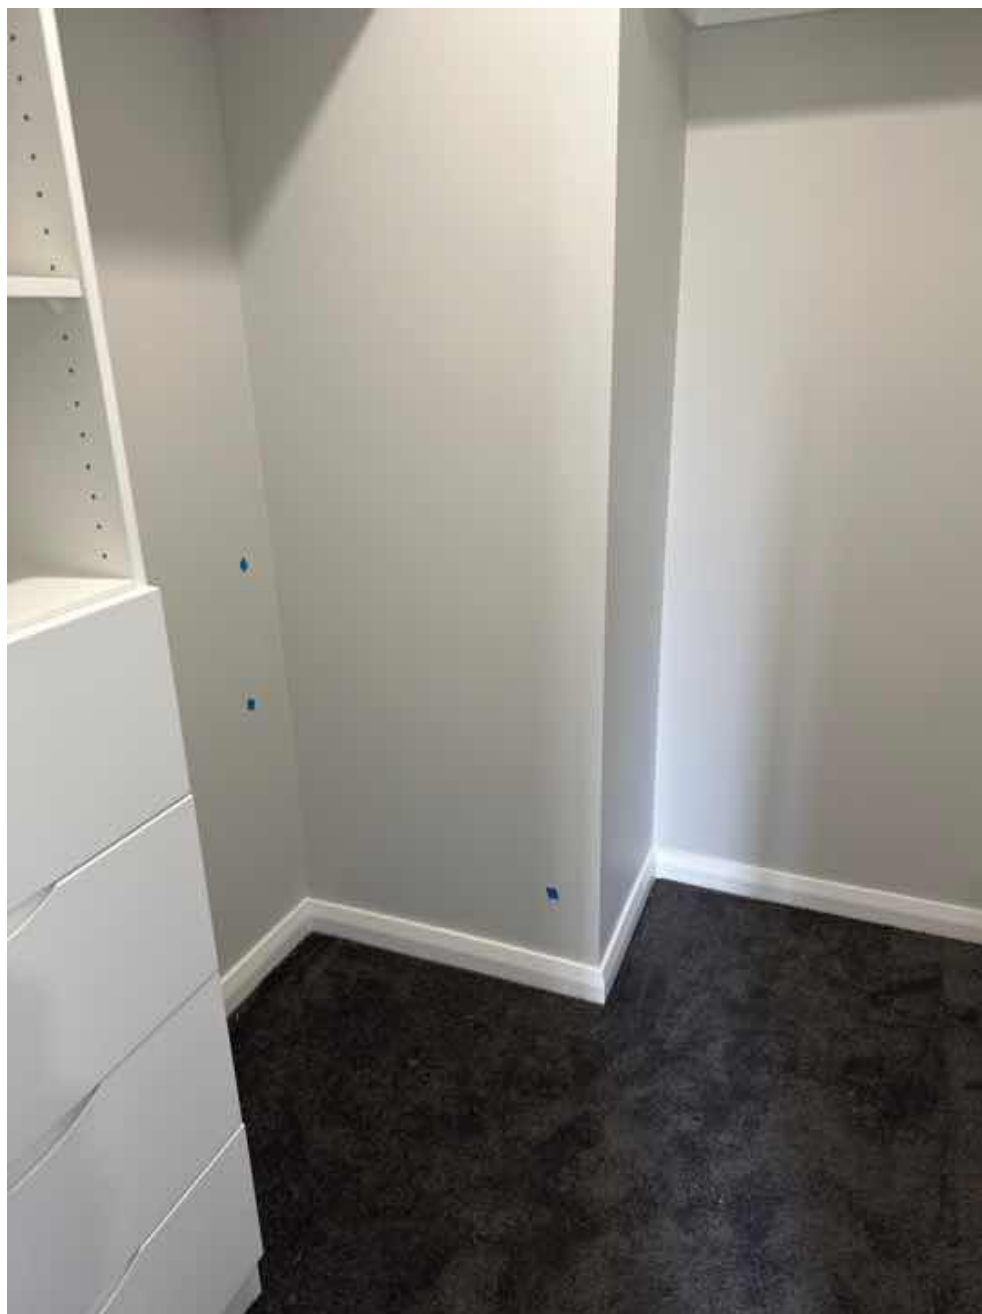
Paint touch ups required. Defects noticeable from normal viewing position. Additional plastering, sanding and painting required.

The paint cover to areas of this room are thin and see through in areas. Re painting of entire wall required in some areas.

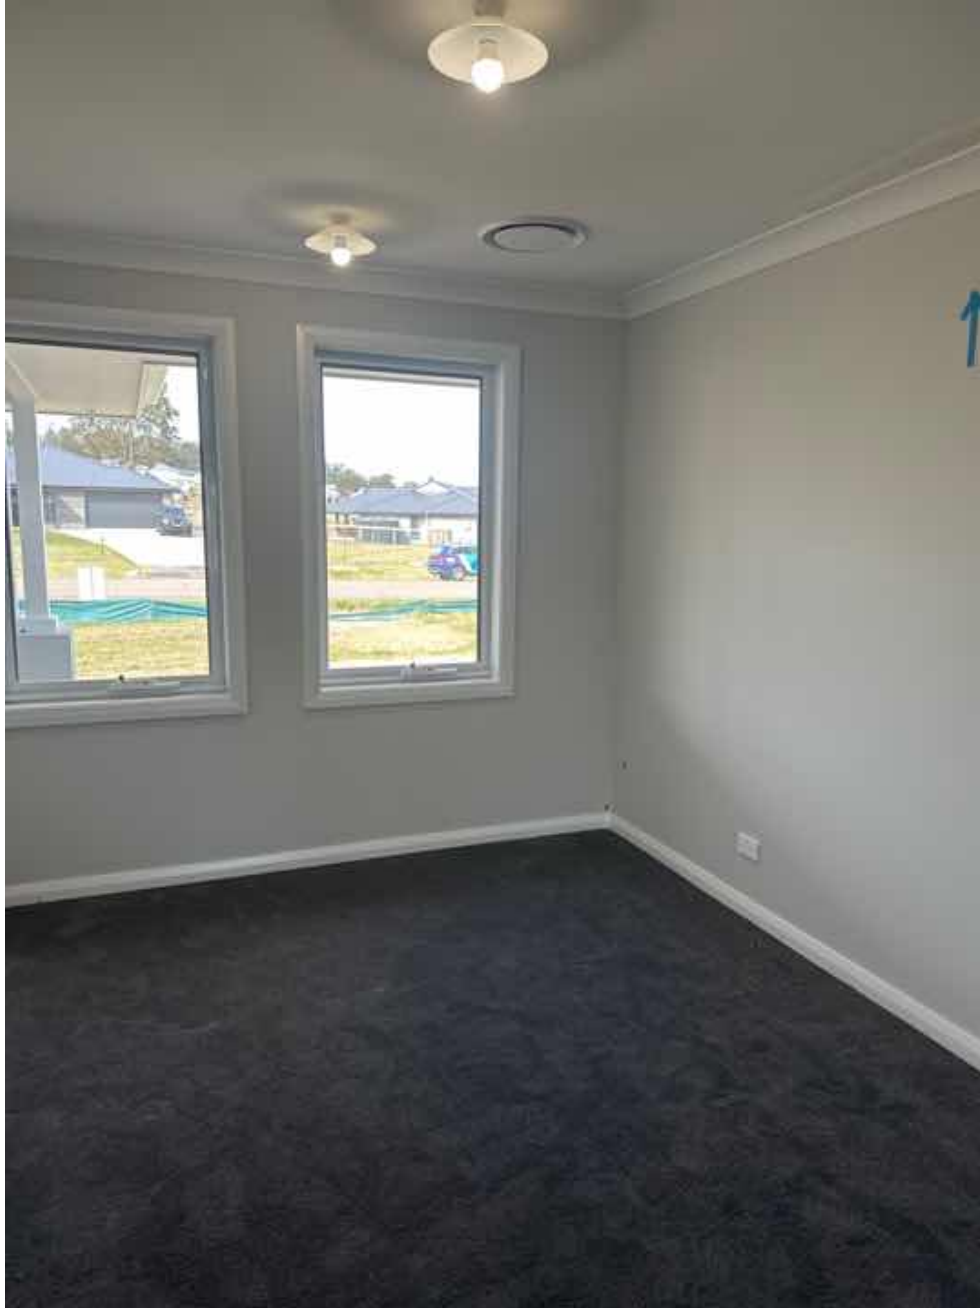
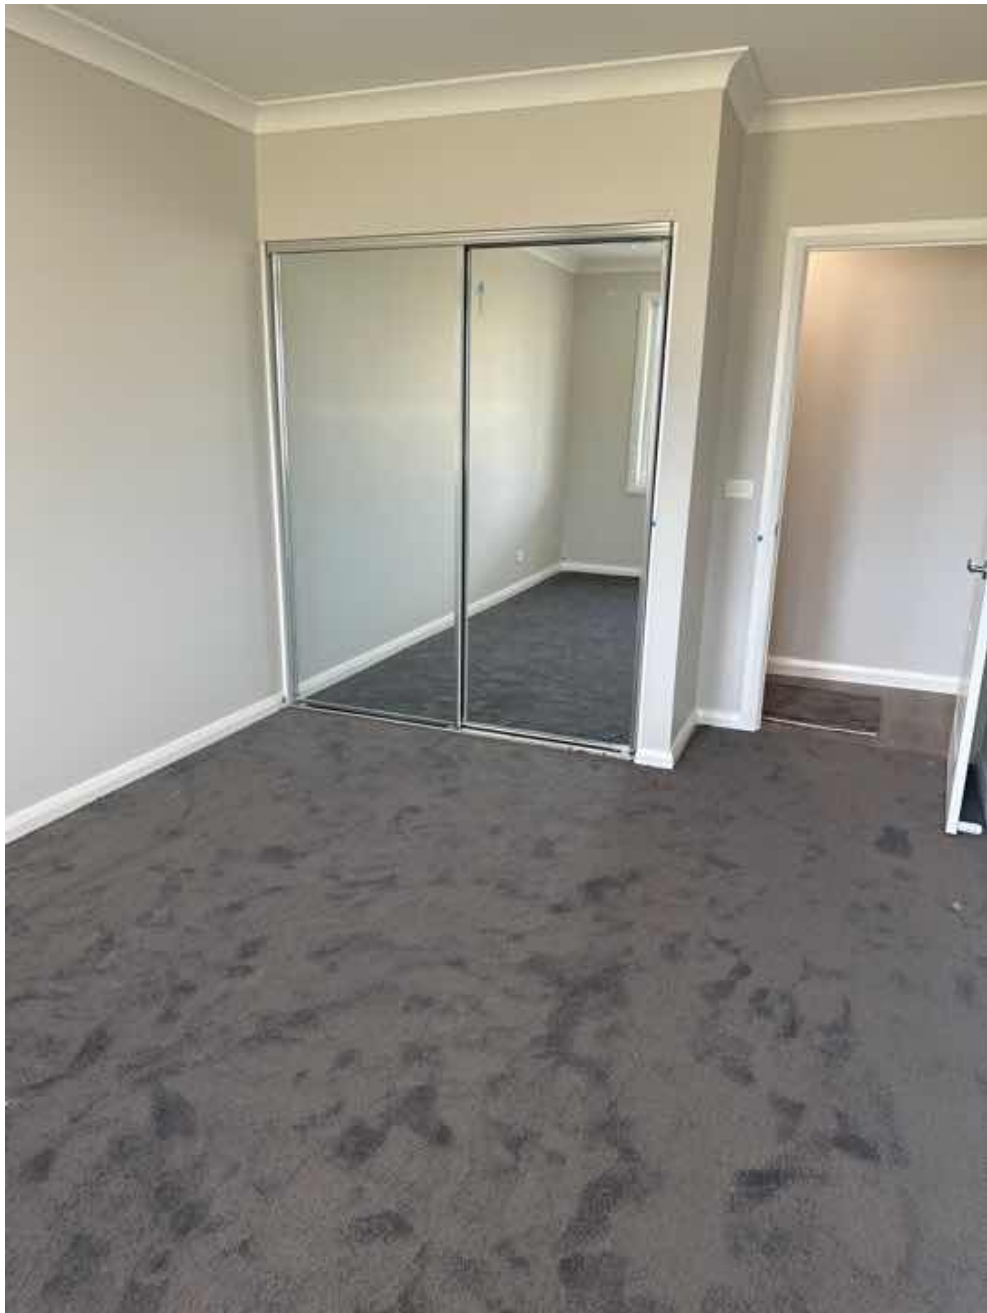
Rectification work required

A builders clean is required.

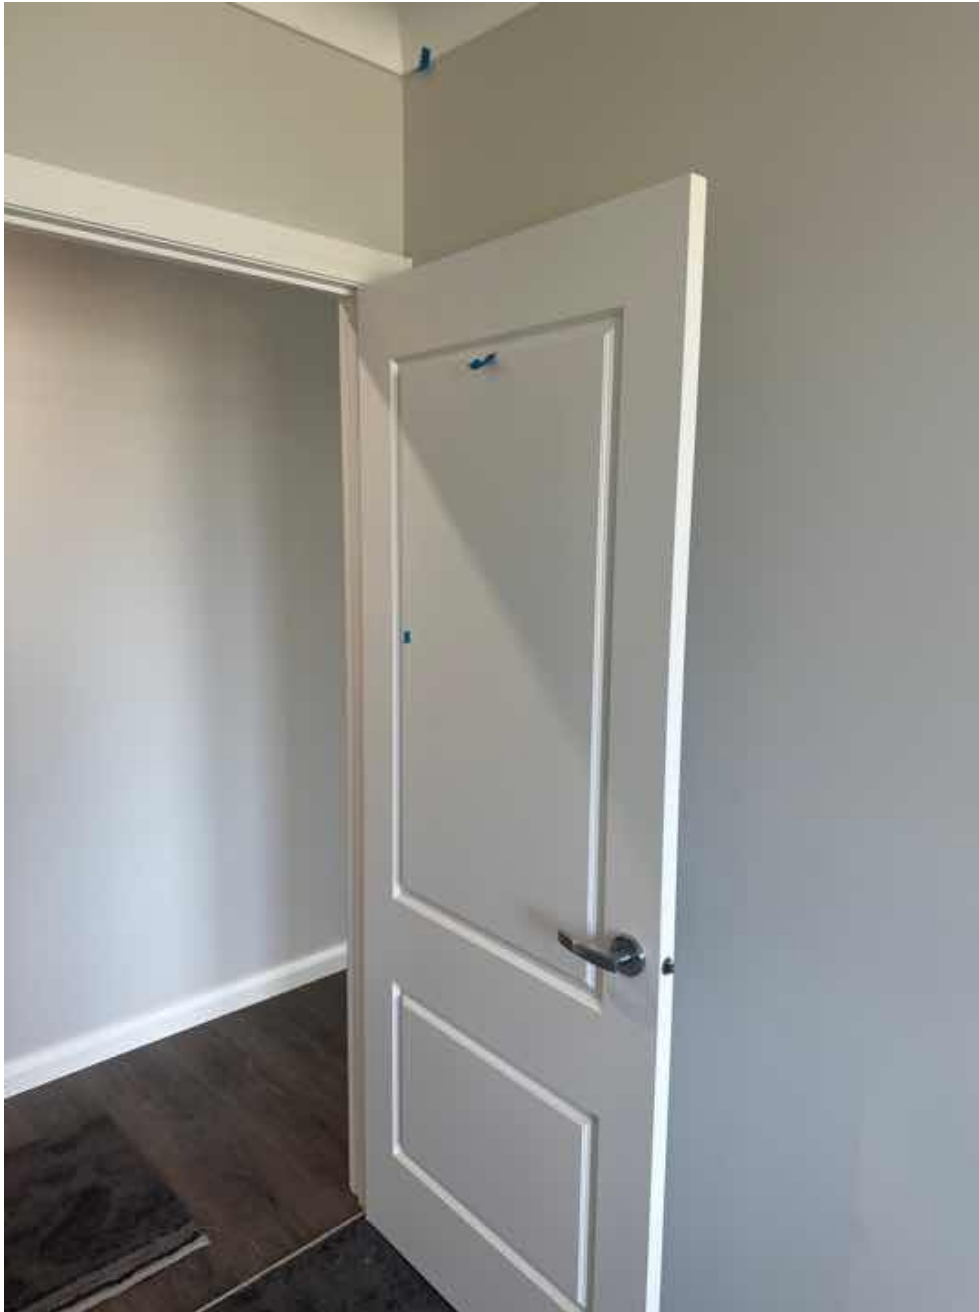
## Door

Paint touch ups required as indicated by markers

The door face router detail has not been sanded between coats. This detail is fuzzy in appearance from a normal viewing position of 1.5m and is rough to touch. Requires a light sand and re painting.

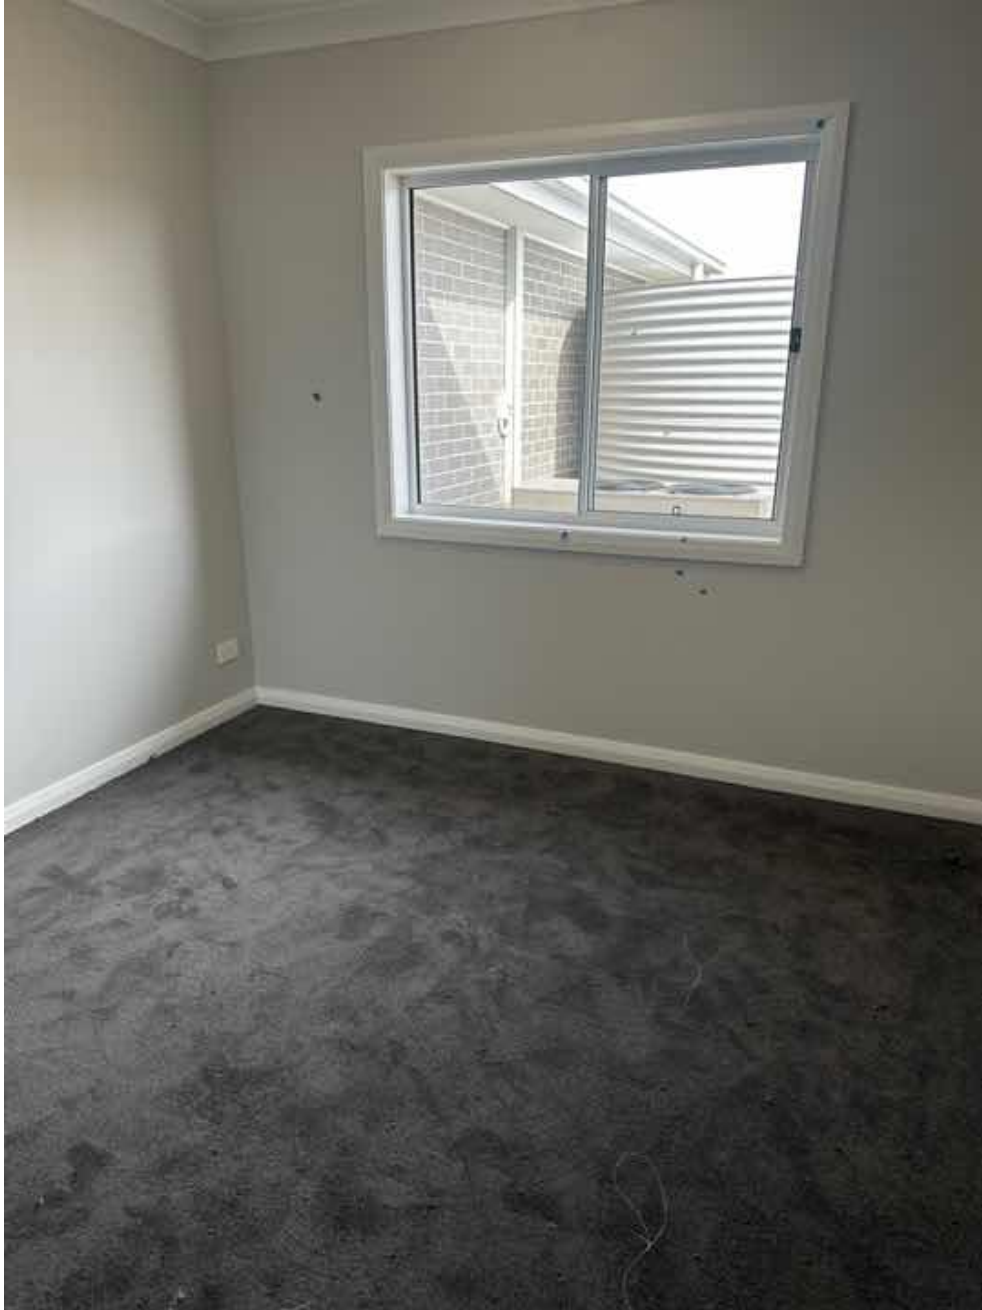
### **Bedroom 3**

Rectification work required

A builders clean is required.

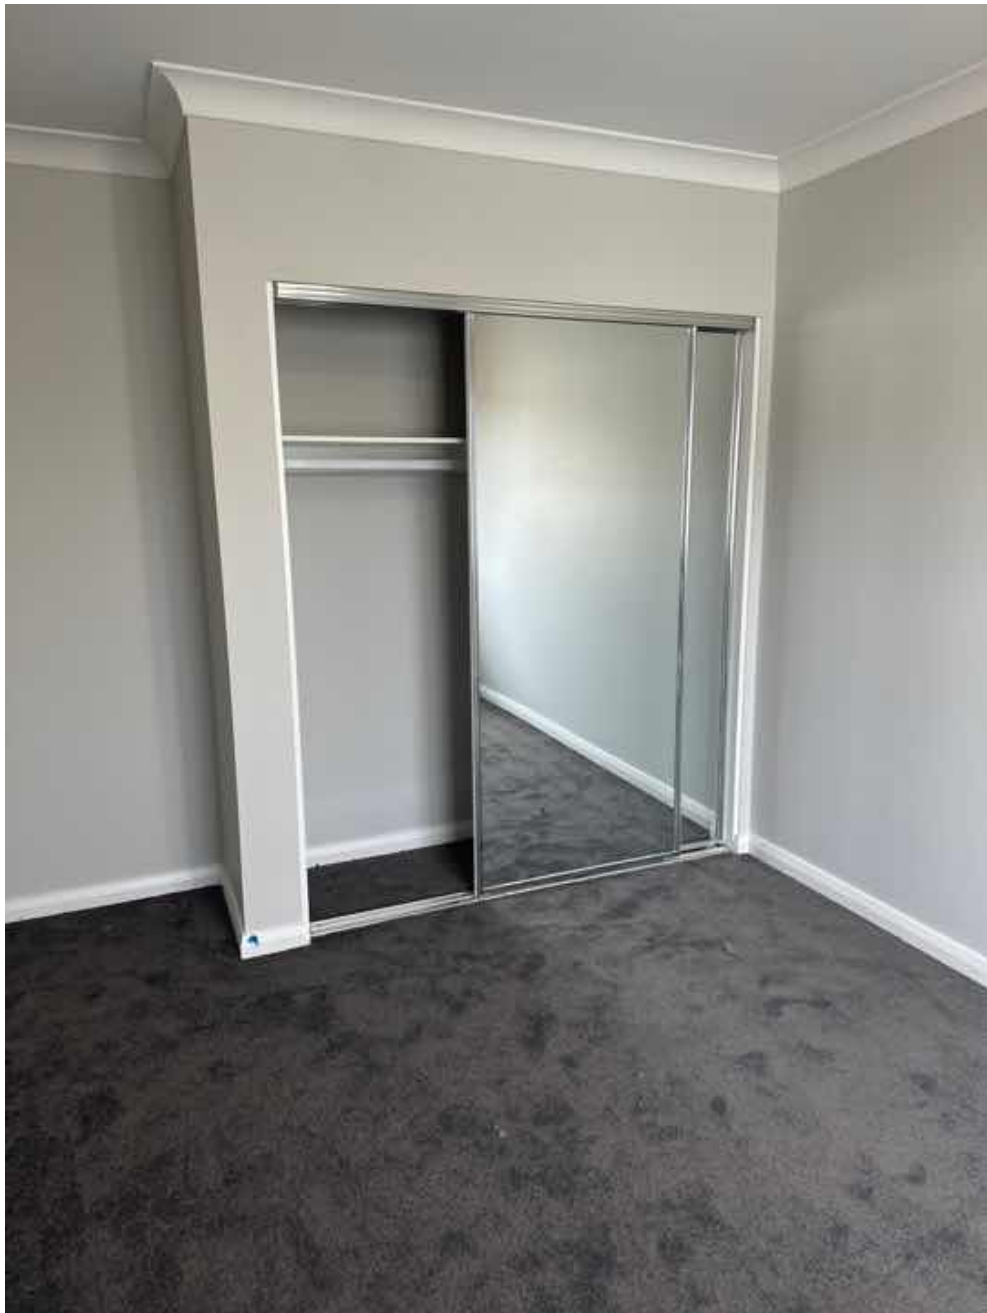
Paint touch ups required as indicated by markers

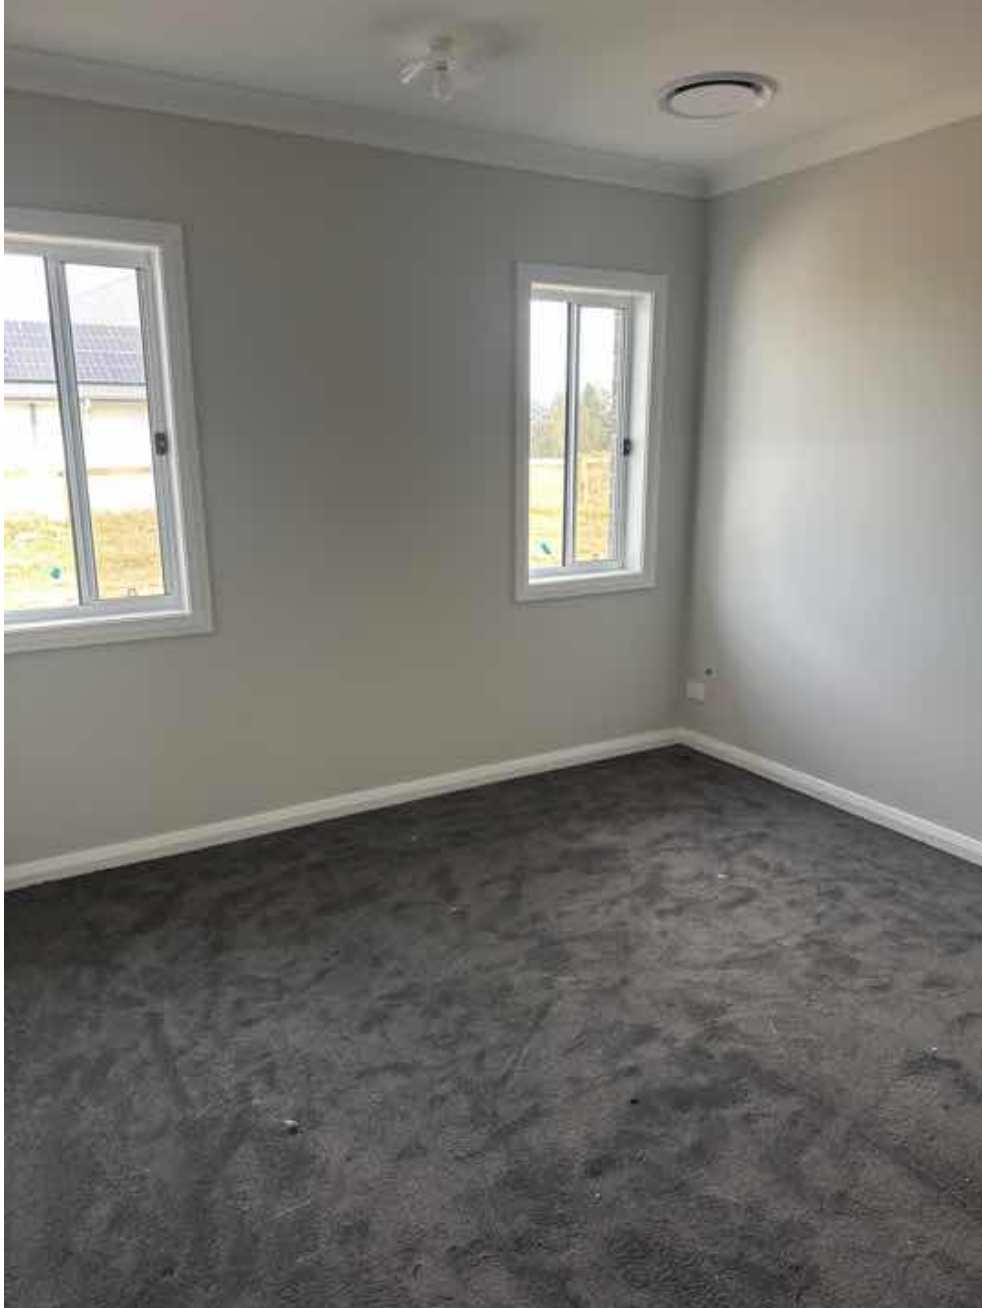
**Door**

Paint touch ups required as indicated by markers  
Door rattles, stricter requires adjustment

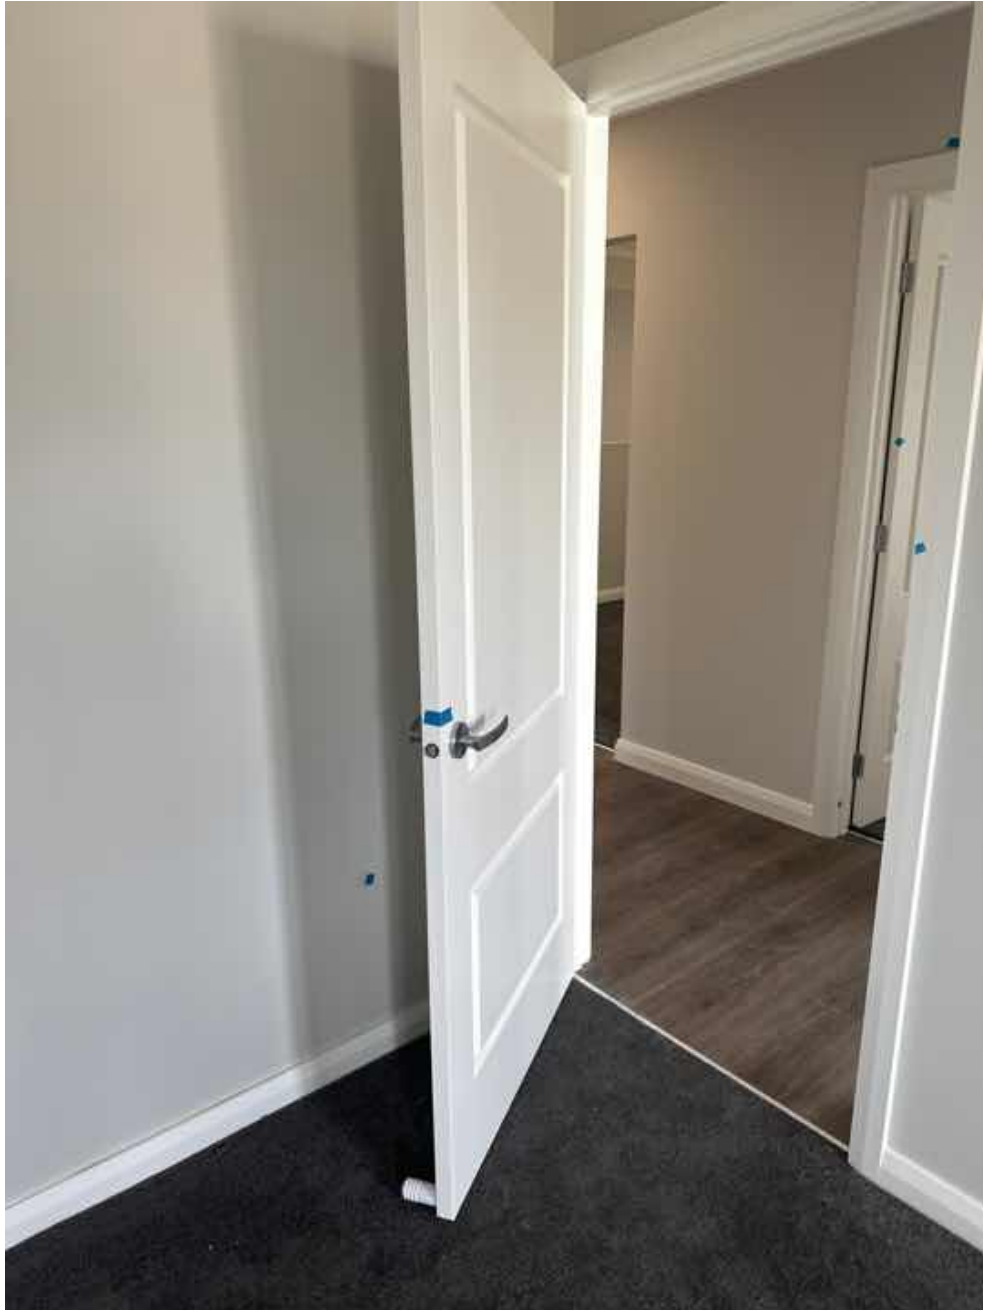
**Walls**

Paint touch ups required. Defects noticeable from normal viewing position. Additional plastering, sanding and painting required.

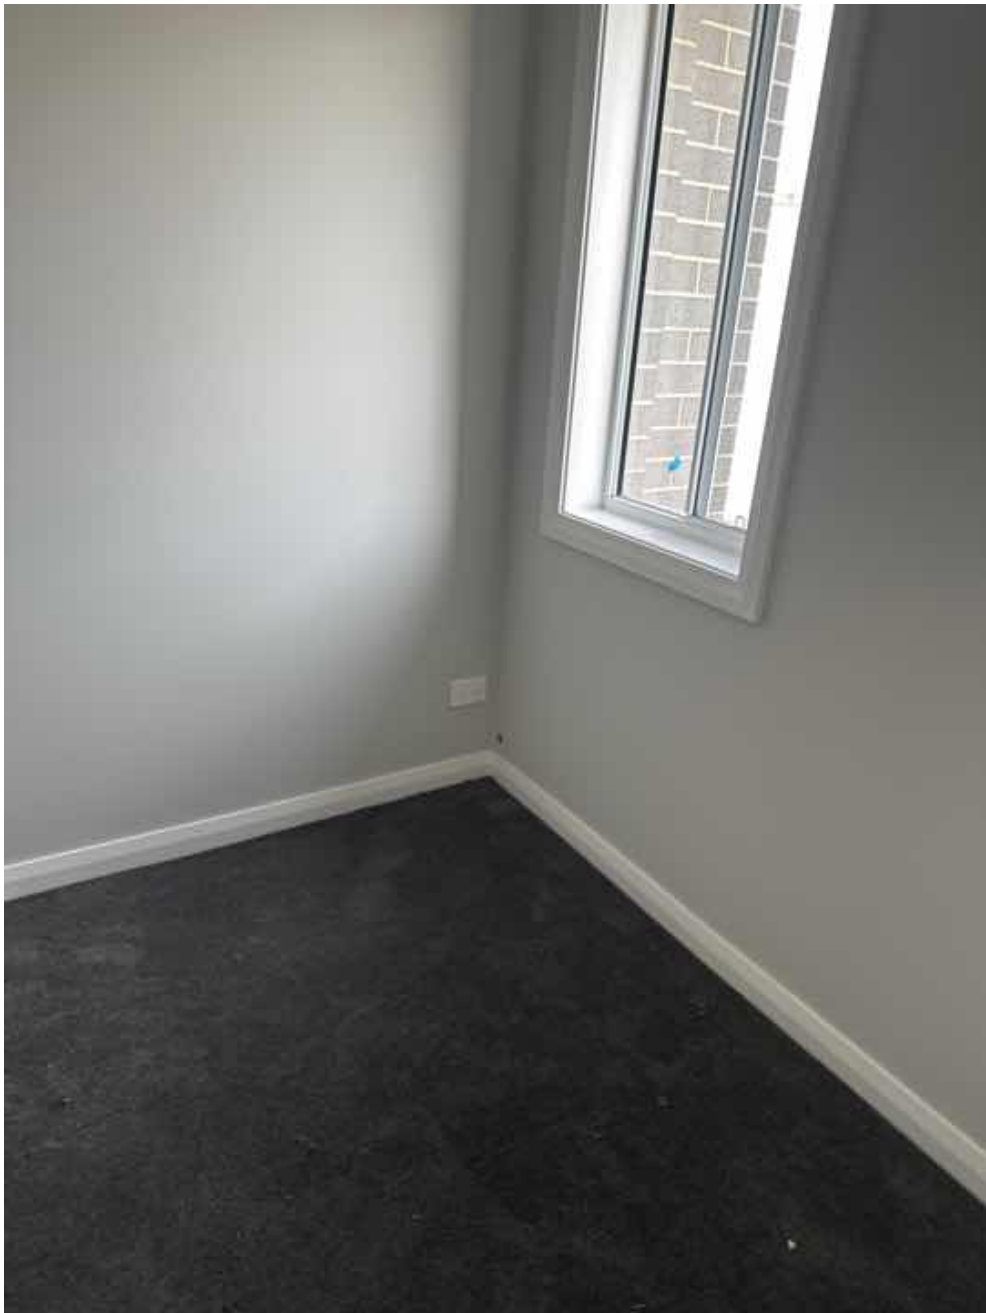
## Windows

Stickers / marks on glass

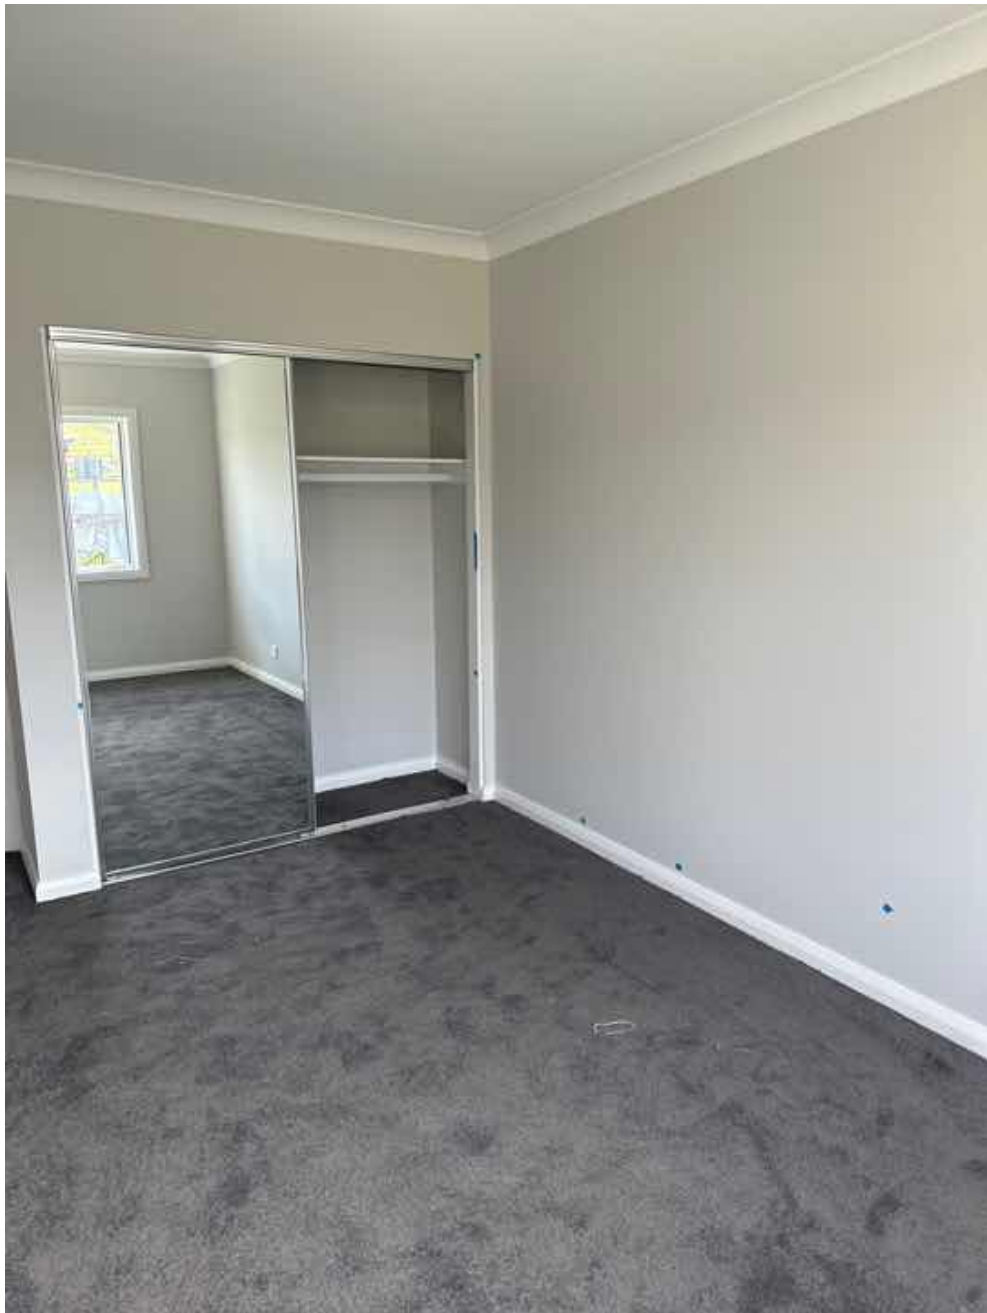
Paint touch ups required as indicated by markers
