# Inspection Report

**UNCOVER**  
BUILDING AND PEST INSPECTIONS

**1 Sample St , Sample, Nsw, 2281**

### Handover Inspection

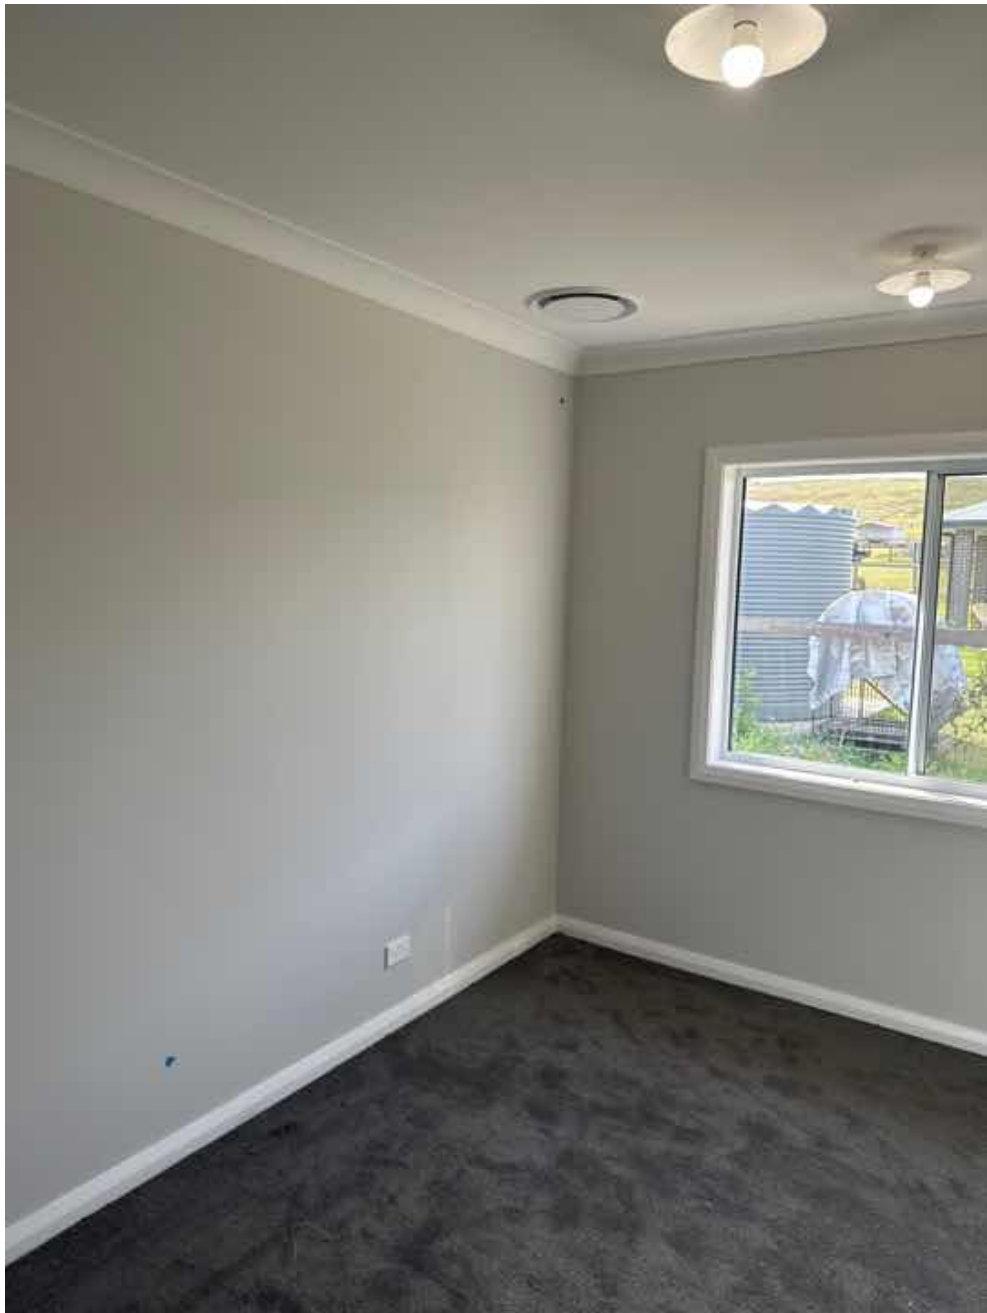
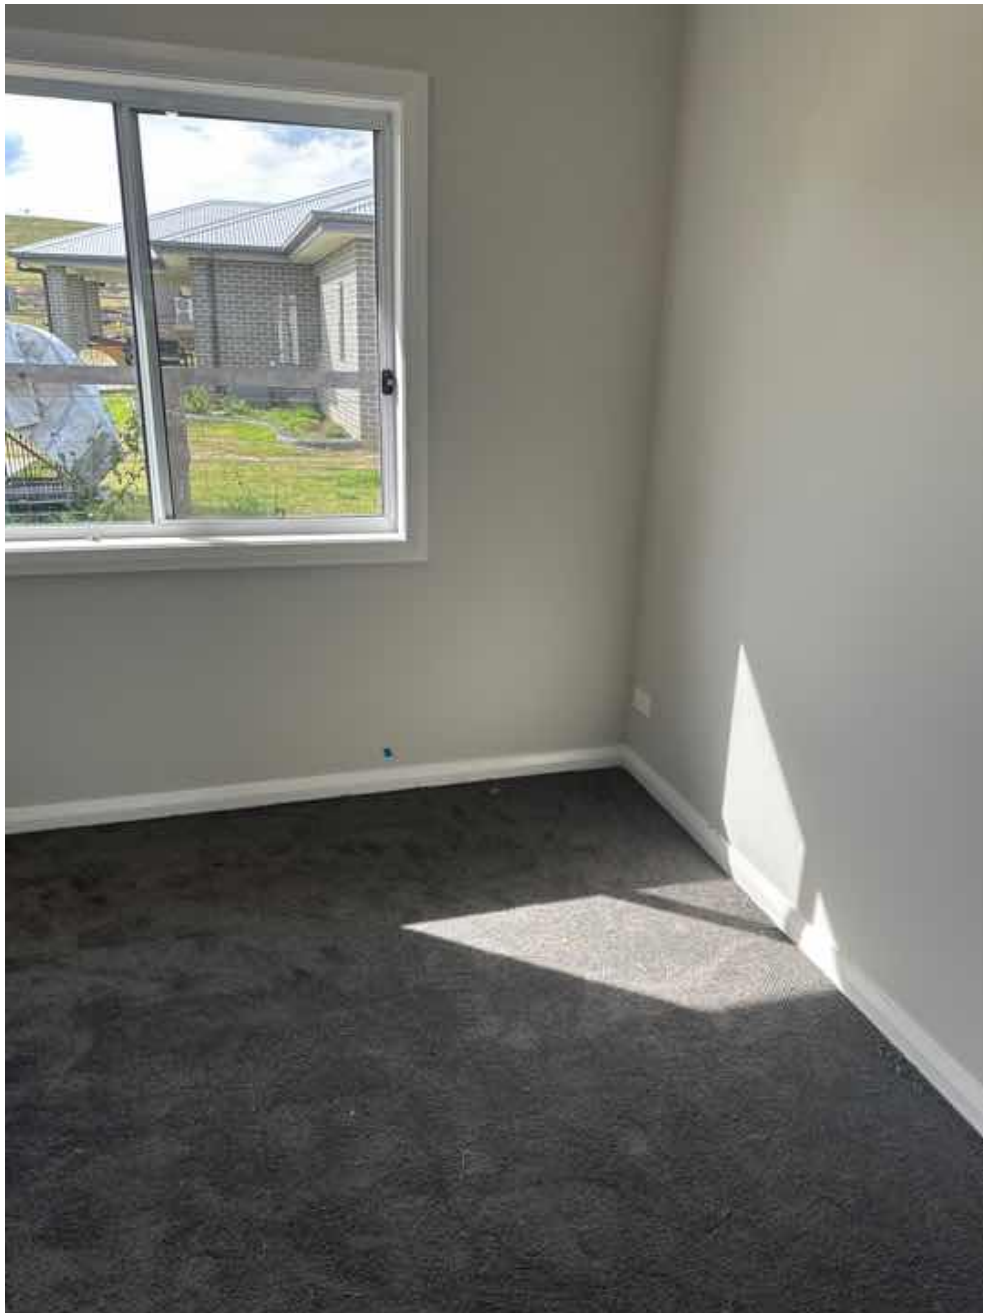
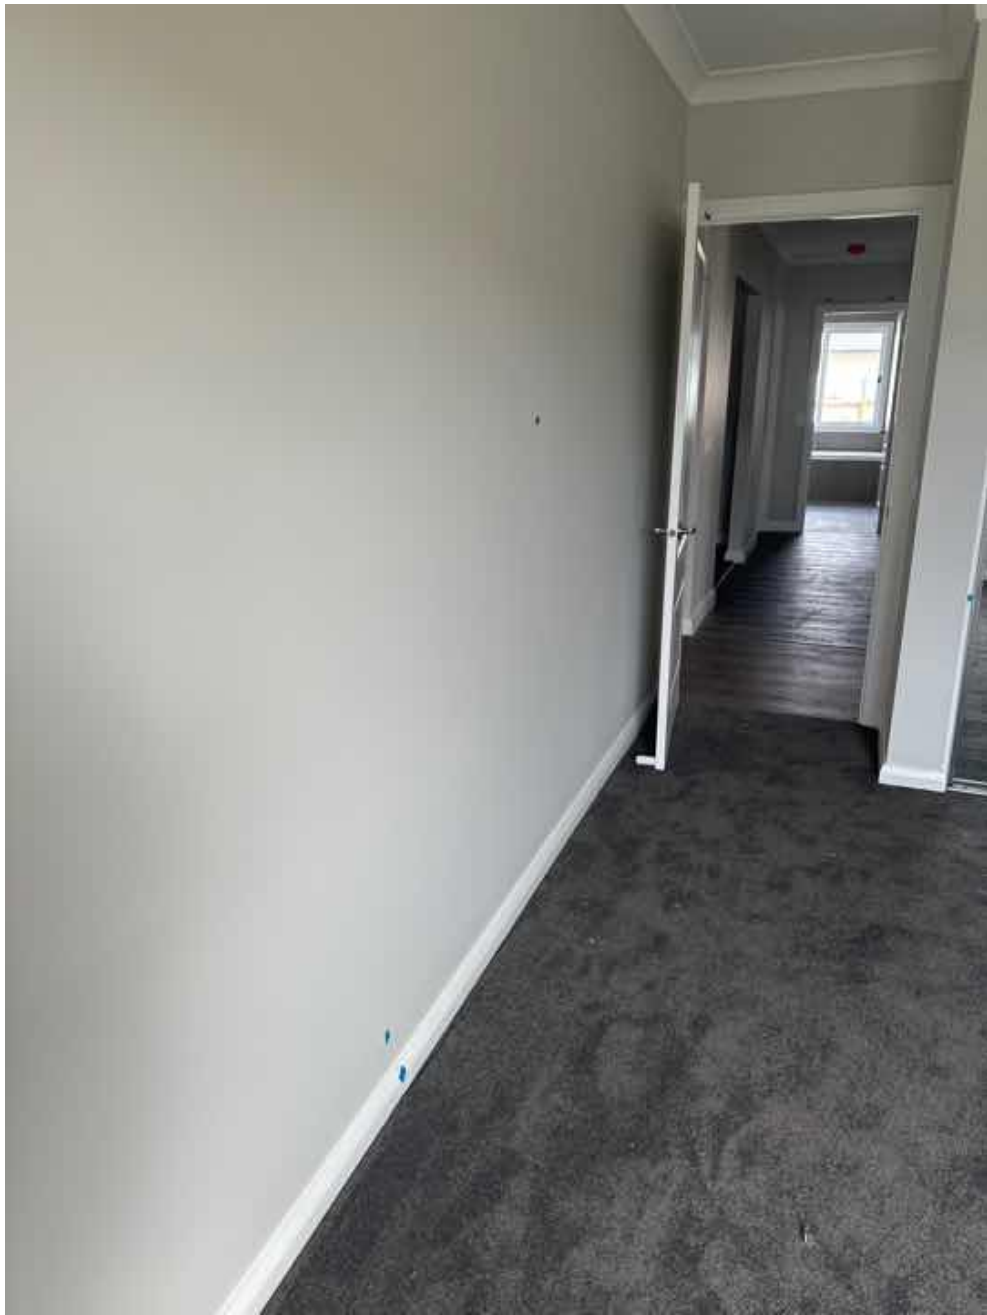
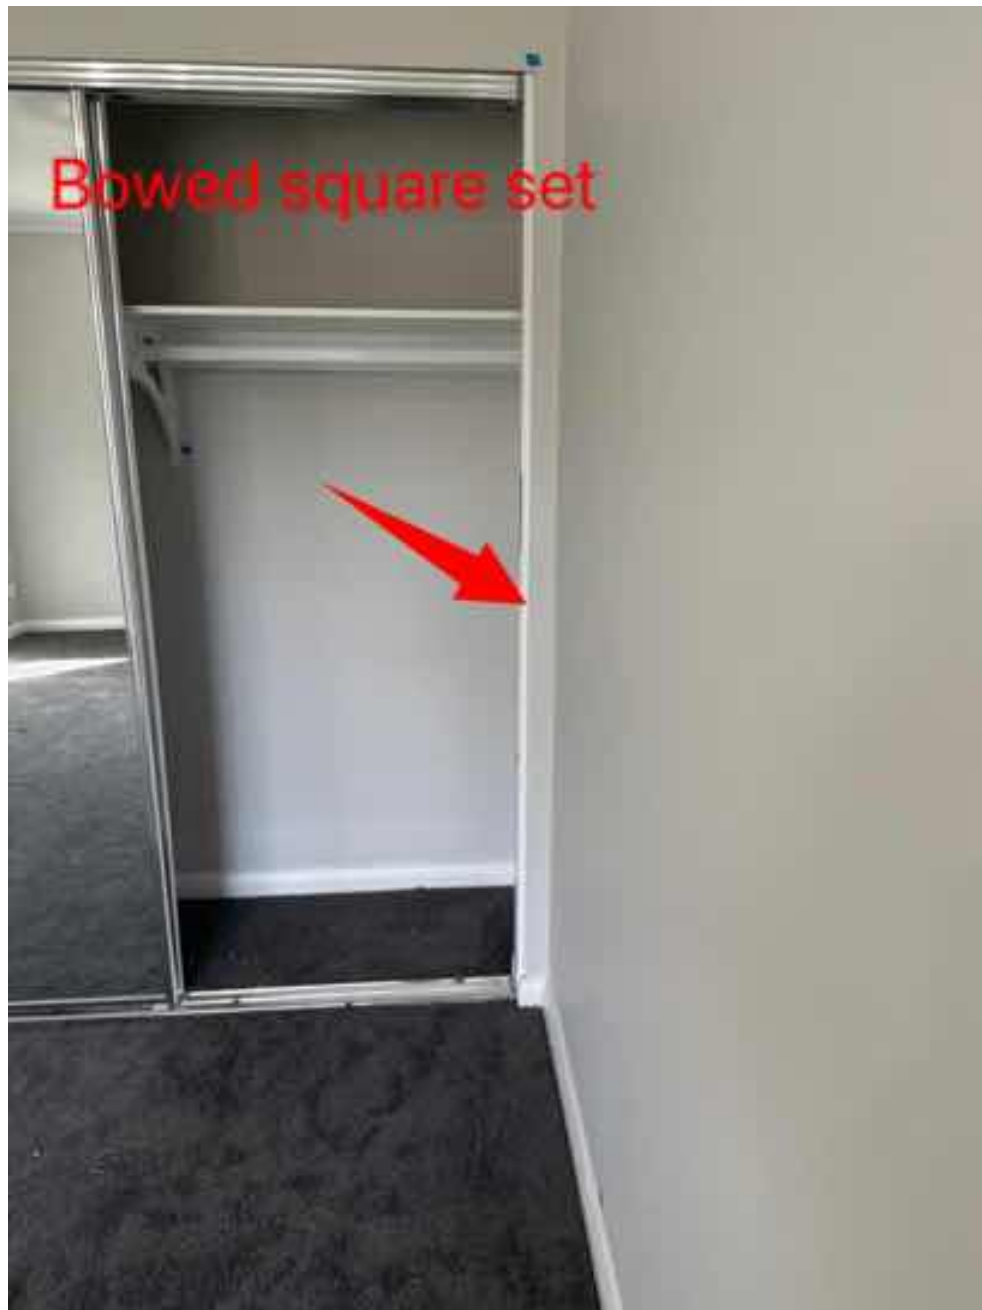
Paint touch ups required. Defects noticeable from normal viewing position. Additional plastering, sanding and painting required.

Bowed square set. Bowed approx 6mm over 2m. Rectification required.

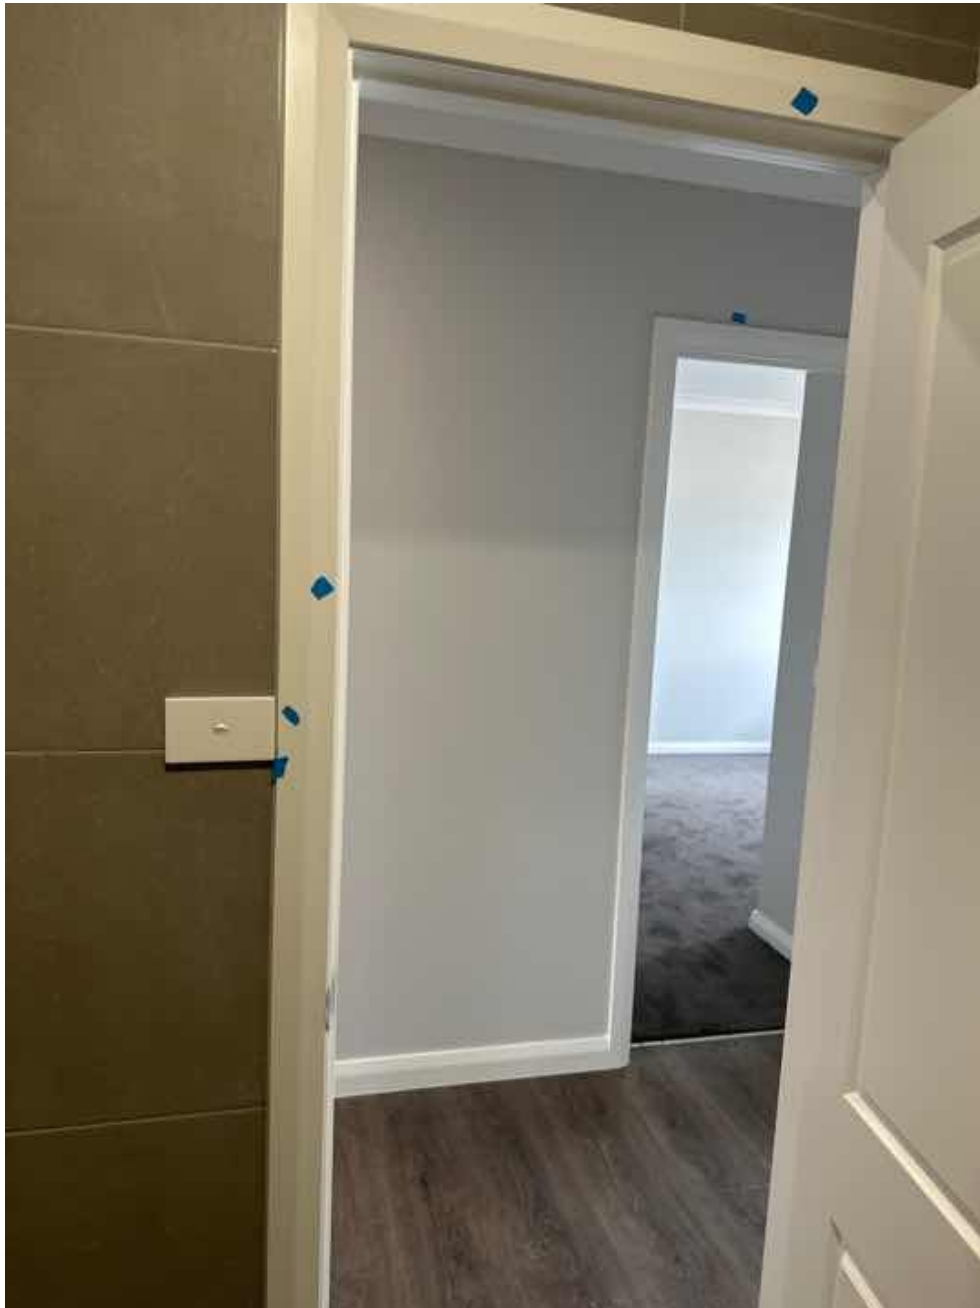
Paint touch ups required.

The door face router detail has not been sanded between coats. This detail is fuzzy in appearance from a normal viewing position of 1.5m and is rough to touch. Requires a light sand and re painting.

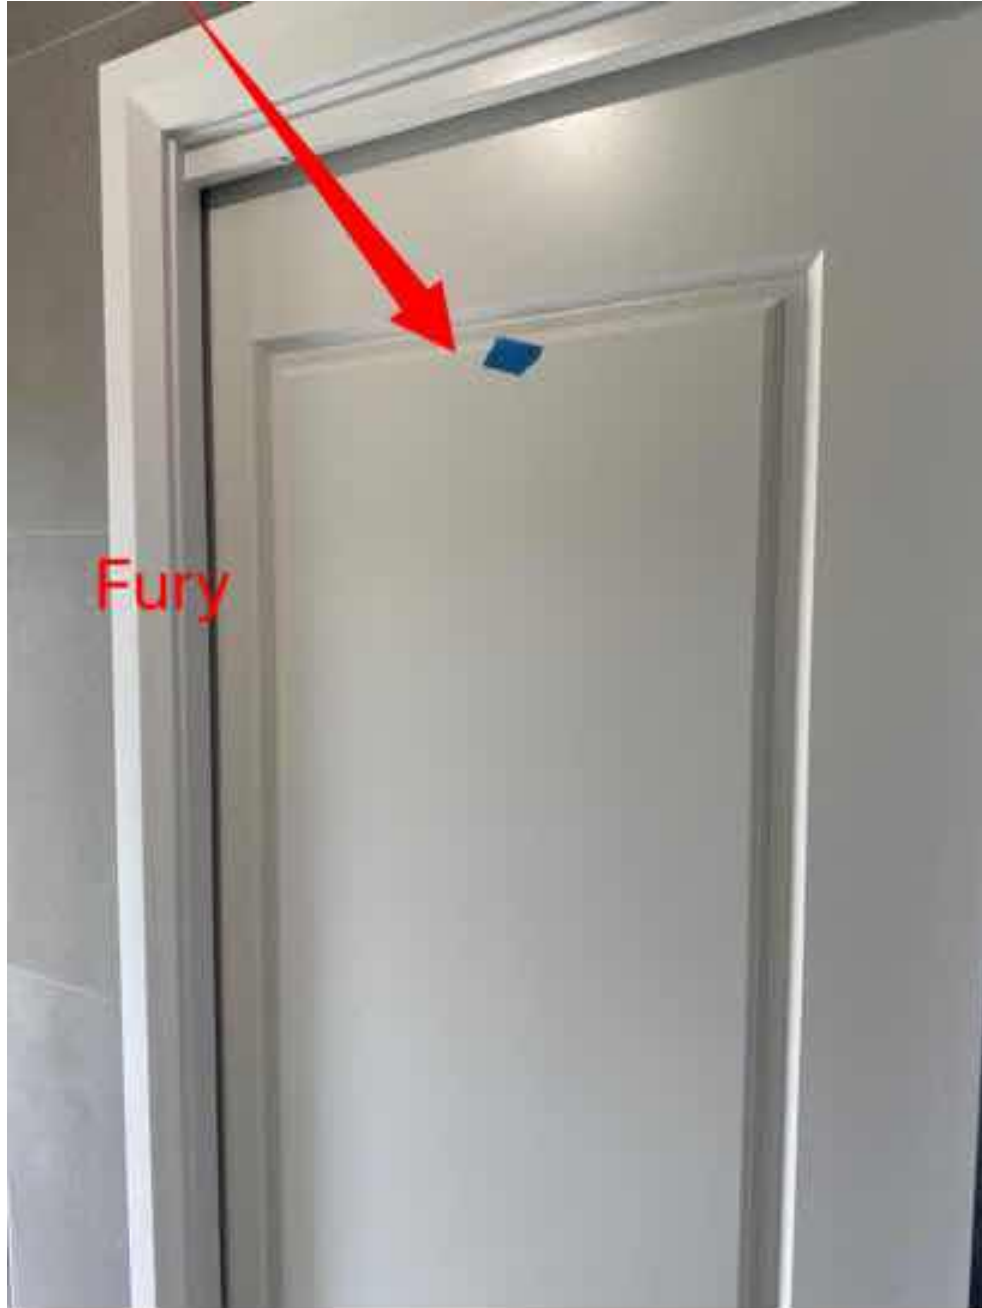
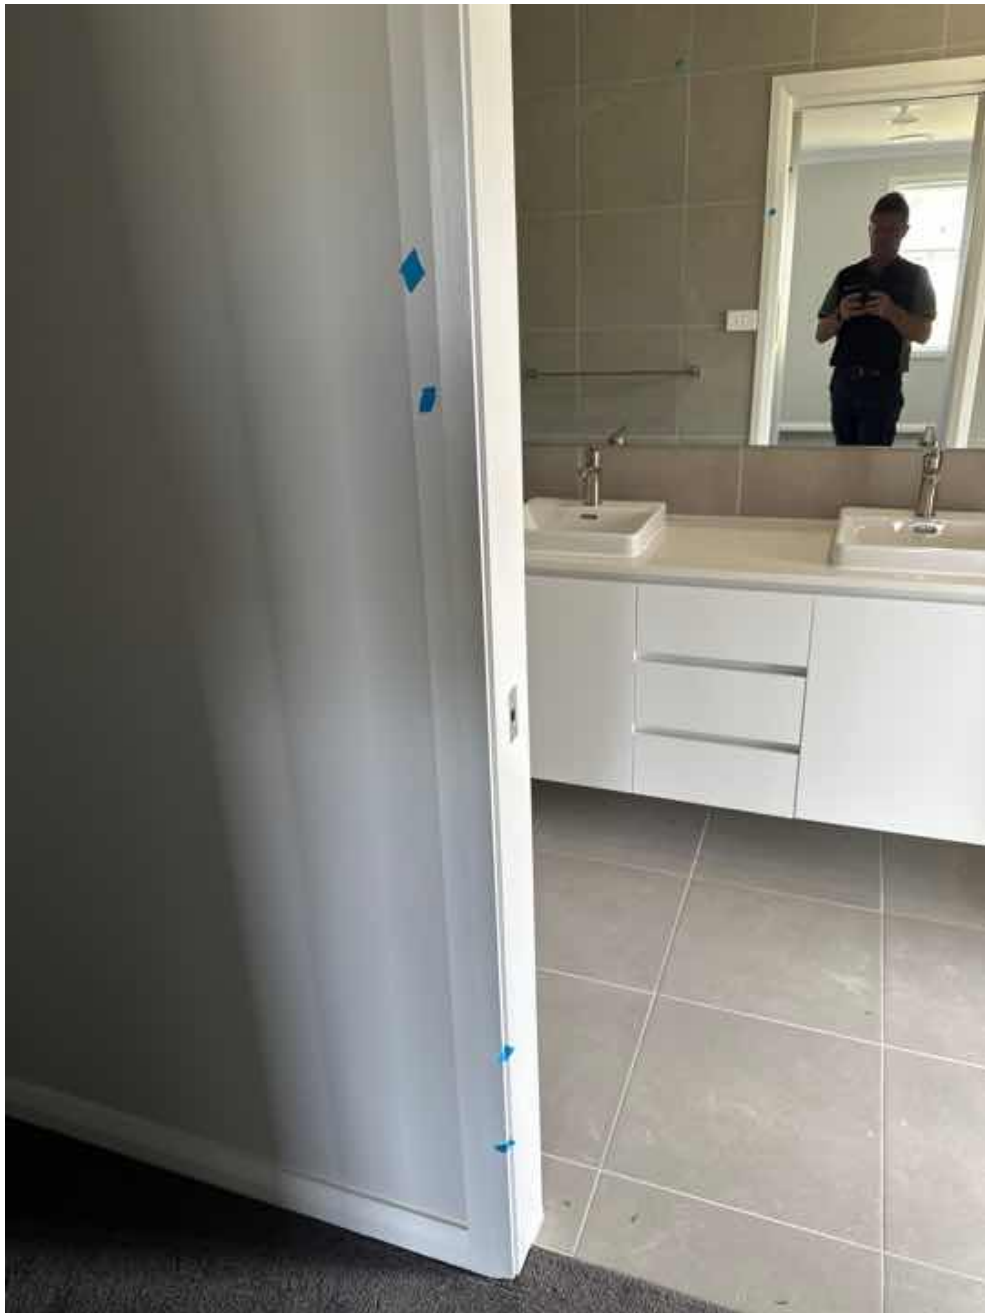
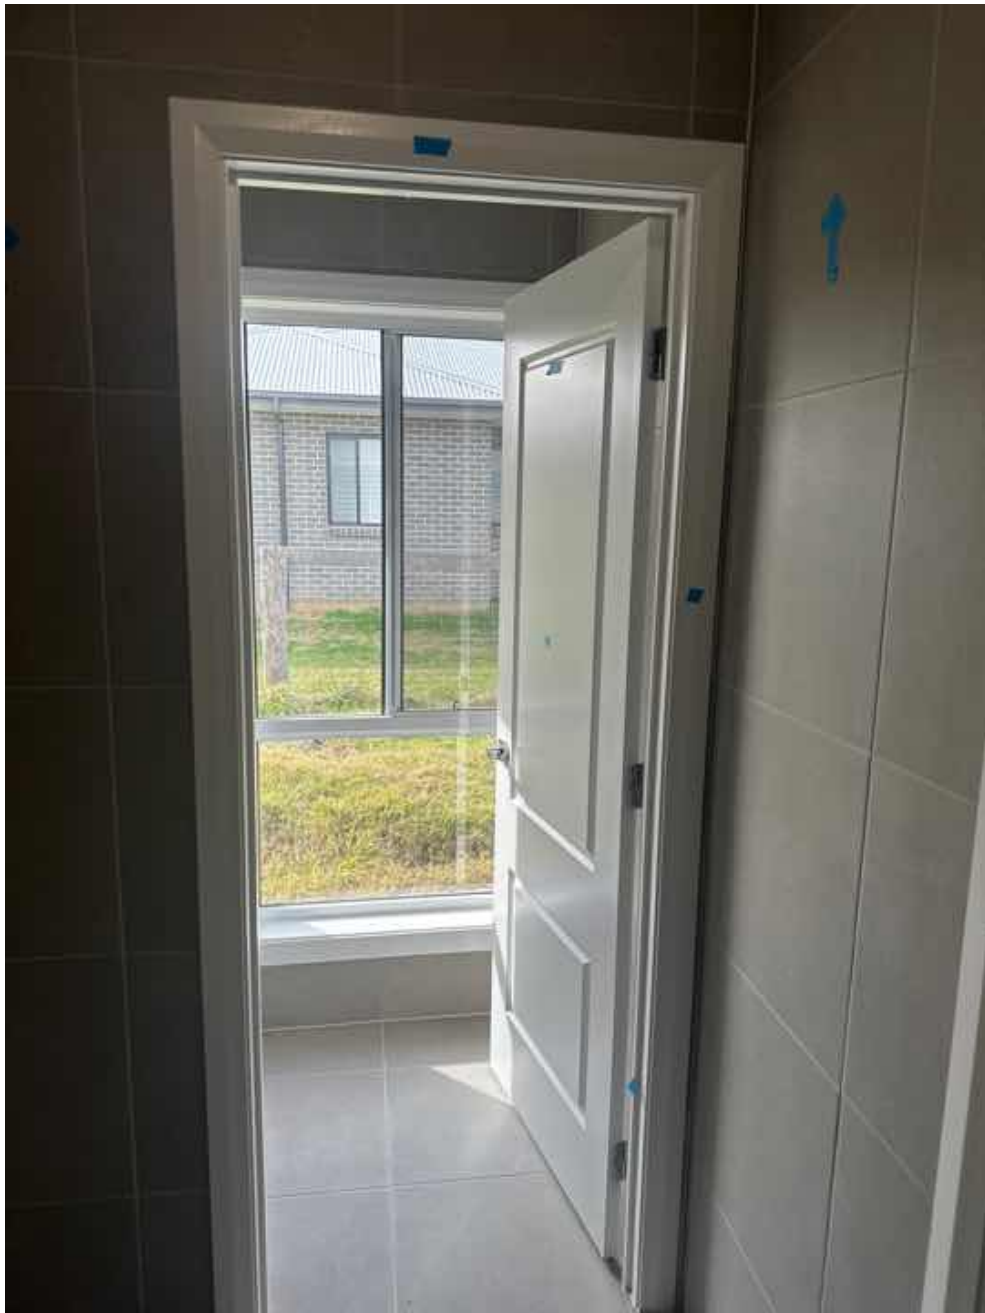
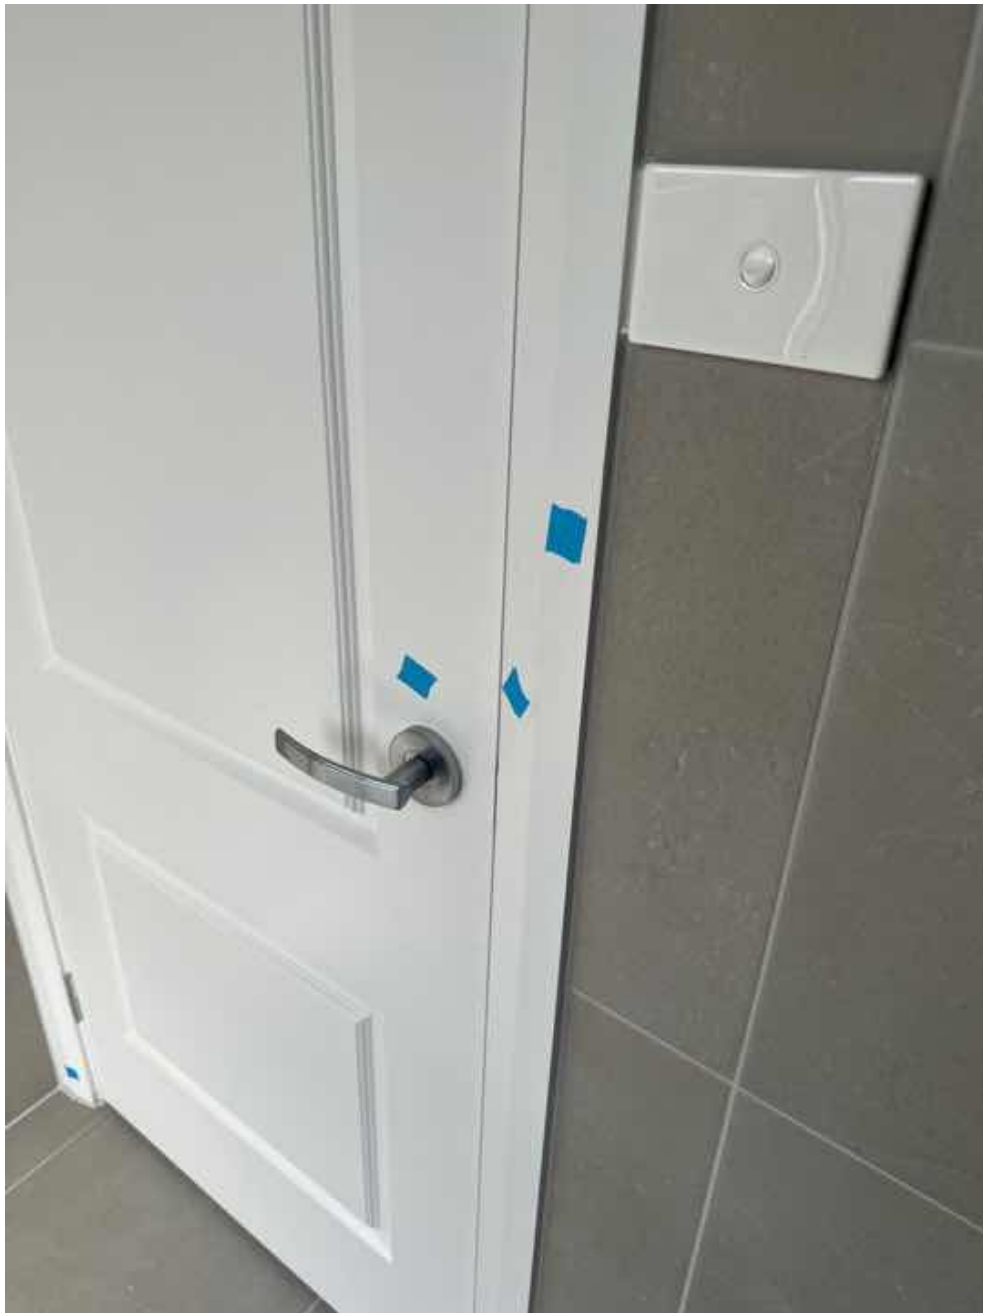
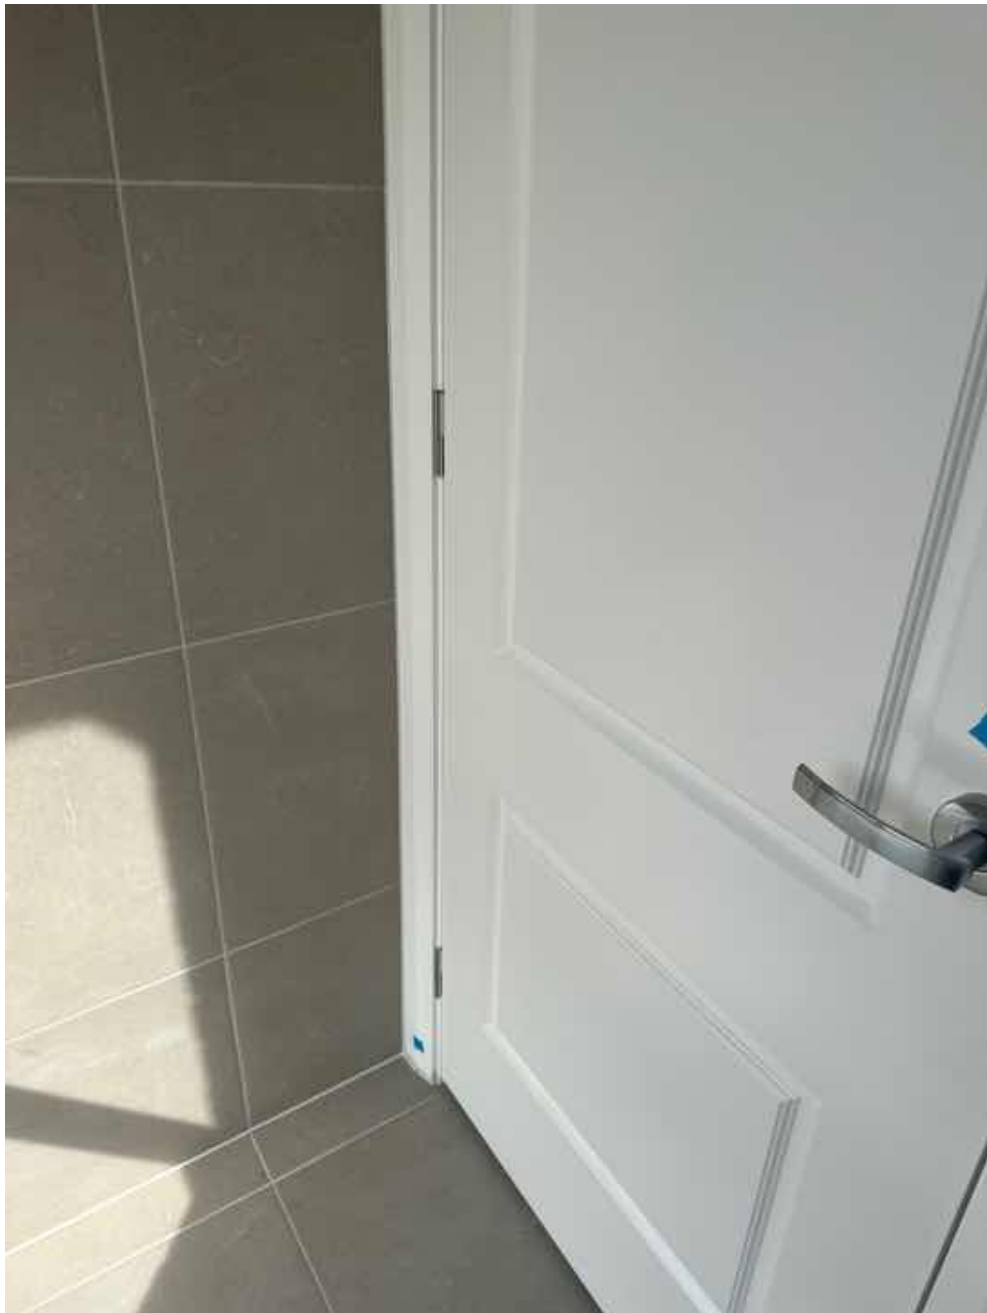
Paint touch ups required.

The door face router detail has not been sanded between coats. This detail is furry in appearance from a normal viewing position of 1.5m and is rough to touch. Requires a light sand and re painting.

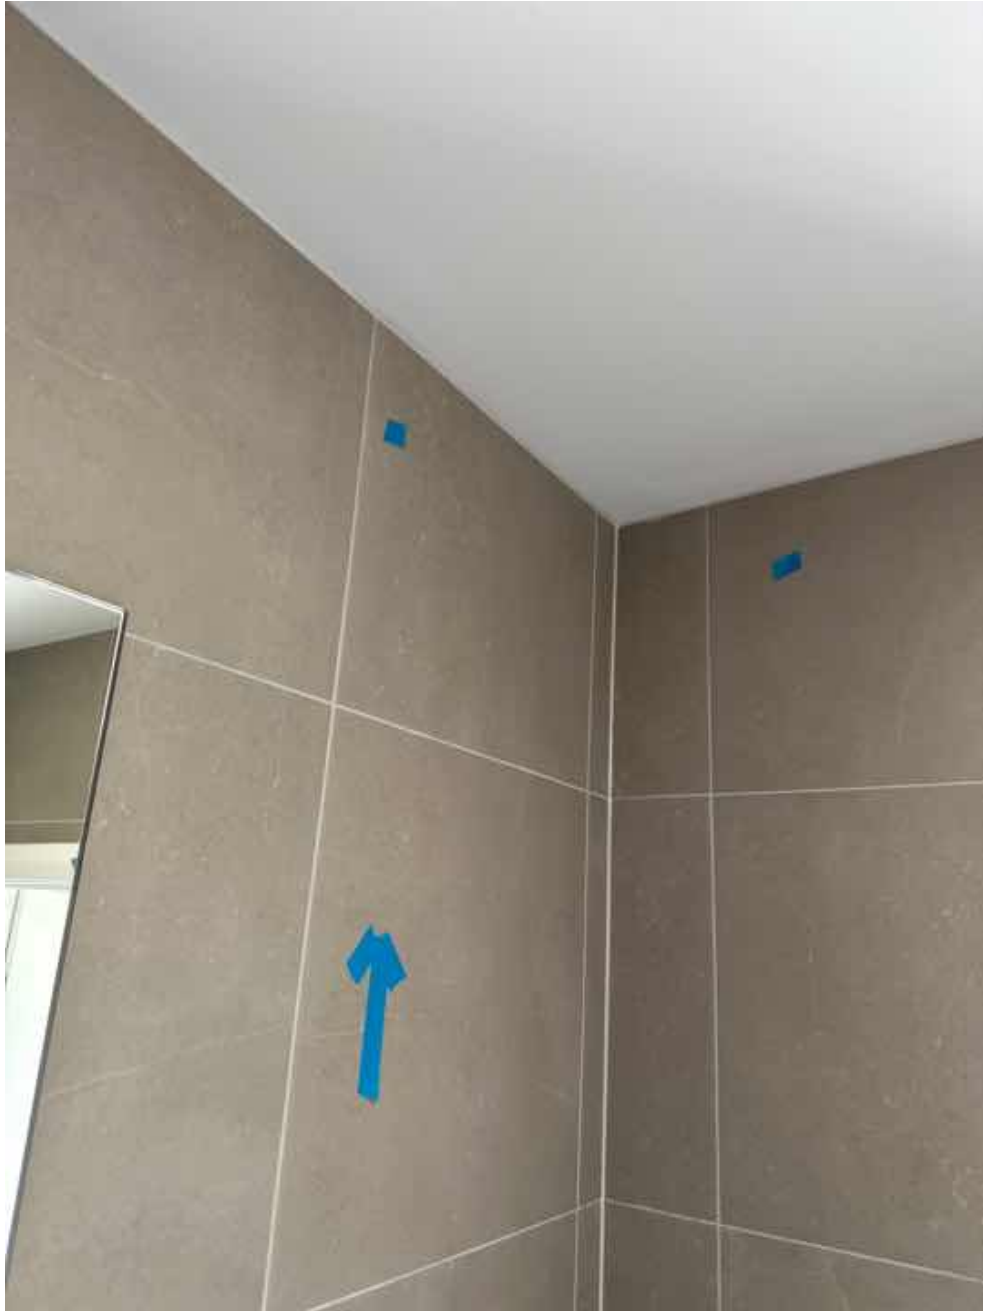
**Ceiling**

Paint touch ups required.

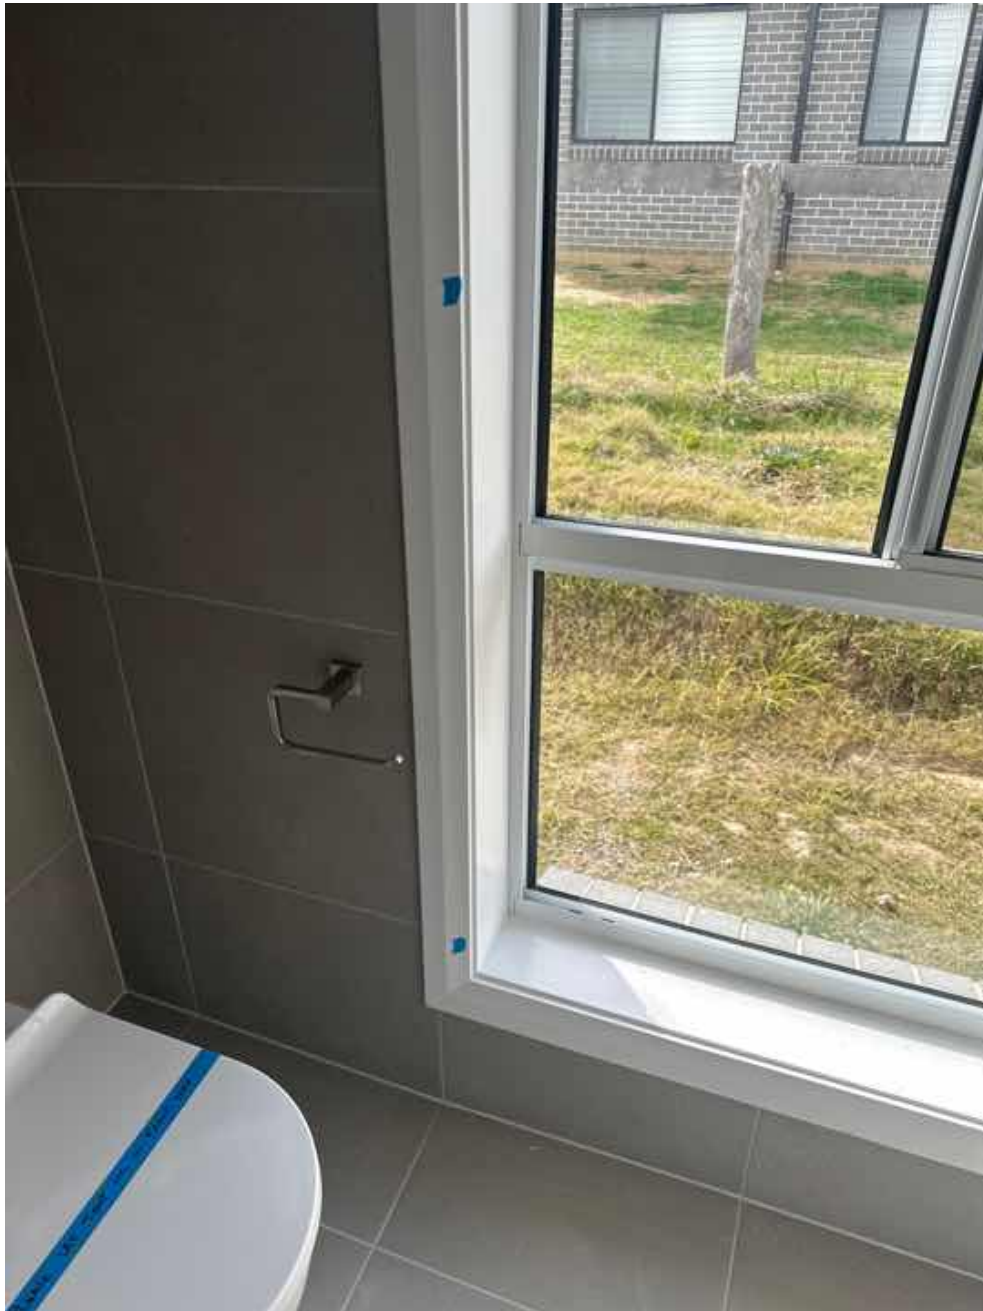
**Window**

Paint touch ups required.

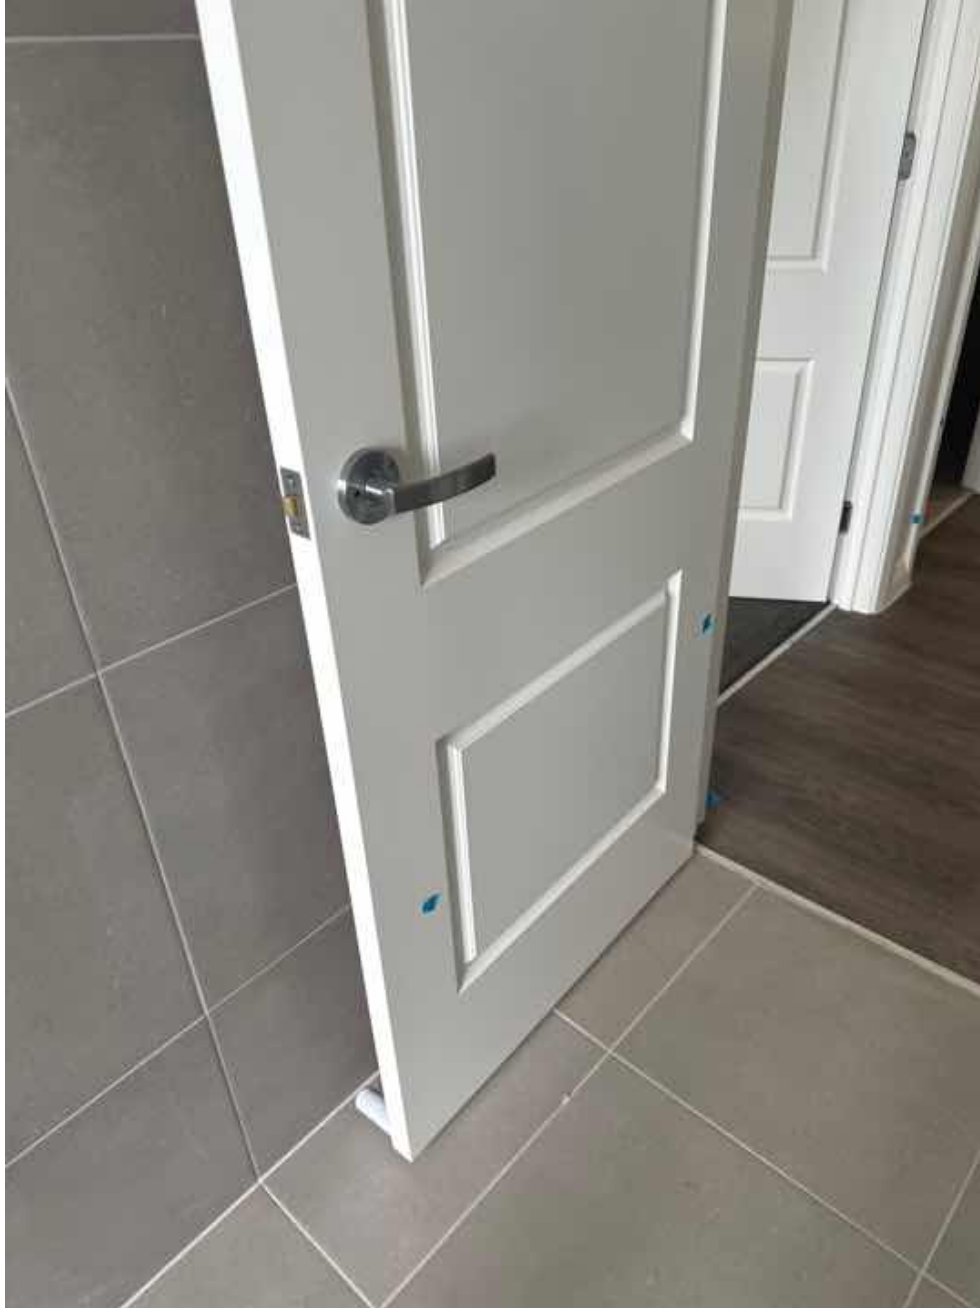
Paint touch ups required.

The door face router detail has not been sanded between coats. This detail is fuzzy in appearance from a normal viewing position of 1.5m and is rough to touch. Requires a light sand and re painting.

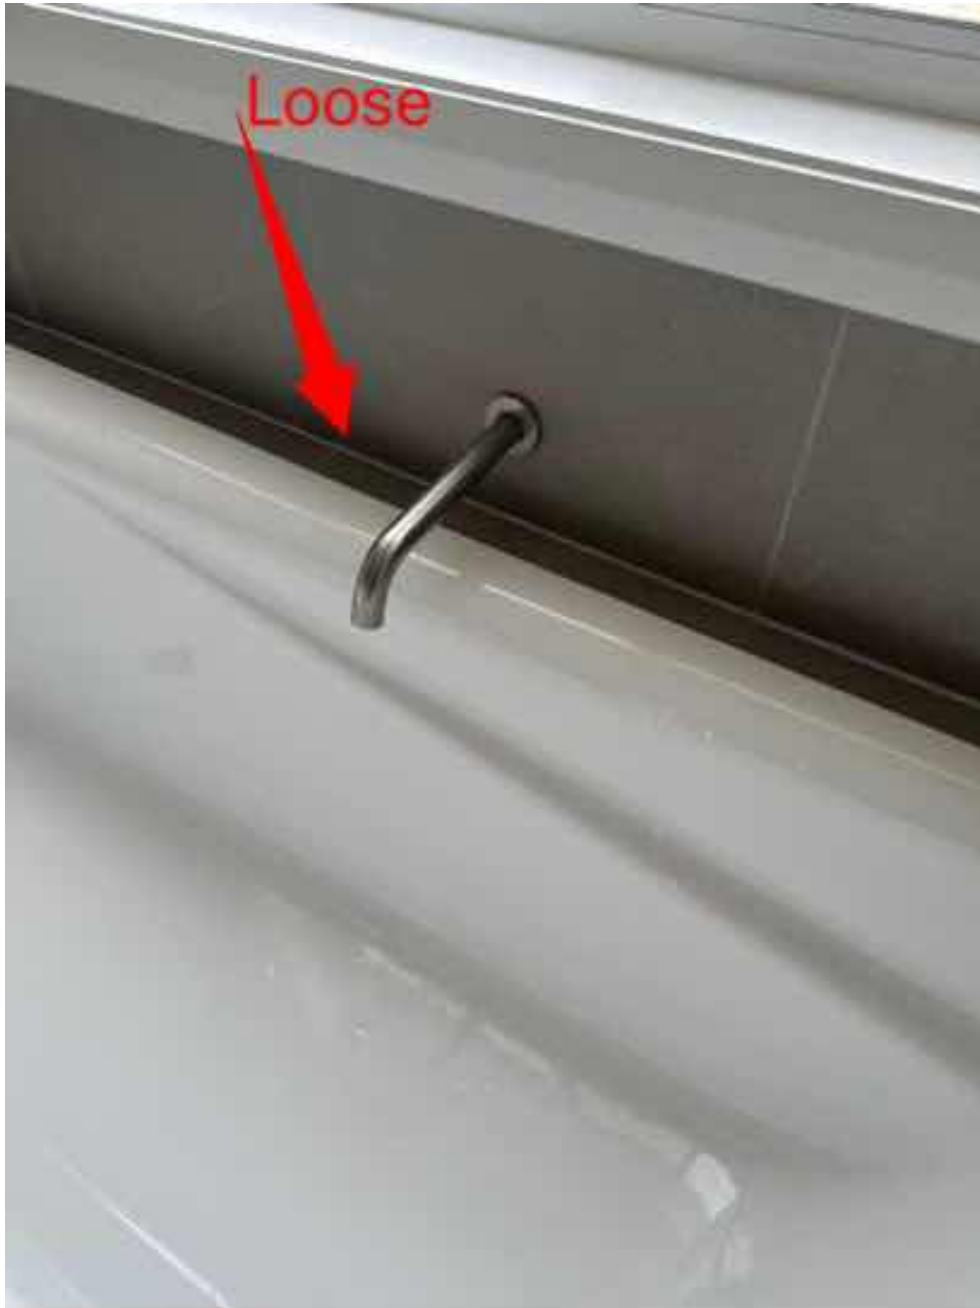
Shower head is leaking.

Bath spout loose.

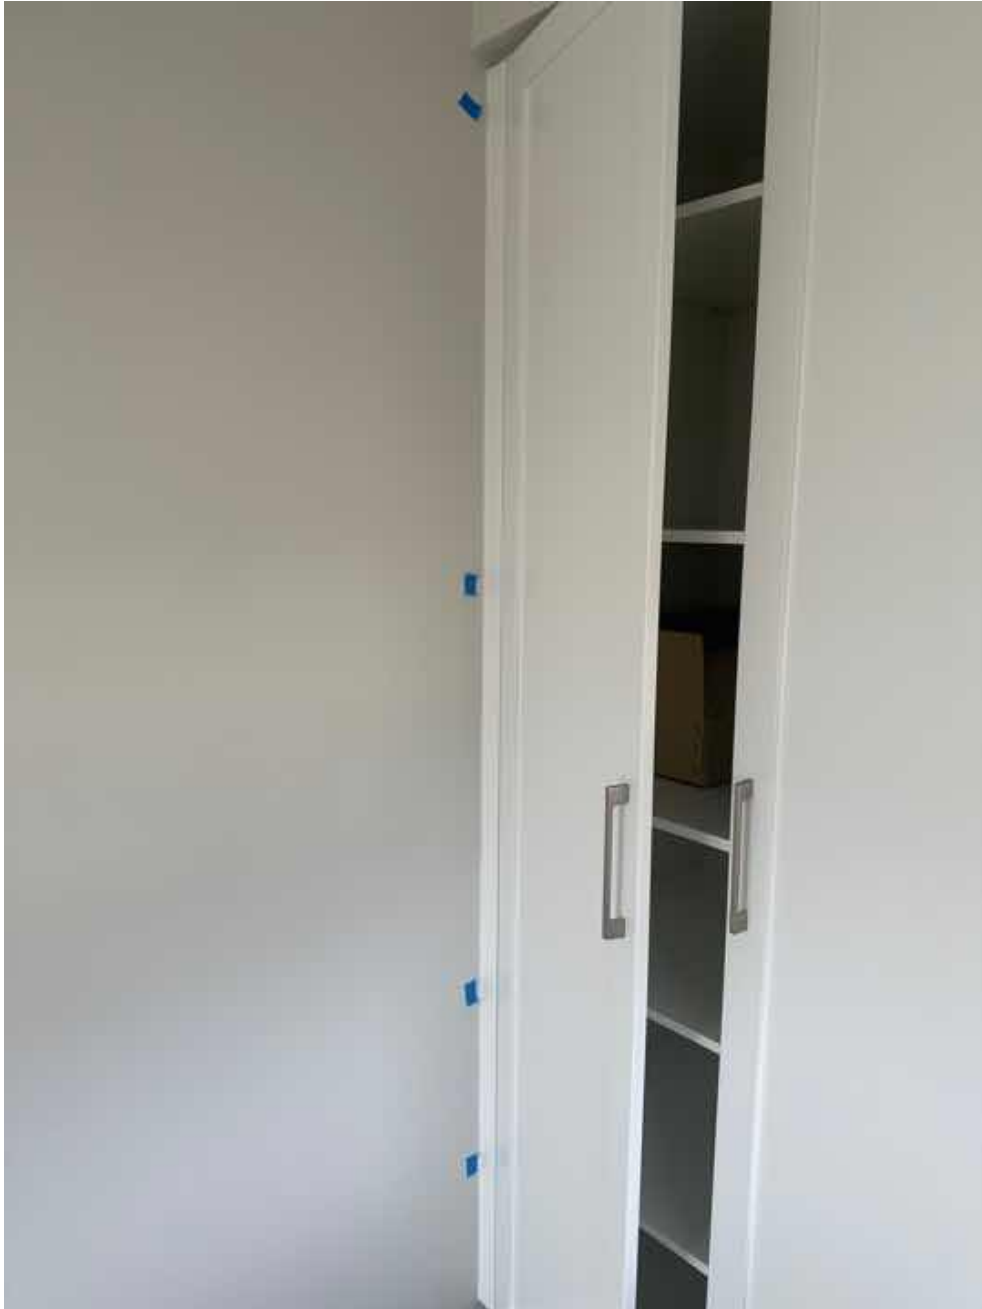
**Walls**

Paint touch ups required.
