# Inspection Report

**UNCOVER**  
BUILDING AND PEST INSPECTIONS

**1 Sample St , Sample, Nsw, 2281**

### Handover Inspection

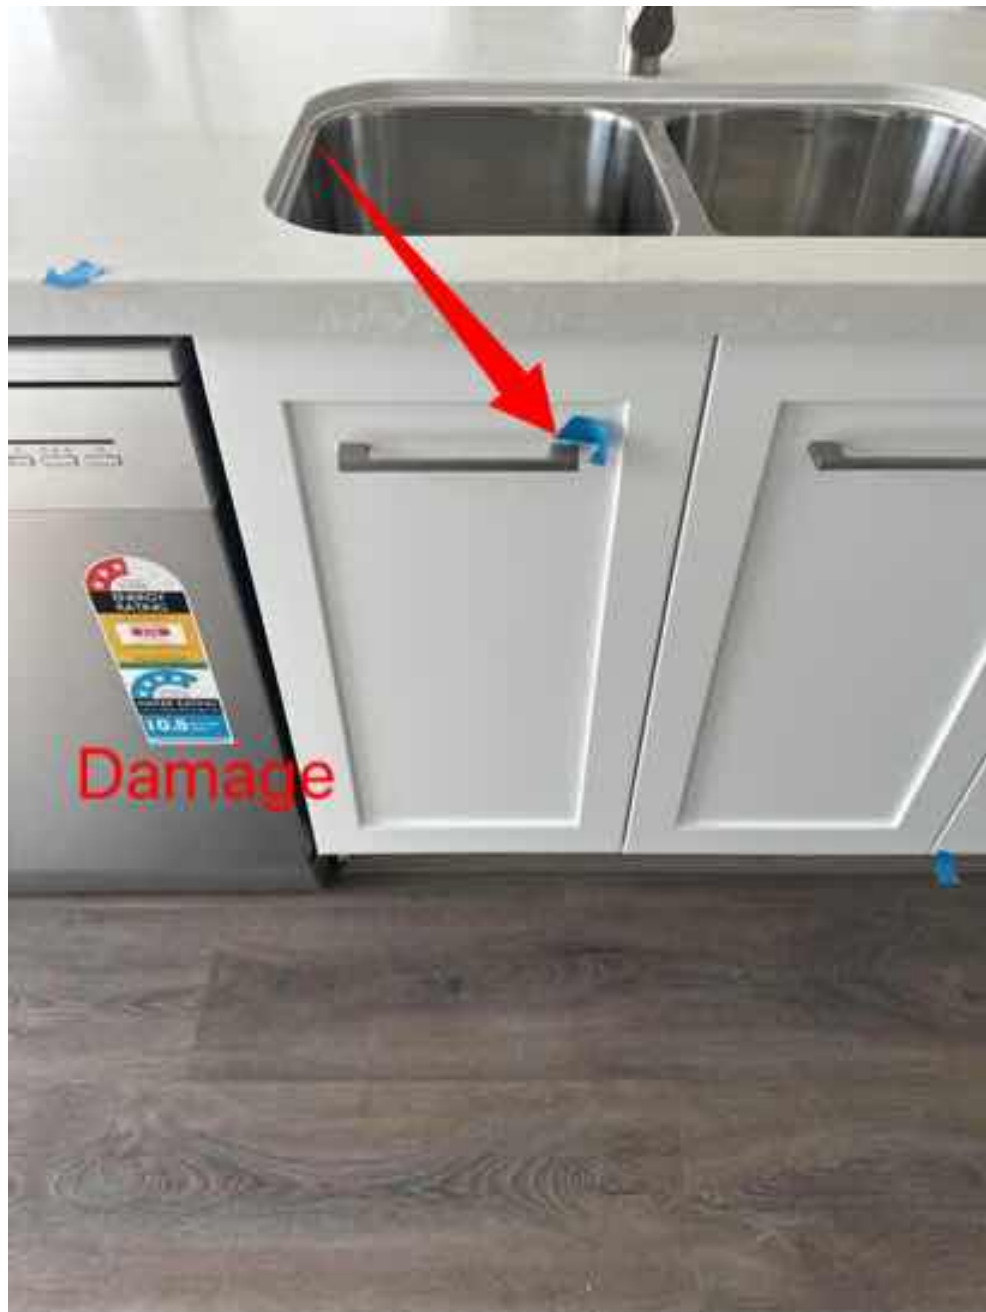
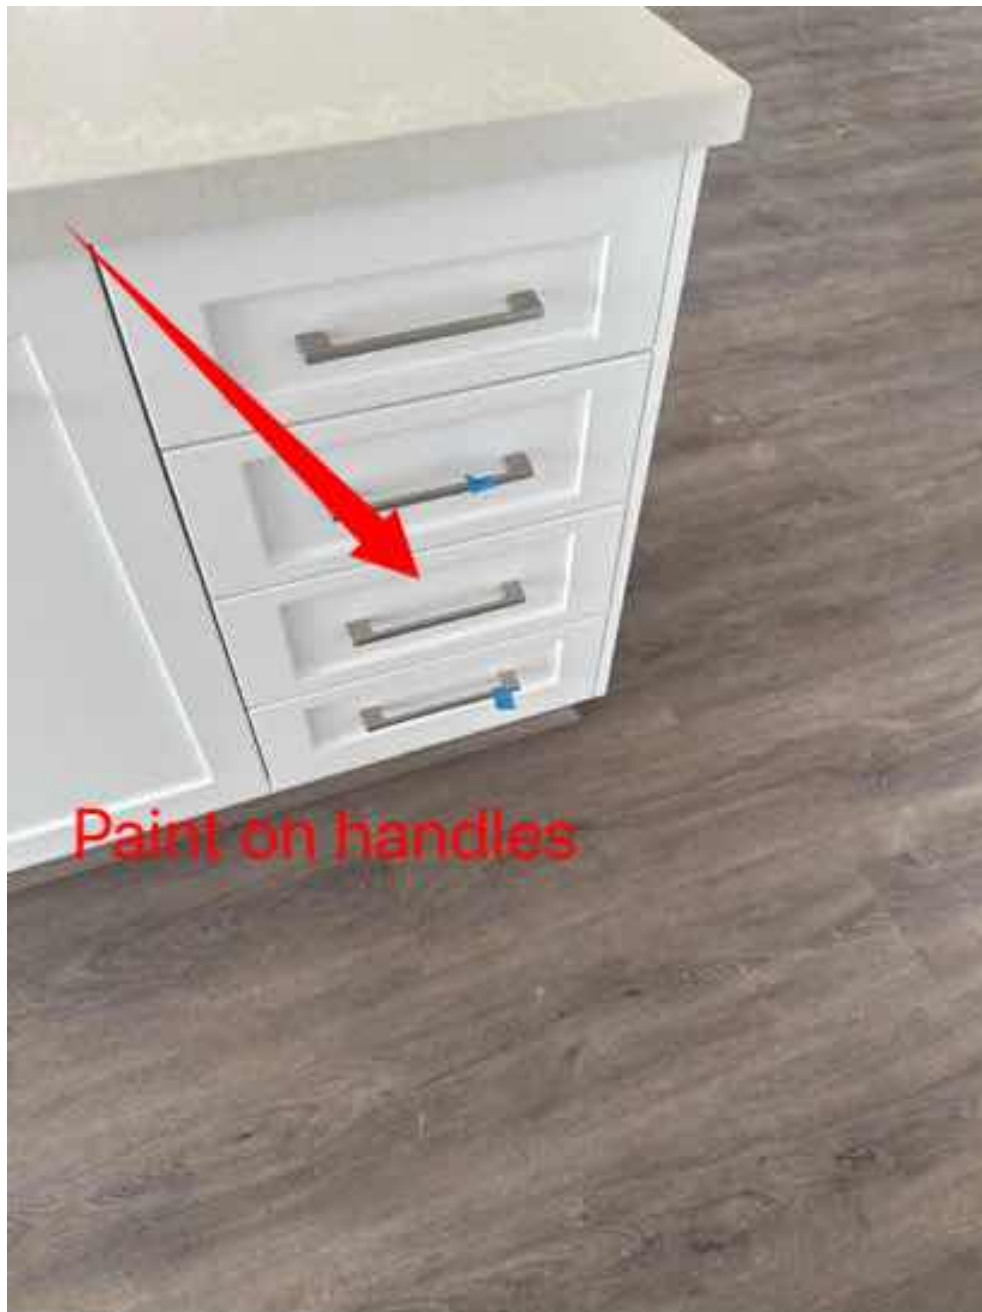
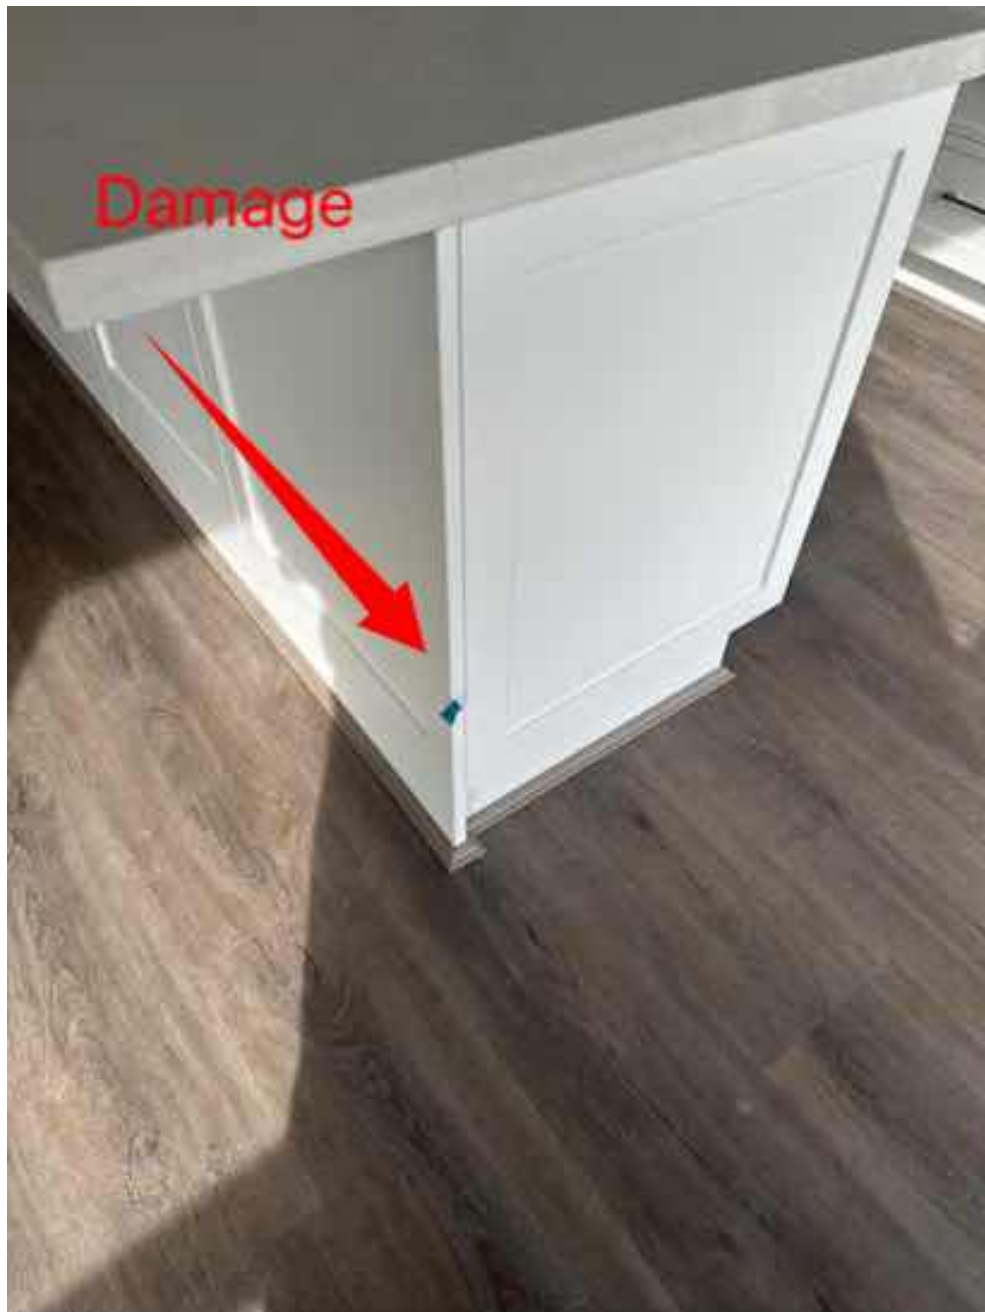
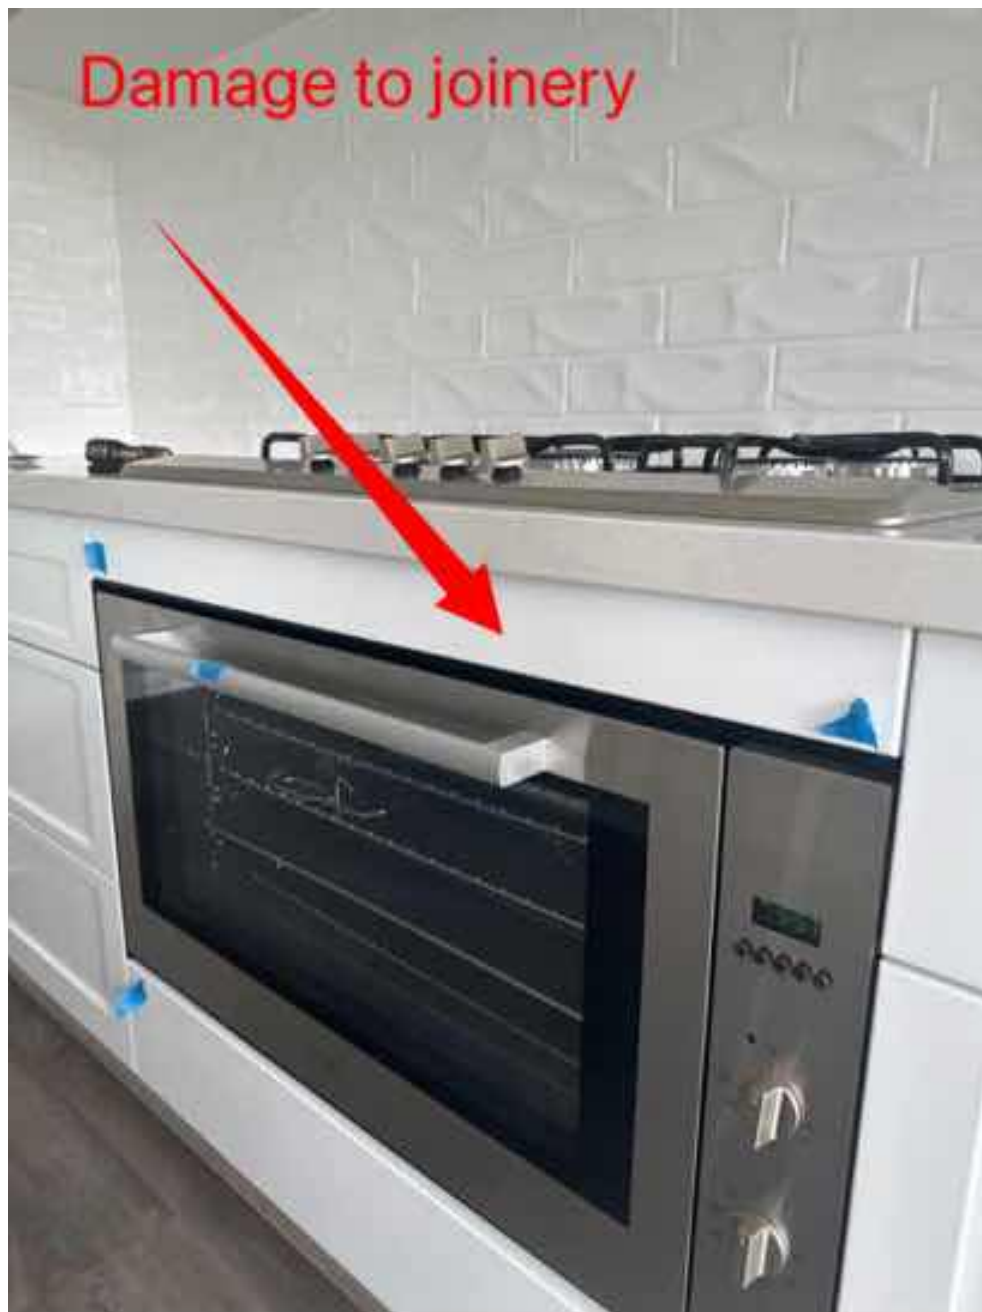
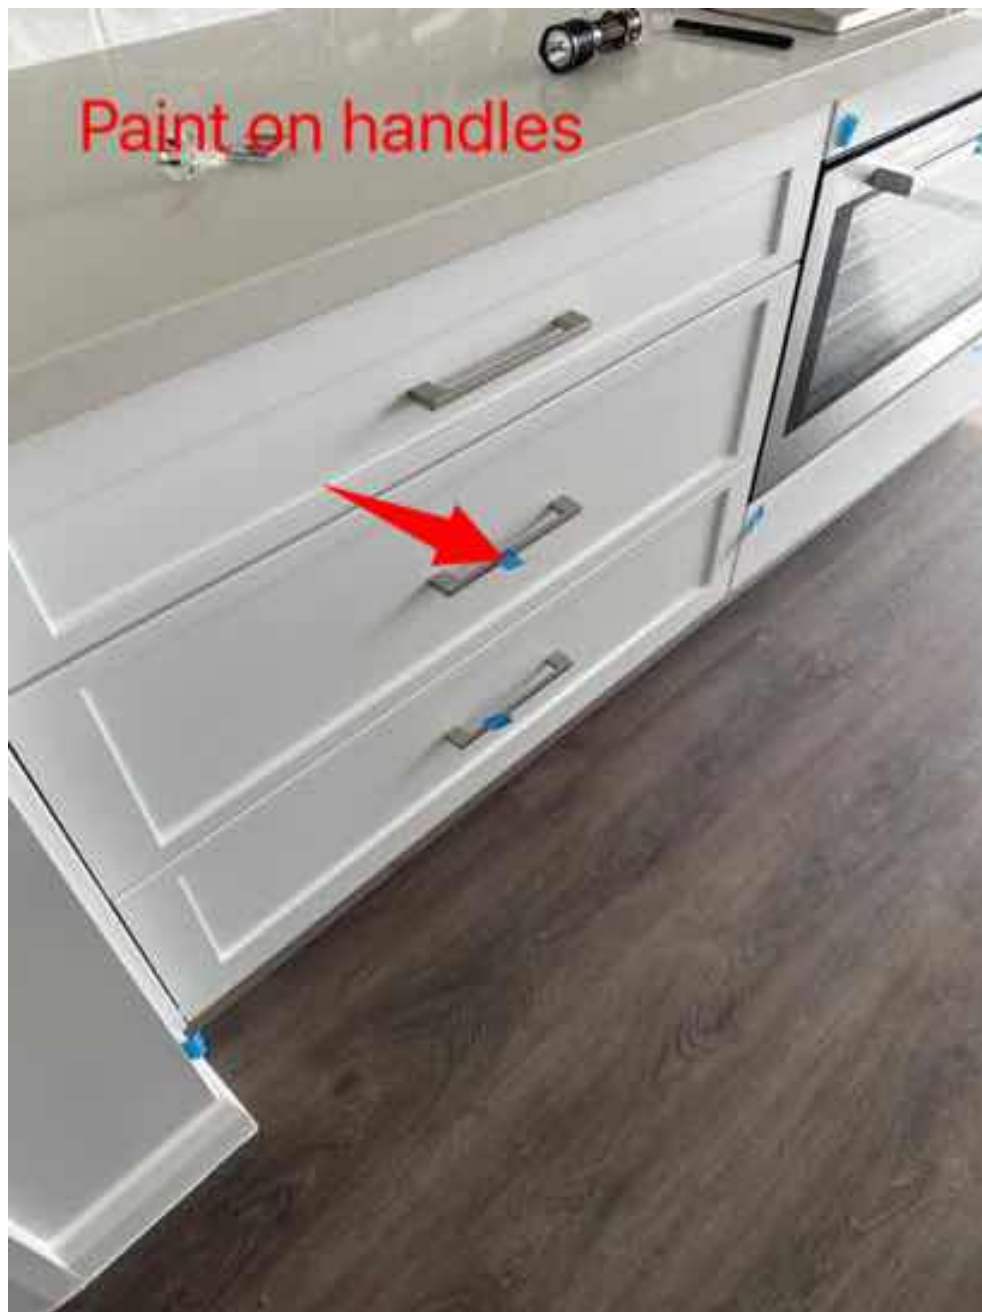
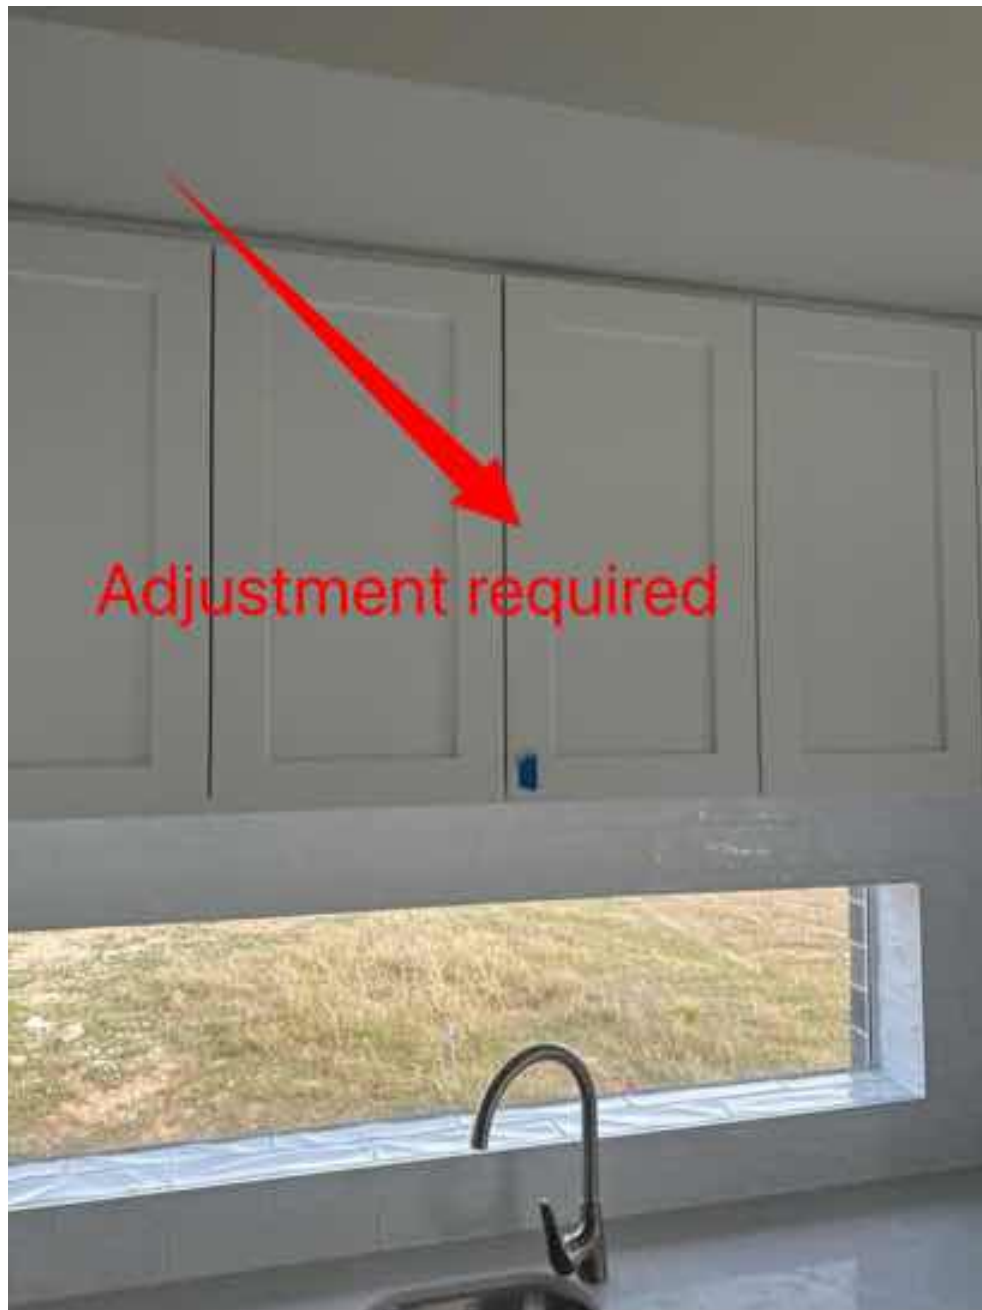
## Sink & Joinery

Chips/Damage/Dents was noted to the cabinets from a normal viewing position which is 600mm. Rectification required.

Cabinet doors/drawers require adjusting for consistent gaps. NSW Guide for Standards and Tolerances 2017 -section 11.4 "cabinet door and draw fronts are defective if they are not aligned, or do not have consistent gaps between them at handover"

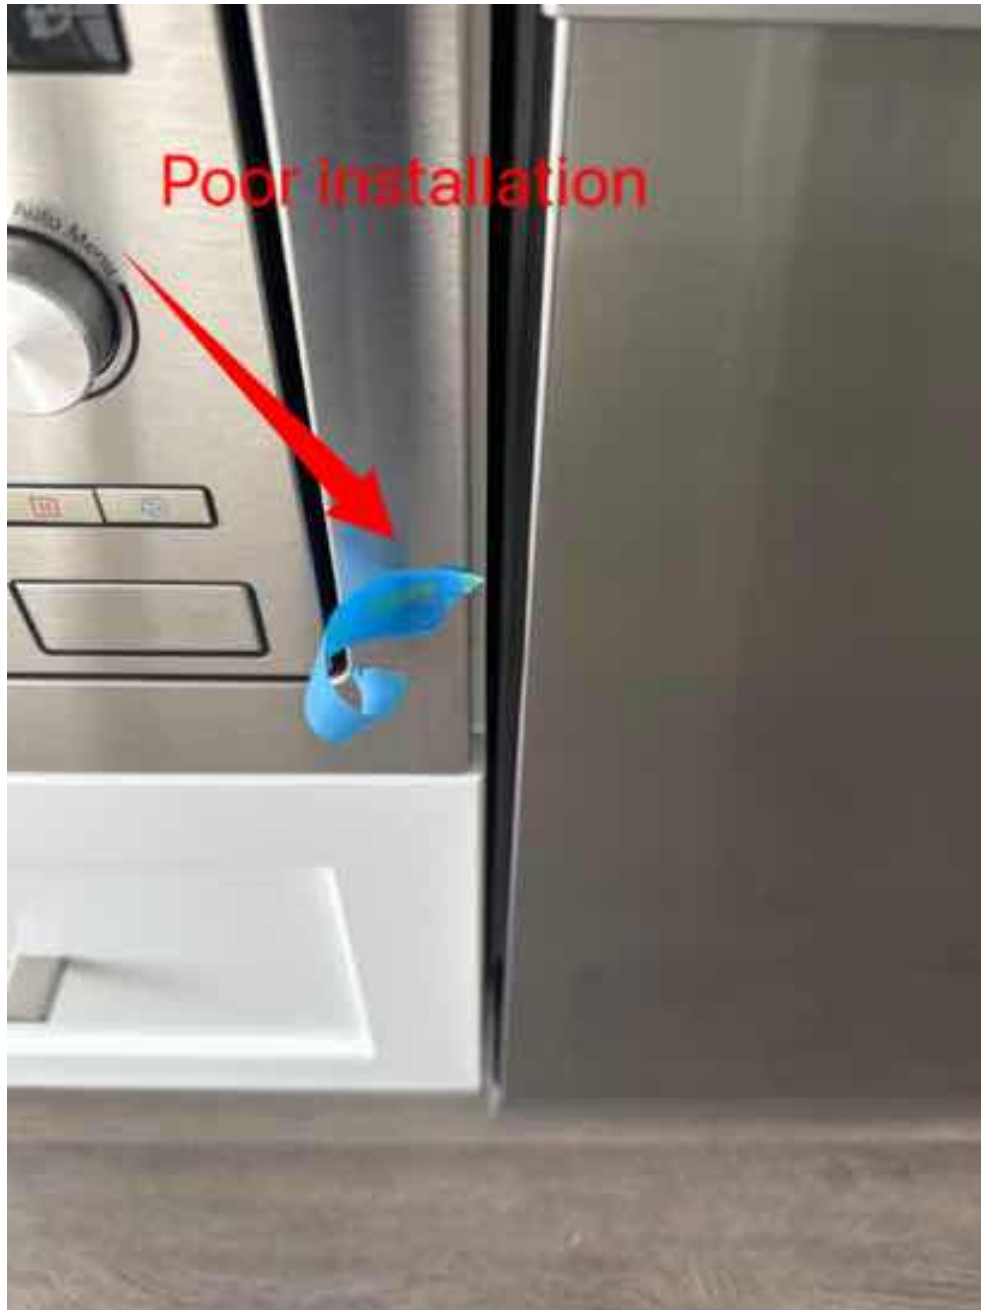
## Appliances

The microwave has been poorly installed. The microwave should be centred with the door below. Amendment required.

The oven is not installed correctly. It is out of parallel with the joinery. Amendment required.

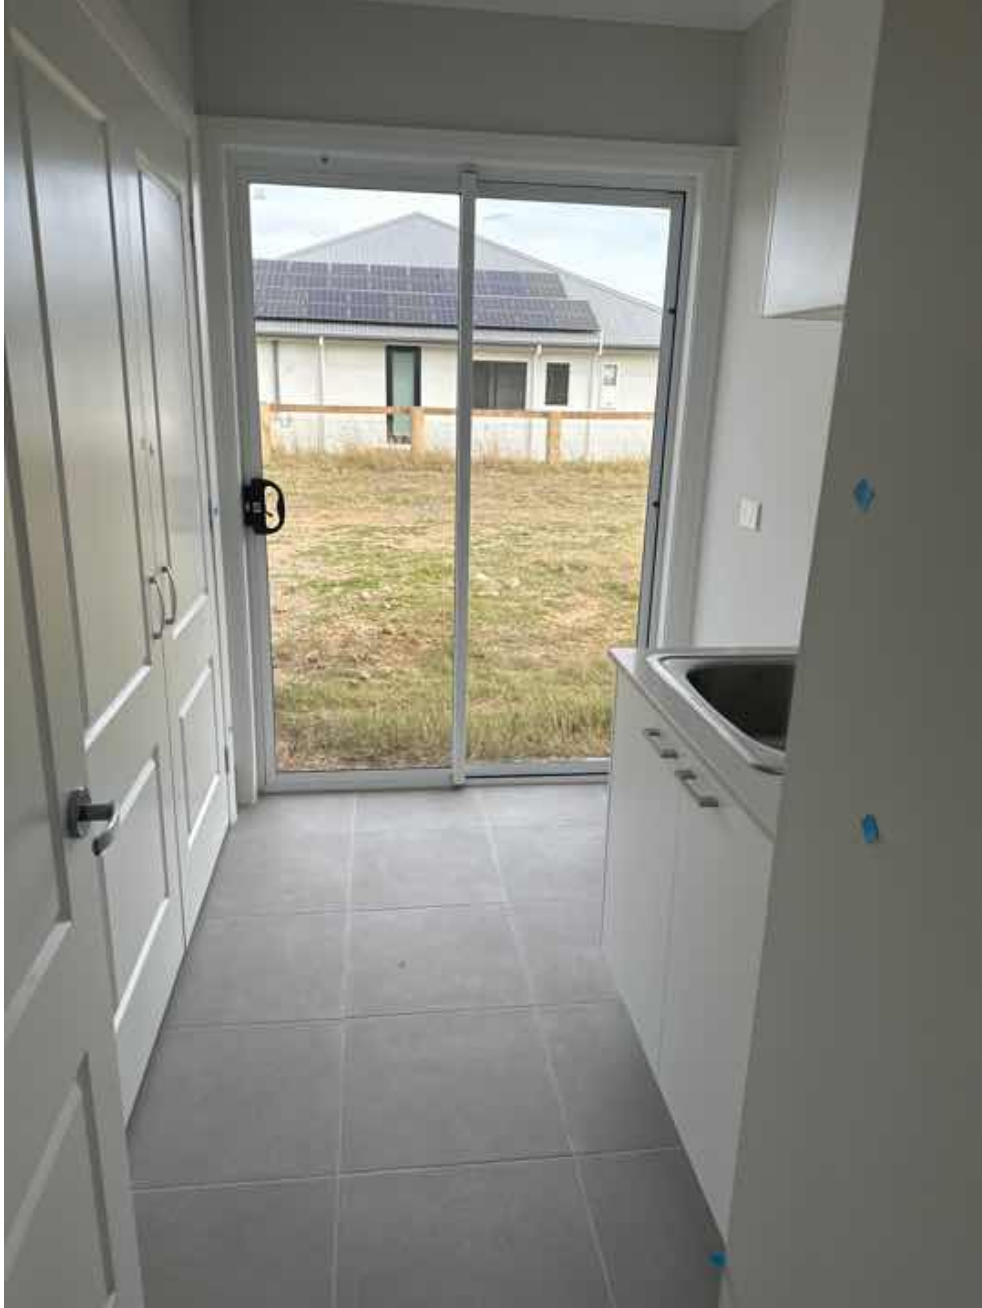
Rectification work required.

Clean required.

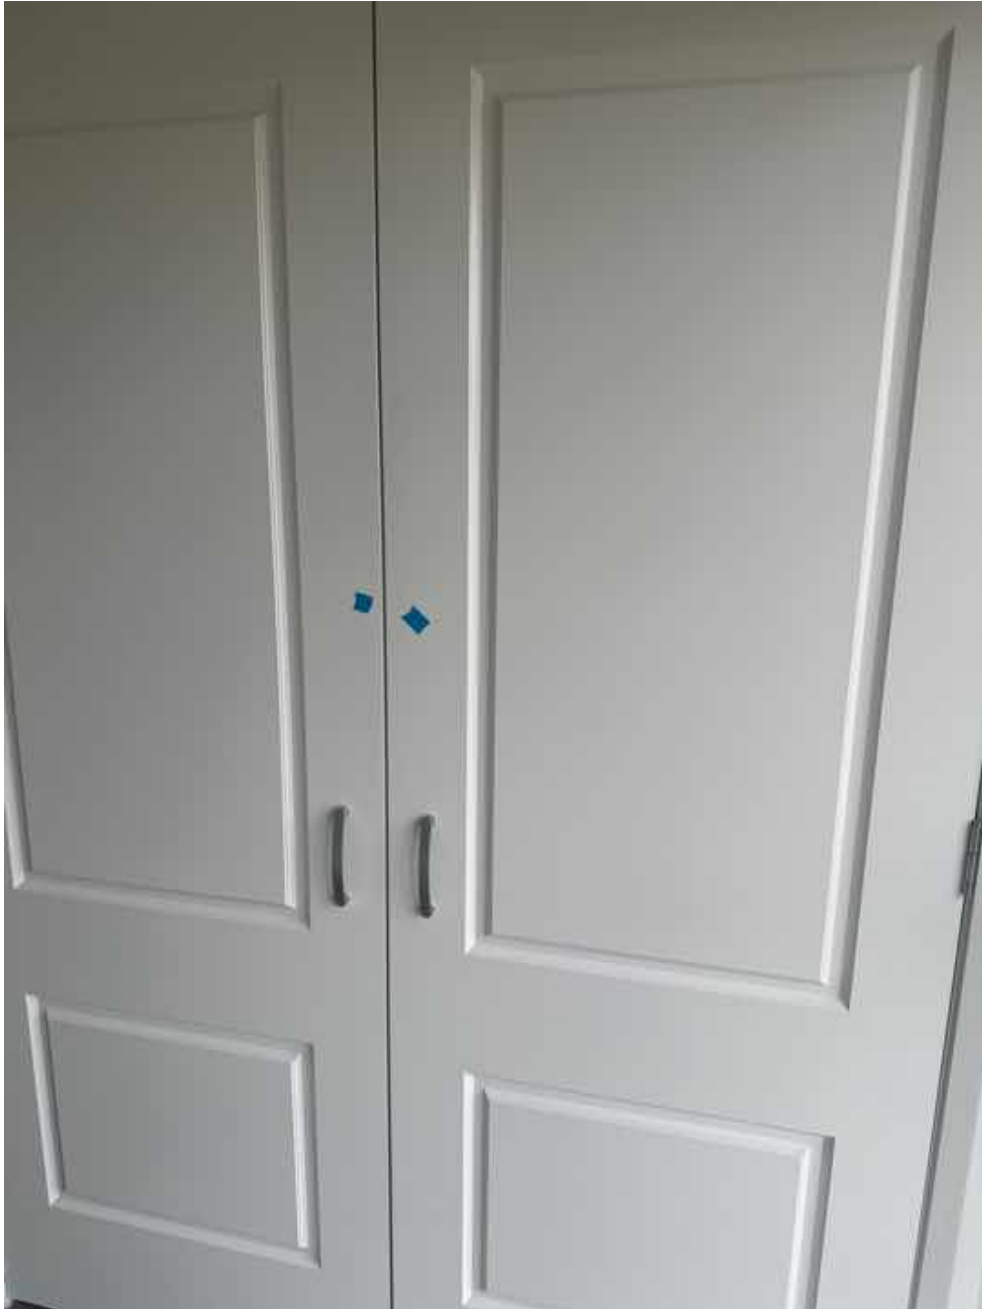
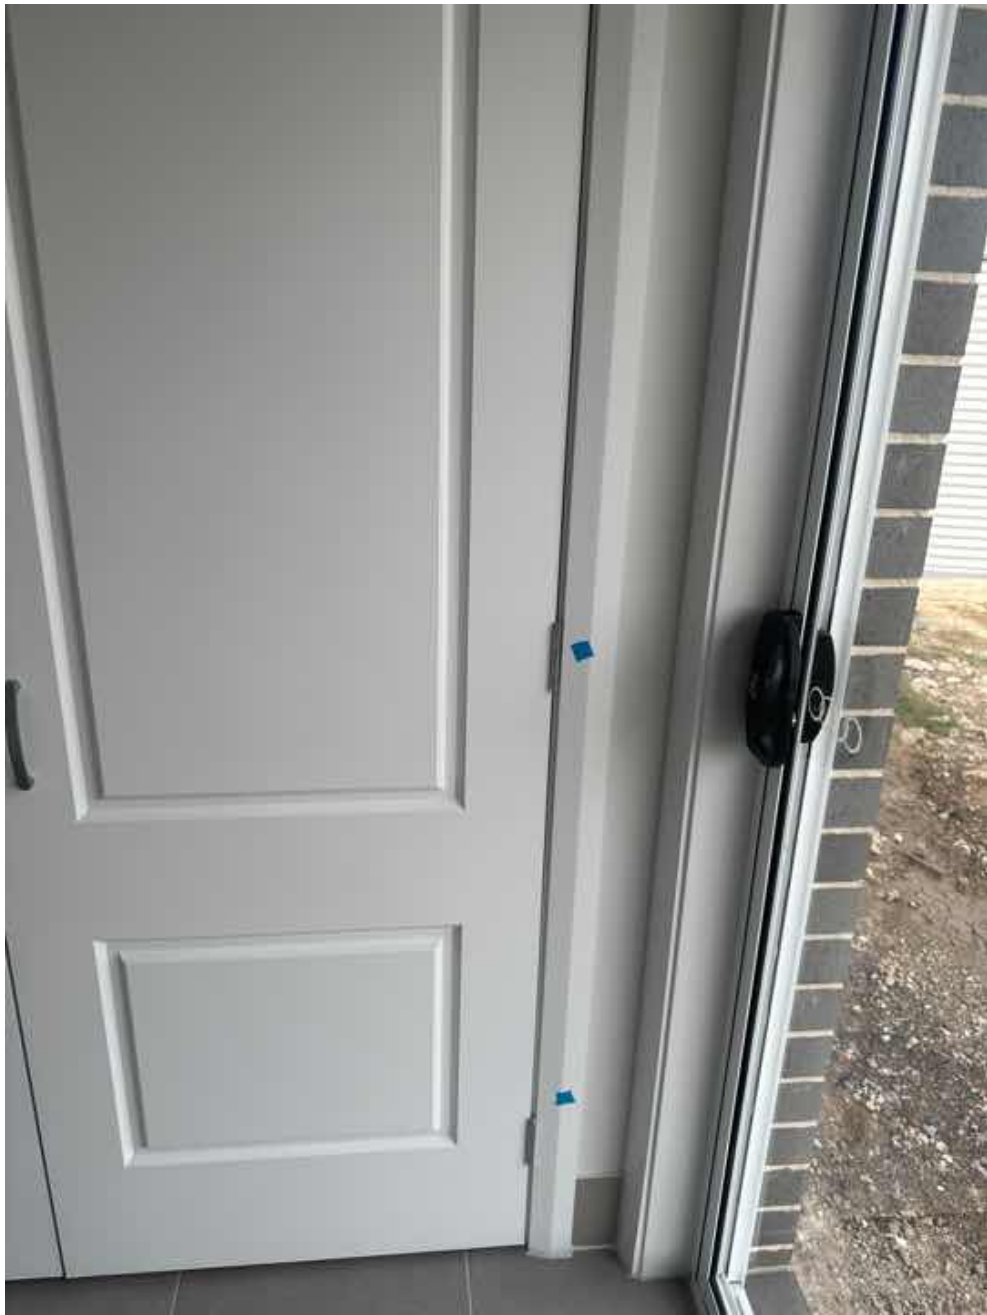
**Door**

Paint touch ups required.

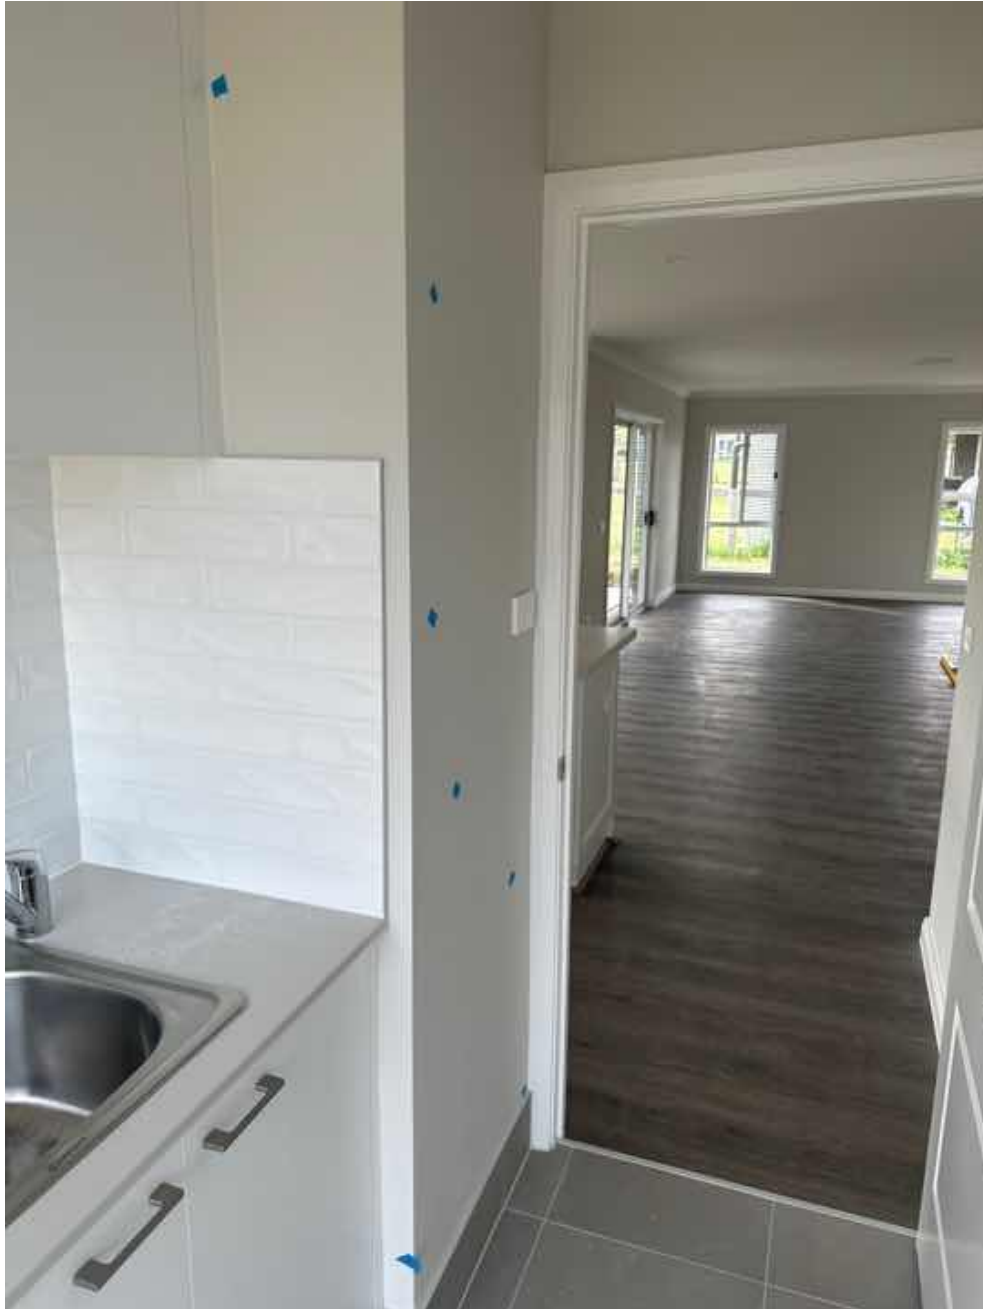
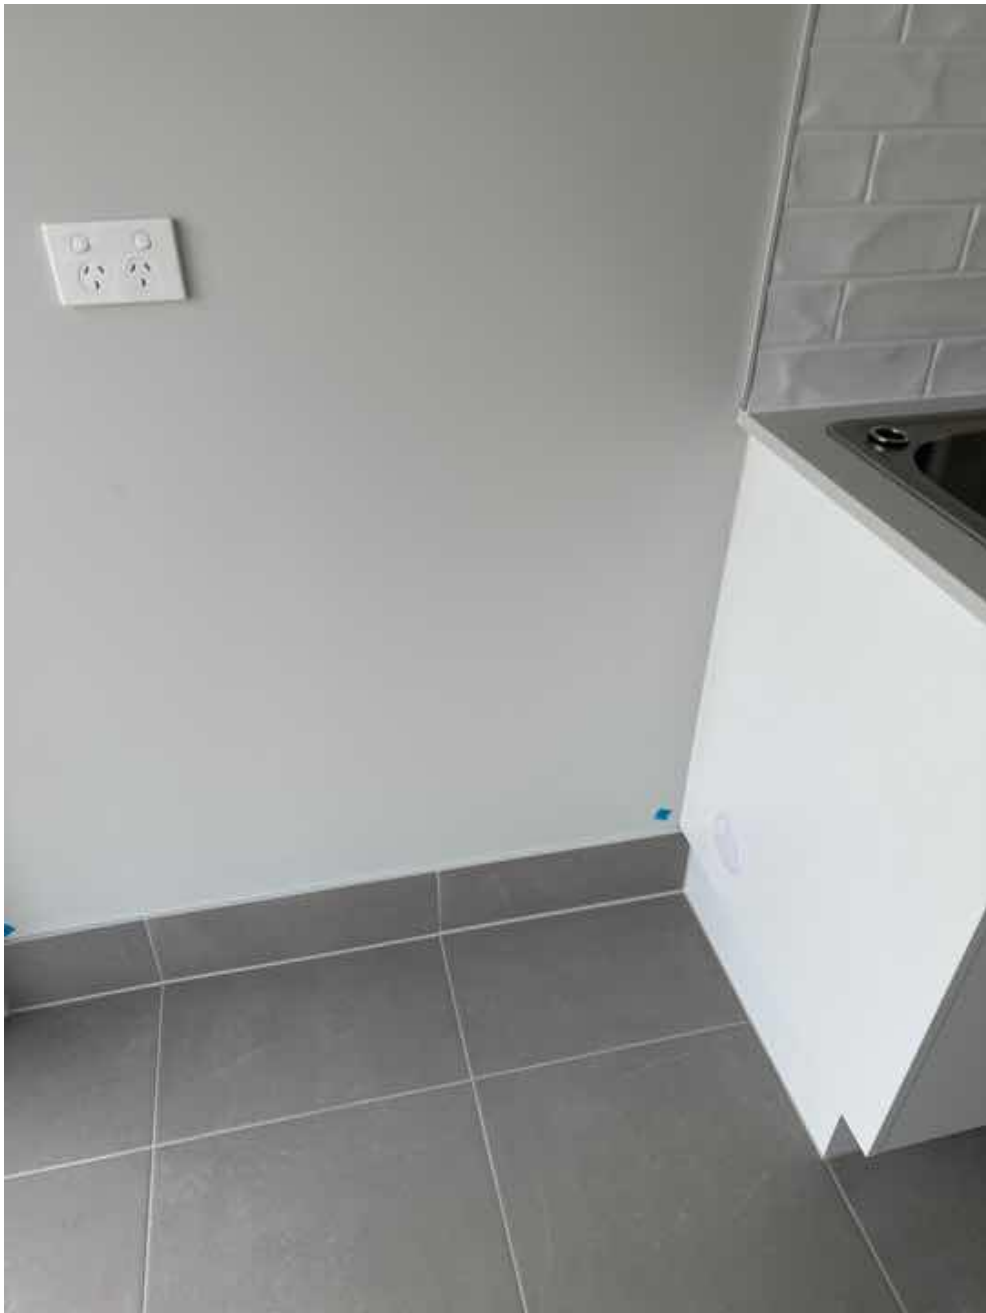
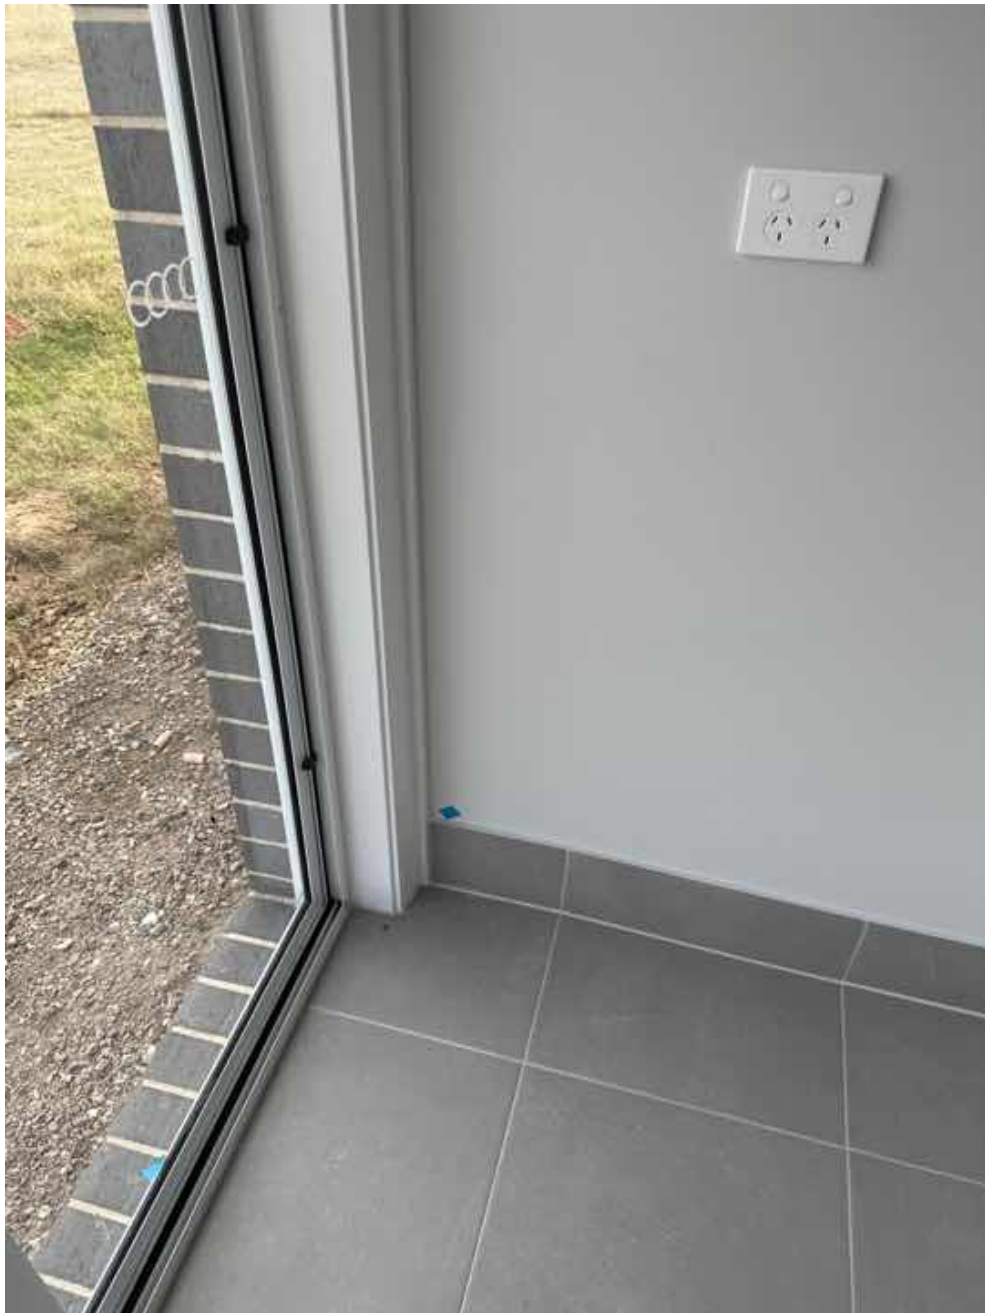
**Walls**

Paint touch ups required.

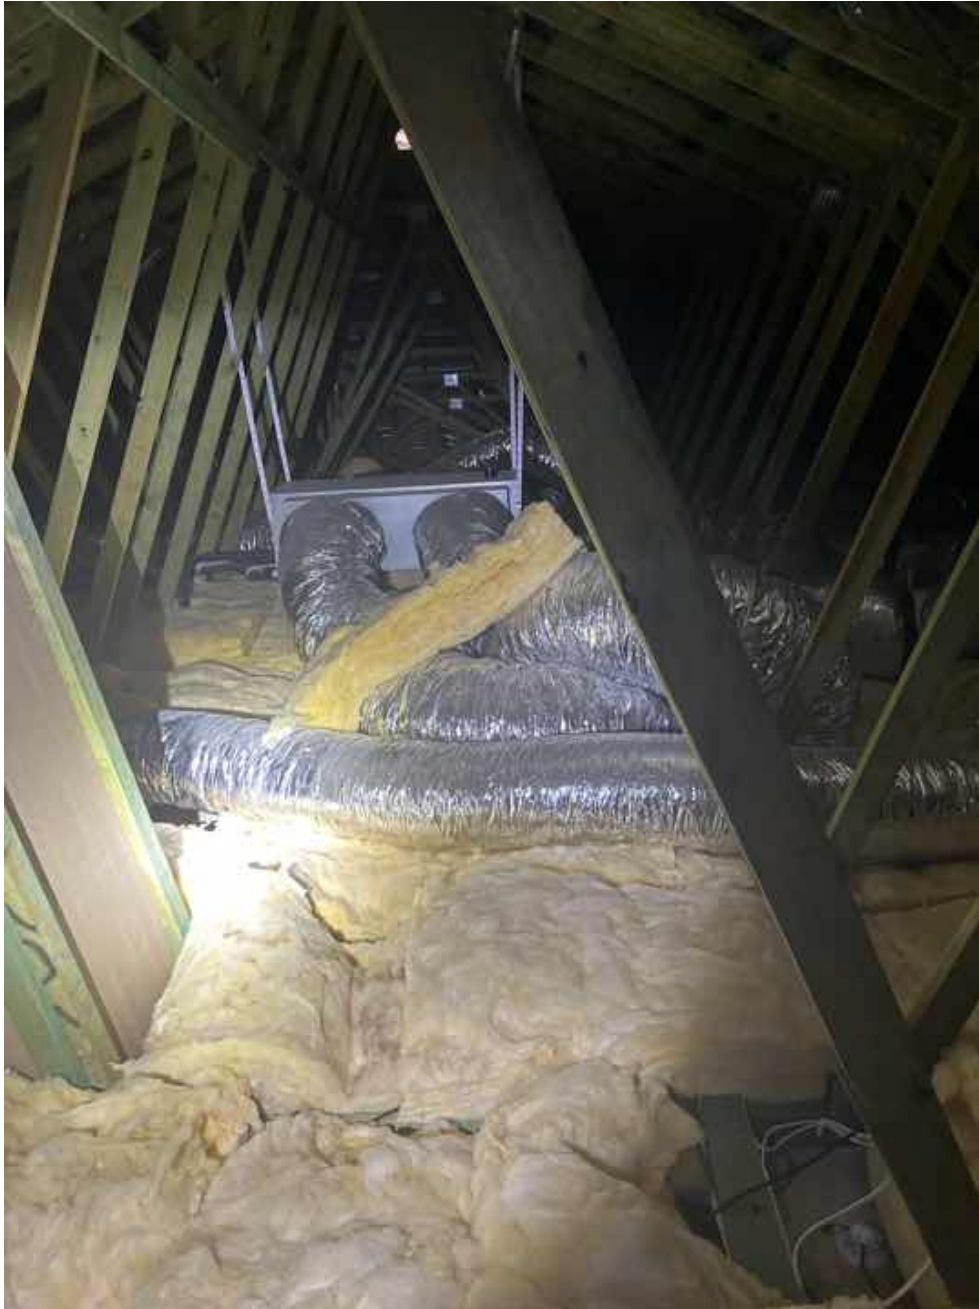
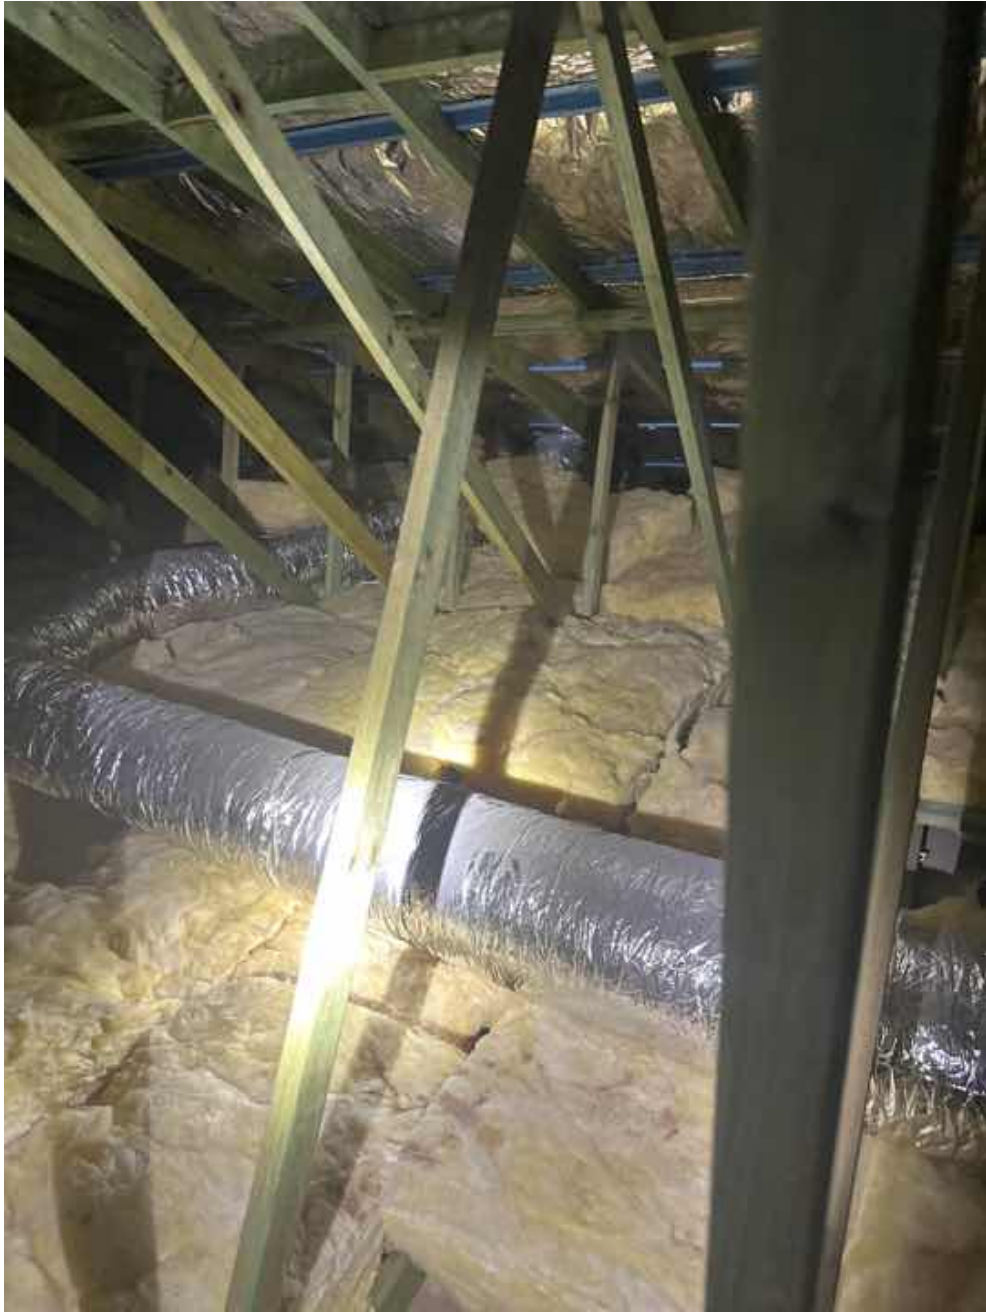
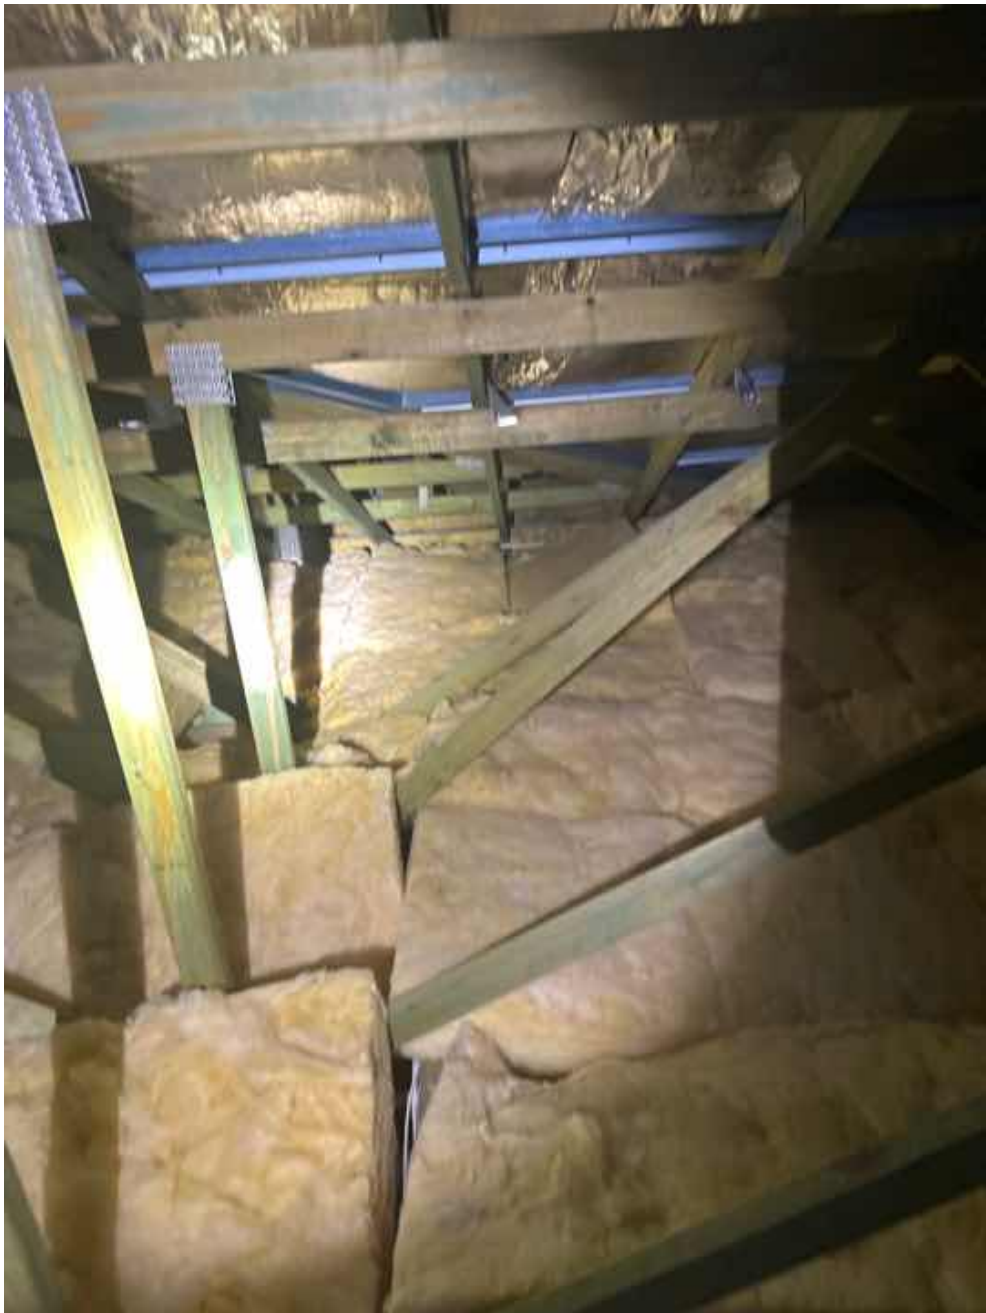
There is insulation present in the roof space/void. This is preventing a full inspection of ceiling joists from being undertaken.

There is low clearance in areas throughout the roof void which is preventing a full/thorough visual inspection taking place.
