# Inspection Report

**UNCOVER**  
BUILDING AND PEST INSPECTIONS

**1 Sample St , Sample, Nsw, 2281**

### Handover Inspection

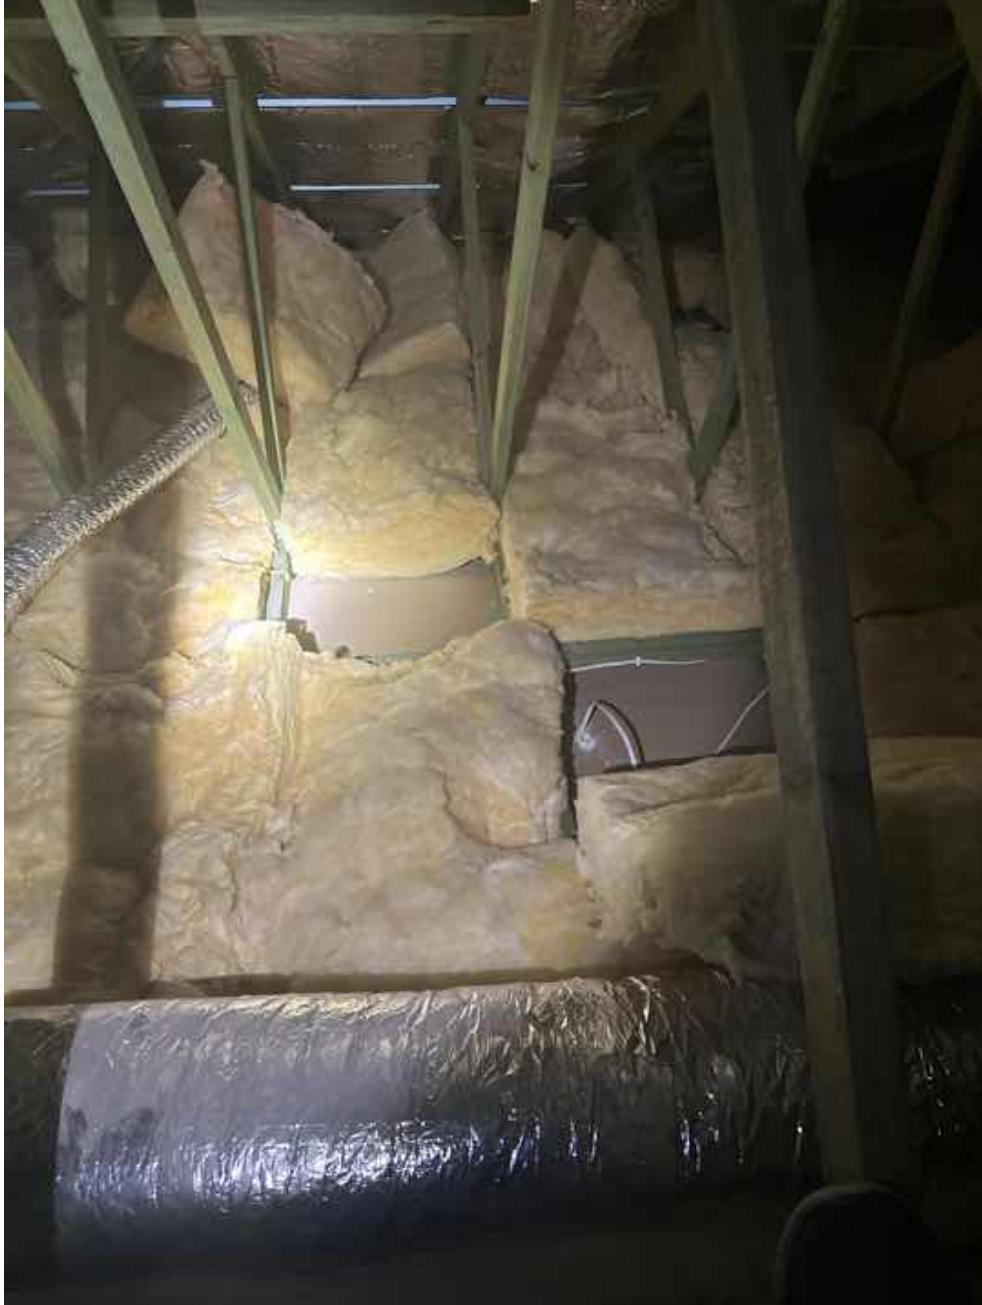
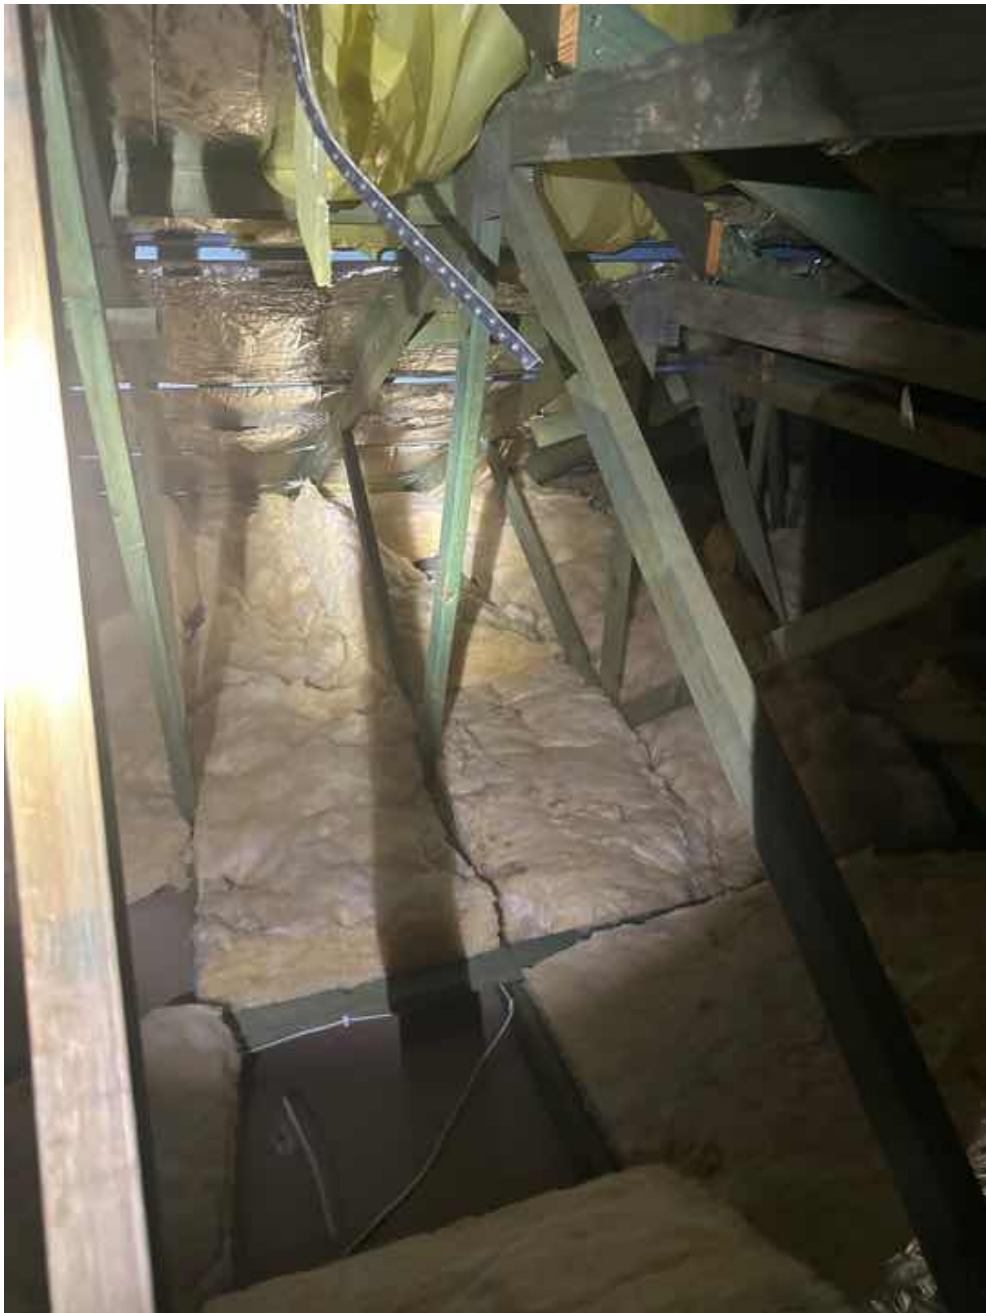
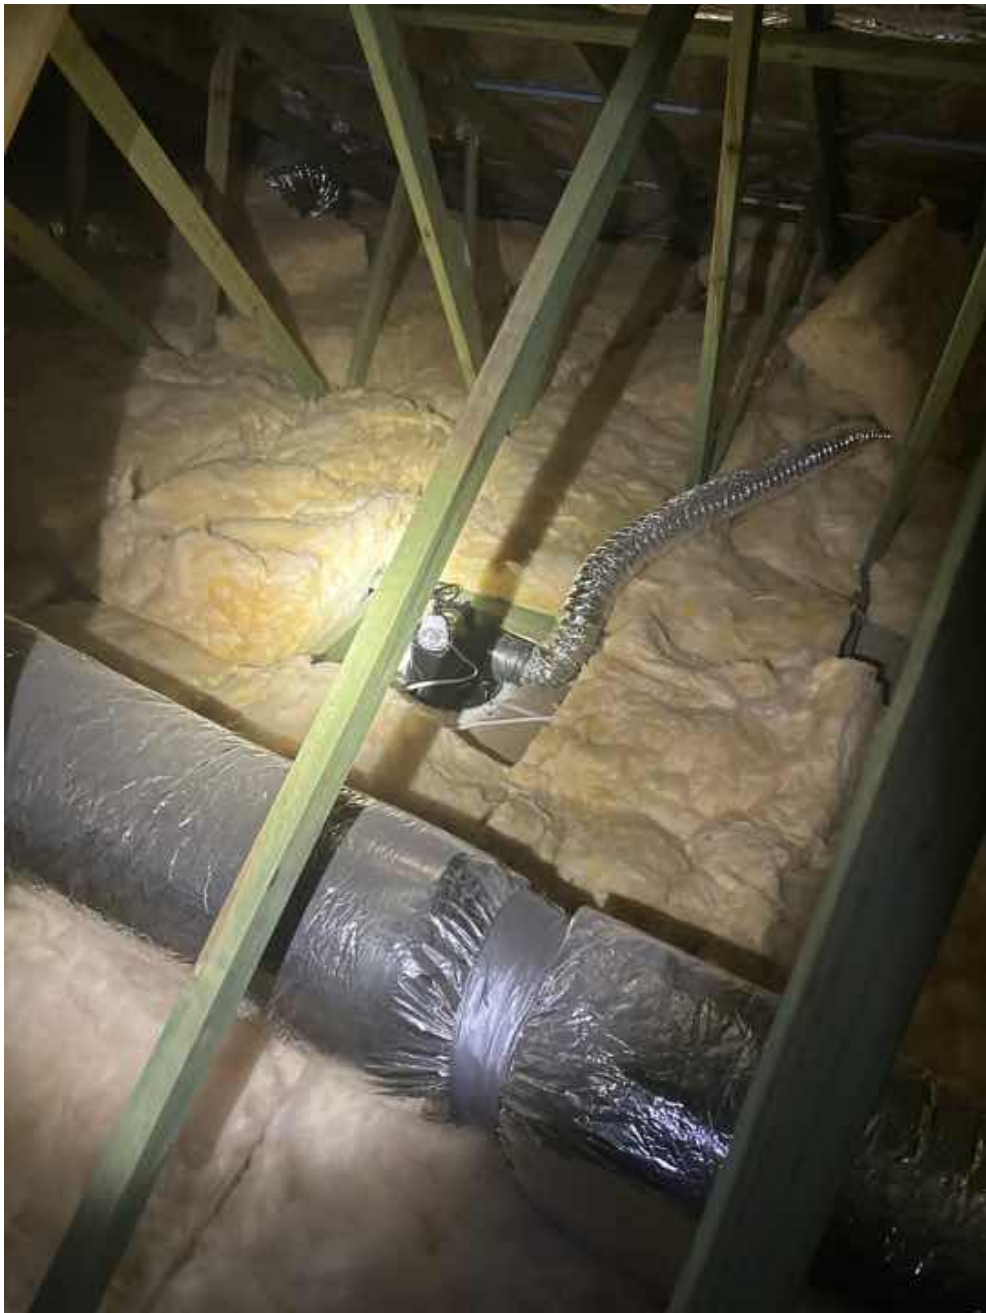
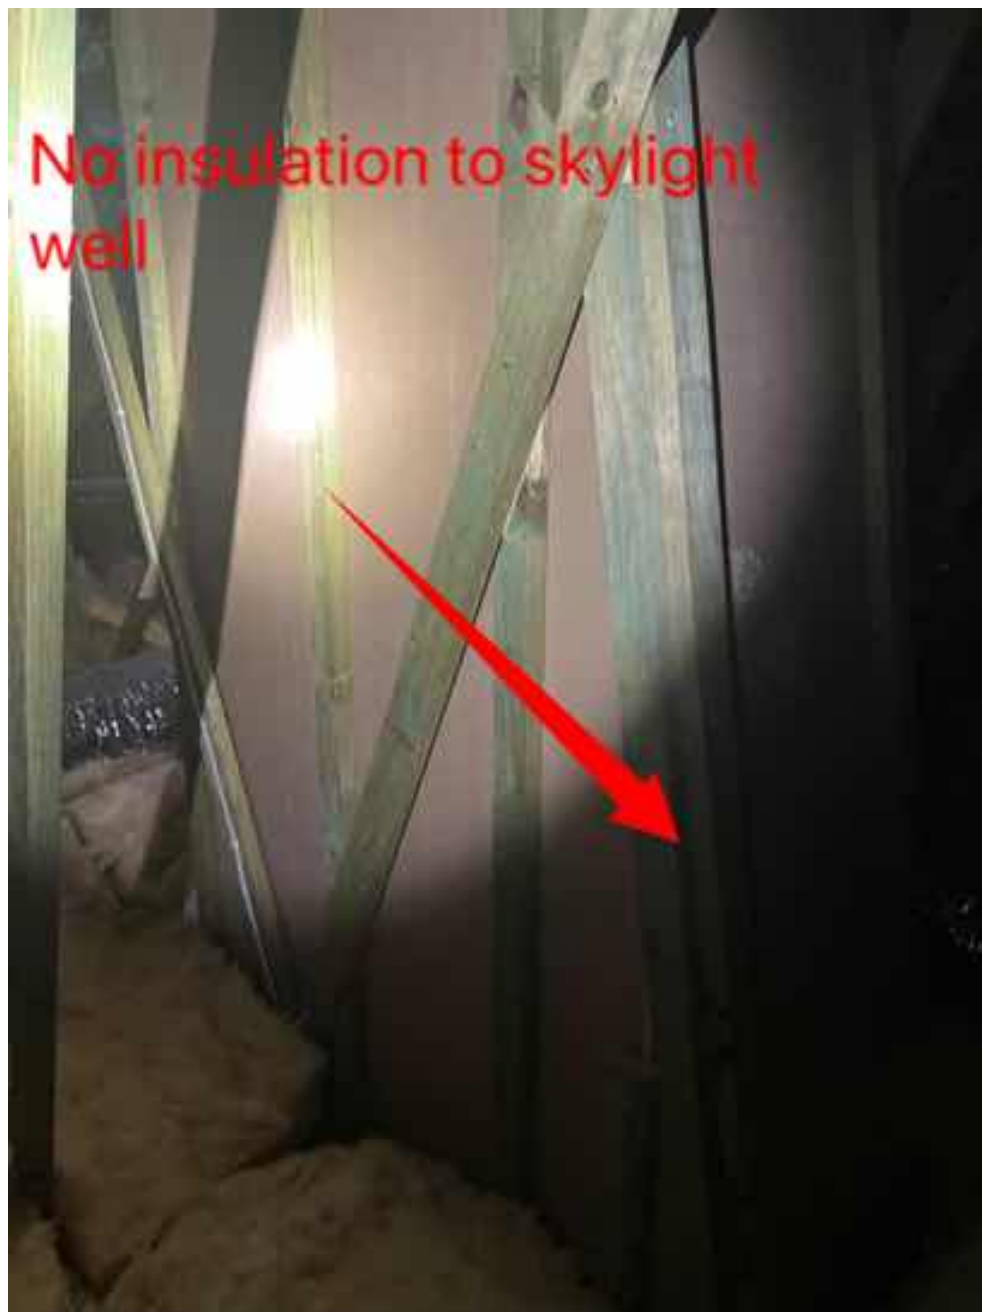
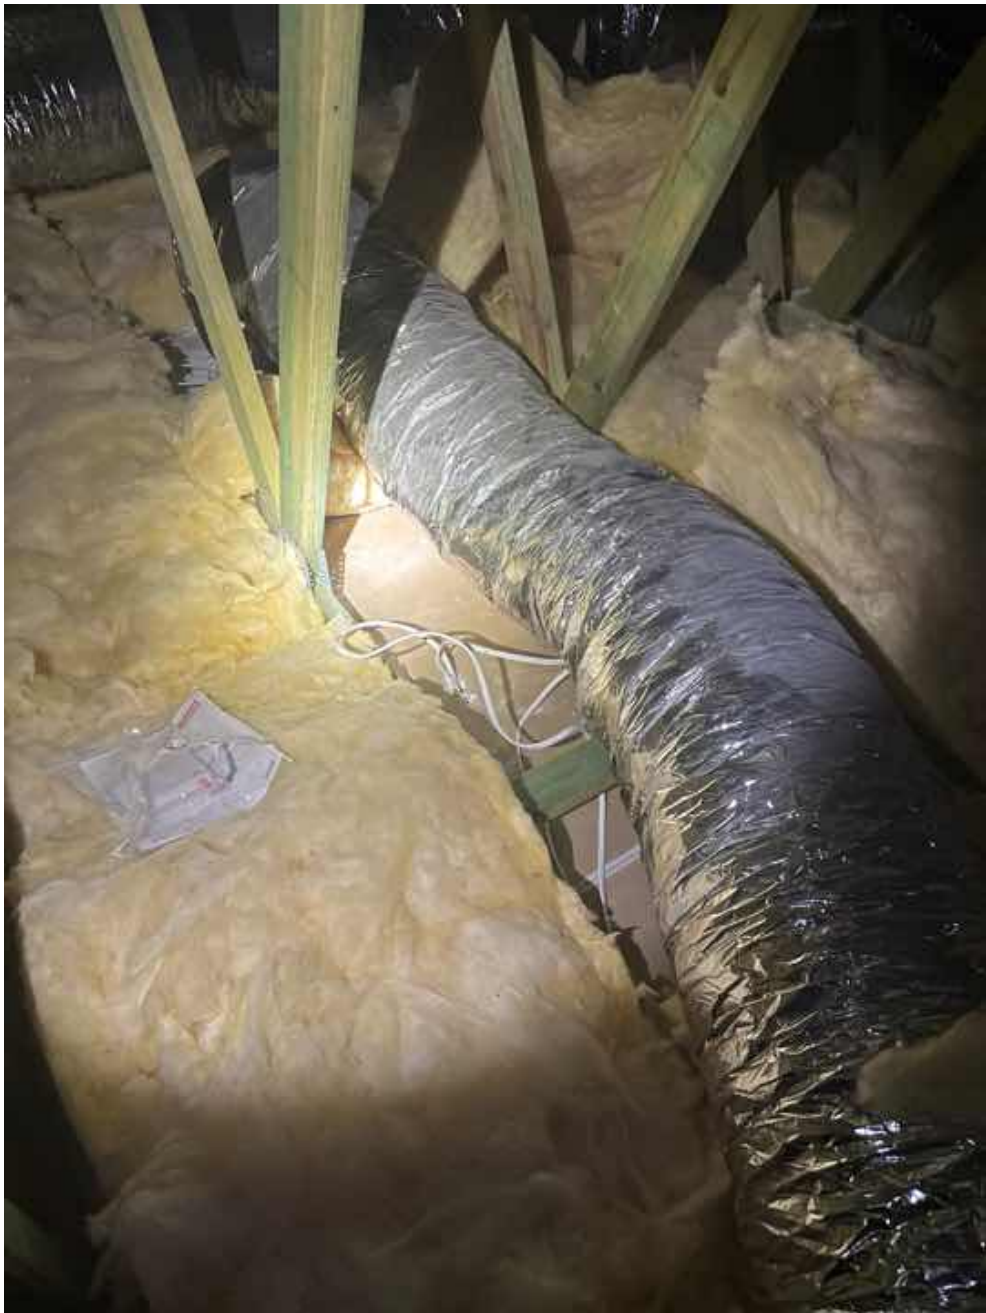
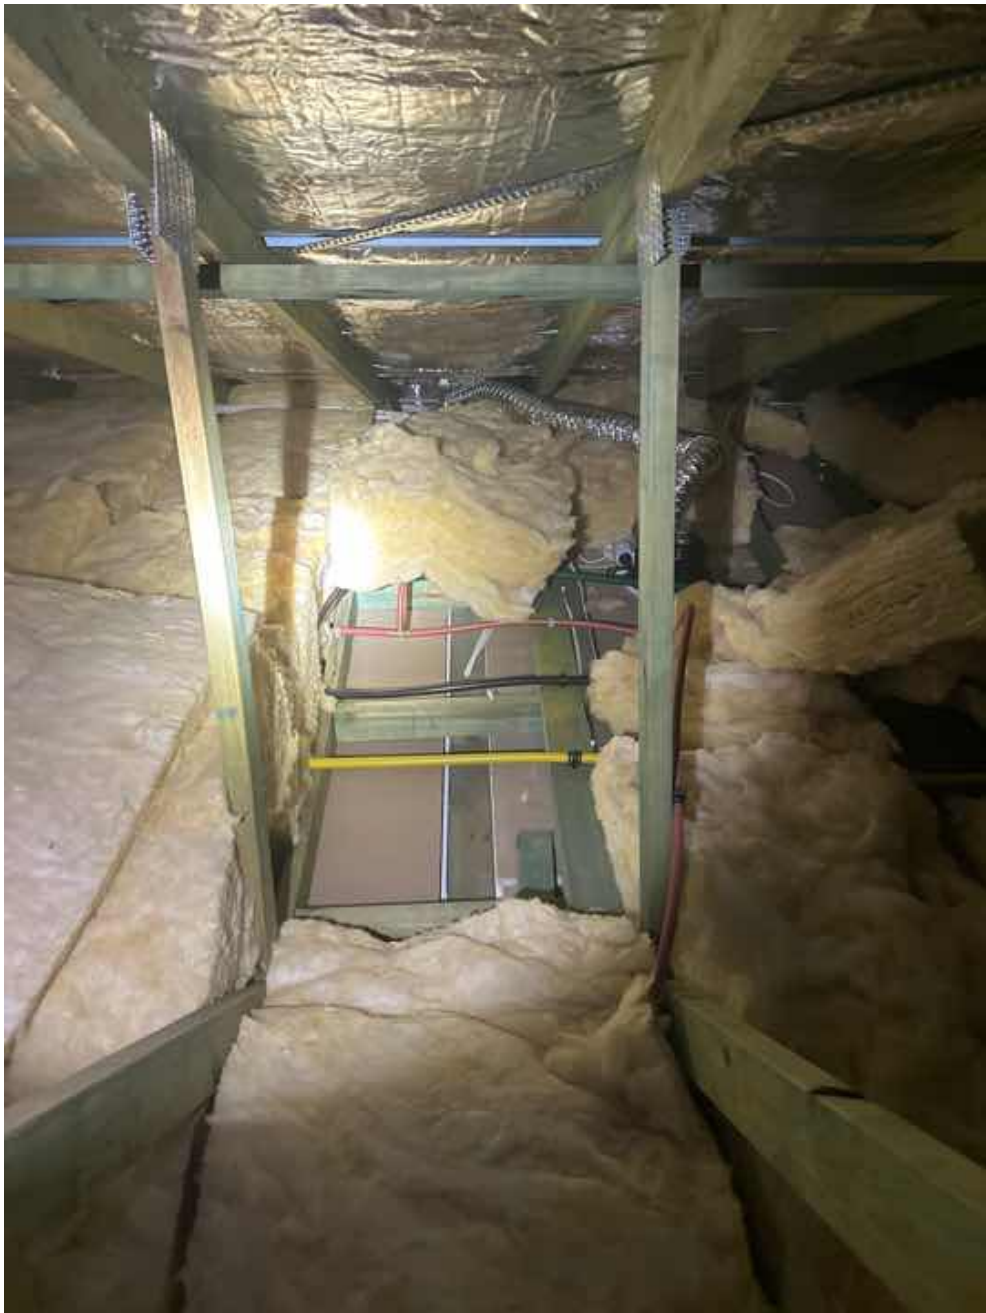
**Condition**

Sections of the insulation were poorly installed / laid with gaps visible in sections. The insulation industry indicates that gaps of 5% in insulation equals approximately 50% insulation loss.
